**CEMENT BARGE**  
(Associated with the stranding of the Greek freighter *Tanais*)

**Wreck Inspection Report**

27 October 1996

**Wreck Inspection Report**  
**Report - Dept. of Maritime Archaeology**  
**WA Maritime Museum, Wreck Inspection Report, No. 117.**

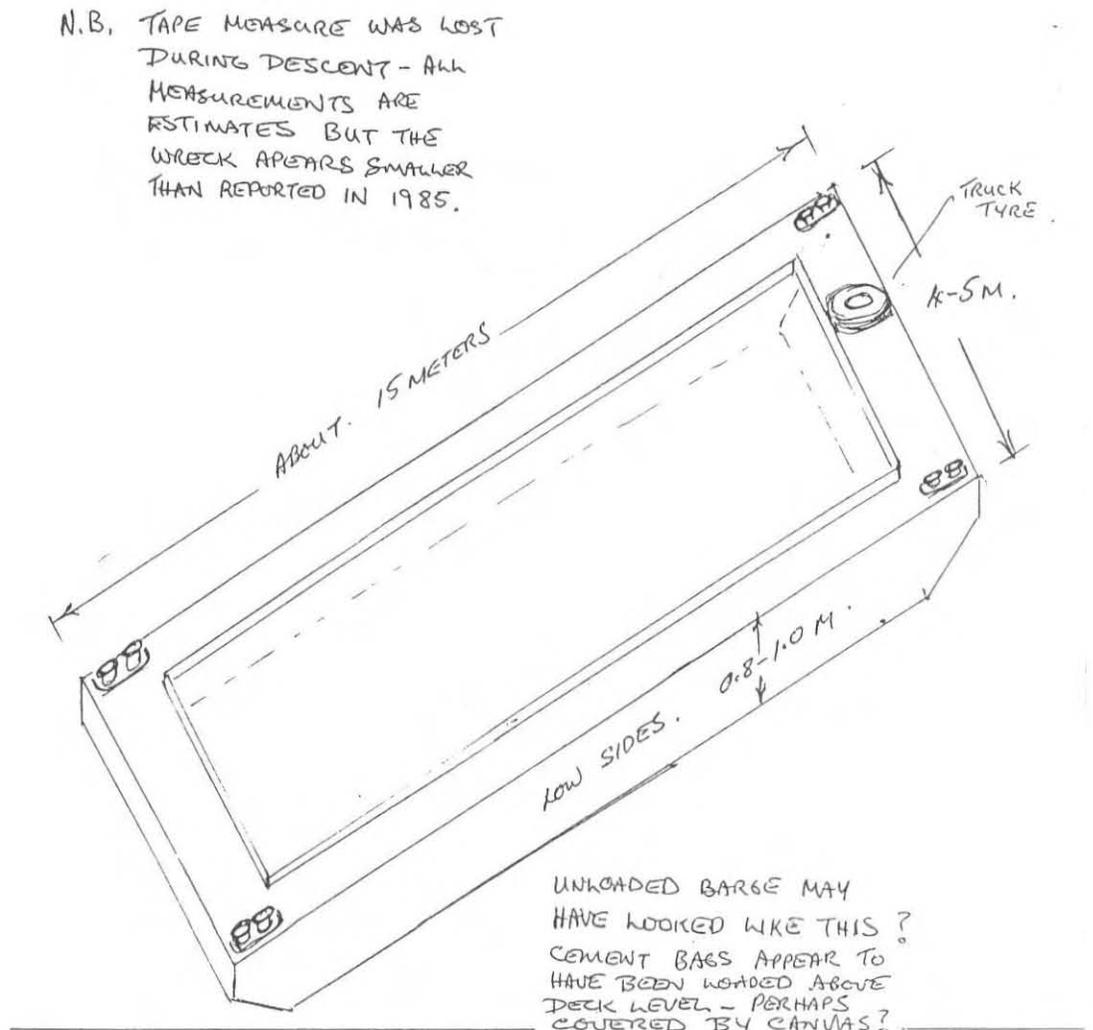
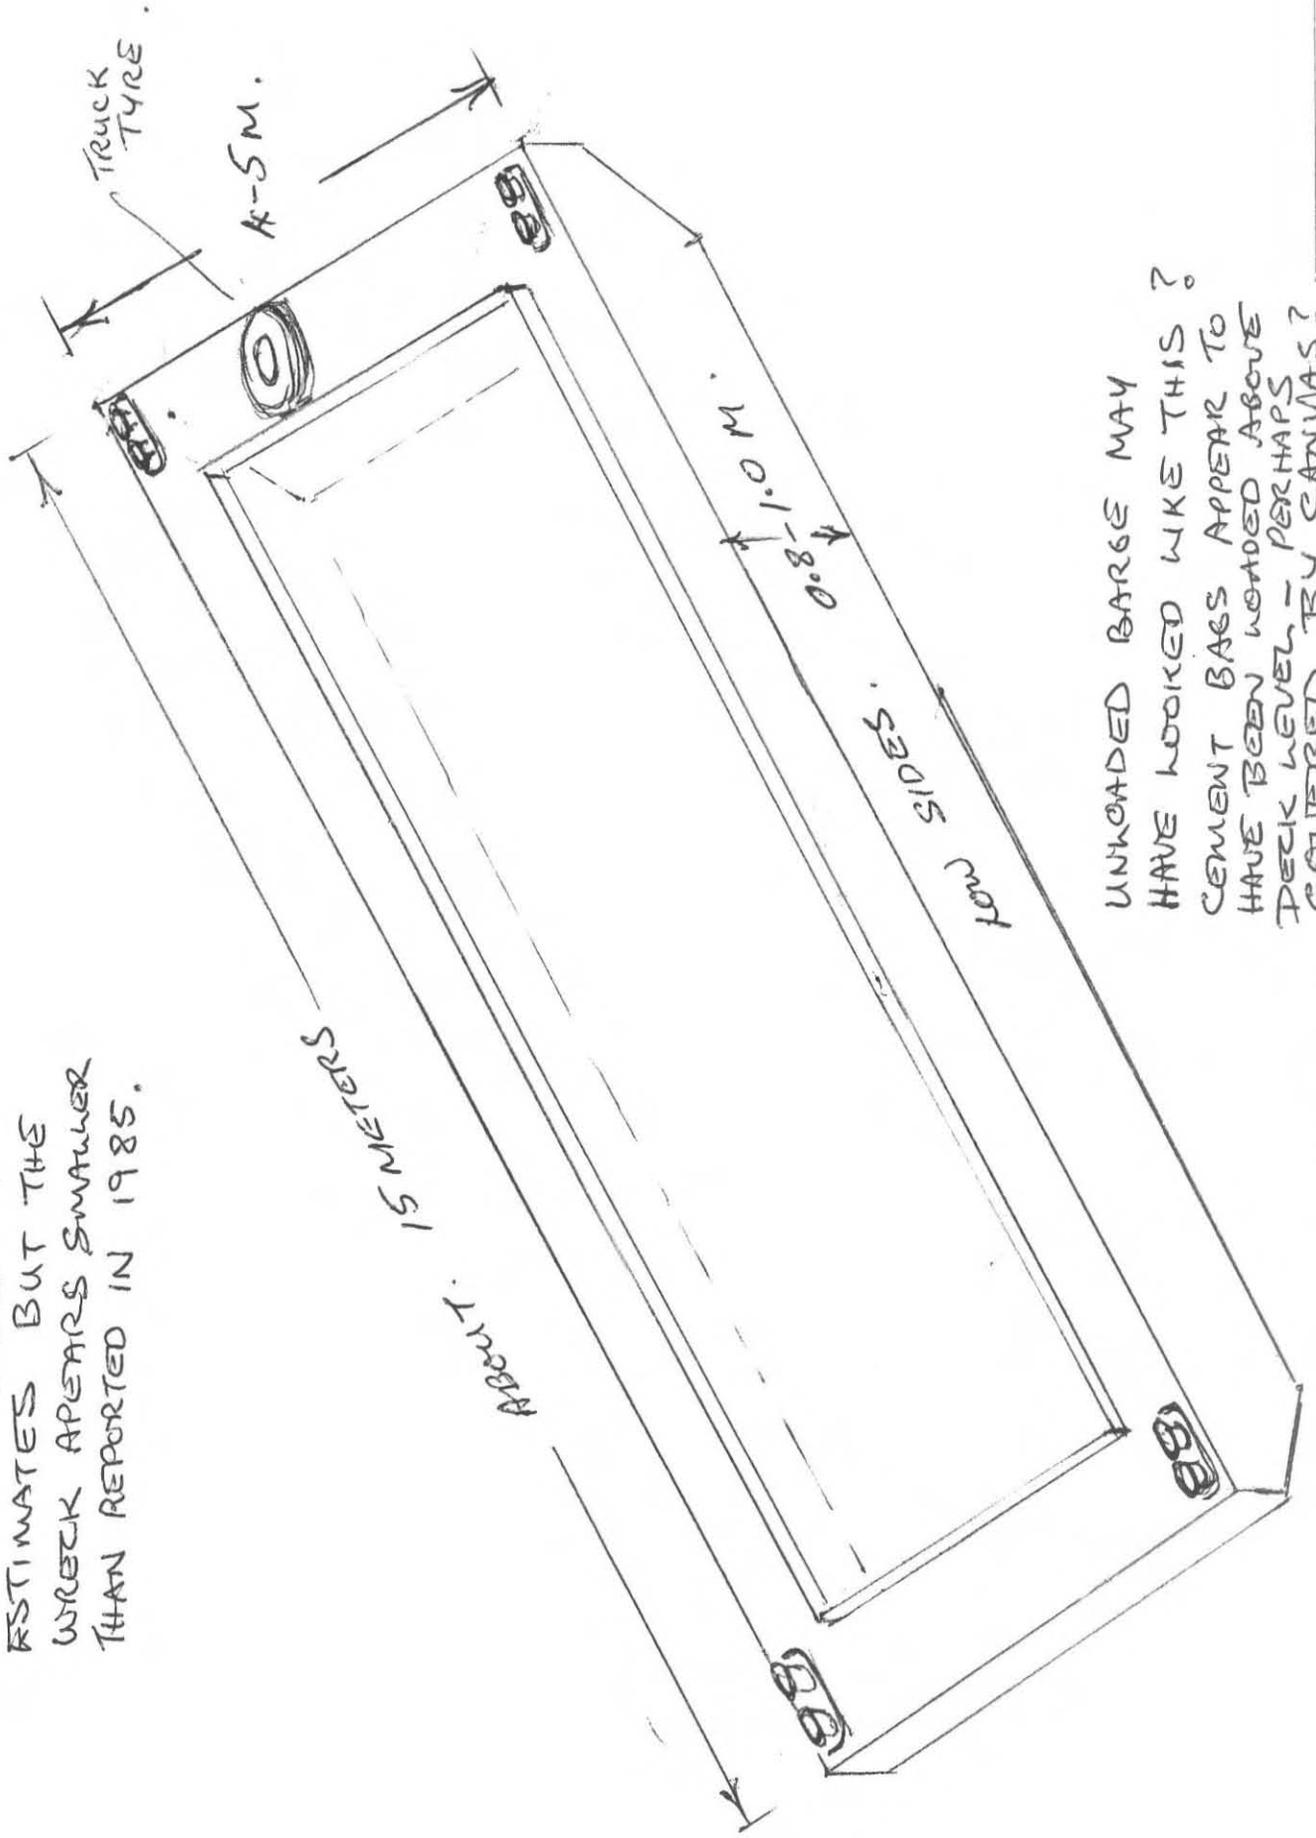
Figure 2. This barge looks more like a harbour or river lighter than an ocean-going barge.

N.B. TAPE MEASURE WAS LOST  
 DURING DESCENT - ALL  
 MEASUREMENTS ARE  
 ESTIMATES BUT THE  
 WRECK APPEARS SMALLER  
 THAN REPORTED IN 1985.

UNLOADED BARGE MAY  
 HAVE LOOKED LIKE THIS?  
 CEMENT BAGS APPEAR TO  
 HAVE BEEN LOADED ABOVE  
 DECK LEVEL - PERHAPS  
 COVERED BY CANVAS?

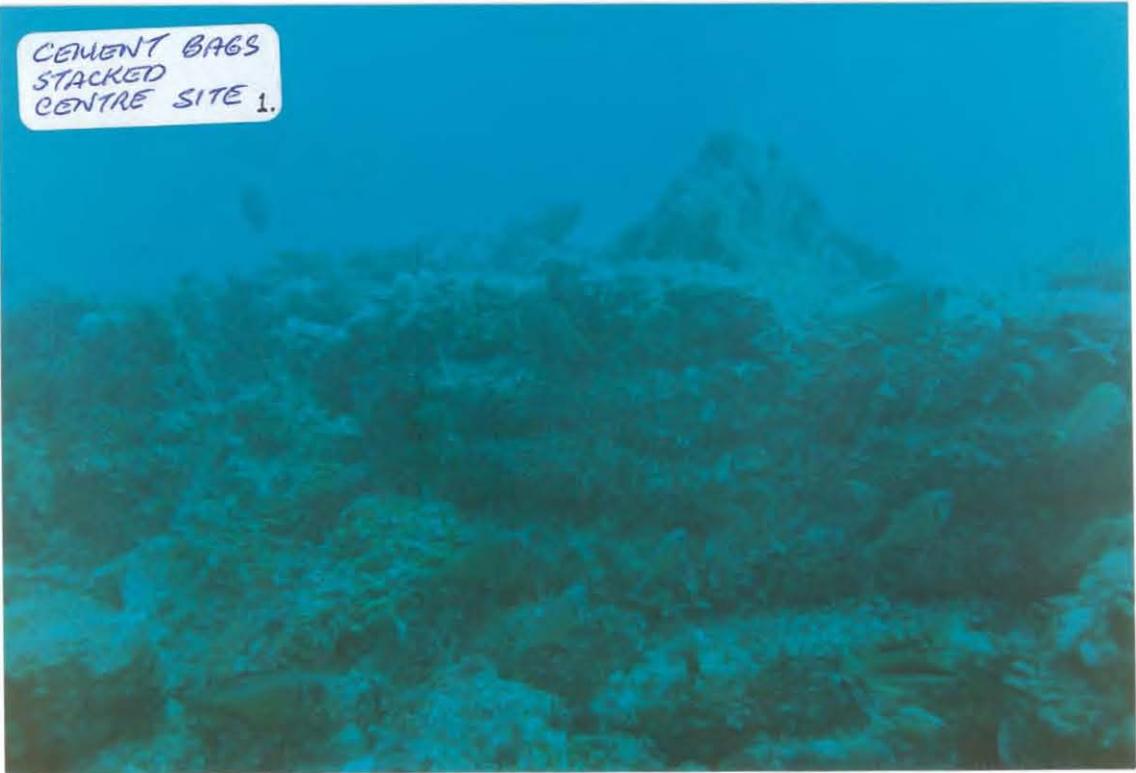
Cement bags - consolidated to a solid mass (See photo Nos. 1 & 2)

The site looks somewhat like a classic ballast pile. Cement bags would have filled the hold. The sides of the hull have collapsed outward so that the deck beams are now vertical. (See photo Nos.8 & 9). The fore and aft decks have collapsed.

CEMENT BAGS  
STACKED  
CENTRE SITE 1.

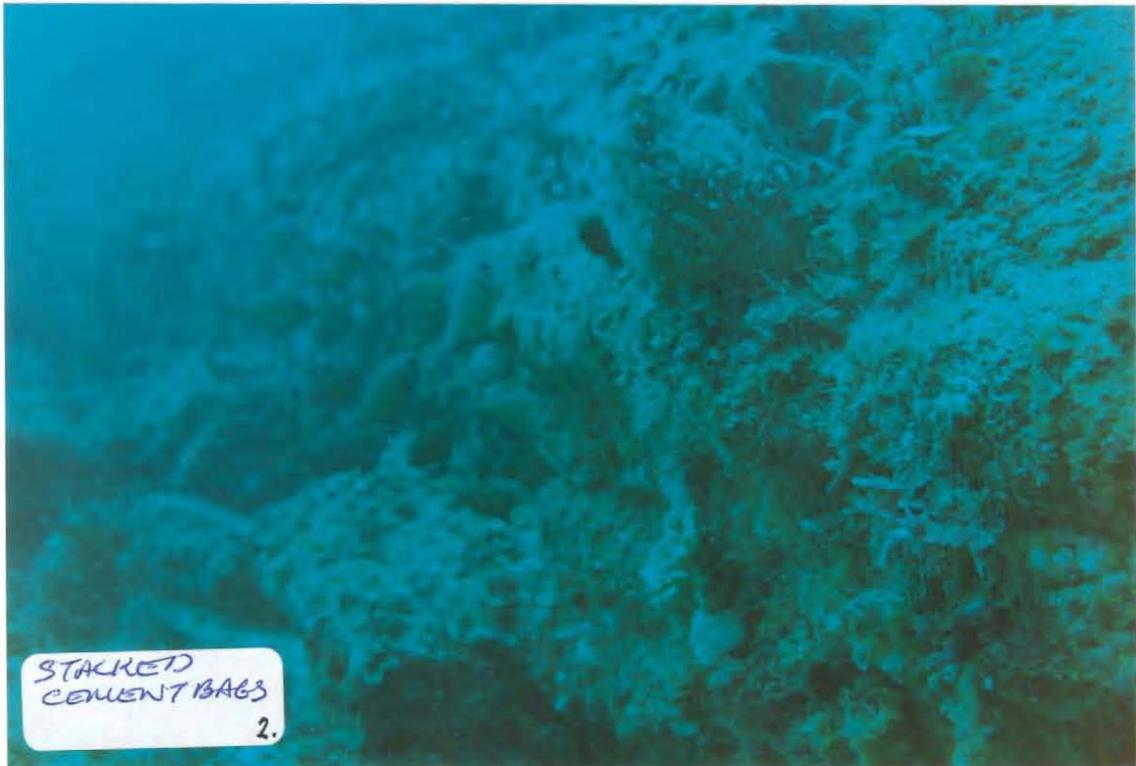
STACKED  
CEMENT BAGS  
2.

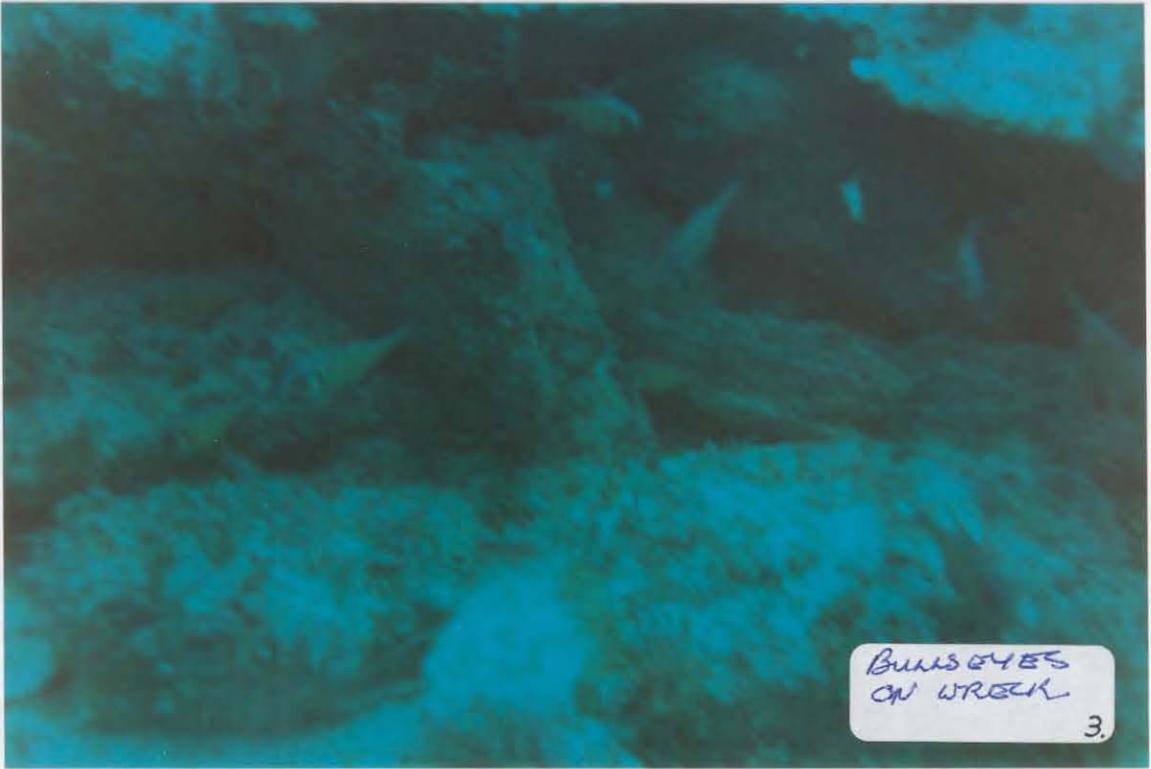
Colonising fauna: An abundance of benthic fish species and Western Rock lobster.  
(See photos Nos. 3 - 6)

BLUEYES  
ON WRECK 3.
