# **THE HAMELIN BAY, JERVOISE BAY AND MANDURAH SHIPWRECKS**

A field exercise linking wreck site archaeological research  
With wreck trail promotion

Submitted by Ed Punchard as a course requirement for the  
Graduate Diploma in Maritime Archaeology (MA 592)

Report—Department of Maritime Archaeology, Western Australian Maritime  
Museum, No. 140

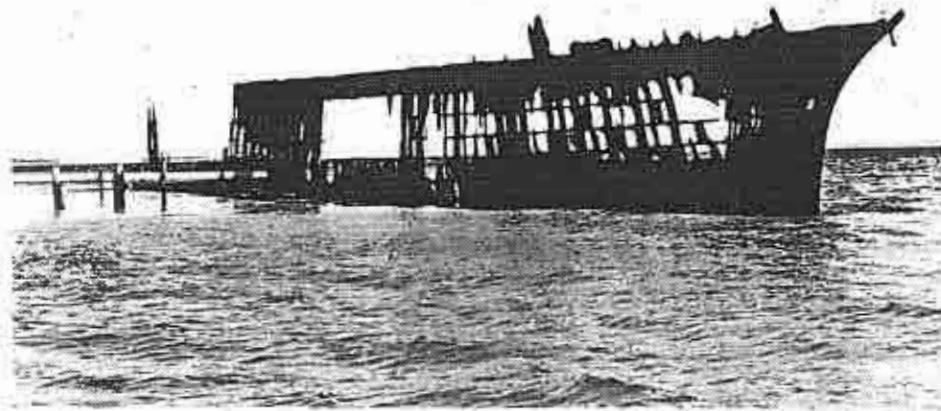
Figure 11. The stronger areas, such as the bow, withstand weathering the best.

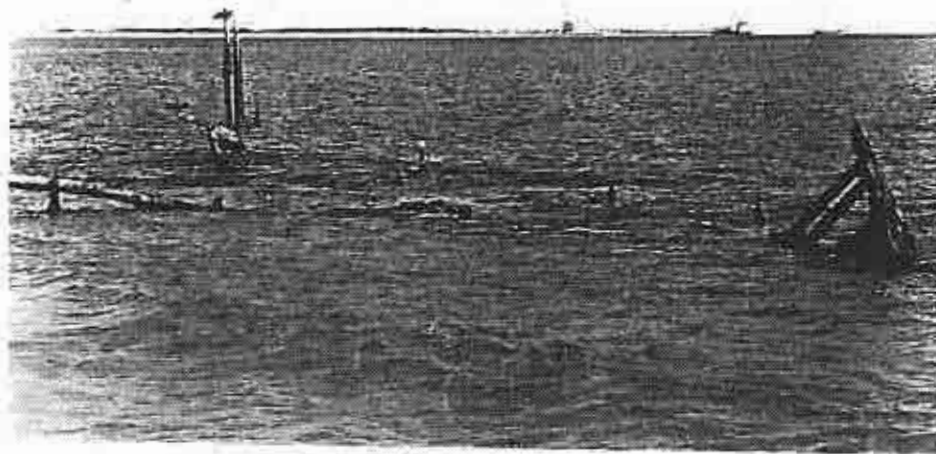
Figure 12. The vessel largely as she is today.

Most of the hull sides are collapsed from the turn of the bilge upwards and noticeably the interior of the hull contained only limited quantities of sand. One can only presume that the prevailing conditions have flushed out the interior. As the winter season has only recently ended it would be interesting to see the state of the hull's interior in March, after the summer conditions have built up beaches.

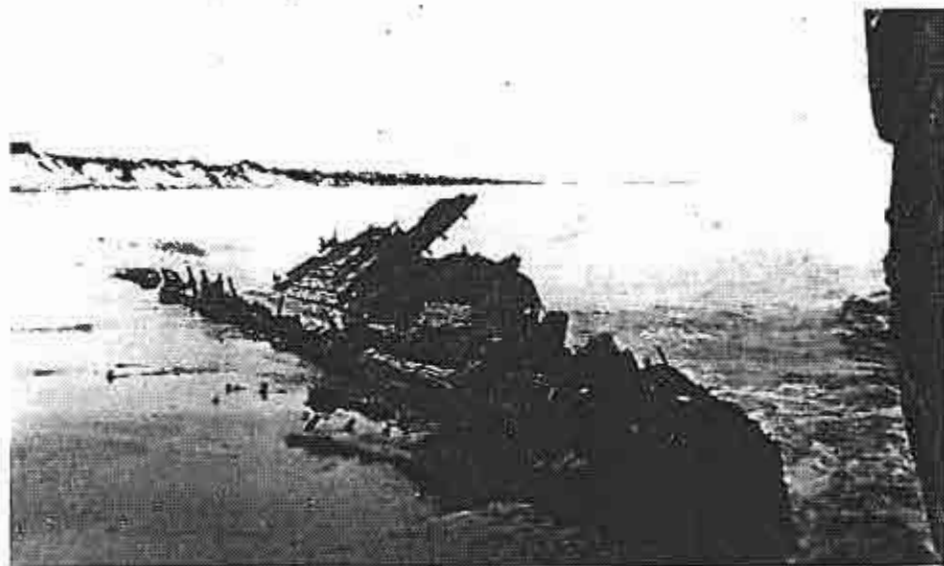
Figure 16. Adjacent to the *Alacrity*, the *Abemama* timbers, the iron knees no longer present.

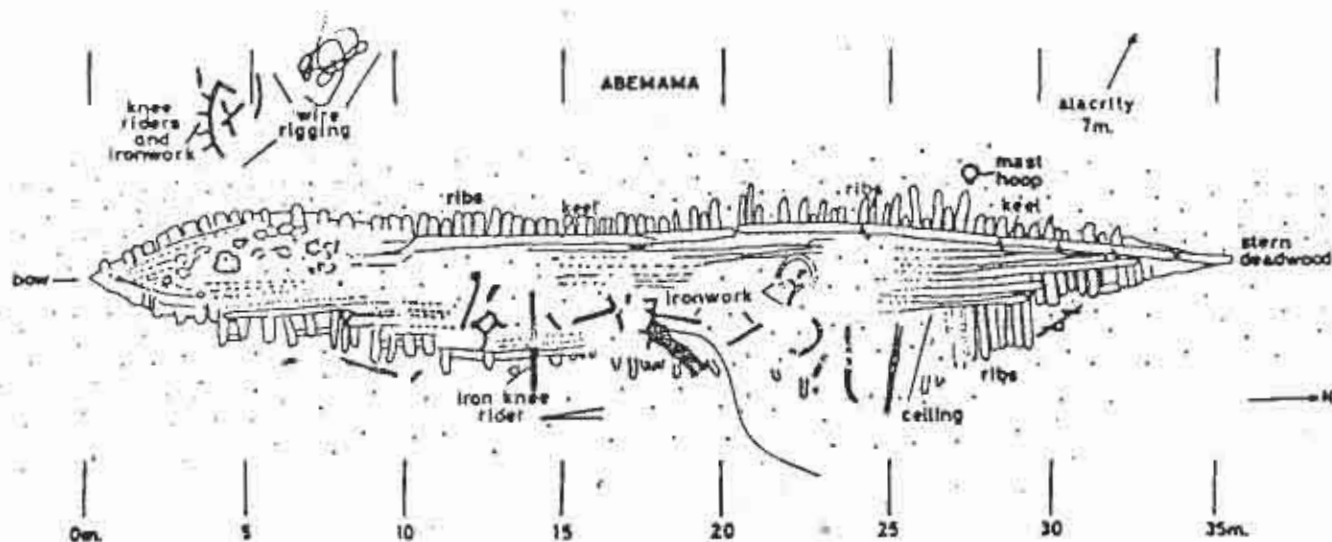
Figure 18. Drawing of the *Abemama* wreck site<sup>9</sup>.

An examination of the site reveals that there is little of the structure remaining beyond the turn of the bilge. When considering whether or not the *Abemama* conforms to the water-line theory we are immediately struck by the fact that this wreck is a burnt hull wreck. This effectively means that the only remains will be from the water-line down and such is difficult to evaluate.

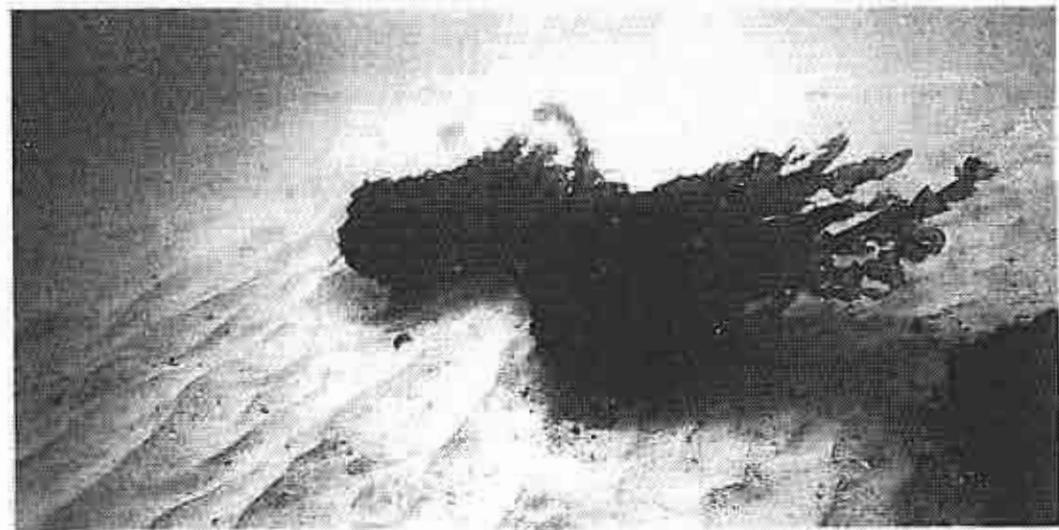
The site of the *James* was located with ease. This was however despite the lack of much visible material. The only sign of the wreck at this time was the long keel bolts that protruded upwards from the sand. These were examined and it became clear that the wood that lies beneath them was to far below surface to allow anything other than a cursory examination of the site.

Figures 19 and 20. Weed covered keel bolts mark the location of the *James* wreck site.

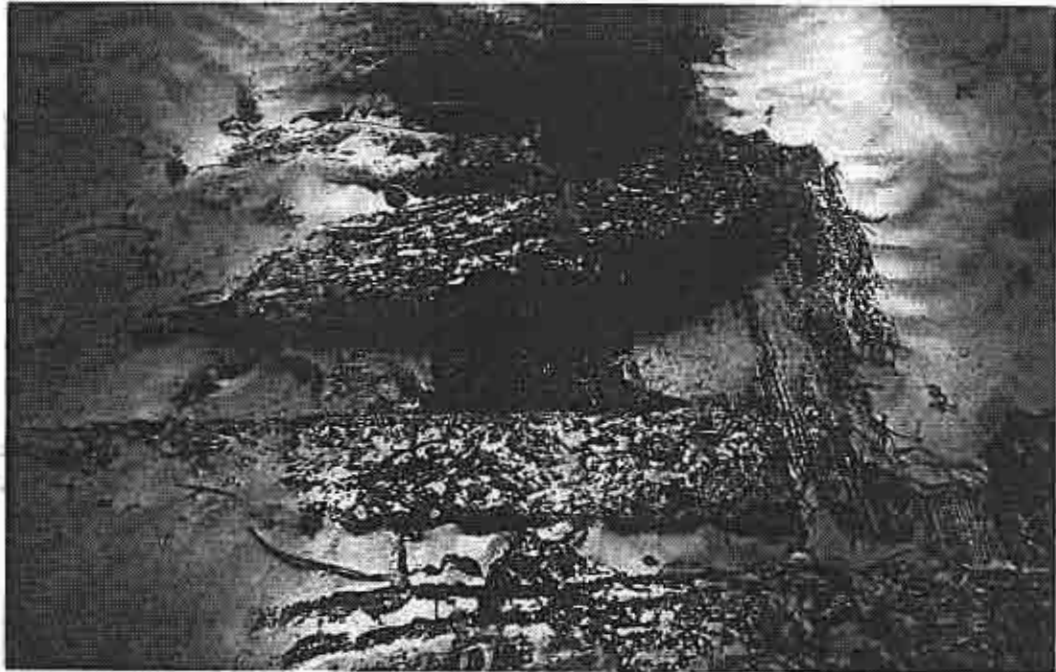
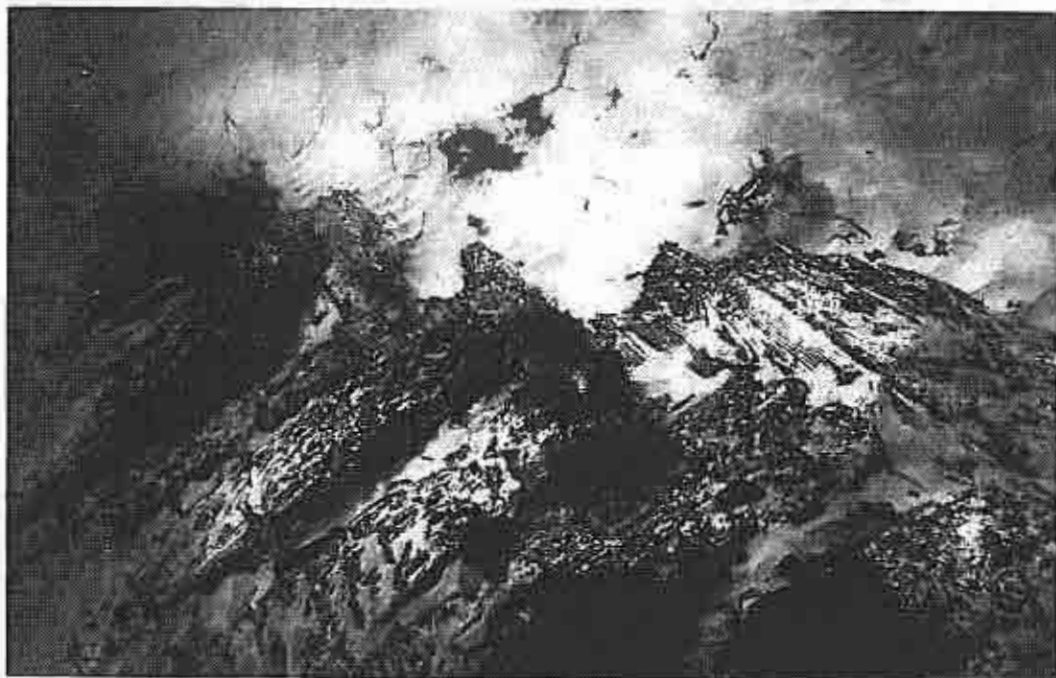
The remains appear more visible than they have been for some years<sup>13</sup>. The keel and ribs are clearly distinguished as is the planking attached. There is little that remains up to the point of the turn of the bilge. The seaward side has fared less well than the landward side. The length of the ribs are clearly shorter on the outer side. A discussion of the reasons for this will follow later in this section.

Figures 21 and 22. Ribs and planking of the *Diana*, with little above the turn of the bilge.

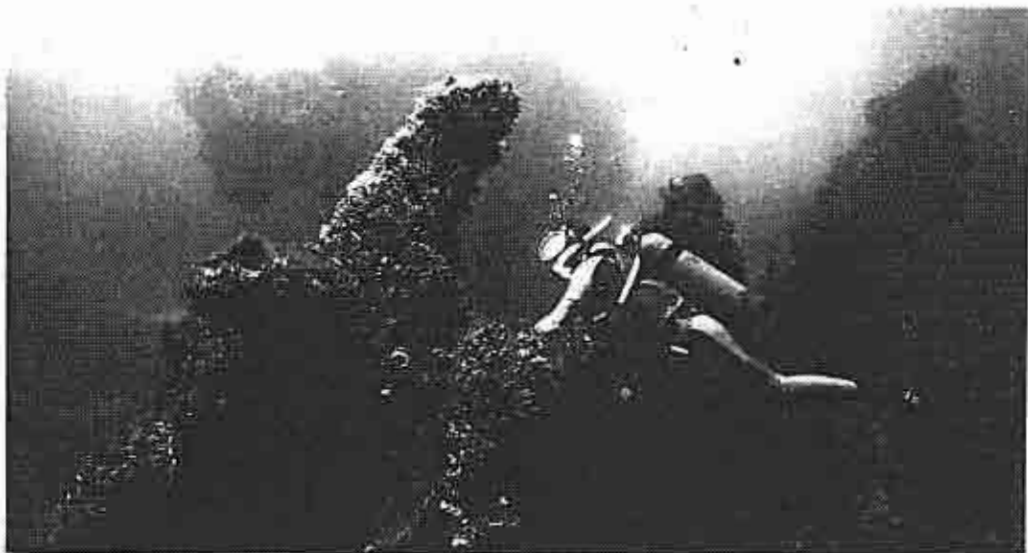
There is an important issue here. All prominent features will be heavily affected by the surge. Initially, when the hull plates are all in place, the wreck will suffer great to and fro force in even the mildest swell, This will 'work' the wreck. Any weakened feature will suffer progressive action until torn away. As each plate opens up, more power will be exerted to the features that remain, until the wreck is reduced to a junk pile that has a comparatively low profile and combines with the existing reef topography.

Figure 23. Rib section of *Highland Forest's* remains.

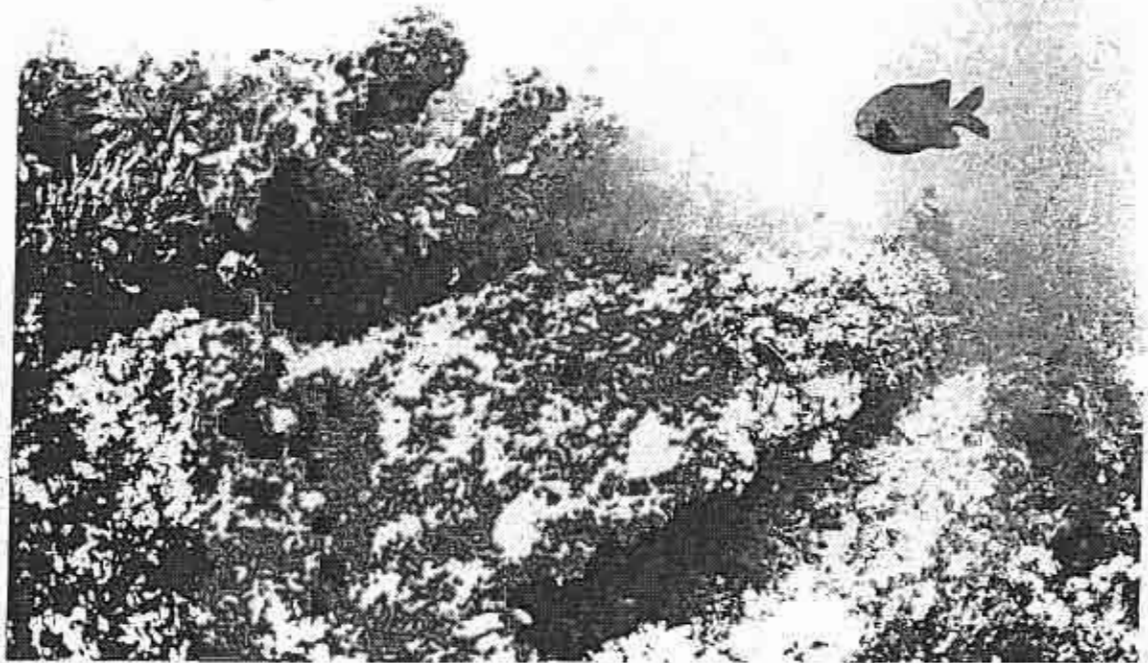
Figure 25. Deadeyes protruding from the general wreckage<sup>15</sup>.

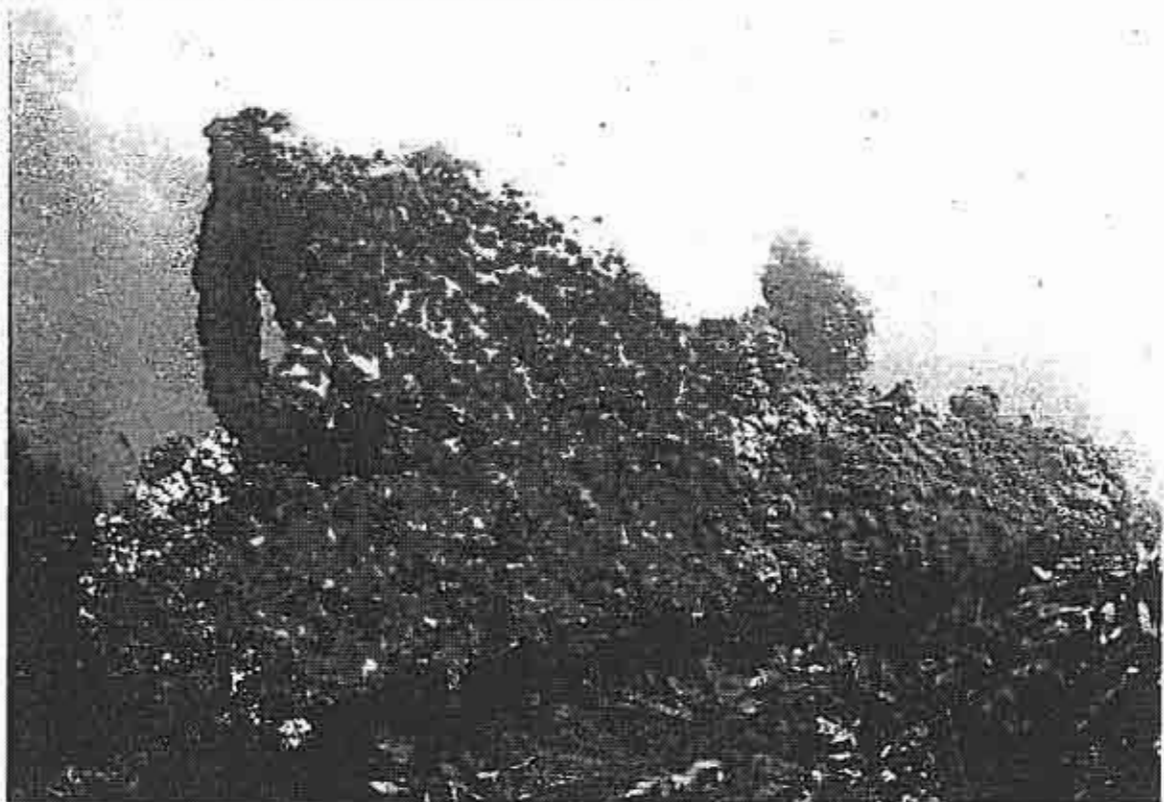
Figure 26. Ribs and plating extend upwards<sup>16</sup>.

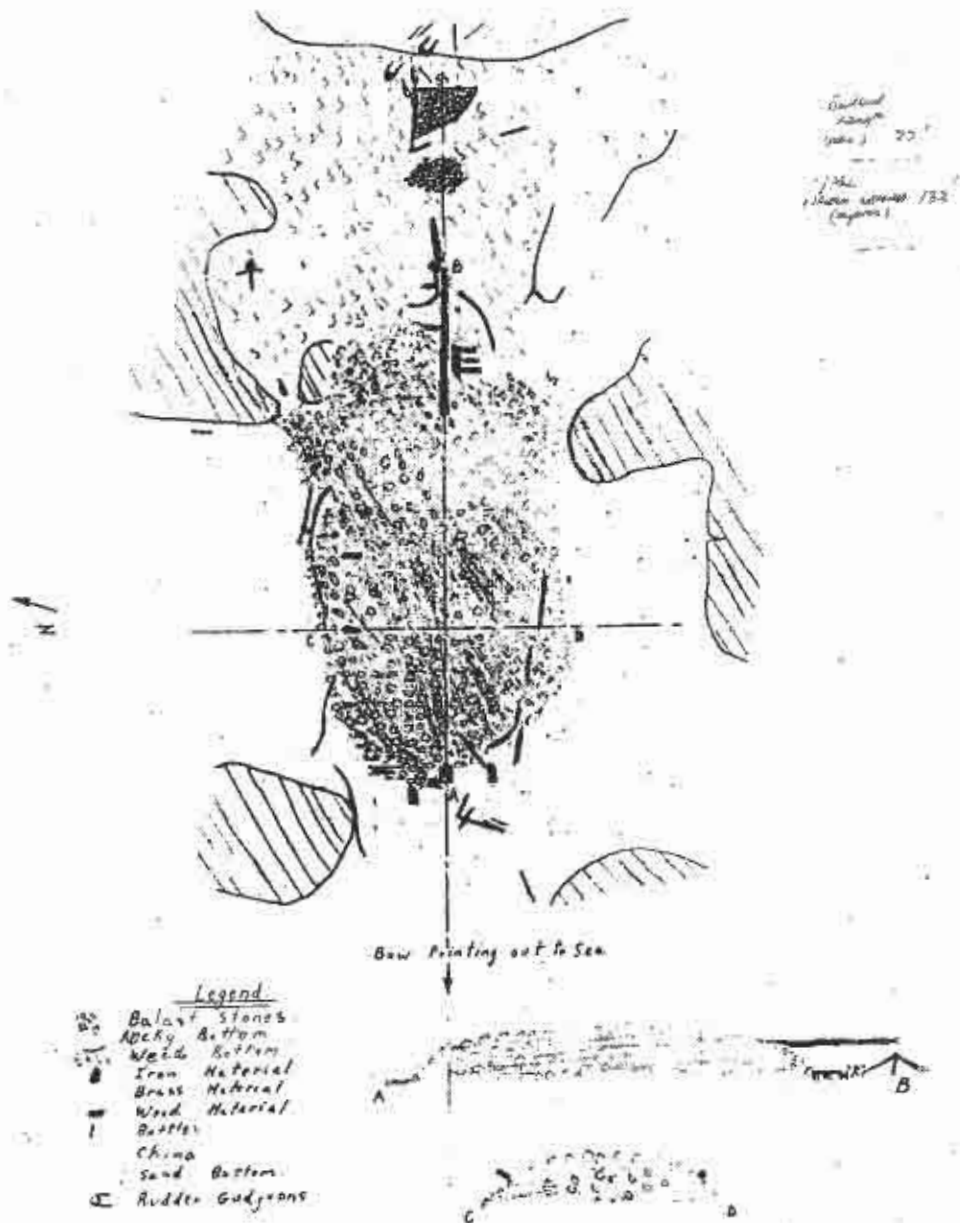
Figure 28. Sketch plan of *Chalmers* wreck site<sup>19</sup>.

As can be clearly seen in the sketch plan below the remains of the *Chalmers* are lying on a sand bottom. In this case therefore, whilst this ship was wrecked on a reef, it fell into a sand filled gully. This identifies a case that must be treated differently from the four basic categories that were identified initially. It is probably more appropriate to consider this wreck as a wooden wreck lying on sand, but no doubt effected in its degradation by the dynamic effects of surge over a reef and whatever effect the rocky overcrops surrounding the wreck have.

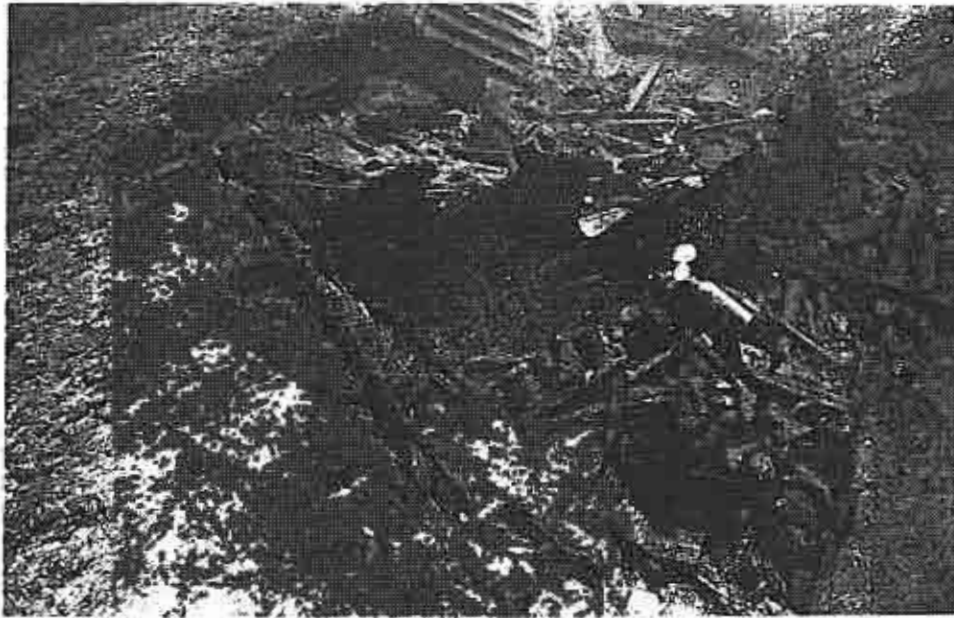
Figure 38: The stern of the *Ben Ledi* is more distinct amongst the broken wreckage.
