Shipwrecks of the Ningaloo Reef: maritime archaeological projects from 1978–2009

Jeremy Green (Editor)

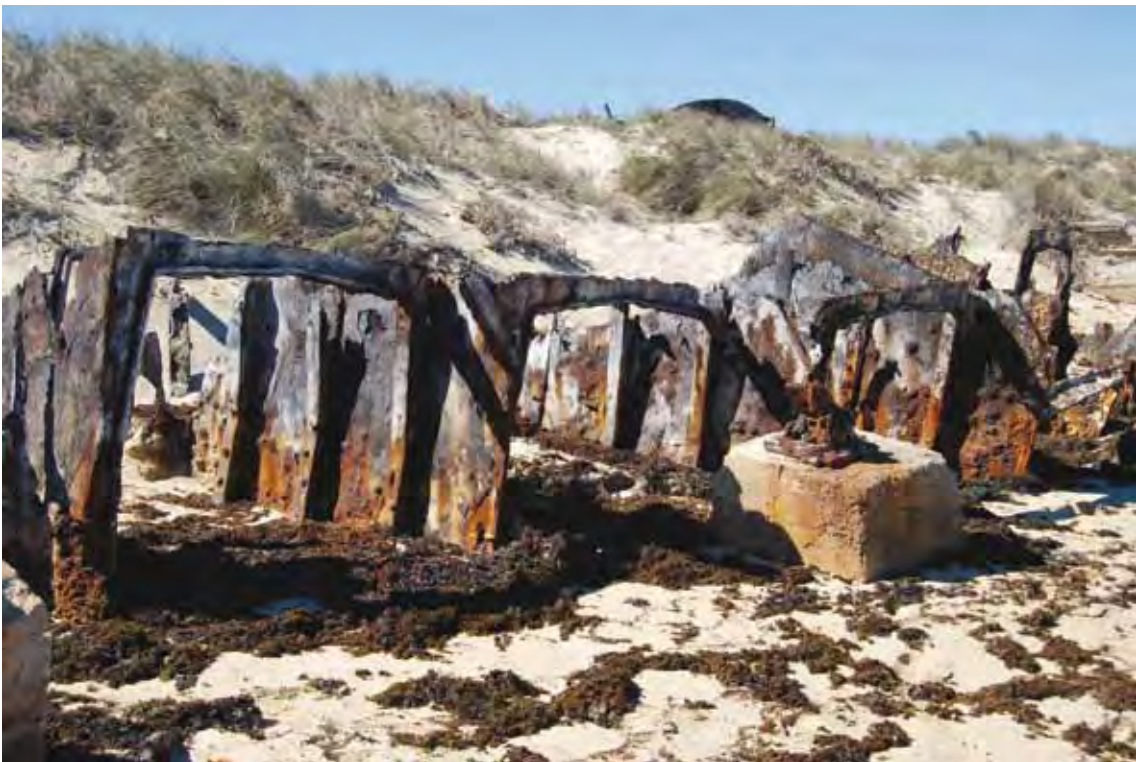
Figure 39. Rusted remains of oil receiving/storage tanks 2009 (Myra Stanbury).

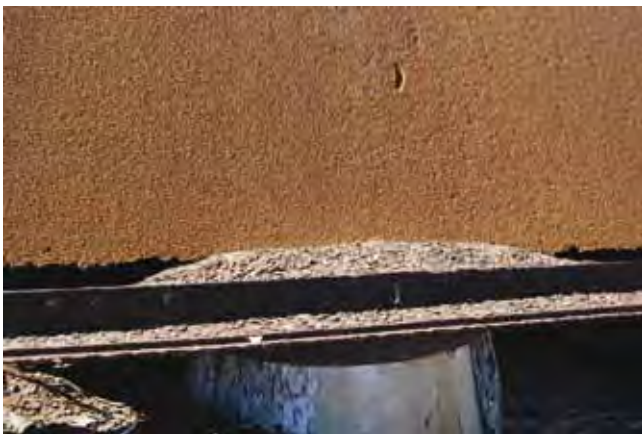
Figure 48. One of the few cement-filled barrels with evidence of timber staves. Note the severe corrosion around the base of the tank (Myra Stanbury).

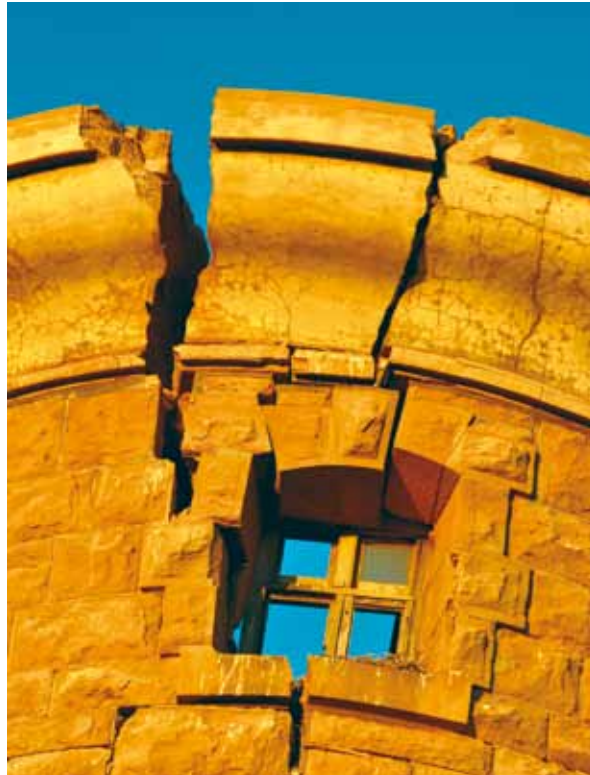
Figure 65. Point Cloates Lighthouse showing structural damage to top of tower (Ross Anderson).

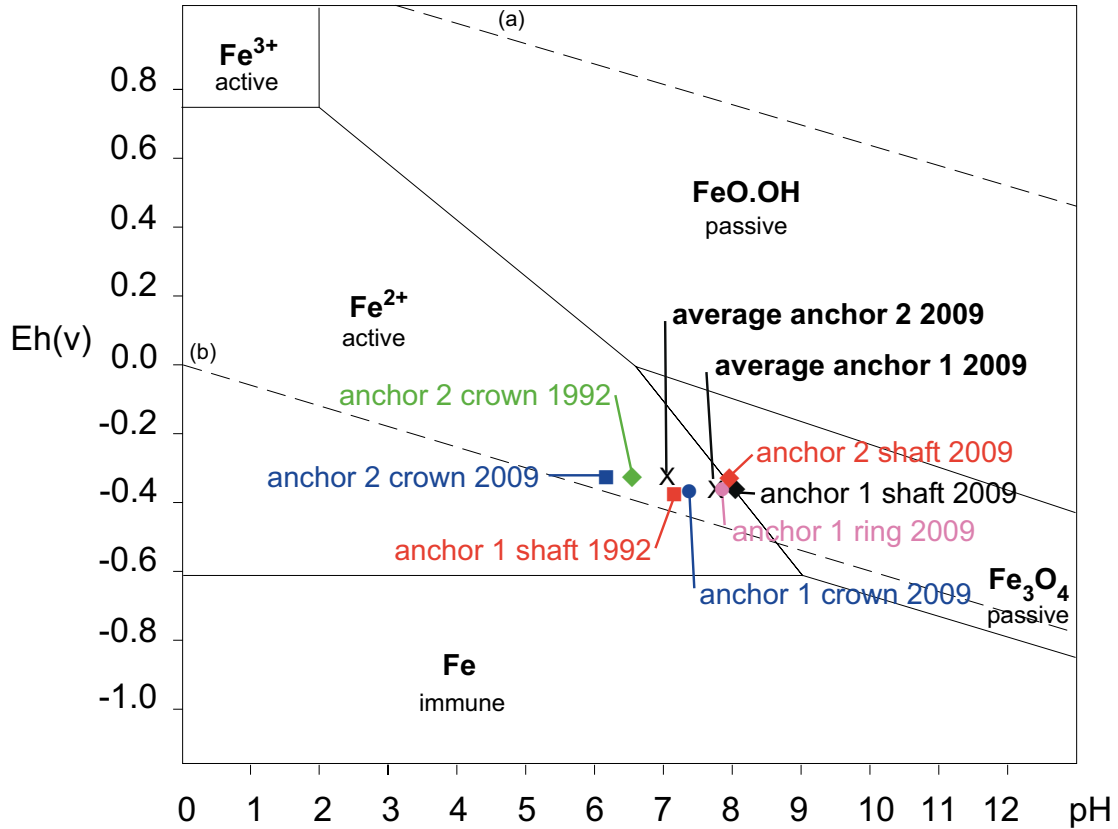
Figure 133. The Pourbaix diagram for iron (10^{-6} molar) in aerobic sea water at 25°C indicating the intercepts of the anchors measured on the *Rapid* wreck site in 1992 and 2009 (Vicki Richards).

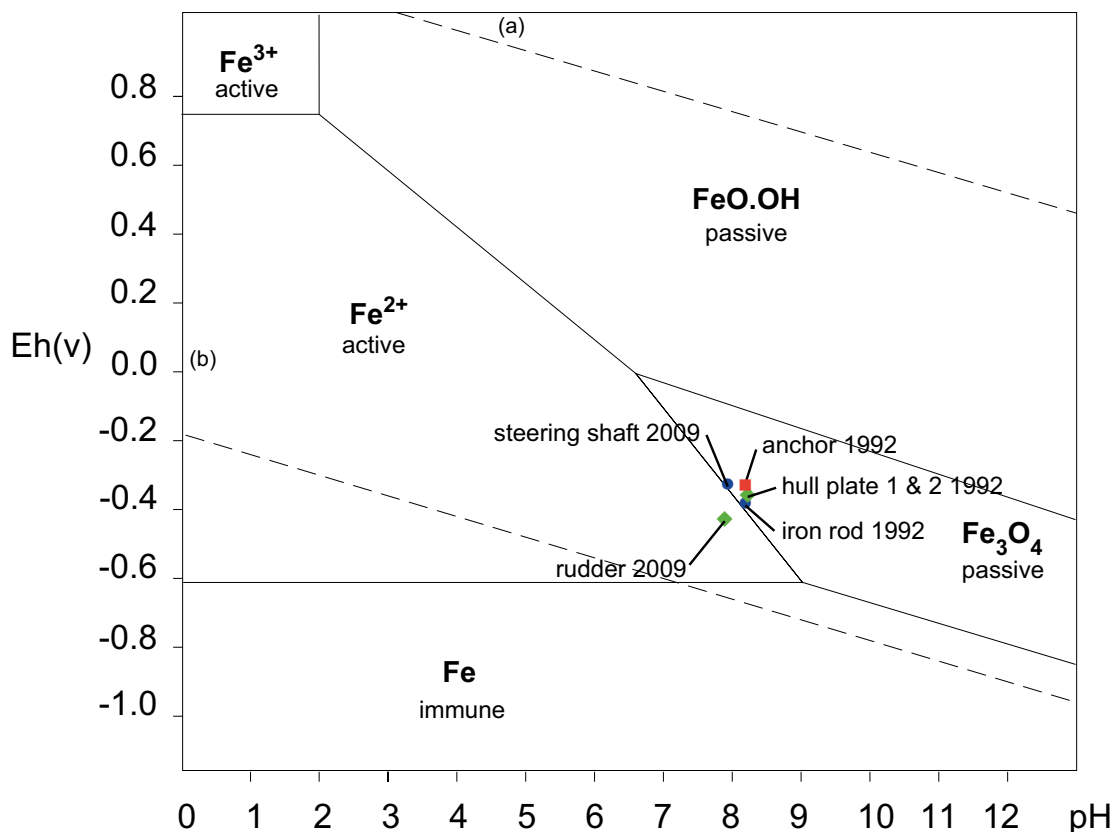
Figure 145. The Pourbaix diagram for iron (10^{-6} molar) in aerobic sea water at 25° C indicating the intercepts of the ferrous structural features measured on the *Benan* wreck site in 1992 and 2009 (Vicki Richards).

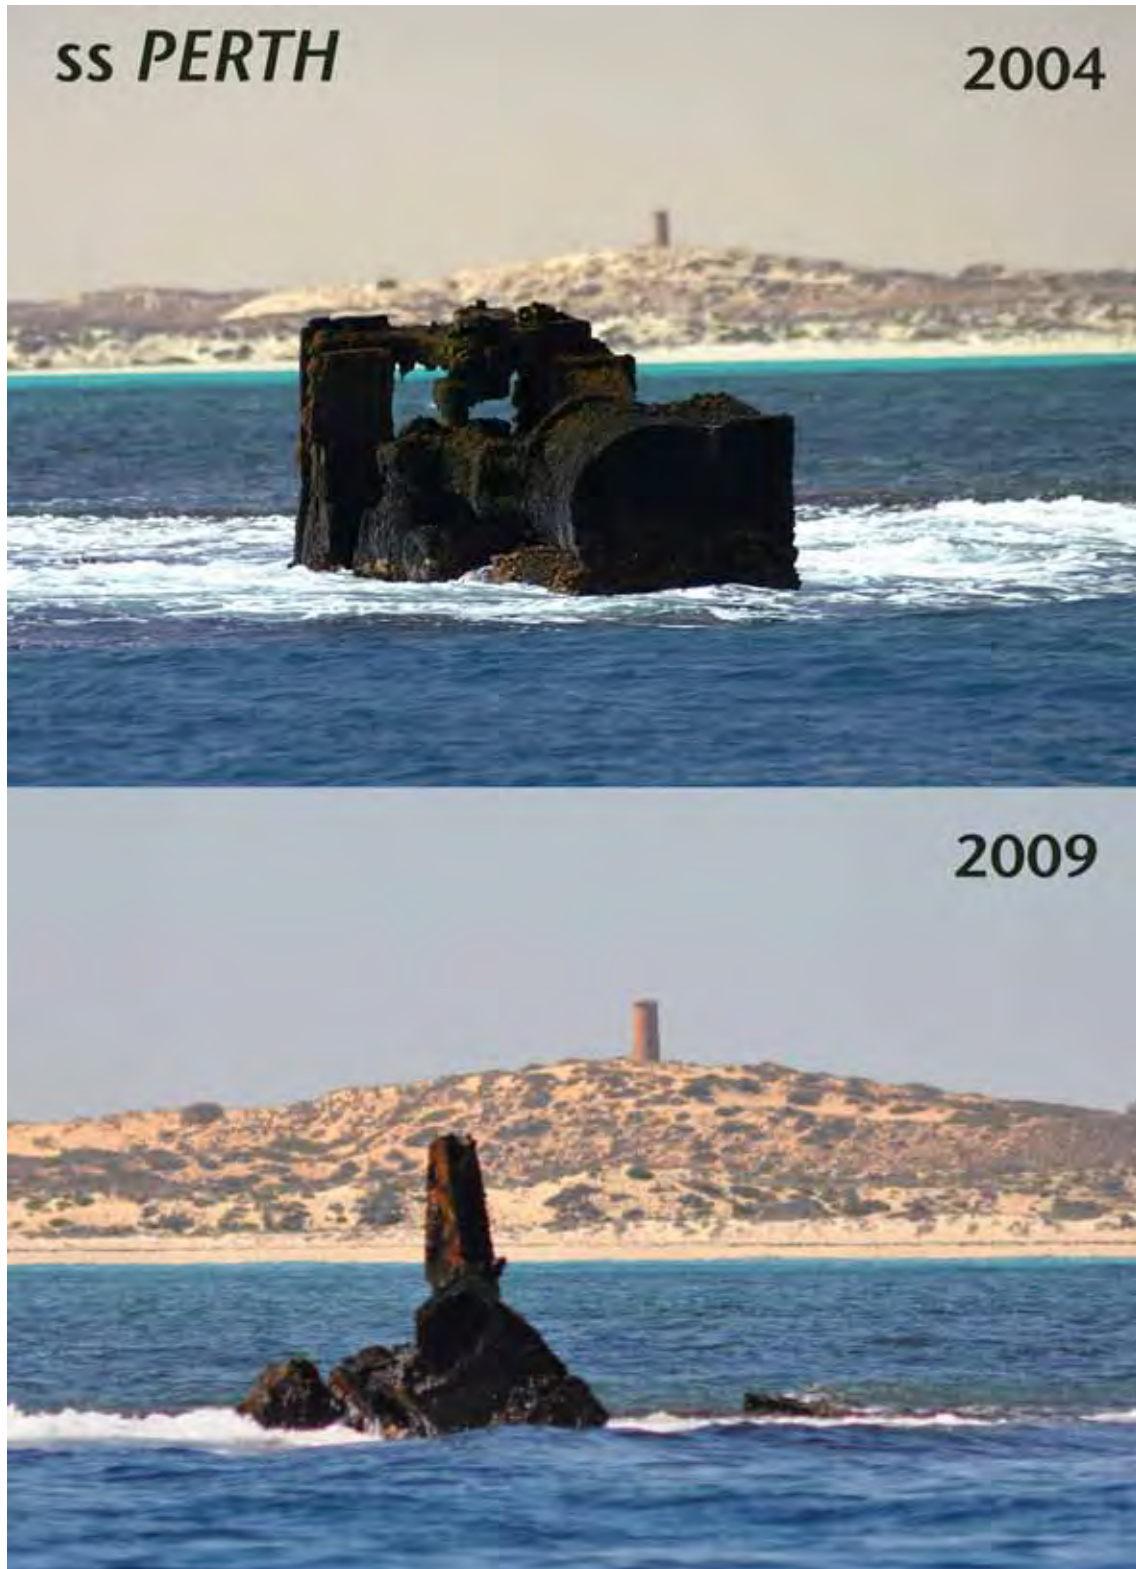
Figure 150. The disintegration over time of the *Perth* (Patrick Baker).

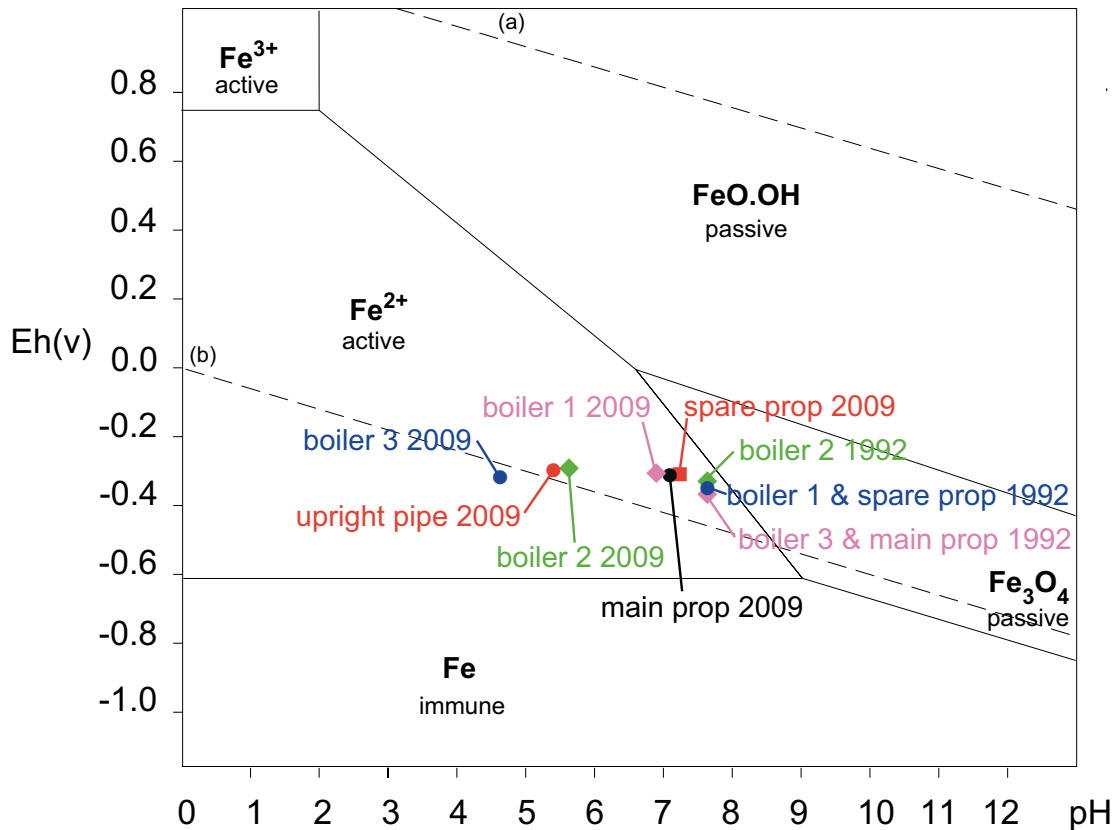
Figure 170. The Pourbaix diagram for iron (10⁻⁶ molar) in aerobic sea water at 25° C indicating the intercepts of the ferrous structural features measured on the *Zvir* wreck site in 1992 and 2009 (Vicki Richards).

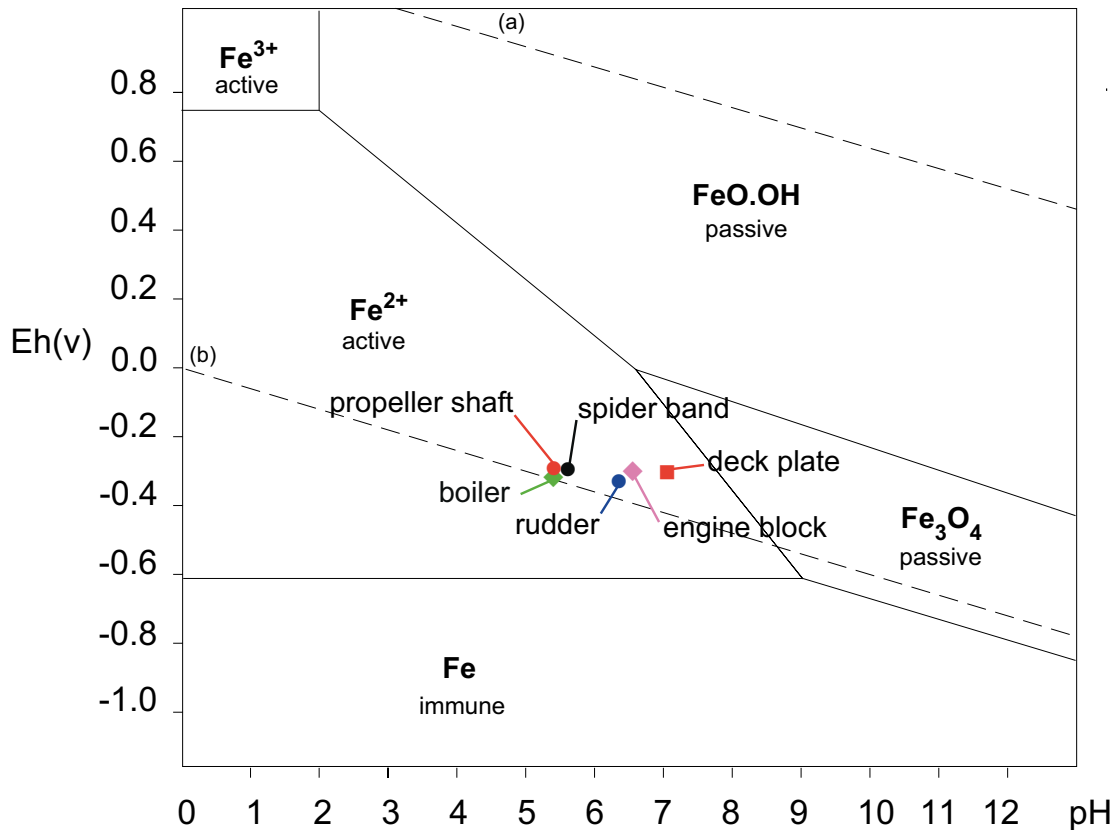
Figure 178. The Pourbaix diagram for iron (10^{-6} molar) in aerobic sea water at 25°C indicating the intercepts of the ferrous structural features measured on the *Chofuku Maru* wreck site in 2009 (Vicki Richards).
