The *REDEMPTORA*

Report-Department of Maritime Archaeology
Western Australian Maritime Museum No. 166

**REDEMPTORA
WRECK INSPECTION REPORT**

Inspected 6th September 2002

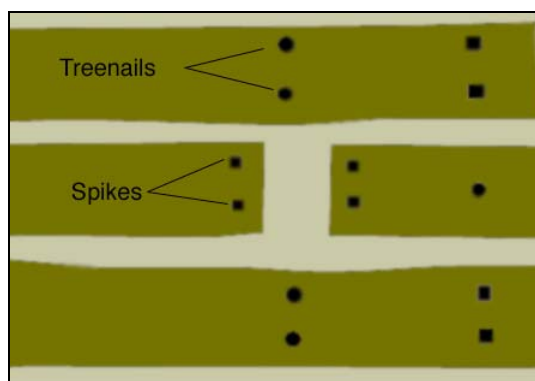
Figure 7. Sketch of some planks on the wreck.

Wooden construction sheathed with copper. Through bolts made from Brass. No evidence of Iron. It appears that the wreck has broken off at the turn of the bilge and therefore all that survives is the hull and the turn on one side. The hull remains are; frames (running NW/SE), outer planking (running NE/SW) and stringers that run in the same direction as the outer planking.

Scantlings: Frames are the most common component of the visible remains. There are over sixty of these that are evenly spaced with a gap of around 0.07 metres between them. They are arranged so that two frames are butted up next to each other with a gap between pairs. Visible remains for each, range from, half a metre to over three metres.

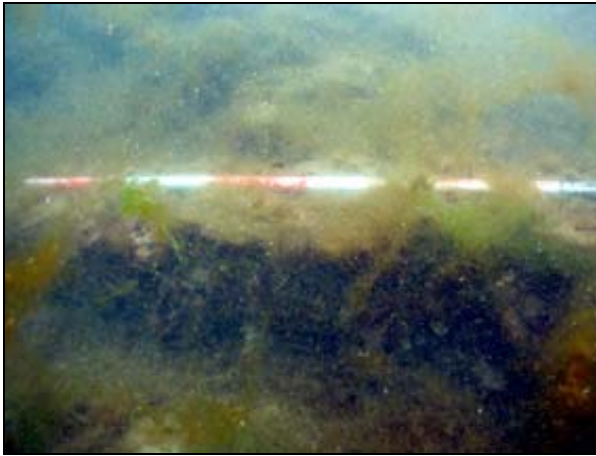
Figure 8. Side view of the frames.

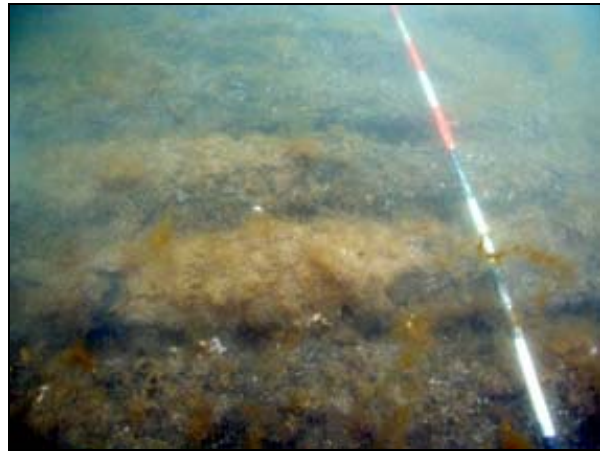
Figure 9. Longitudinal view along the wreck.

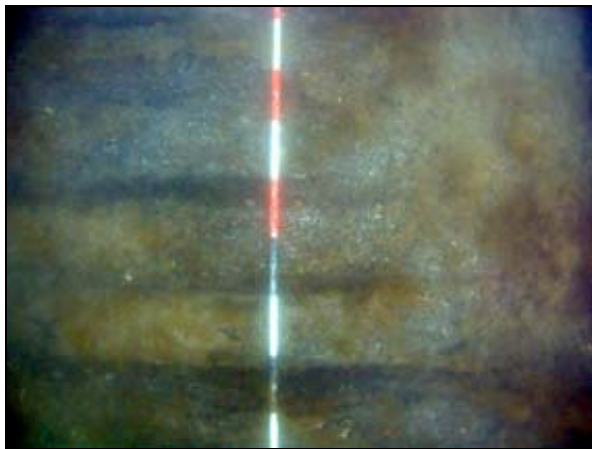
Figure 10. View of frames from above.

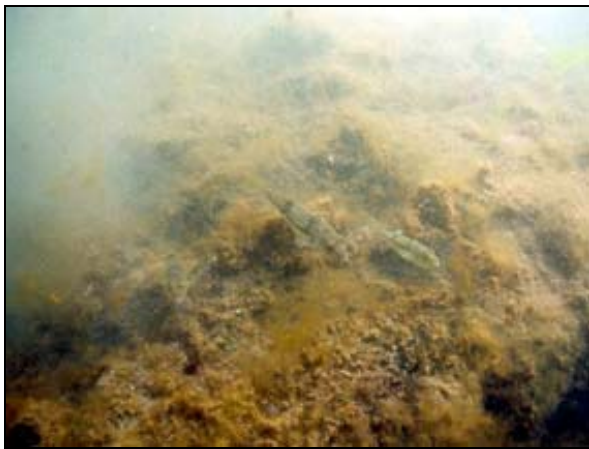
Figure 12. View of frames with organic detritus.

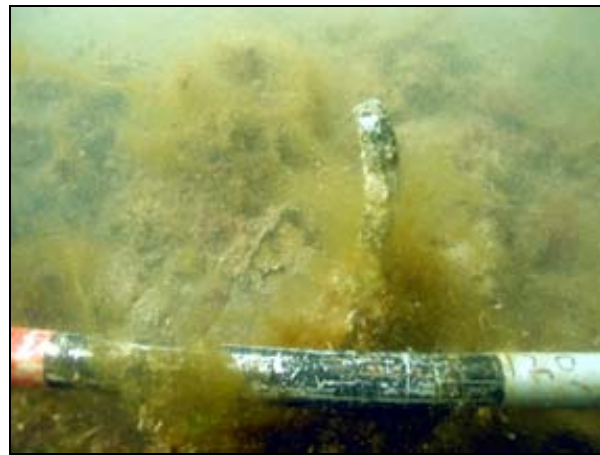
Spikes also are evident and are 0.2x 0.011x 0.011 metres in size. These have a square shaft and protrude 0.1 metres past planks.

Figure 13. Spike with algae that proliferates at the site

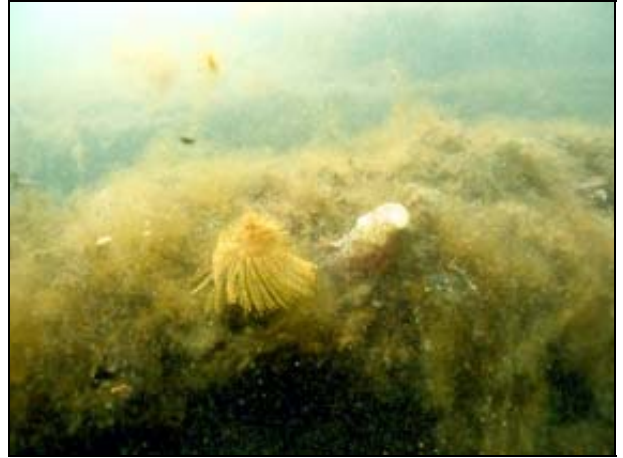
Figure 15. Marine life on the wreck.

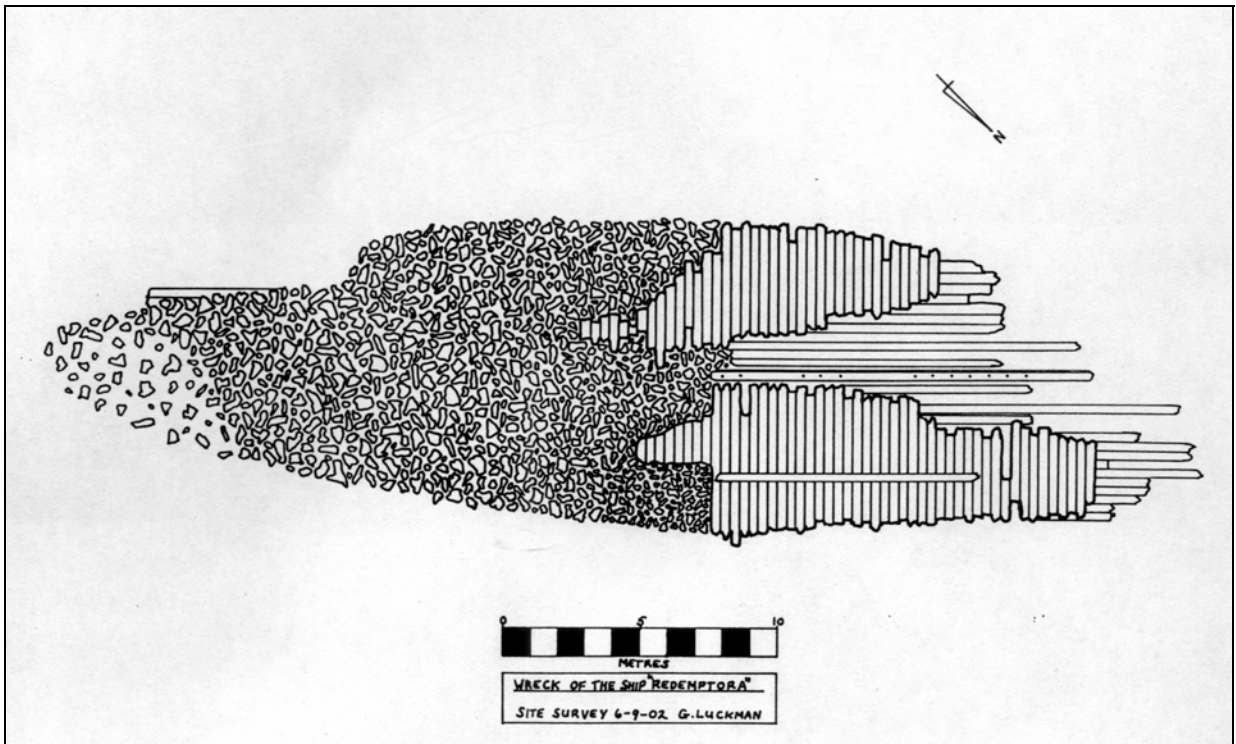
Figure 16. Plan drawing of the *Redemptora*. Drawing G .Luckman.

The wreck of the *Redemptora* is a wooden vessel that, until recently, was covered by a ballast mound. Recently it was noticed that ballast had been removed from about half of the wreck site exposing the wooden structure to the elements. The WA Maritime Museum was notified of this matter and subsequently sent a group to investigate the newly exposed site. At the time Museum staff took digital photographs and created an outline of the wreck with the help of a hand-held GPS. It was decided that because the wreck had been exposed, a strategy should be put in place to gather as much information from the site while it was uncovered. Masters of Maritime Archaeology students, that were attending the Museum as part of their course, were invited to conduct a detailed inspection and survey of the wreck. This was accomplished over six days and concentrated on developing a database that would provide essential information regarding the site for use in the future.

The best method for conserving the vessel is to replace all of the ballast that has been removed from the site. This would allow sediments to build up over time creating a protective barrier from the further interference by divers and from the effects of sea life.
