Port Refuge Unidentified (Cocos Keeling Islands) Inspection Report

M. McCarthy

Site Name: The Port Refuge unidentified wreck.

Date of Inspection: 2/11/2004

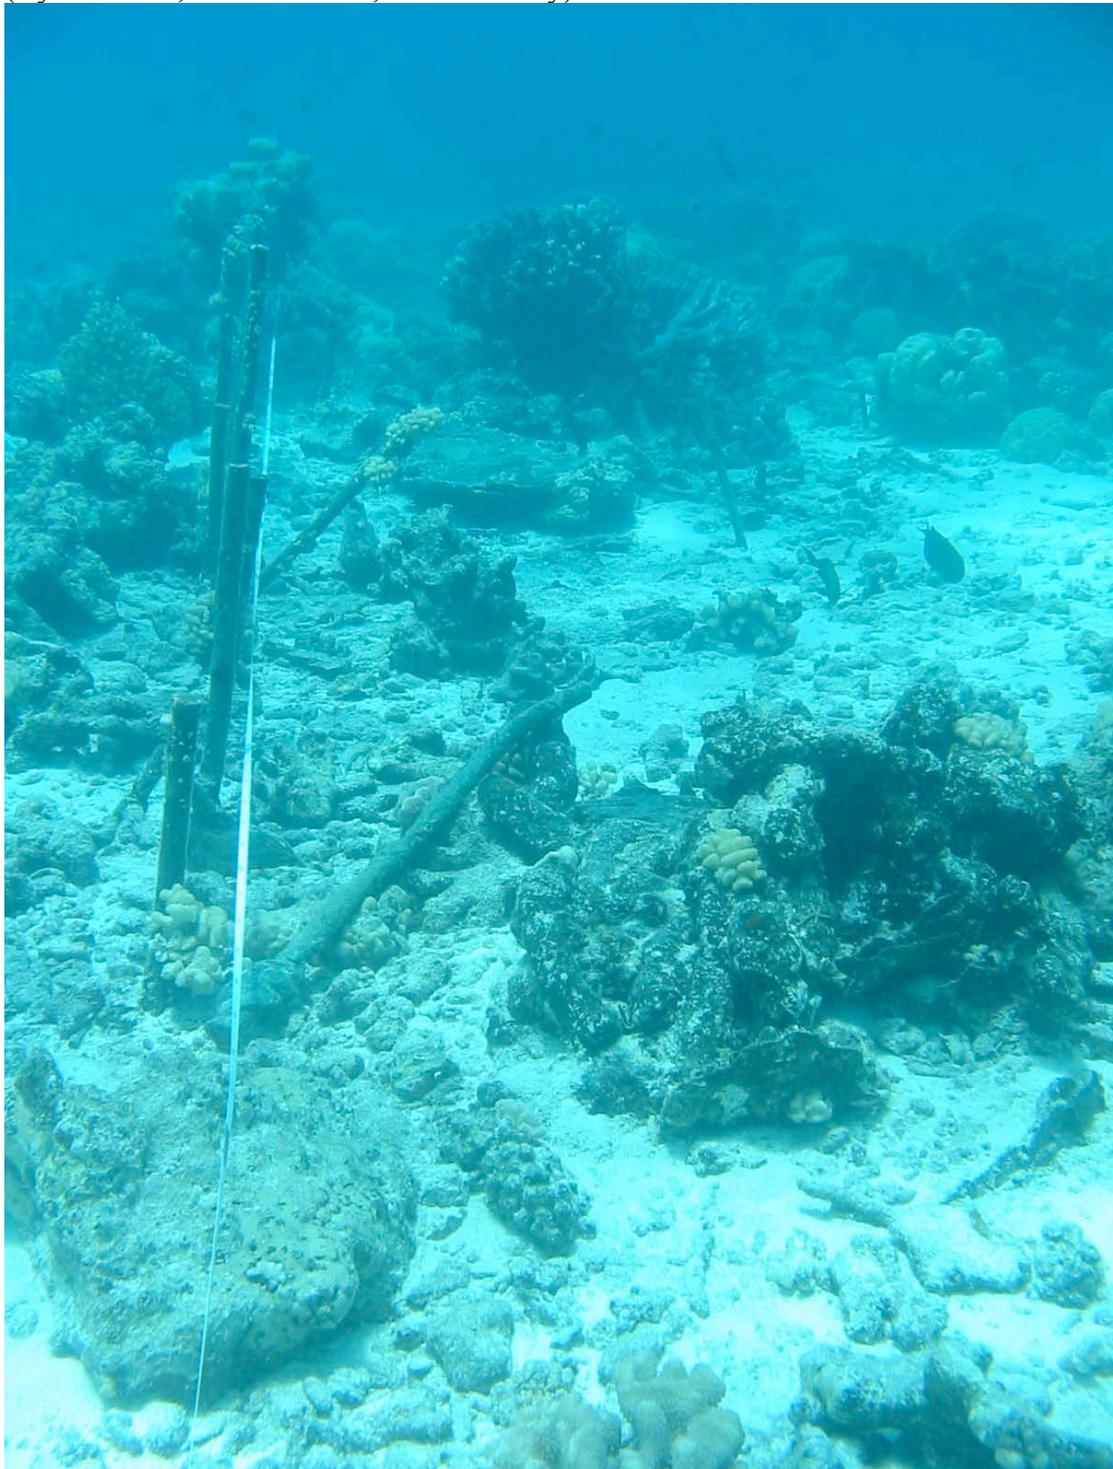
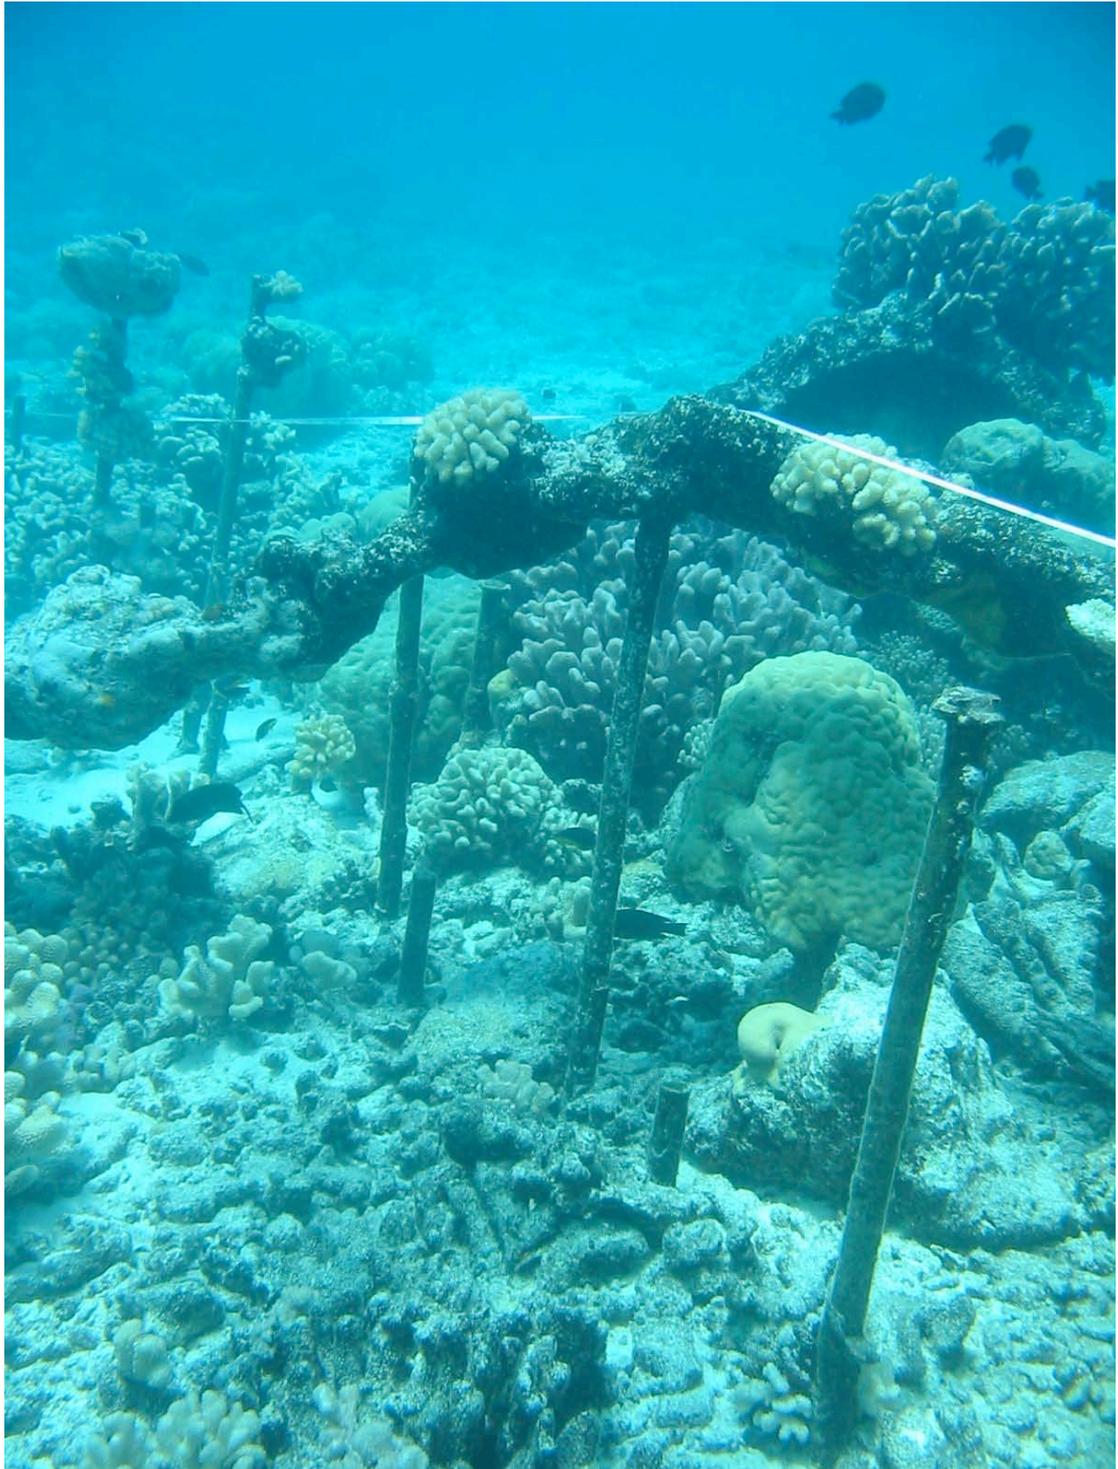
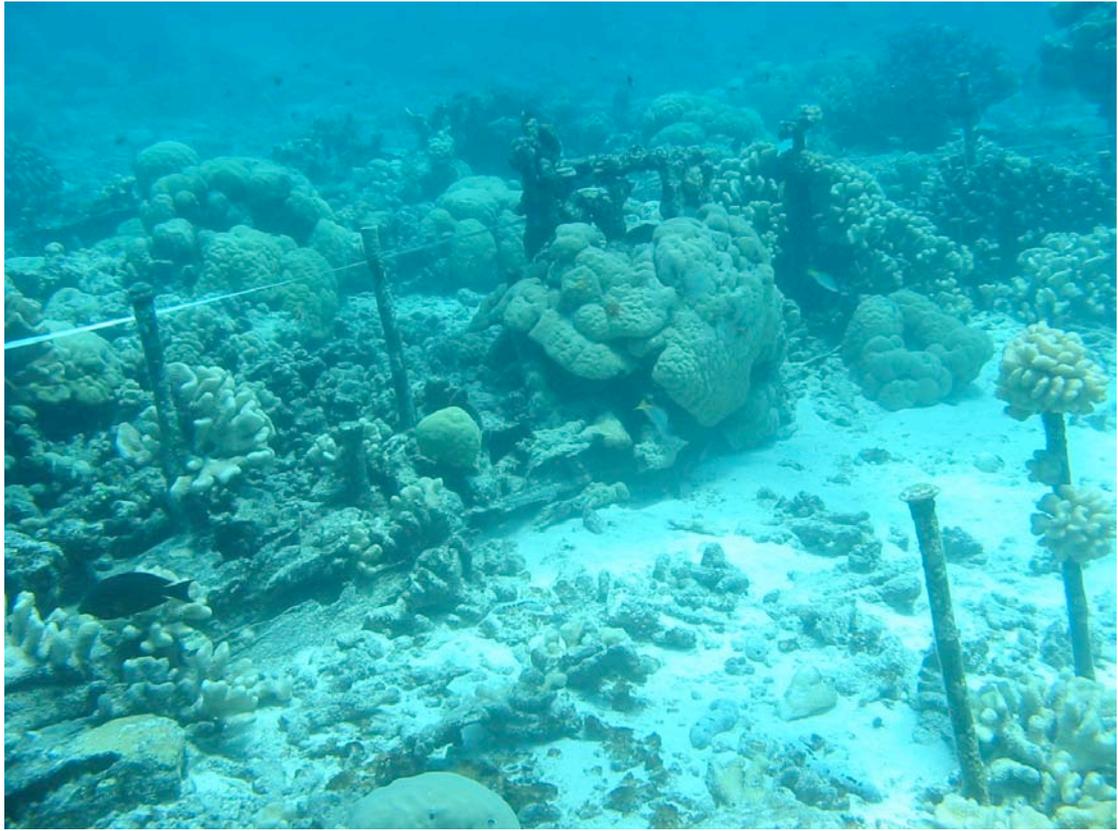
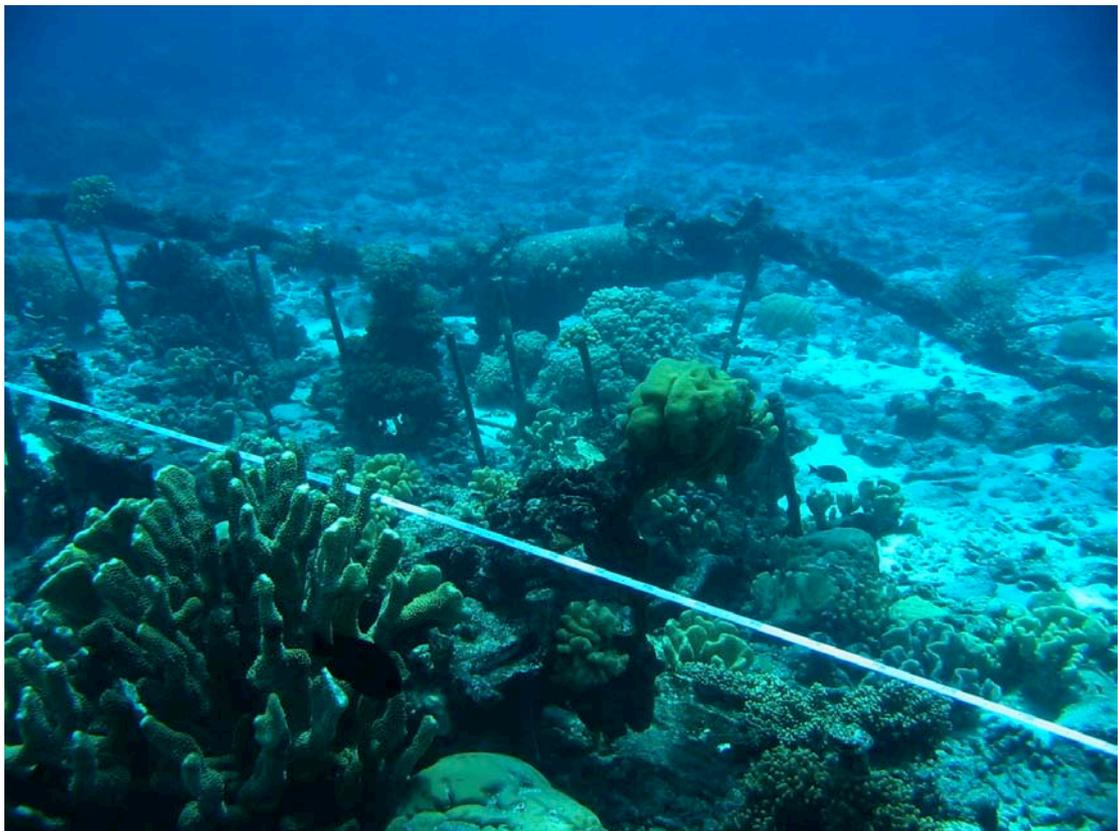
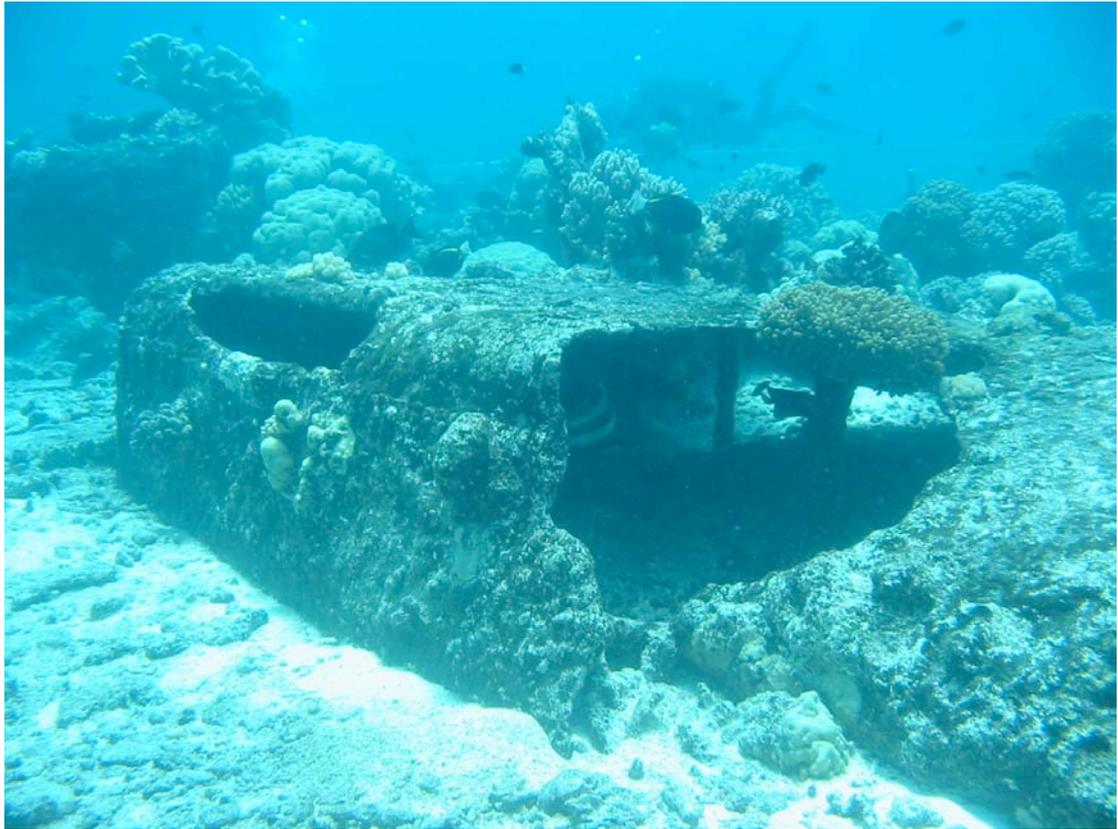
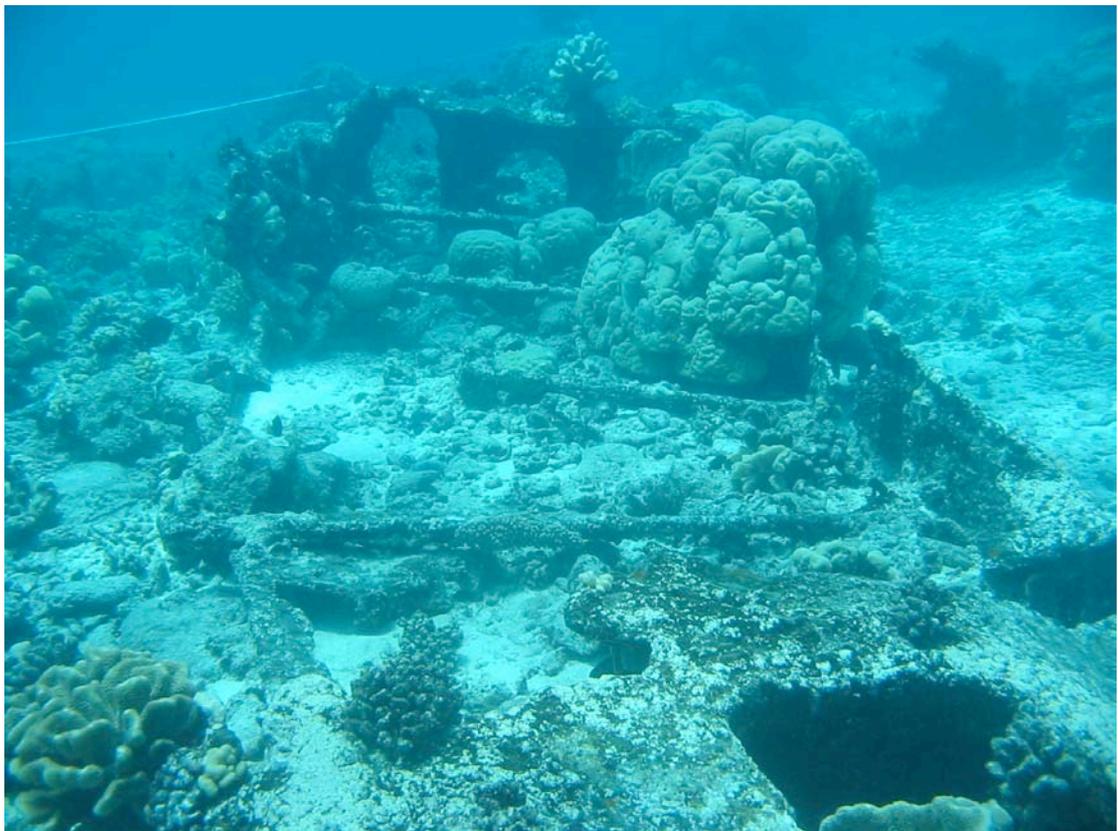
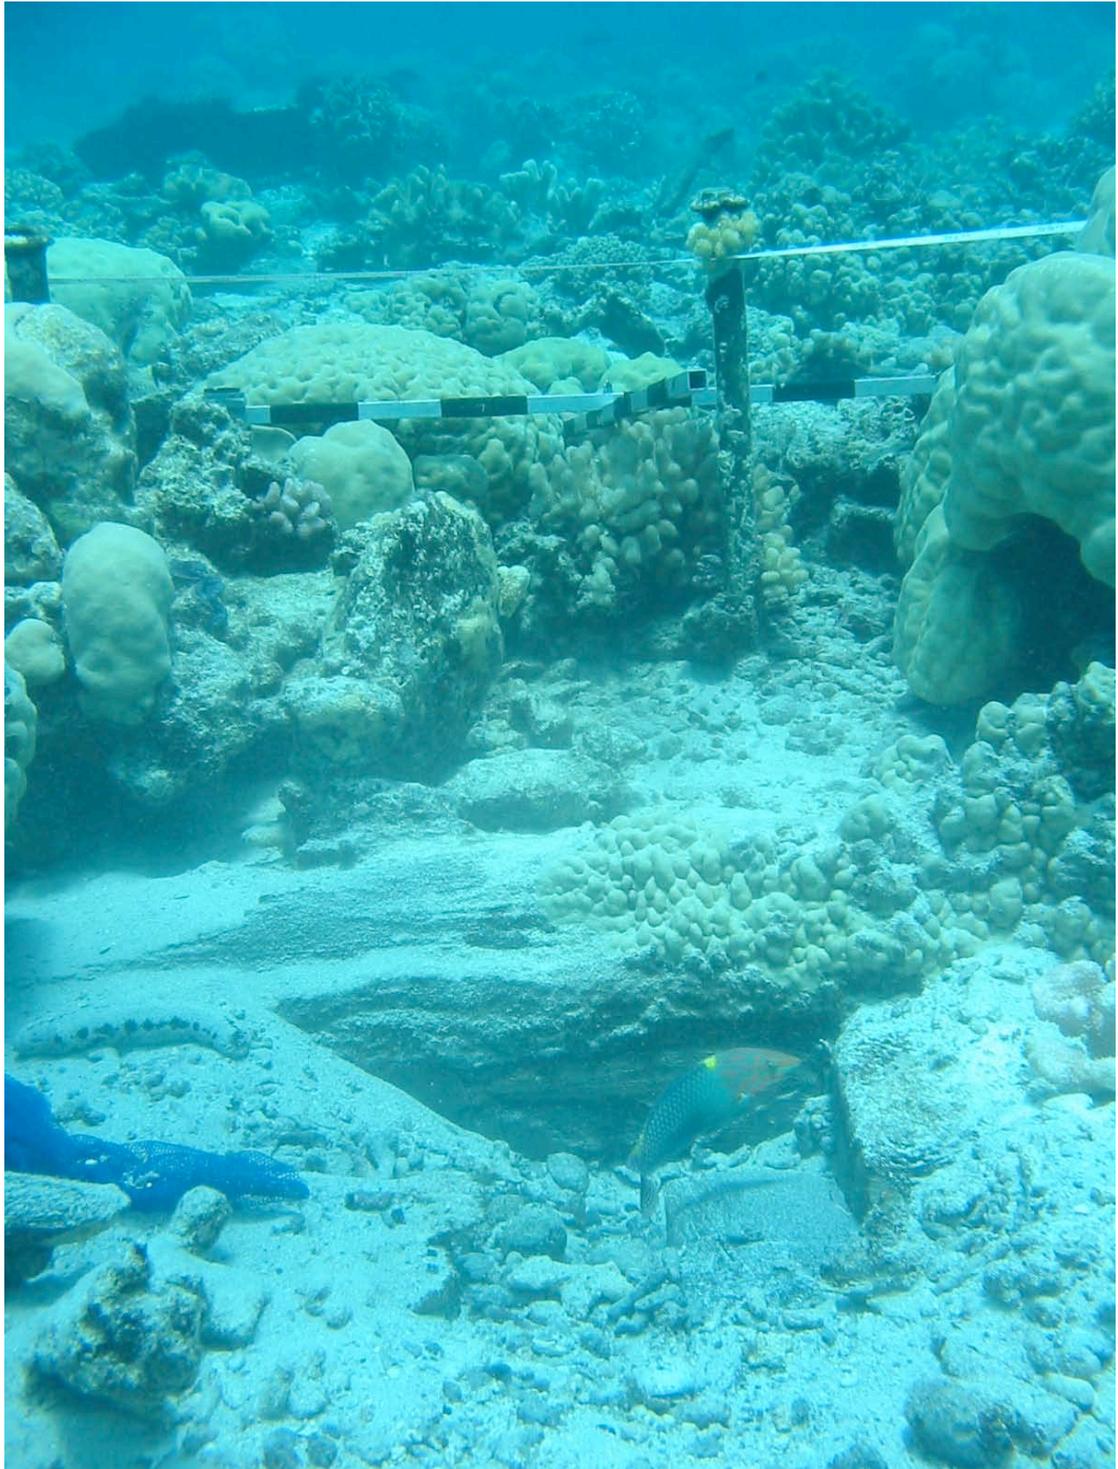
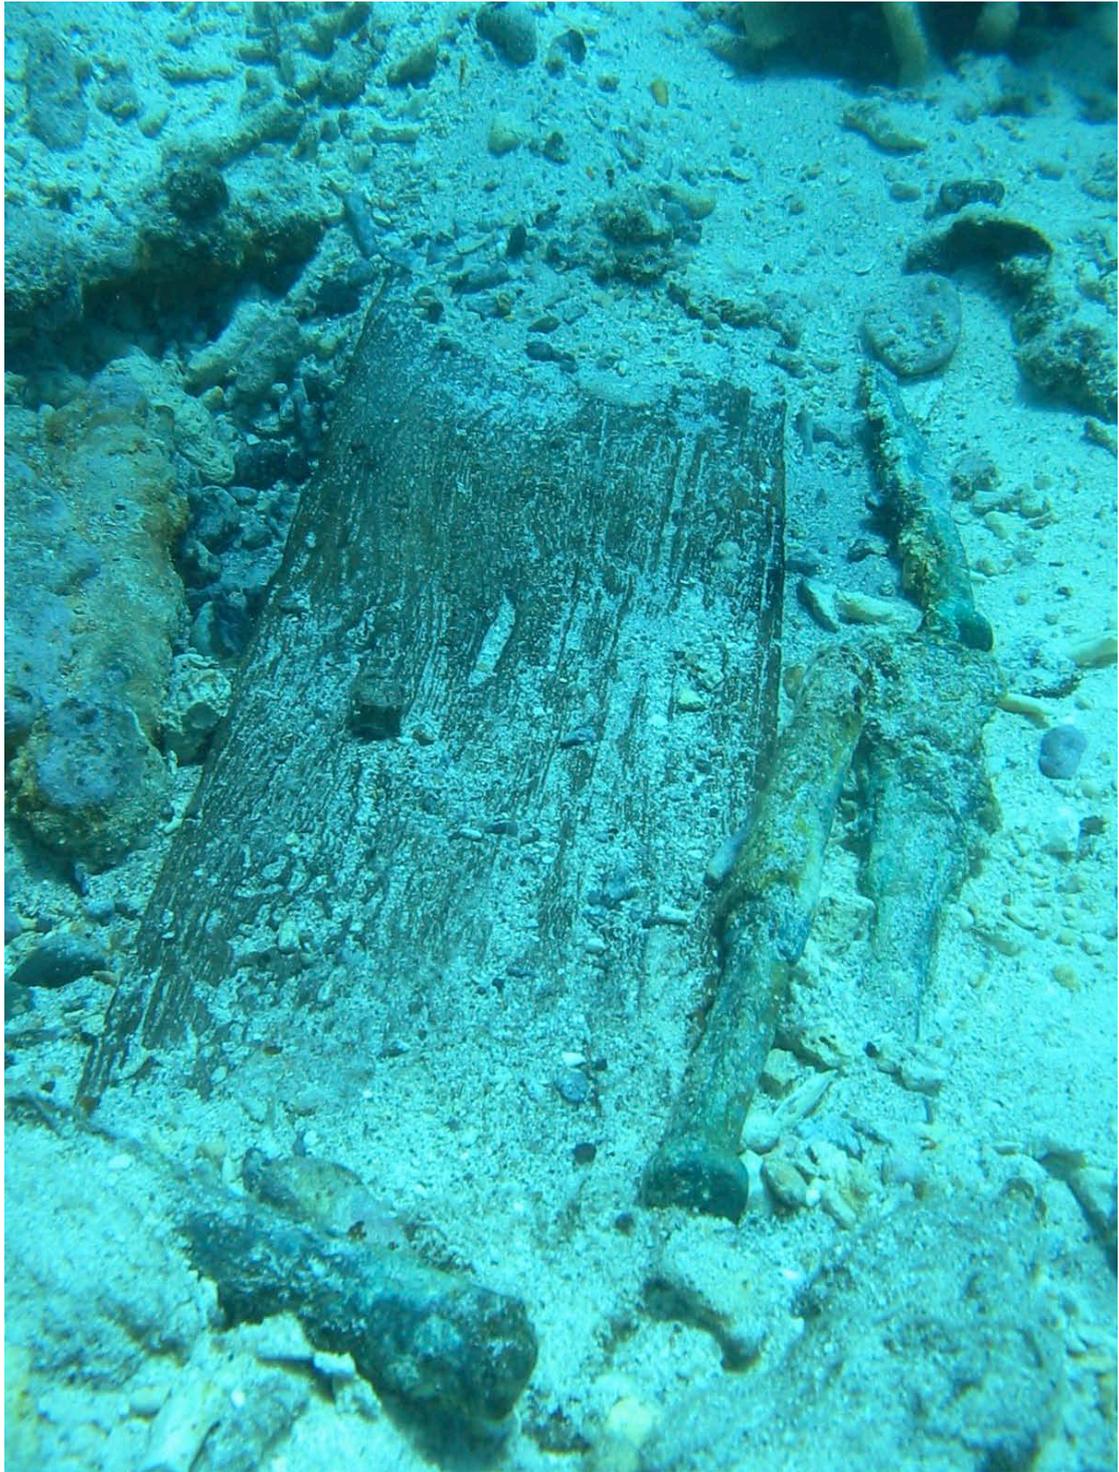
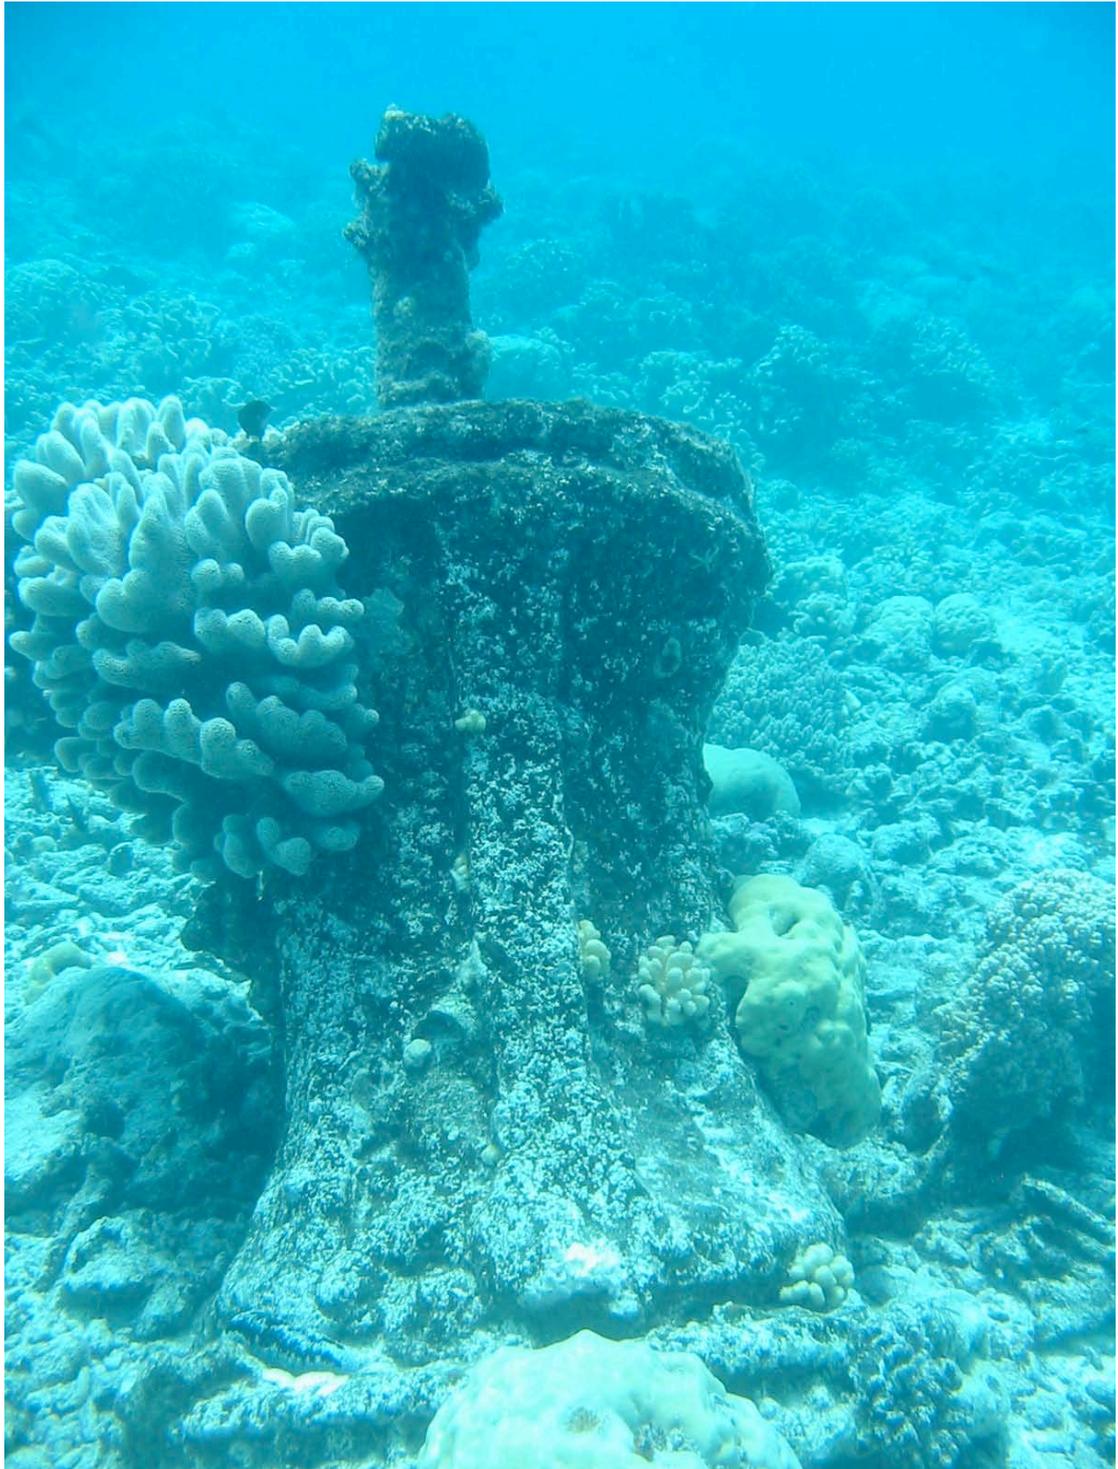
Views of the site

Measuring 46 m long, this 'pristine', wreck lies in c.4m of water, almost upright on a sand bottom amongst coral outcrops and on an axis of 060/240°M. Crumpled sheathing is visible at the bow, which lies towards the southern end of the site. Where it is not buried, the wooden hull of this wreck has entirely disintegrated, leaving only metal work and other non-organic materials visible above the seafloor. Loose copper-alloy fastenings (mainly bolts) lie around the site and a row of nearly-vertical copper alloy keelson bolts is visible atop the degraded remains of the keelson. These are the most distinctive feature of the site and they led to its first being called the '*Peg [fastening] Wreck*', by Parks Australia staff. These bolts stretch along the length of the site and below them lie the keel, which is visible when the sand is cleared away by hand fanning.

At the forward end of the site (0m) and 11m to starboard of the line of bolts at the bow lie the remains of a heavily-degraded iron tank. Directly opposite on the other side of the bow, 12m to port, lies a capstan. A further 3m on again (at the very SE extremity of the site) lies one barrel of a windlass that has broken in two to finish with its bare axle projecting at an angle upwards towards the surface. The other half of the axle and what appears to be one of the pawl rims lies closer to the site. The other barrel is located quite some distance away, closer to the line of keel bolts and 4m aft of the bow. It has a very heavy chain comprising c. 10 inch 'D' links tightly wound around its whelps.

One end of this line of chain passes aft from the windlass to cross the centre line of the wreck at a point 10m from the bow to terminate alongside a heavily-built iron tank. This measures 5.8m (19 feet) long, by 1.8m (6 feet) wide by 0.9m (c. 3 feet) and it is lying to starboard between the 6m and 14 m mark, aft of the bow. Another line of chain—some of it cemented in a suspended state above the seafloor—snakes in an arc aft from the windlass, along the port side of the wreck, passing through a hawse pipe at a point 18m aft of the bow and c. 5m to port of the keelson. This too lies suspended above the seabed. From there the chain proceeds aft in an arc to cross the keel line 26m from the bow where it turns back parallel to the keel. From there it continues running towards the stern, terminating alongside the keelson at the 42m mark, with the last bolt at the stern visible 2 m further on.

Of the remaining visible iron-work, an iron deadwood strap lies to port forward. A second capstan lies just to starboard of the keel line 7m aft of the bow and rounded ballast (appearing like granite) was occasionally visible amongst the wreckage.

Many large copper-alloy bolts (often termed 'drift bolts' to differentiate them from equally large through bolts) lie loose on the seabed throughout the site.¹ Some of these were 42 inches (1.46m) in length by 1 and a quarter inches (c.30mm) in diameter. In the stern area on the port side copper alloy 'through bolts' measuring 30 inches (c 86cm) by 1 and a sixteenth inch diameter are also visible. Two lines of smaller bolts are visible 1.5m apart, and 1.5 m from the keel midships on the starboard side between the 24-30m mark aft. A single line of bolts is visible on the port side, a similar distance from the keel and between the 15 and 21m mark.

Five metres from the bow a line of round headed (one and a quarter inch diameter), square-sectioned spikes, 11 inches long were visible. These were found to protrude

from planking (possibly the garboard strake or a nearby strake) which when hand-fanned proved to have scantlings of 9 inches wide by 4 inches thick.
