Phaeton (1889)

Wreck Inspection Report

Date of Inspection: 2/11/2004

c. 1Nm SE of Horsburgh Island in Port Refuge at the north west corner of the lagoon at the Cocos (Keeling) Islands

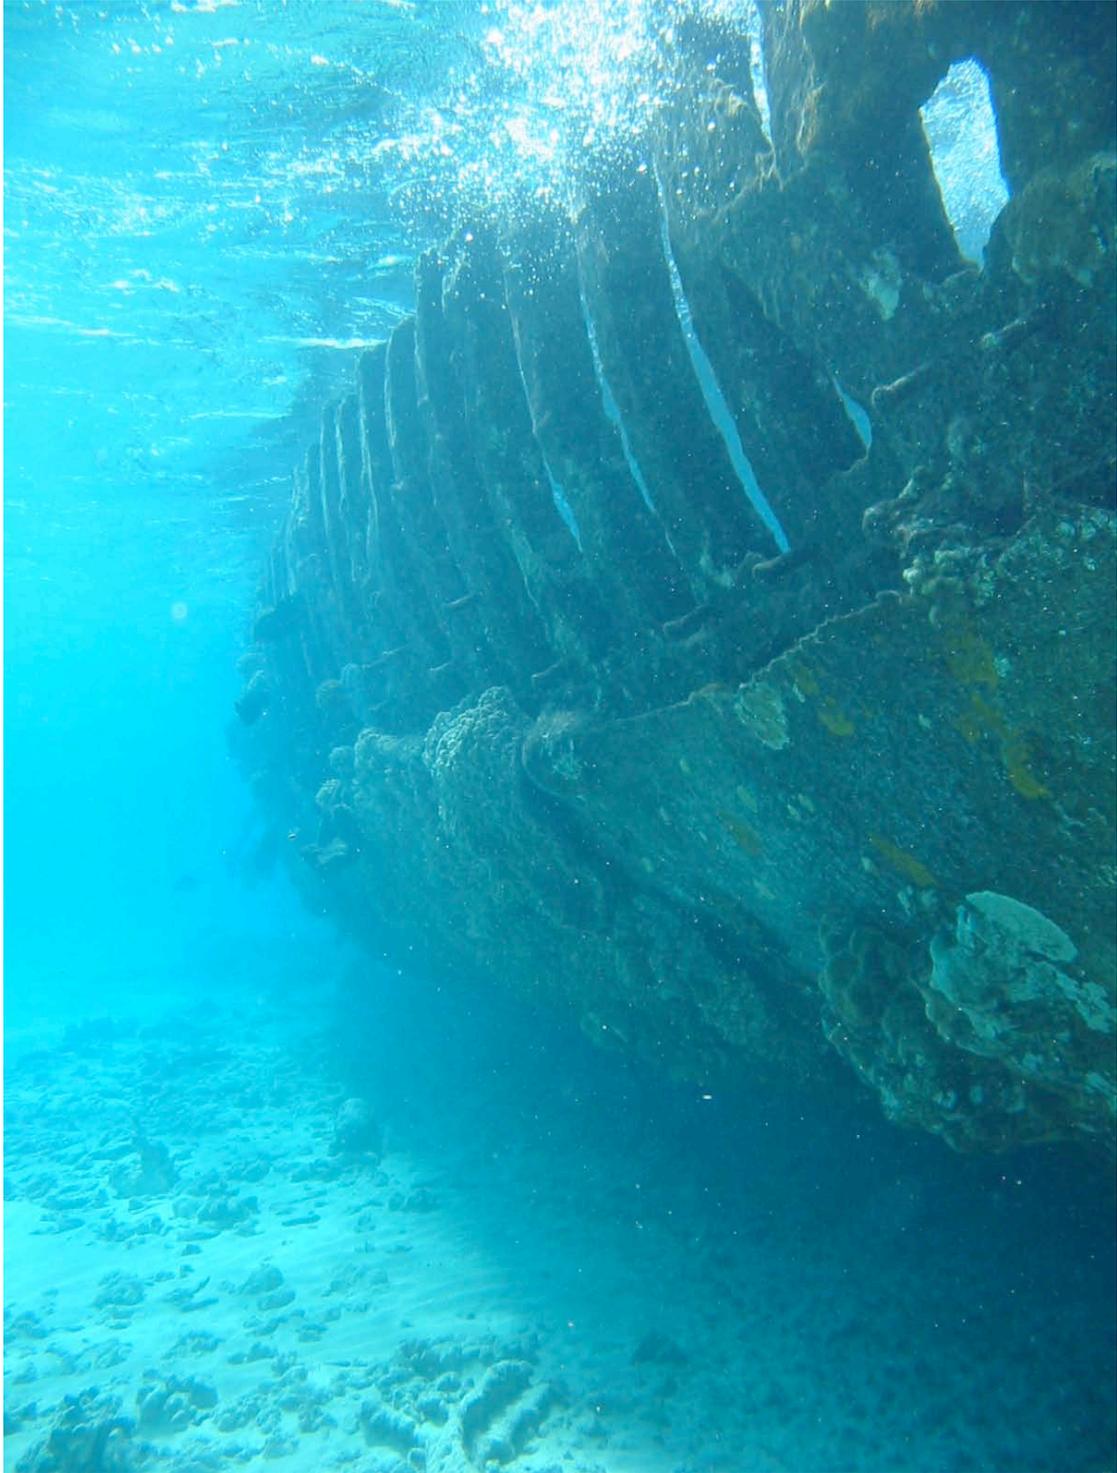
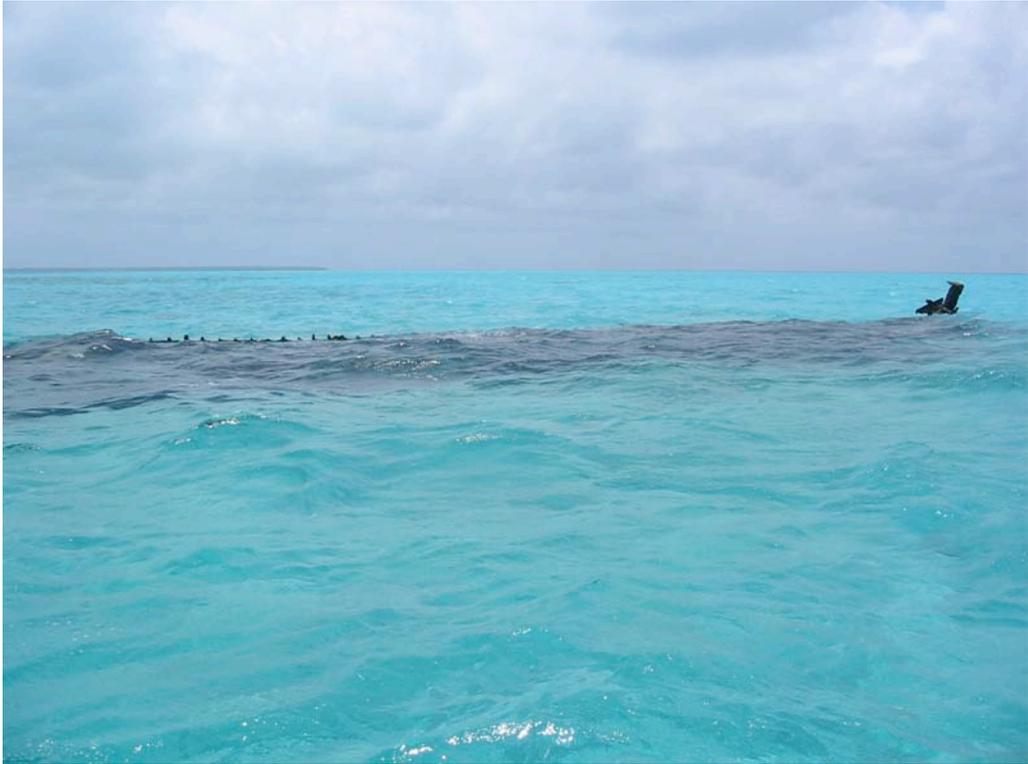
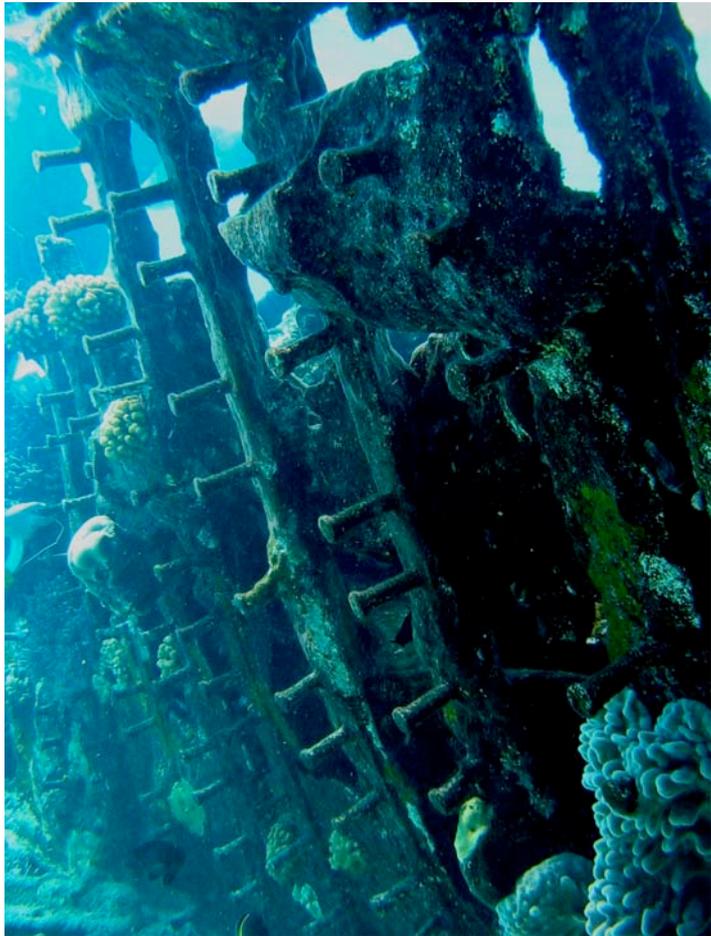
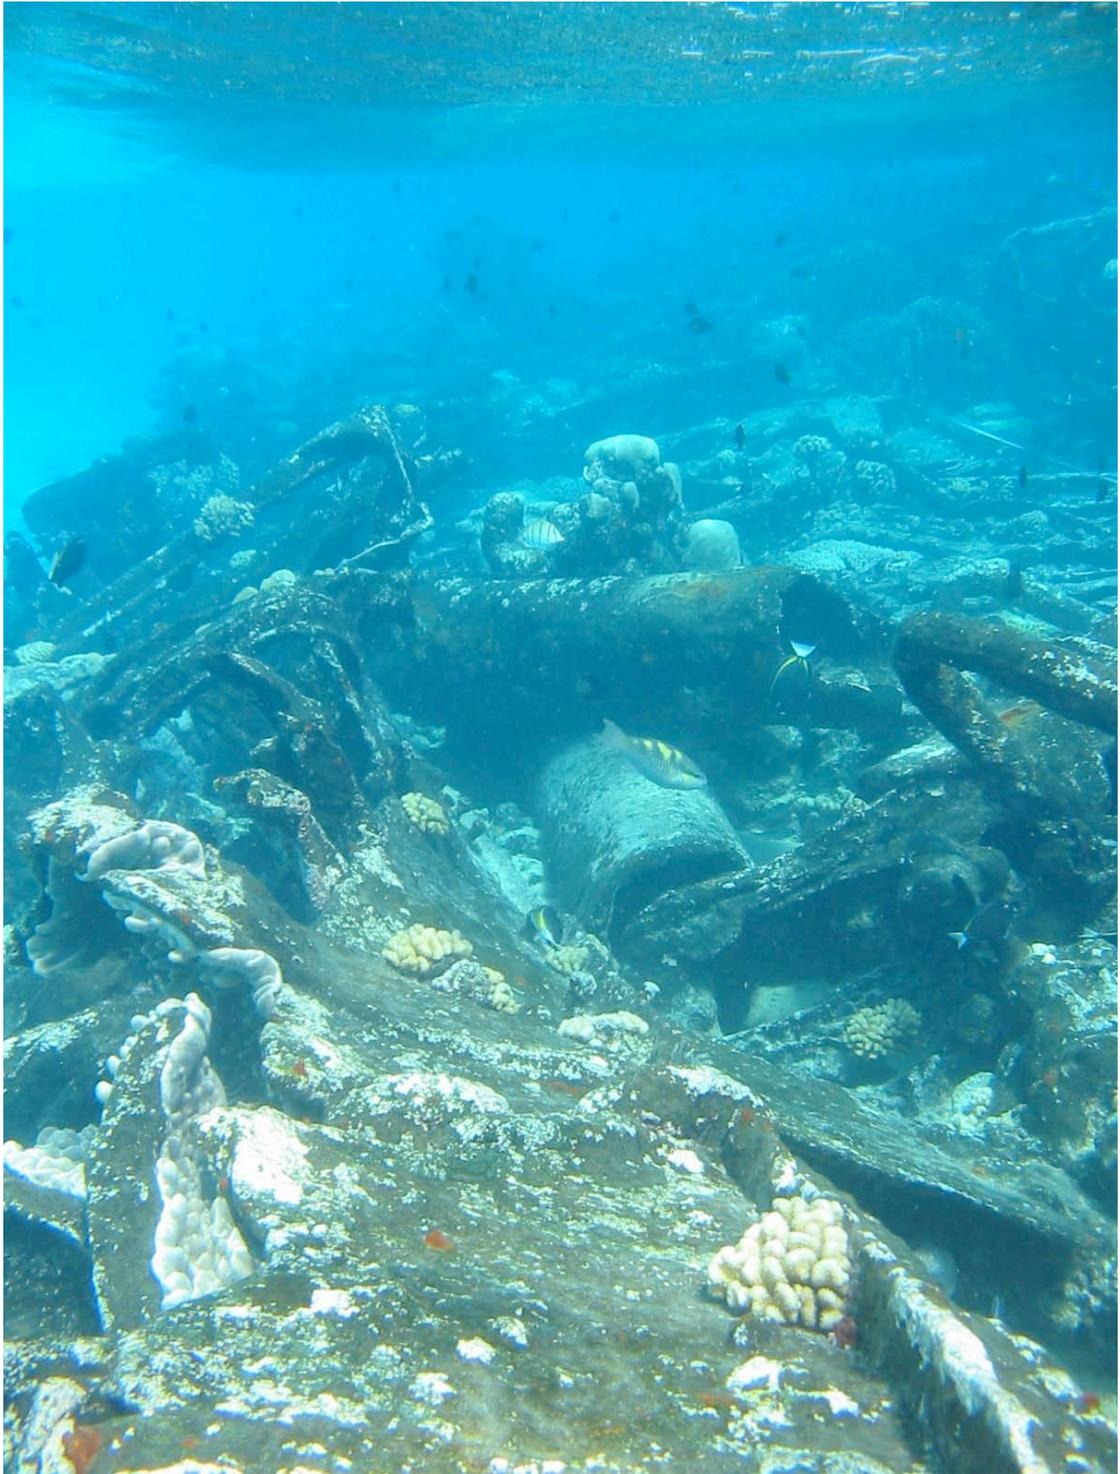
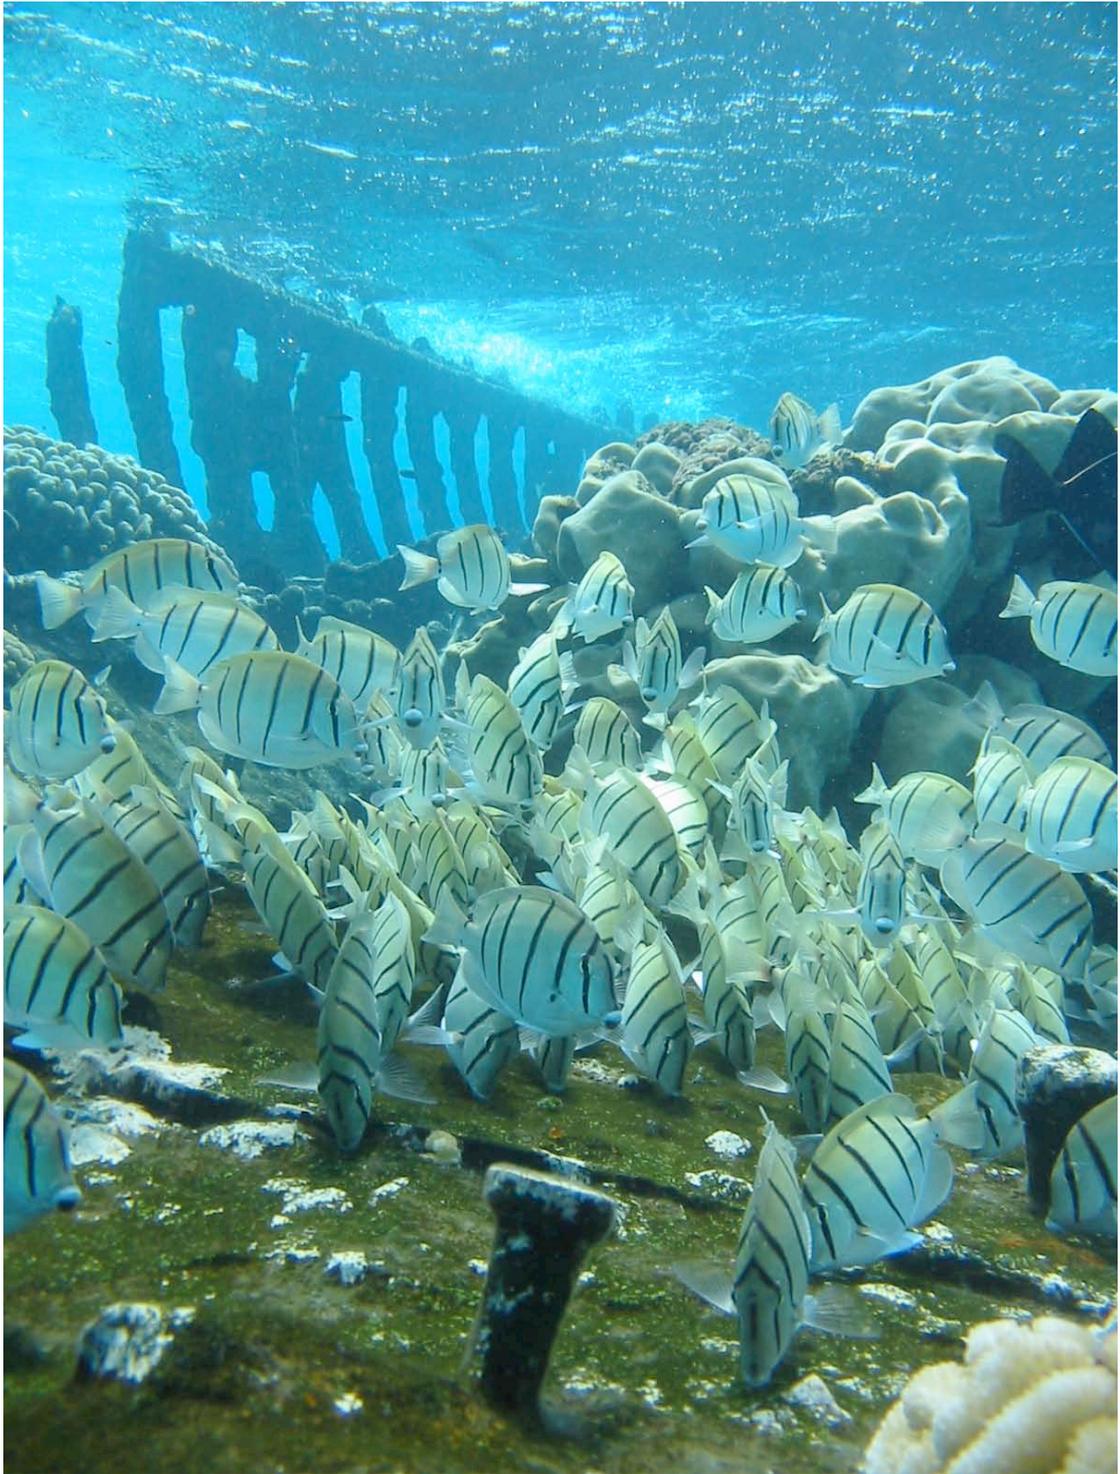
Images of the site (By Robert Thorn)

The fore-part and midships section aft to a break in the hull at the 40m mark from the bow are intact and are lying virtually upright on a sand bottom. The iron frames of the fore part of the wreck are all intact from the sea surface down to the keel, i.e. from around the turn of the bilge. This situation presents an immensely strong 'cup' or 'vessel' that is filled with cemented and concreted iron wreckage (anchor, chain, beams, mast sections &c).¹ Some wreckage lies outside the hull. Where exposed to the action of the seas, all the woodwork, outer and ceiling planking appear to have disappeared, leaving only their fastenings projecting from the iron frames. The iron stem projects above the surface, for example, and it carries large copper alloy through bolts that were set into the ironwork to secure the heavy timbers of the bow. These timbers have long-since disappeared. The frames immediately aft of the stem also carry lines of copper alloy bolts, each with a head and a thread on which a copper alloy nut is hove down, but again each is devoid of the timber planking they once secured. Further aft and closer to the keel, the copper-alloy sheathing is intact, and possibly some of the timbers underneath the sheathing may remain.

Aft of this intact section lies the stern, which, in contrast with the bow and midships section, is completely disarticulated and lying flat on the seabed. Adding to the problems in this section, each of the elements comprising the stern were difficult to recognise out of context in the short time available on this inspection. Preliminary indications are that this area has been torn apart with considerable force, to lie scattered on the sand bottom.
