Wreck inspection report

City of York (1861 - 1899)

**Report—Department of Maritime Archaeology, Western Australian
Museum, No. 263**

2010

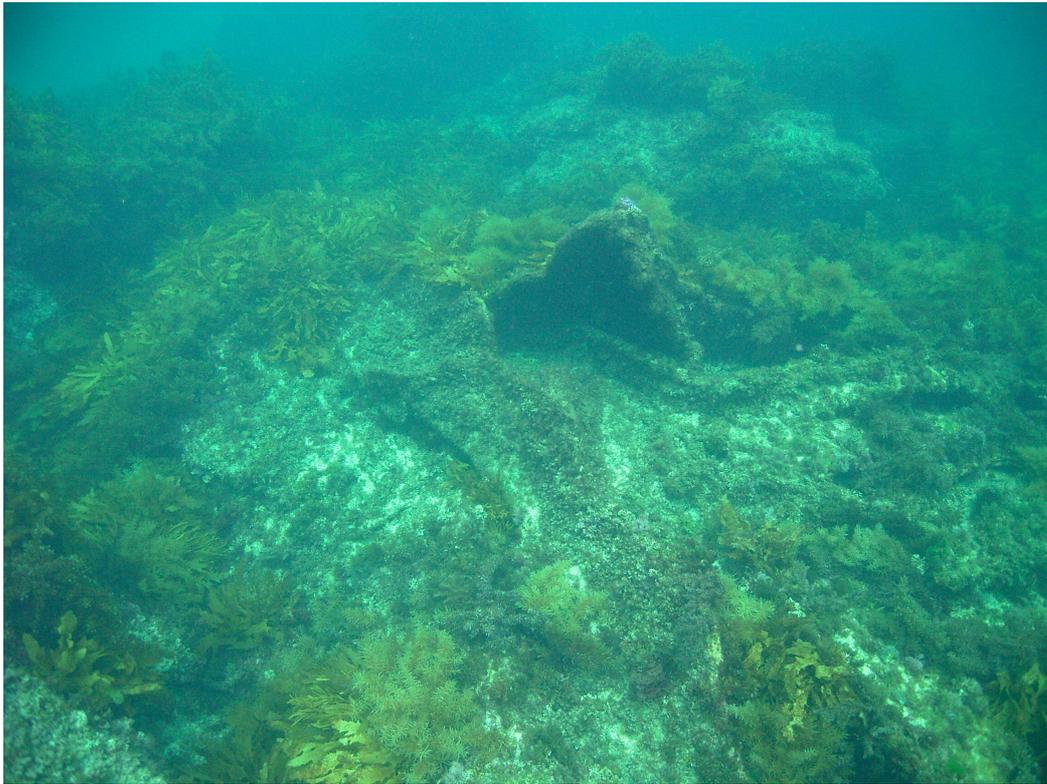
Fig. 2 The curved stem of the City of York's broken and collapsed bow is still visible, though is flattened against the reef (Patrick Baker/ WA Museum)

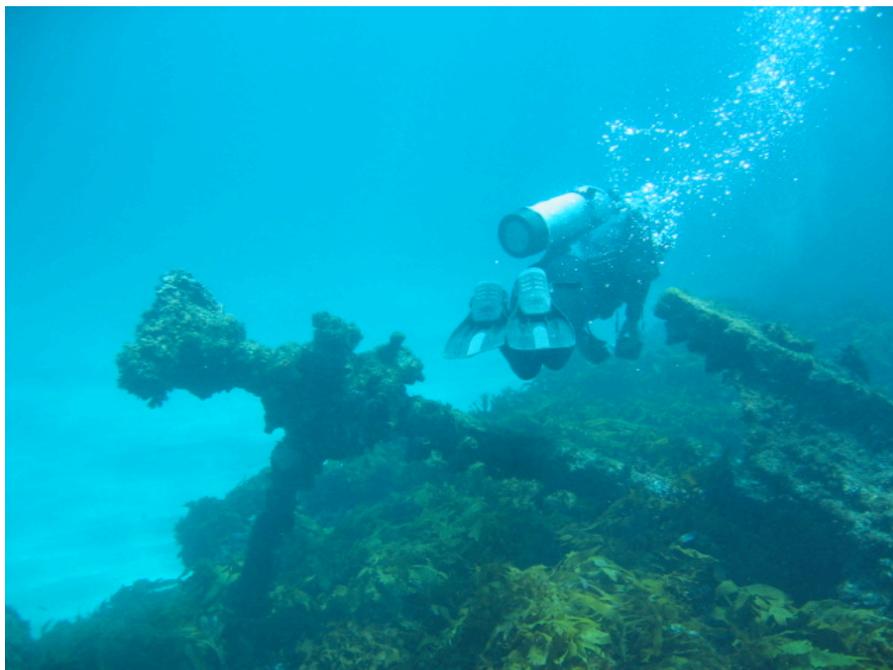
The site lies on a shallow reef in an exposed location, and has been heavily broken up by natural physical forces, though substantial iron features are visible and identifiable. The cargo was salvaged at the time of wrecking. After the wrecking event the hull broke up and disintegrated with hull and rigging components collapsing to starboard down the slope of the reef to the seabed. Comparison with photographs taken in 2004 show that the port stern hull plating that was joined to the sternpost has since collapsed.

The site appears to be in a stable state, though corrosion and collapse of iron hull plating at the stern has been noticed.

Fig. 3 Diver swimming between rudder post (left) and sternpost at northern end of site.
(MAAWA)

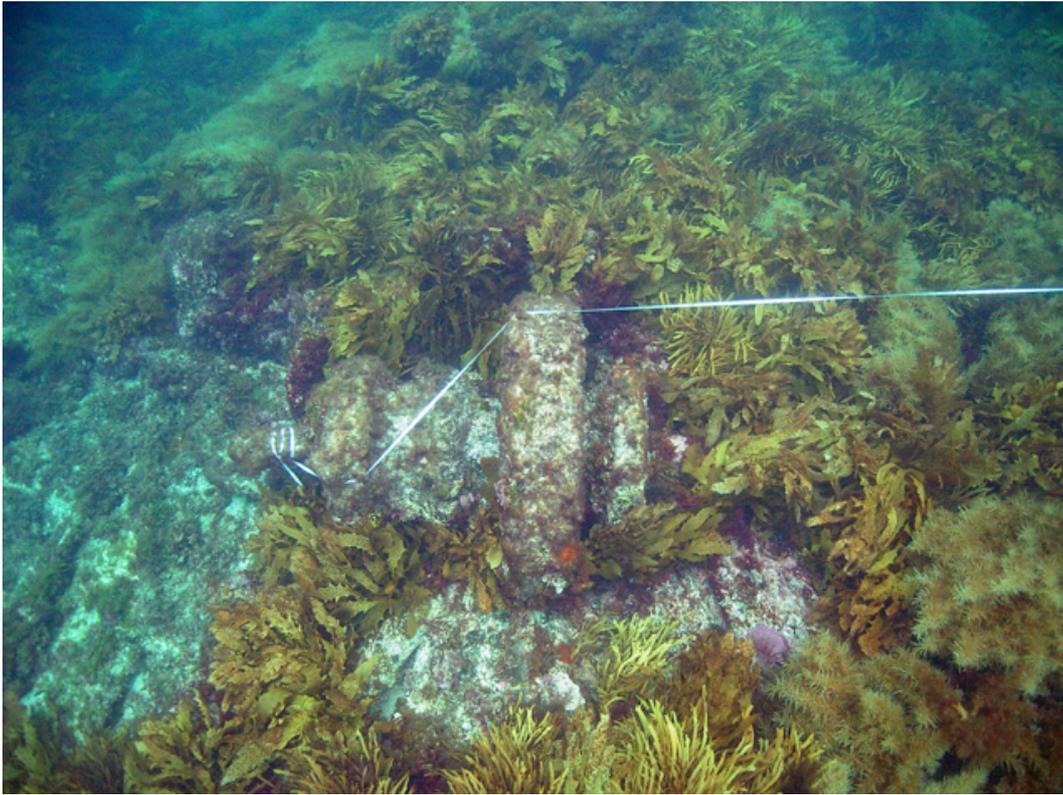
Fig 4. Windlass in bow area in 5.8m depth (Patrick Baker/ WA Museum)

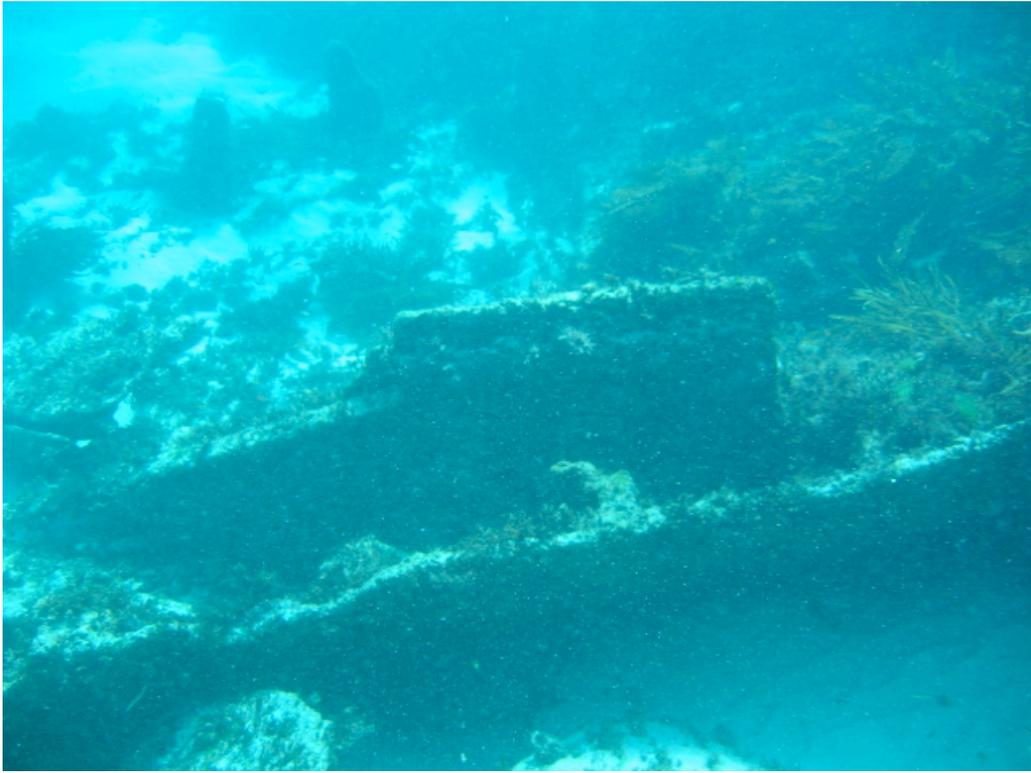
Fig. 6 Section of collapsed yard on seabed in 2004, and observed in 2010 (MAAWA)

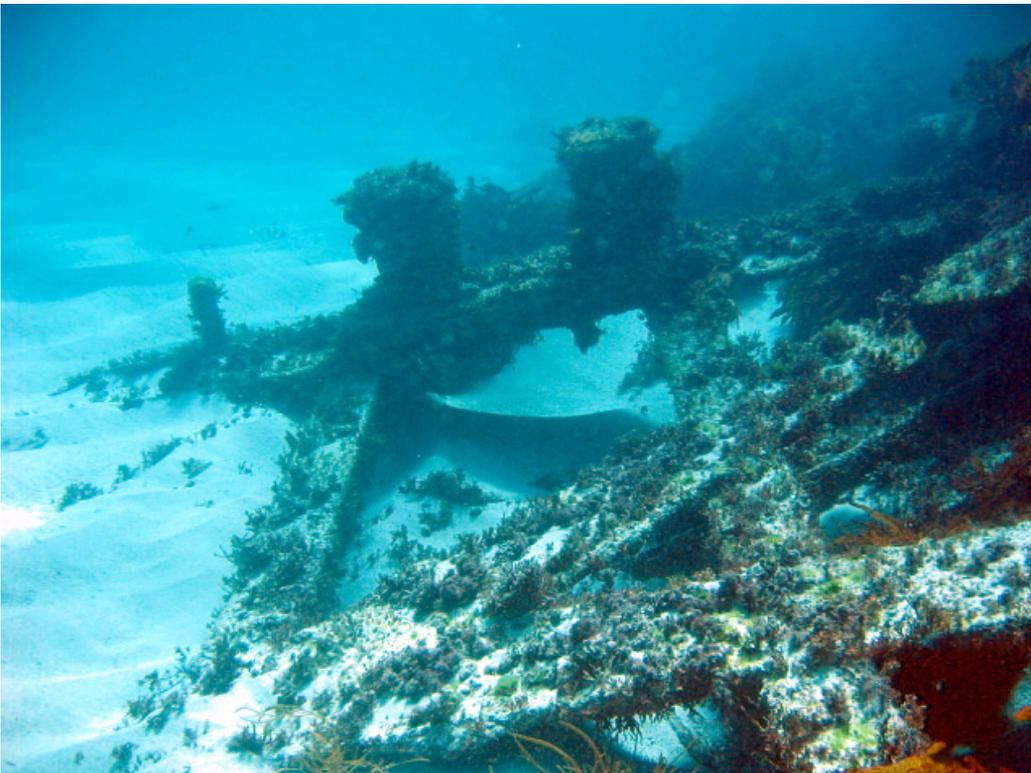
Fig. 7 Collapsed section of deck structure showing beam shelf plating (with bitts still attached), deck beams and stringers in 2004, and observed in 2010 (MAAWA)

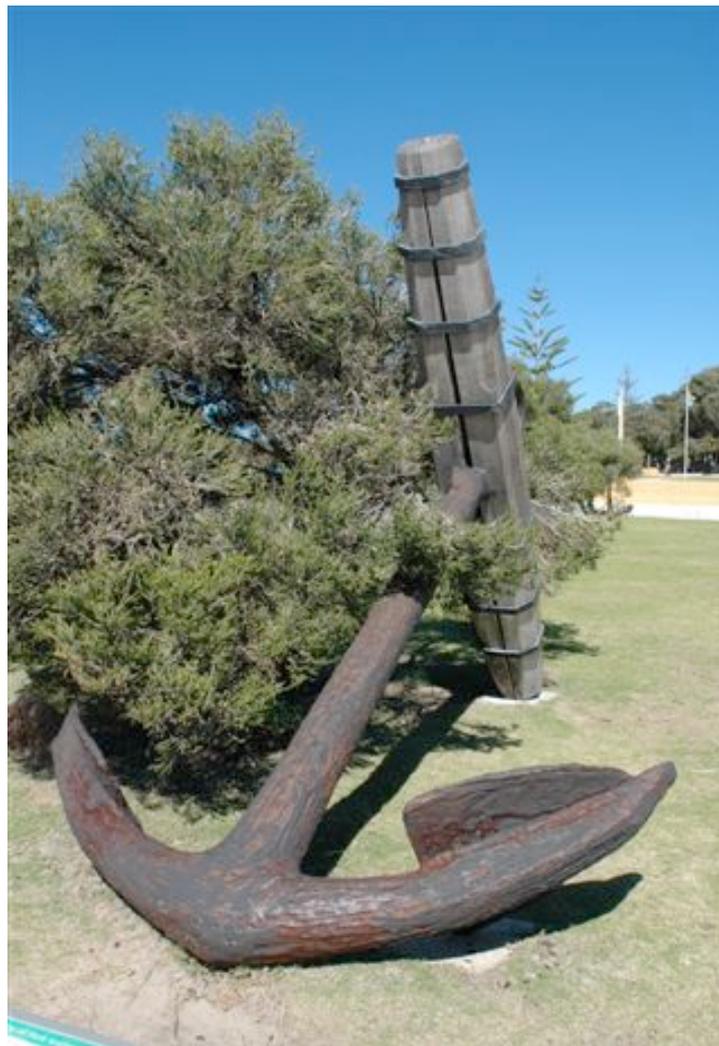
- 3) The anchor of the *City of York* on display outdoors at Rottneest Island, in its current state requires it to have its original display supports re-installed (Carpenter and Kimpton 2000). Raising the anchor from ground level is required to avoid corrosion that is being caused by contact with wet earth.

Fig. 11 *City of York* anchor on display at Rottnest Island in 2005
(Jon Carpenter/ WA Museum)

- 3) That the WA Museum continues to liaise with the Rottnest Island Authority regarding management and interpretation of the site and artefacts;
- 4) That the outdoors display supports for the *City of York* anchor on Rottnest Island are re-installed to avoid further corrosion and damage;

- 5) That conservation recommendations from 2000 and 2005 (Carpenter and Kimpton 2000; Carpenter 2005) regarding the maintenance of the *City of York* and *Mira Flores* anchors on display at Rottnest Island are implemented;

- 6) That due to the highly saline and exposed conditions of the *City of York* and *Mira Flores* anchors on display at Rottnest Island, a regular inspection and maintenance program is established.
