The 2012 Bunbury Jetty Survey

Report prepared for City of Bunbury

Jeremy Green

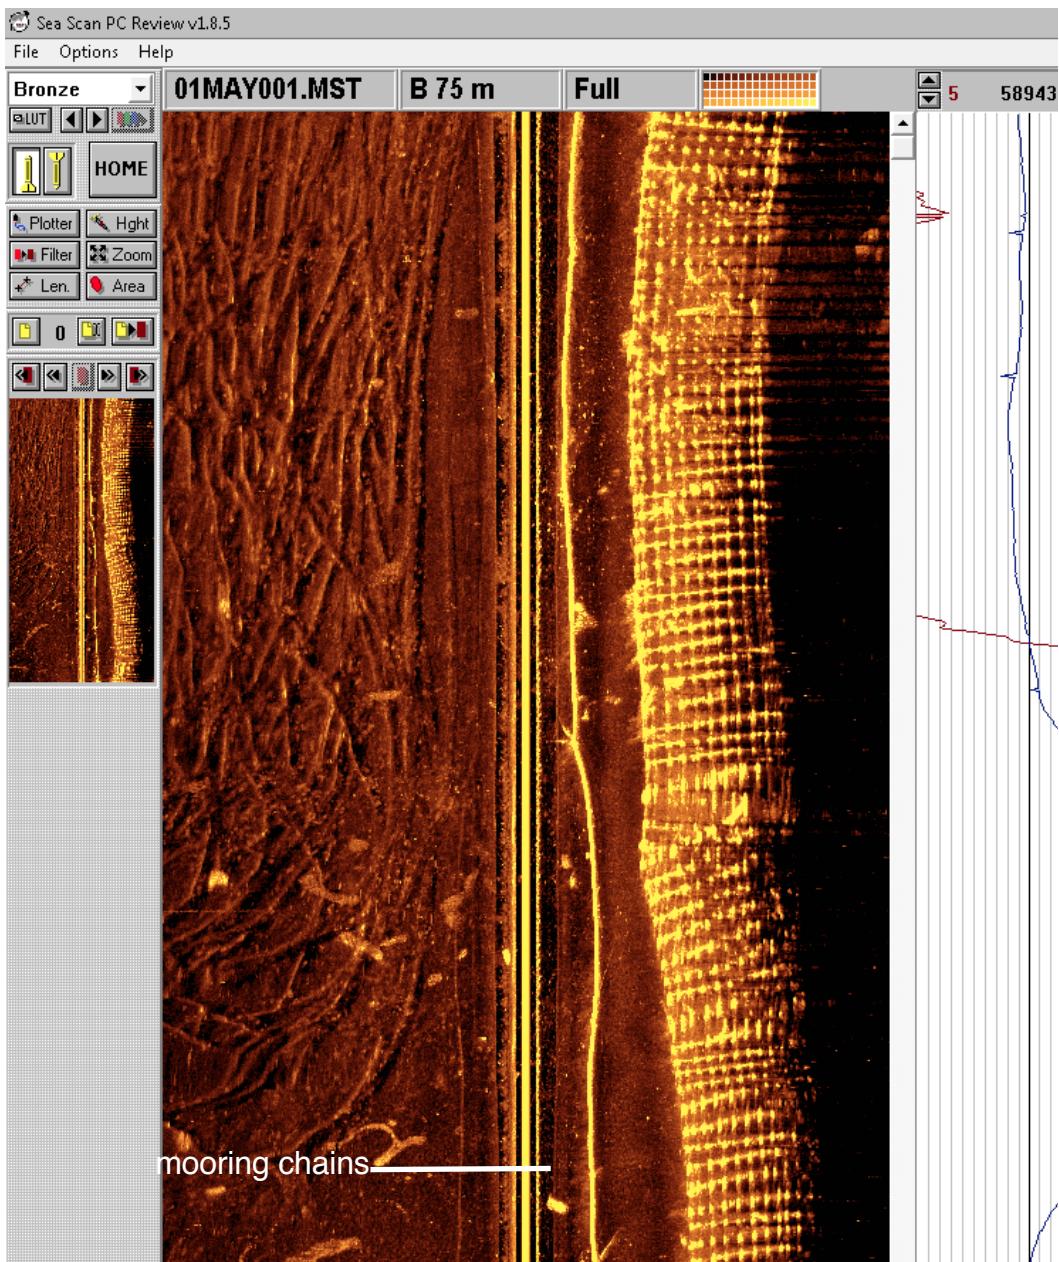
The magnetometer, as it turned out, was not practical to use on the Bunbury Jetty Survey. Within the first few minutes of operation it was found that there were large geomagnetic anomalies in and around the jetty. In addition a large bulk carrier, *BBC Zarate*, which was anchored on the modern Berth 1 to the north-west of the jetty that created an additional magnetic signal (Figure 1). Subsequently, the Geoscience Australia website <www.geoscience.gov.au> was consulted and it was found that the region has a considerable amount of geomagnetic variation (Figure 2).

Figure 1. Marine Sonic side scan sonar interface showing sonar waterfall and on the right hand side the magnetometer trace, showing the large magnetic anomalies over large distances.

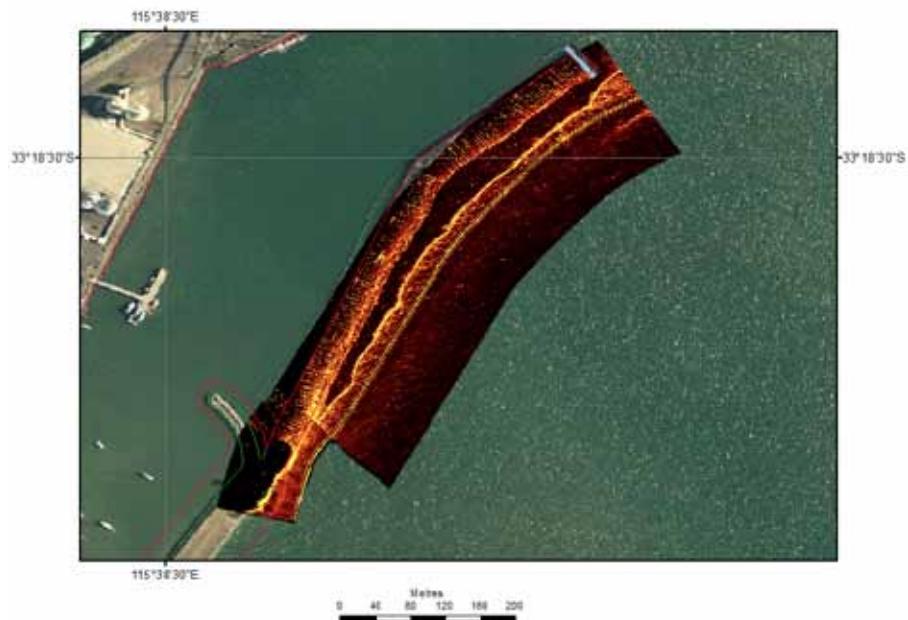
Figure 5. Second part of first survey of the east side of the jetty (MST 003–005).

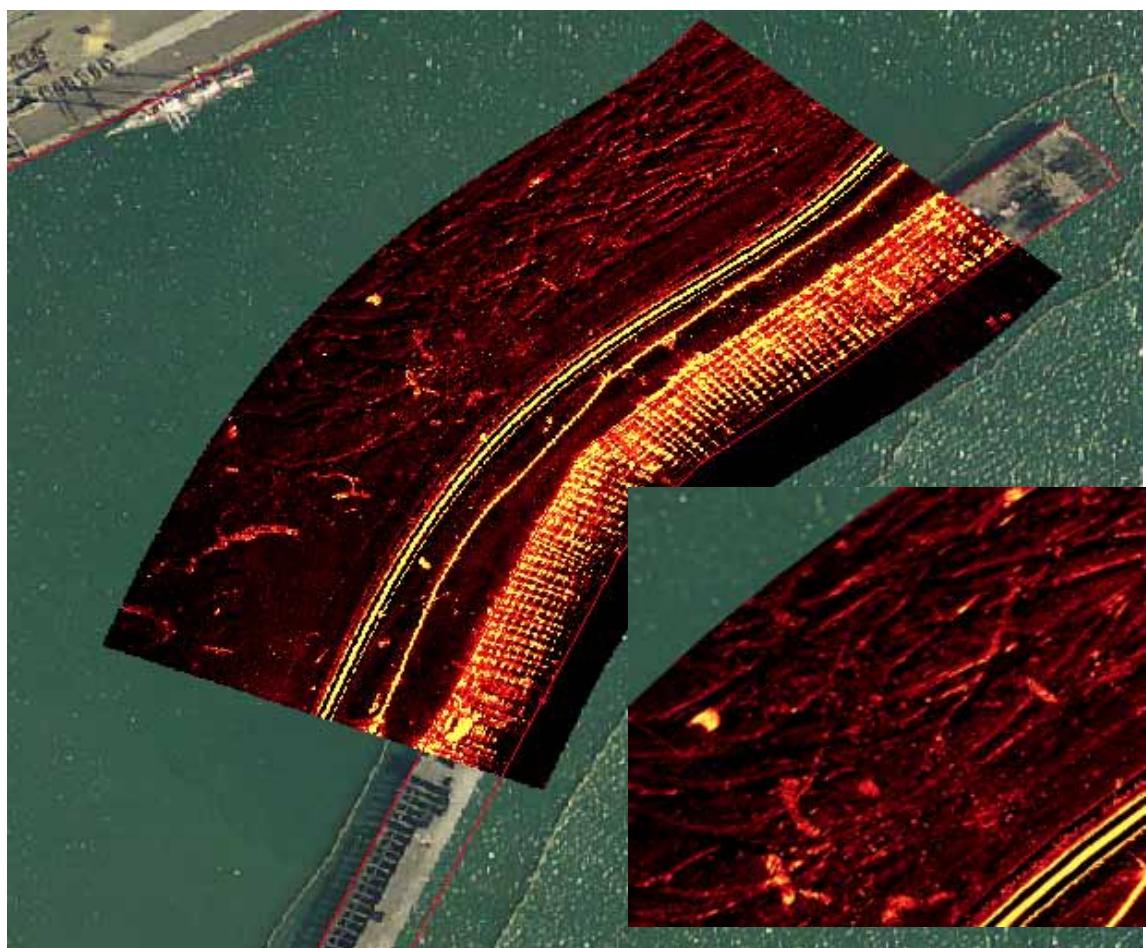
With the side scan operating in a dual channel mode 75 m on either side of the towfish, the top half of the west side (Figure 65) and the whole of the east side (Figure 56) of jetty was surveyed with side scan. It should be noted that the side scan image showed a large amount of scouring on the west side of the jetty, possibly due to dredging of the Outer Harbour around Berths 1 and 2.

Figure 6. First part of survey 1, the top half of the west side of the jetty, showing the bund and the jetty bents (MST 001) together with the scouring possibly due to dredging. (Insert show an enlargement of the scouring).

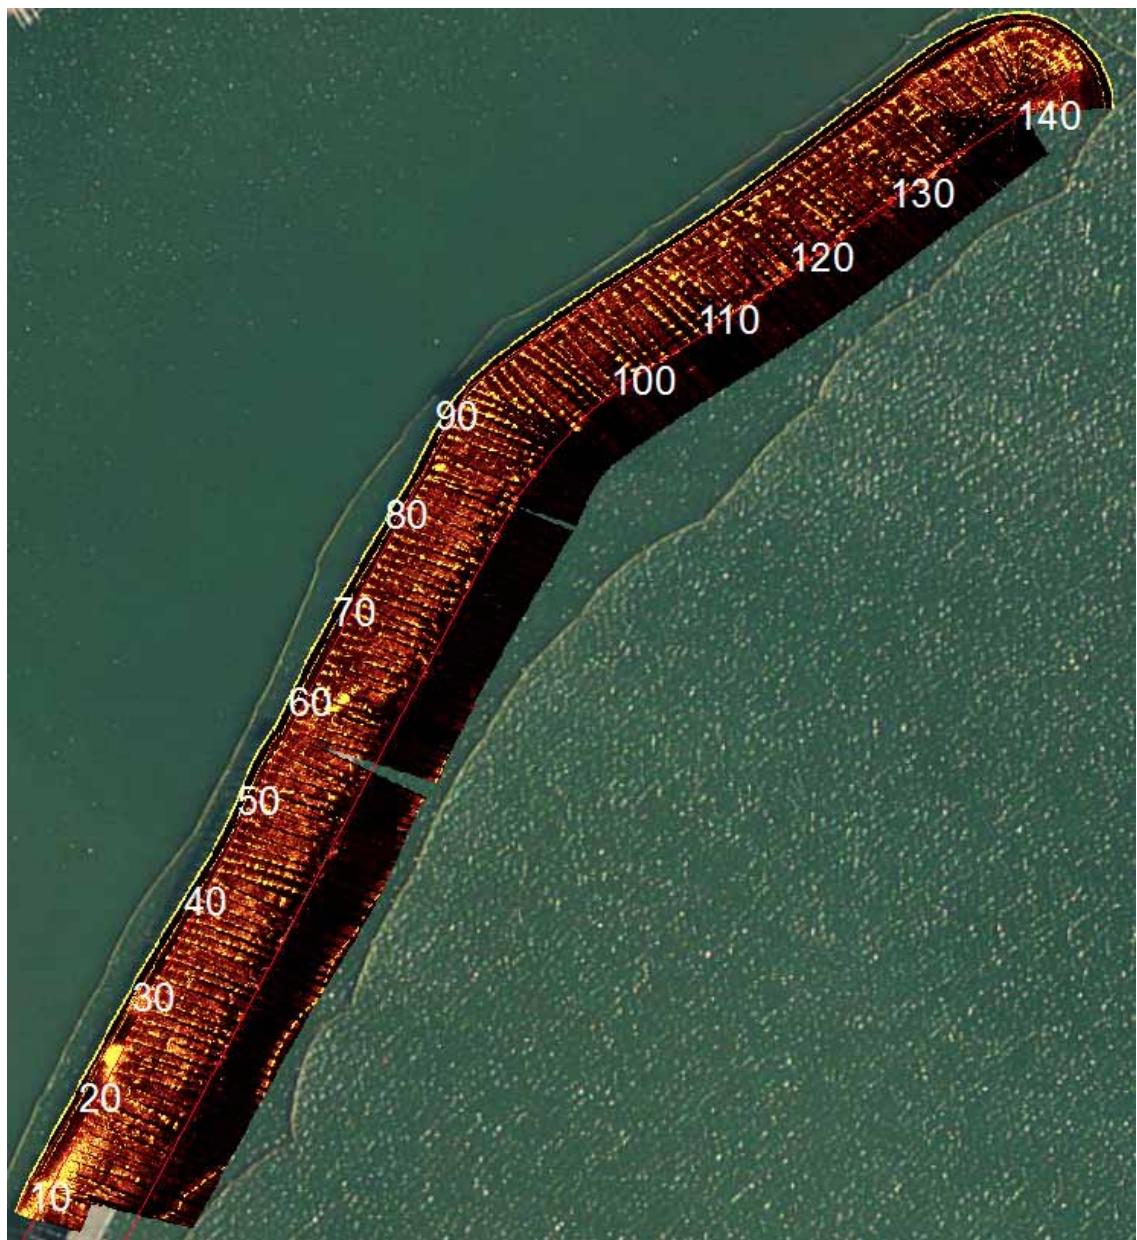
Run MST 015–020 (Figure 7) was a single channel run along the west side of the jetty in a northerly direction, inside the bund. It shows the jetty bents quite clearly and parts of the bund on the east side that have not been shadowed by the jetty bents. At 81 m from the start of the jetty on the west side around bent 21.

Figure 7. Third sonar survey run MST 015–020.

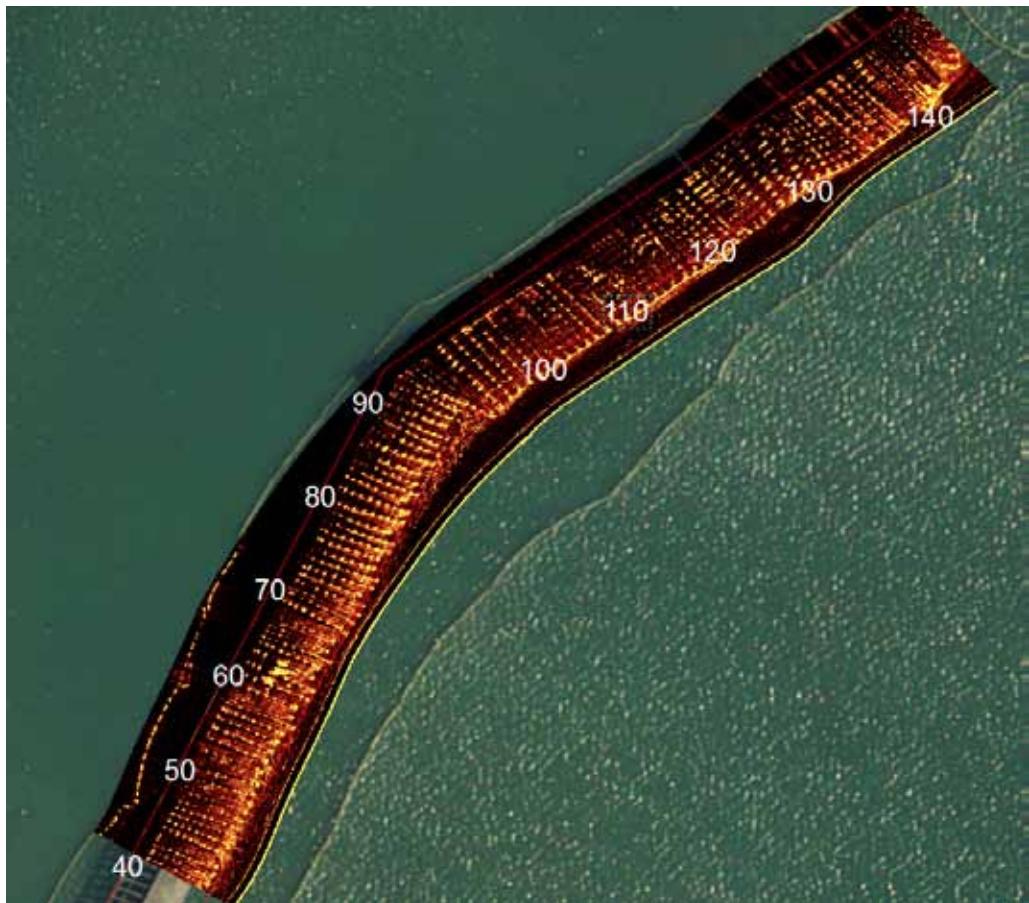
The run MST 021–024 (Figure 8) was a single run on the east side of the jetty running south. This trace showed debris lying on the seabed along most of the

east side of the jetty from the start of the jetty up to Bent 90, particularly between Bents 40 and 90.

Figure 8. Third sonar survey run MST 021–024.

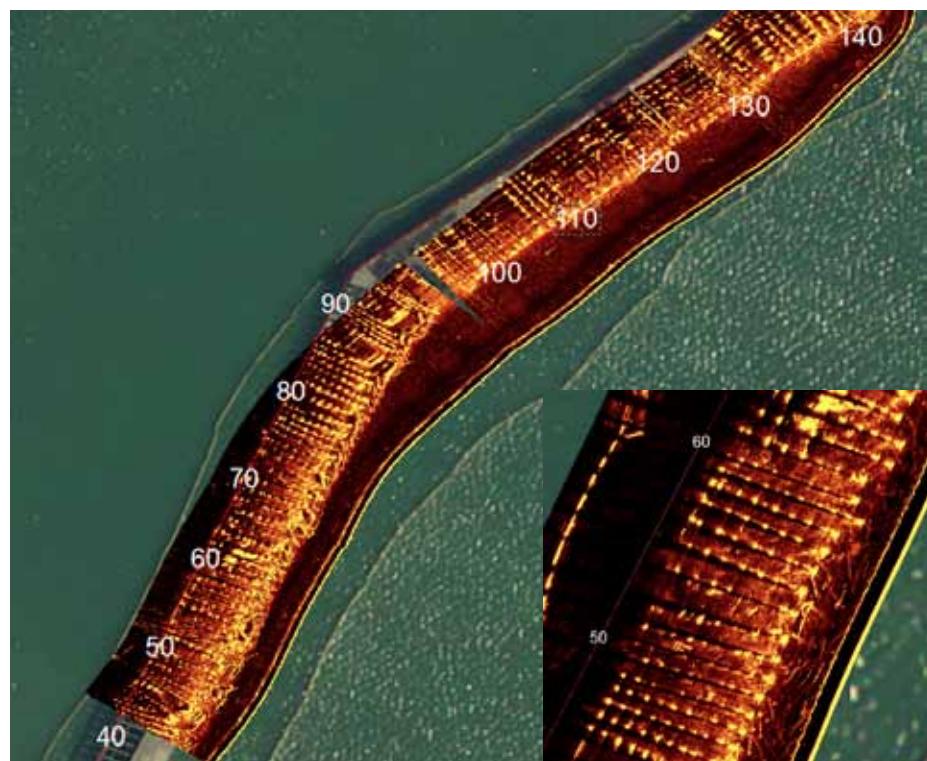
This was a single channel run in a northerly direction on the east side of the Jetty (Figure 9).

Figure 9. Fourth sonar run (MST 026–029), insert shows details of debris.

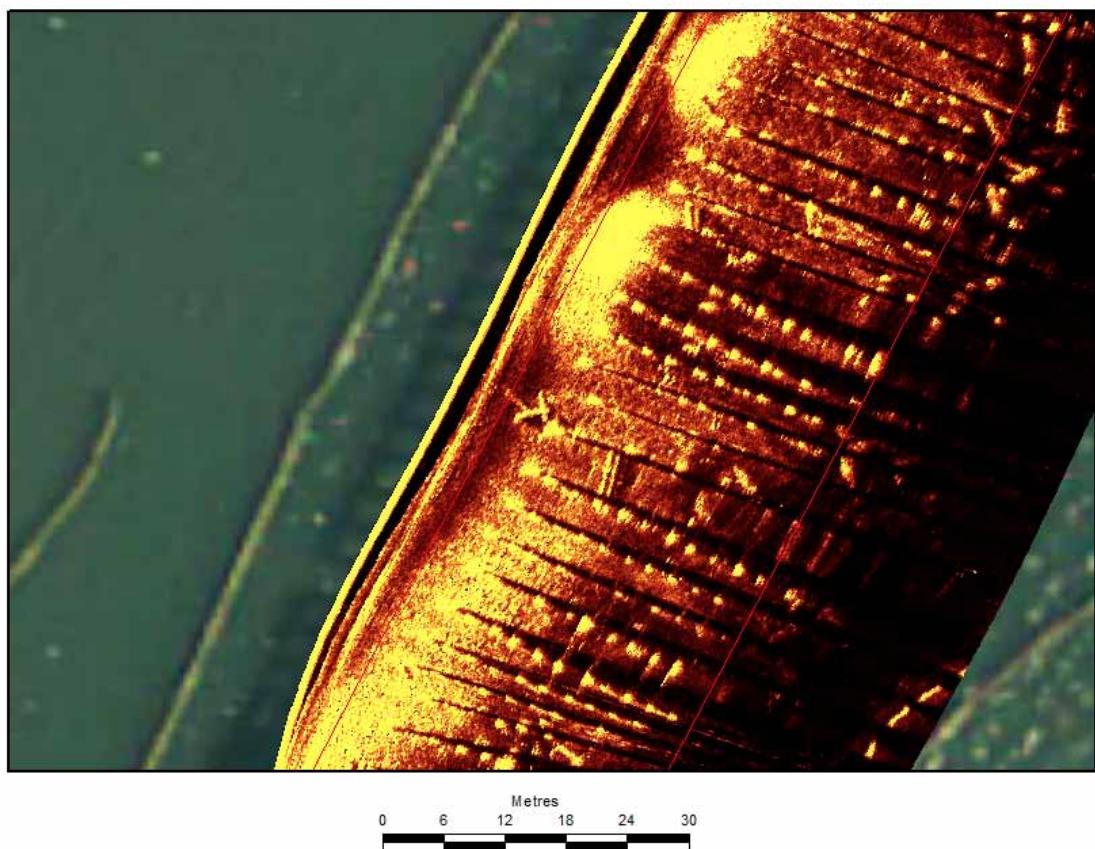
Figure 12. Unusual feature at Bent 22, possibly dolphins.

This was a single channel run in a southerly direction on the west side of the jetty (Figure 10). This showed a number of unusual features including one at Bent 22 (Figure 12), possibly dolphins seen in Run 1, MST 003–005 (Figure 5). In addition, submerged bents, about 5 m long were noted at Bents 39, 54, 57, 99, 110, 125 and 134 (Figure 14 and Figure 15).

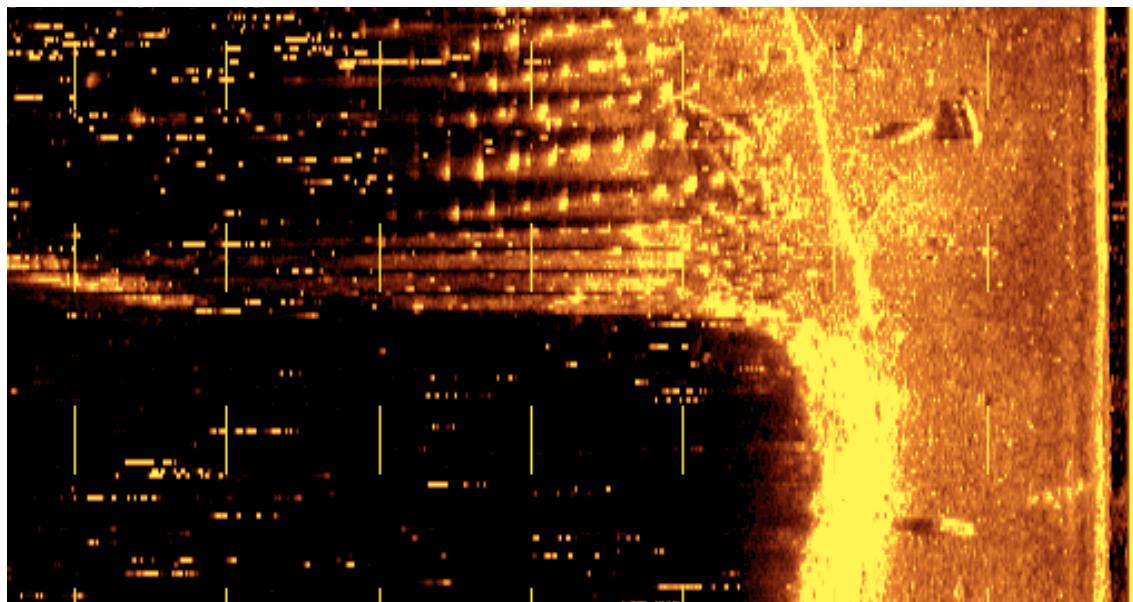
Figure 13. Probably 3 dolphins, these could be the same seen later in the survey (see Figure 12). These features are clearly something swimming in the water column because the acoustic shadows are separated from object this indicating they are not features on the seabed.

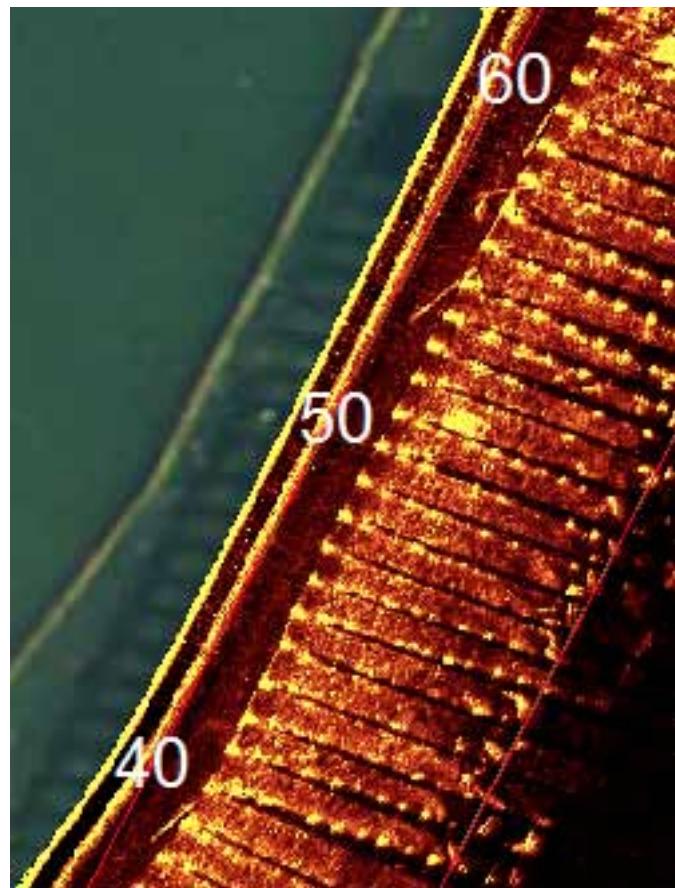
Figure 14. Submerged bents at Bent 39, 54 and 57. Piles are about 5 m long.

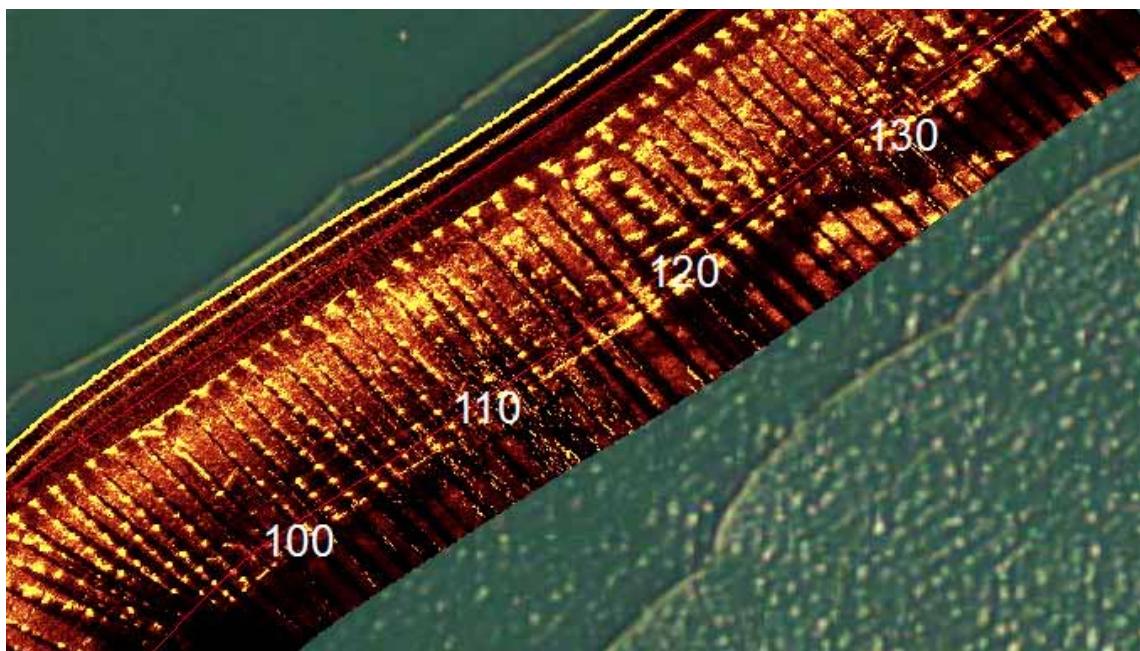
Figure 15. Submerged piles at Bent 99, 110, 125 and 134.

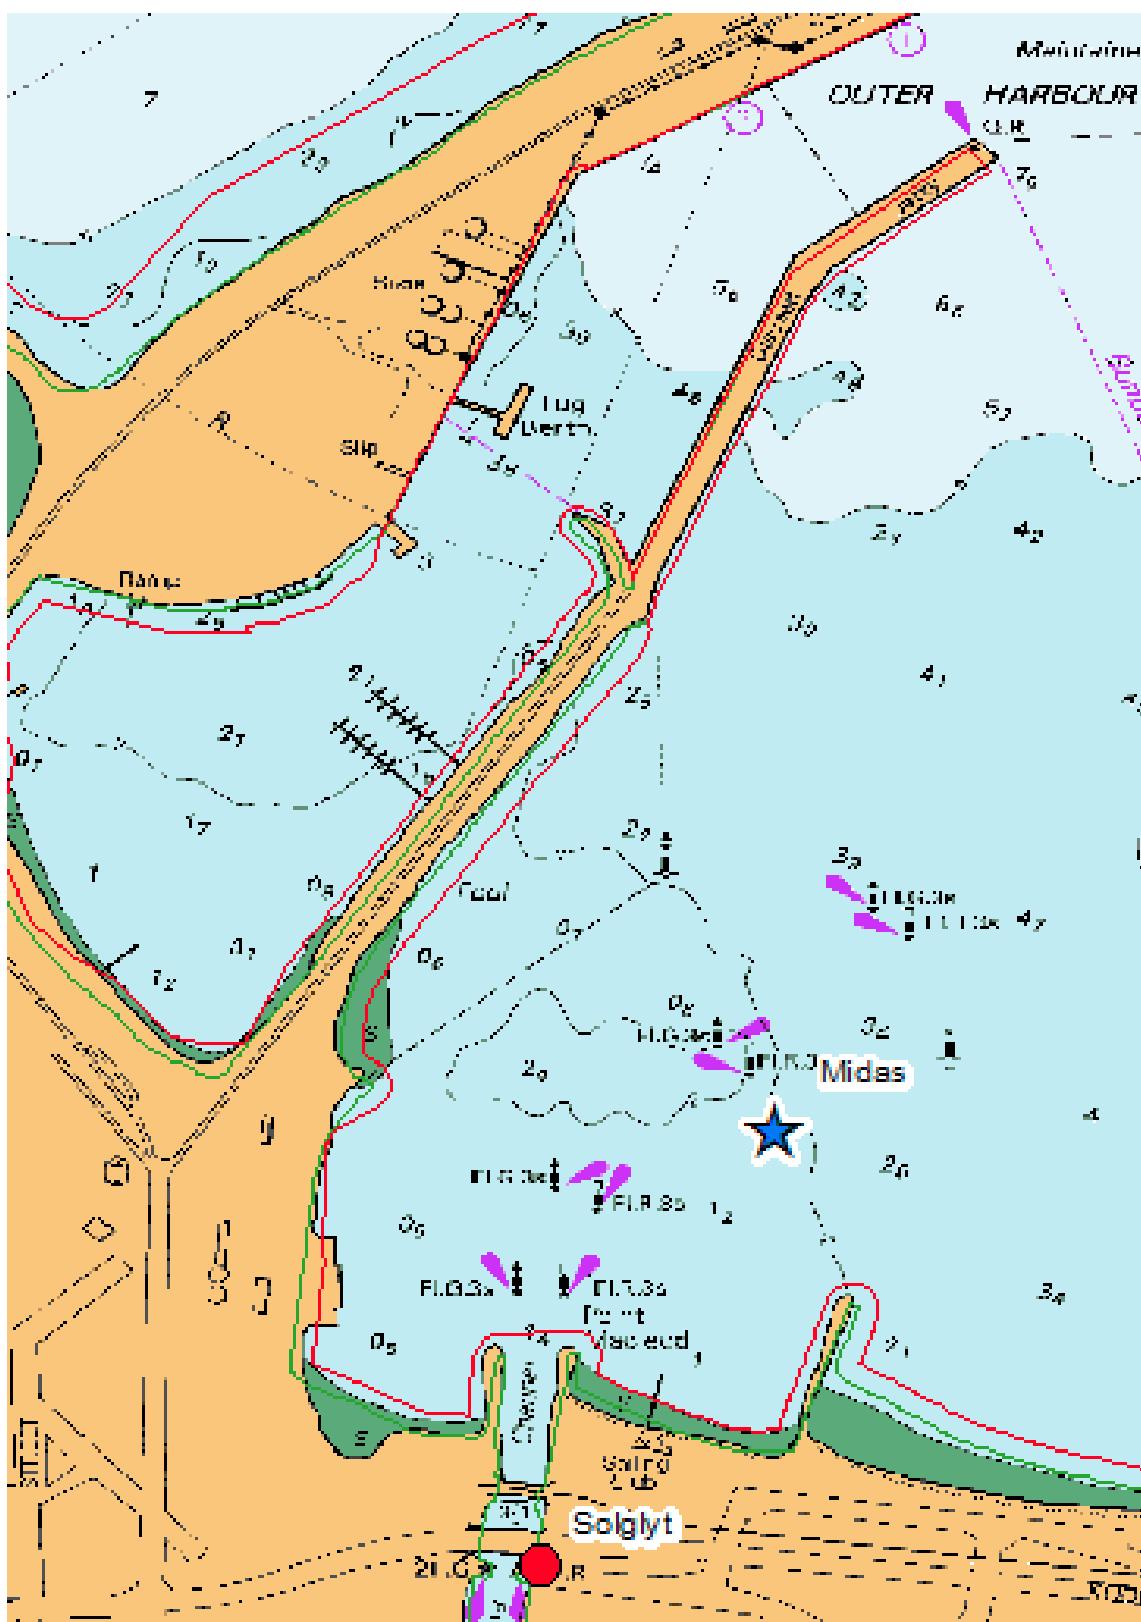
Figure 16. Chart showing position of the wreck of the *Solglyt* in relation to the jetty.

It seems therefore that the site shown in Figure 16, is not the site of the wreck of the *Solglyt*.

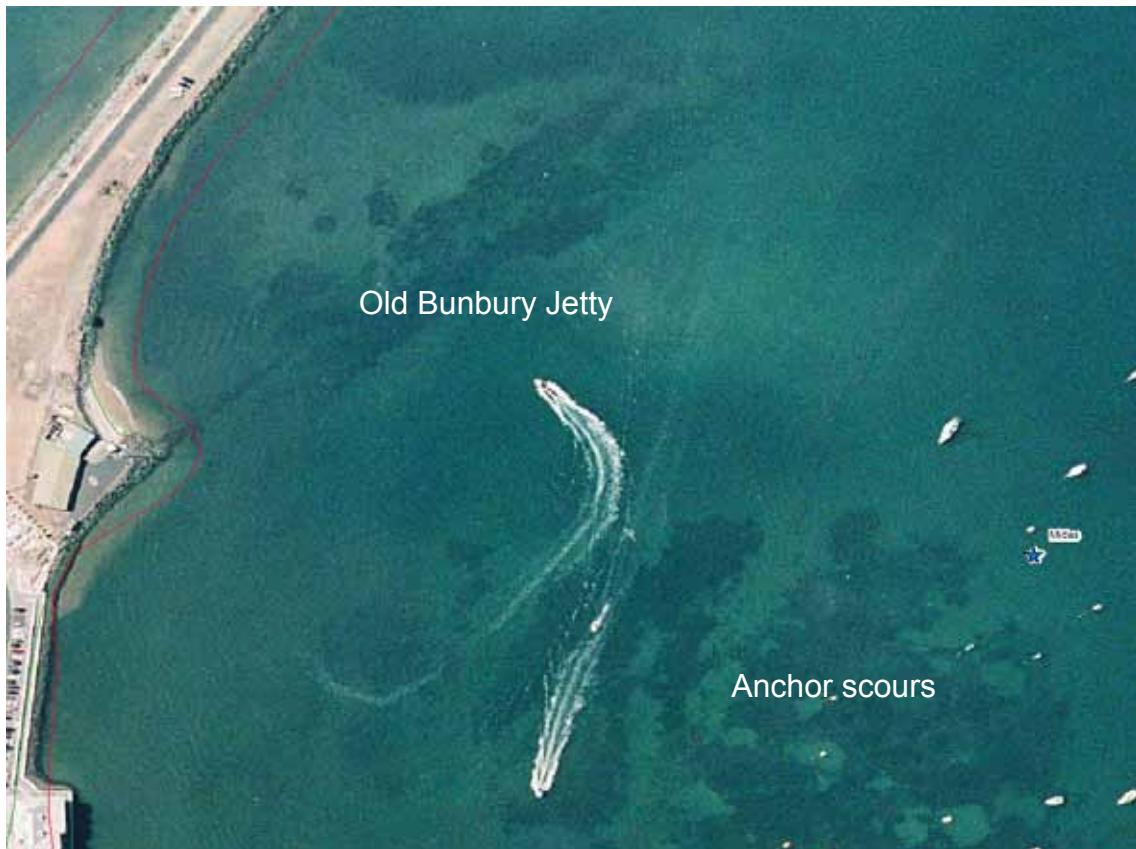
Figure 17. Aerial photograph taken in 2004 showing the location of the *Midas* wreck site, the anchor scours from yacht moorings and the old Bunbury Jetty. (Image courtesy of Landgate).

During the survey a brief sonar survey was undertaken to see if there was any evidence of the *Midas* lost in 1872 (Henderson, G. & K. 1988; Worsley, J. & P & Green, 2012). Unfortunately, the site (see Figure 16 and Figure 17) was in the middle of the yacht mooring area and the moorings and chains, together with the scouring of the sea grass by the scope of the chain made it extremely unlikely to show any evidence of the site.

1. It is suggested that on completion of the removal of the jetty bents a sonar survey be undertaken to determine if there is any further evidence of wreck sites or artefacts.
2. It is extremely likely that there will be a variety of artefacts jettisoned from vessels tied up at the jetty and items lost by the public. This has been the case with the old Fremantle Long Jetty and any future work should take this into consideration.
3. In addition, the old first Bunbury Jetty should also be surveyed. Its presence can be seen on aerial photographs (Figure 17).
