WRECK INSPECTION REPORT

(*Solveig*) (1877-1903)

Report, Department of Maritime Archaeology, WA Maritime Museum
Number 137.

Date of Inspection: 12/9/1995

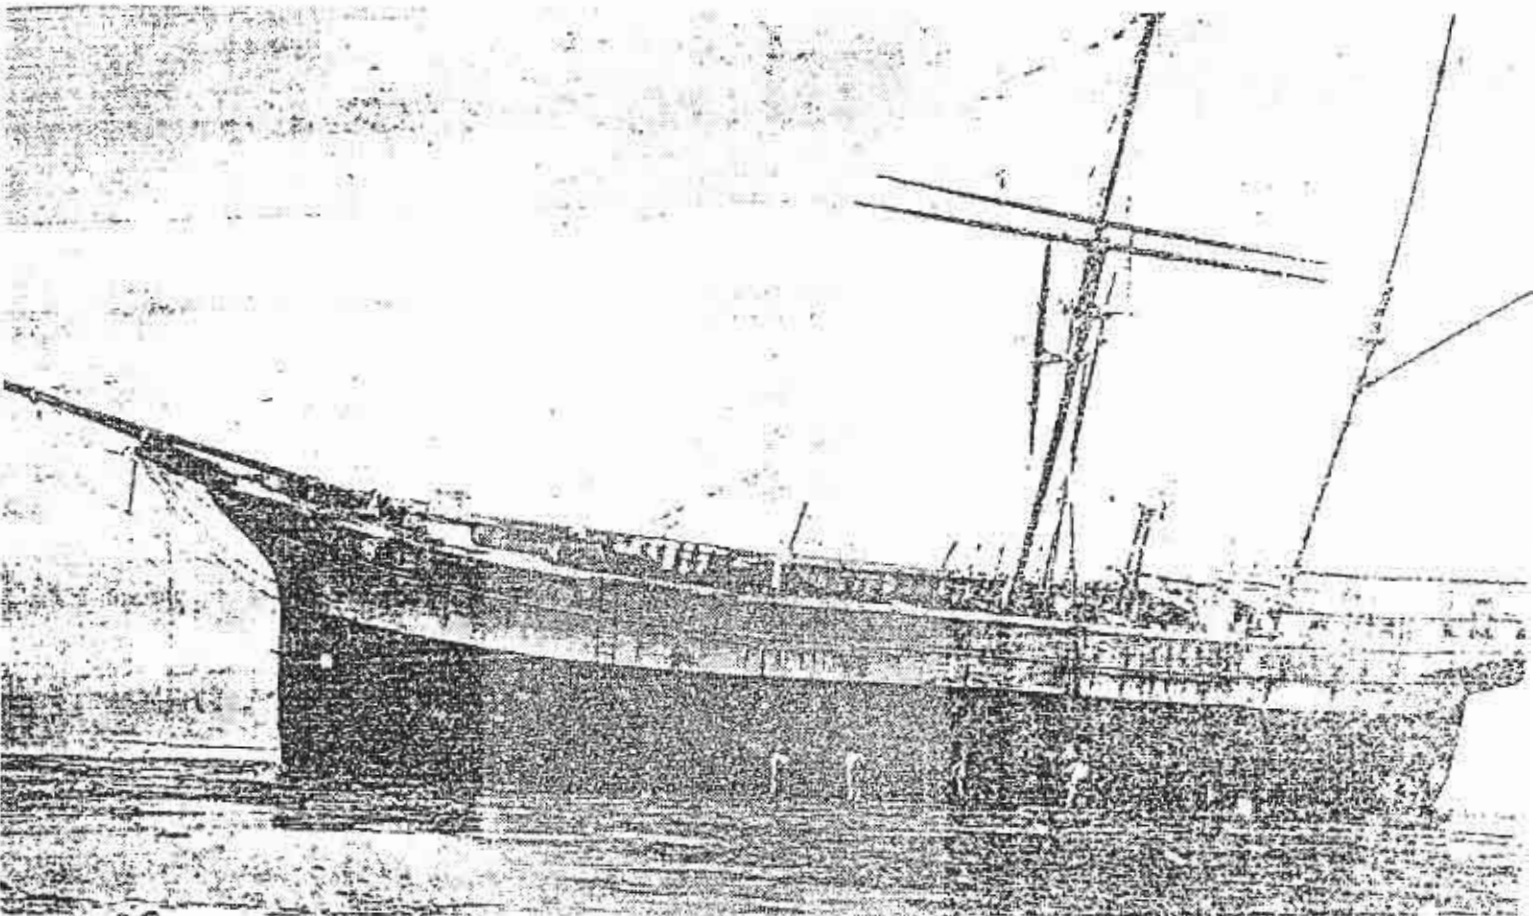
The wreck of the *Solveig*. From the Weekend News, October 9 1971.

• TOP: Seen high and dry at low tide—possibly near Port Hedland about 1900—is the barque *Solveig*. It had just unloaded a consignment of timber and horses, and the state of the masts suggests the vessel may have had an encounter with one of the North-West's famous "blows" . . . Sent in by R. Cracknell, WA Trustee Co, Perth.

Contemporary Salvage: The photograph of the *Solveig* indicates that its back is broken and from its position it is evident that all useful materials could have been relatively-easily salvaged. The anchors for example are no longer on the site. The fact that ironwork, fastenings, the donkey-boiler and the capstan remains on the site indicates that they were considered of value at the time either due to damage sustained during or after the wrecking and/or to the vessel's age.
