INTERIM WRECK INSPECTION REPORT

19 Mile Broome Unidentified

**Report-Department of Maritime Archaeology
Western Australian Maritime Museum No. 177.**

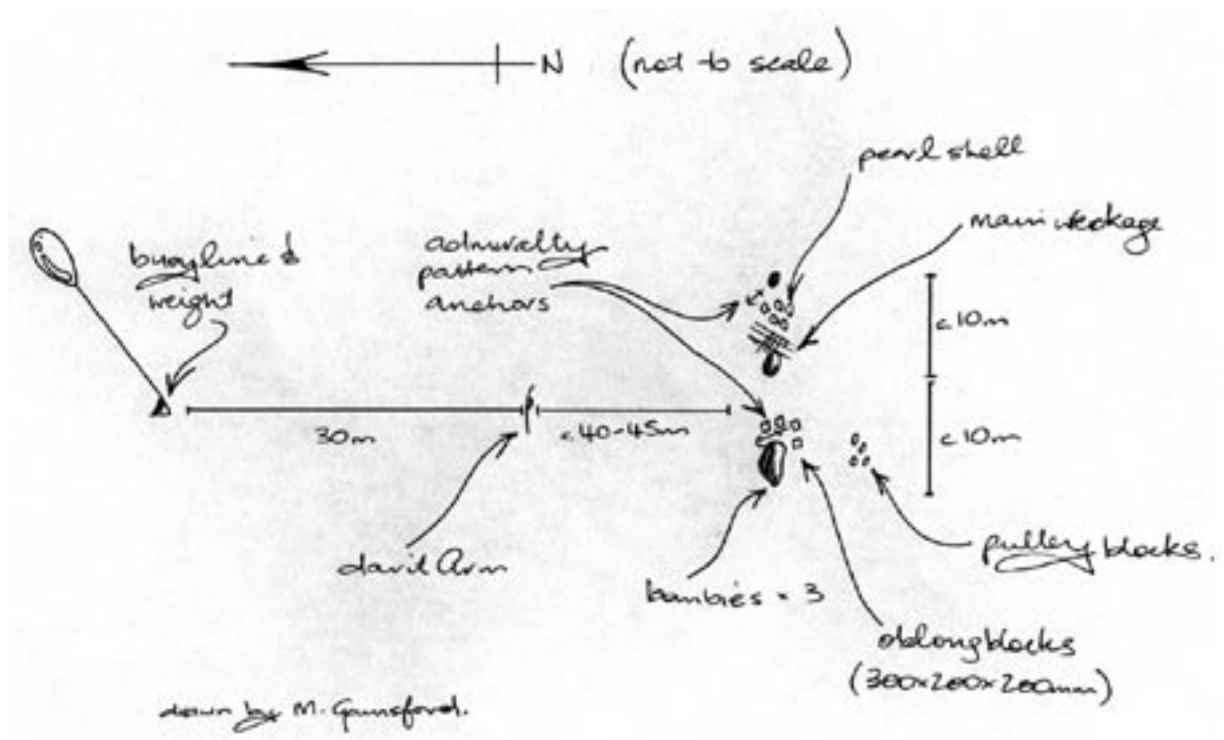
Figure 3. Plan of the 19 nm Unidentified Site (M. Gainsford)

Material from the site is scattered over an area ca. 25 by 10 metres, with little structure remaining above the seabed. Wreckage most noticeable was a frame, some pulley blocks, pearl shell, machinery, anchors, a windlass?, stone blocks and some unidentifiable wreckage.

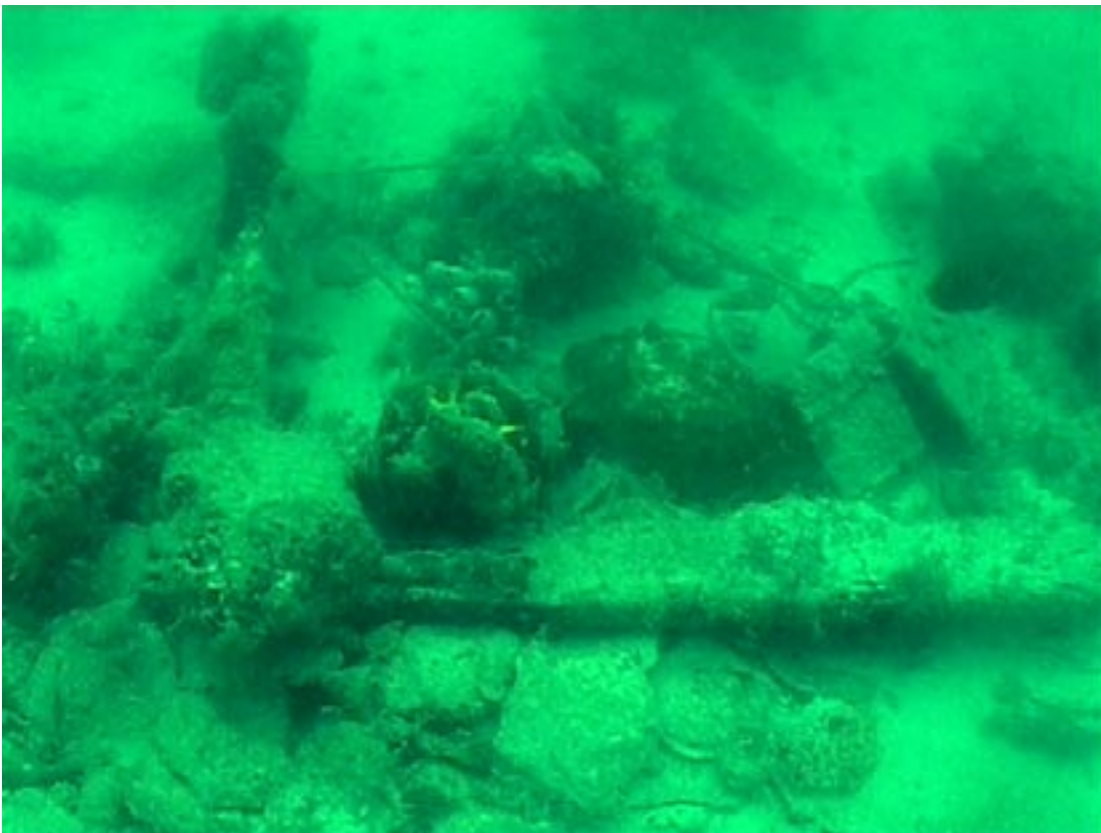
It would have been a wooden vessel. Some wood at the site corroborates this. A wood sample was acquired during the inspection but thi sample is quite degraded. There is also a frame that appears to be joined to perhaps a keel or keelson; also wooden. Wooden pulley blocks are also evident indicating that the vessel was both wooden construction and sail driven.

Figure 5. Main wreckage pile, includes a ships frame (G. Kimpton)

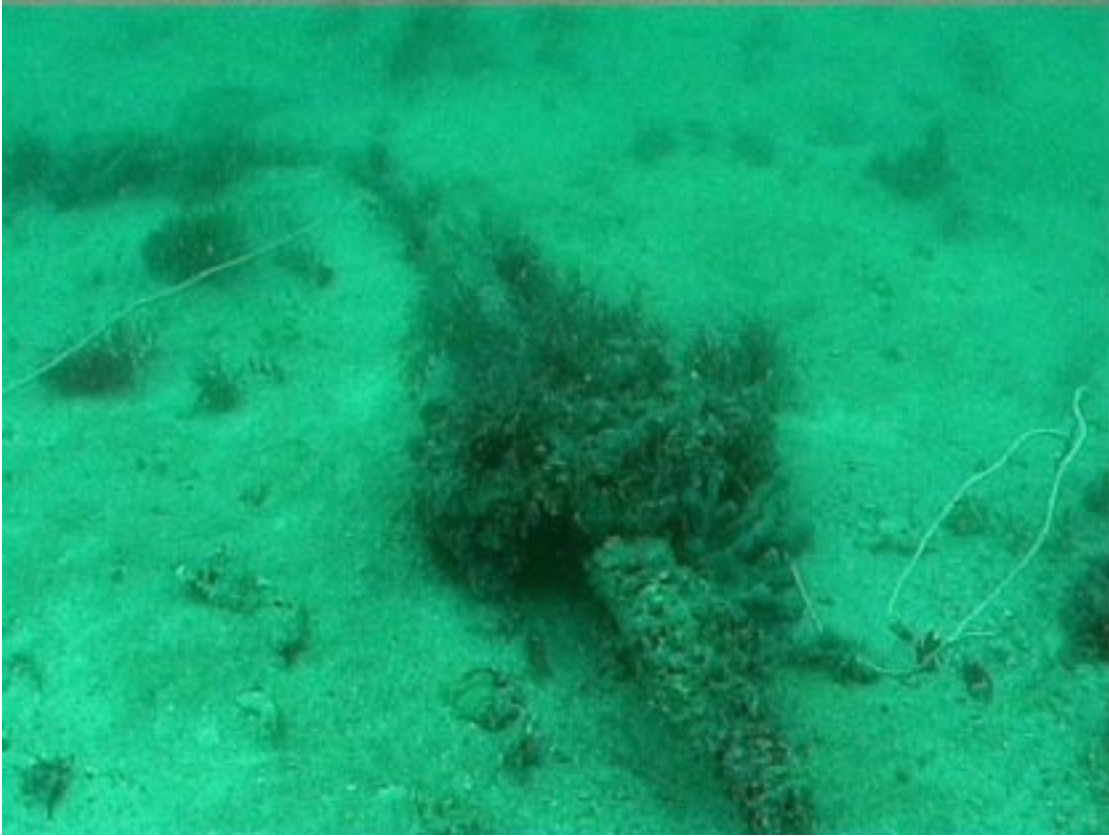
It appears to be either a pearling lugger, mother ship or similar, identified as such from the large quantity of pearl shell at the site. Another indicating factor is the davit arm; used to haul shell over the side of a vessel when the divers bags were full of shell.

Figure 6. Davit? (G. Kimpton)

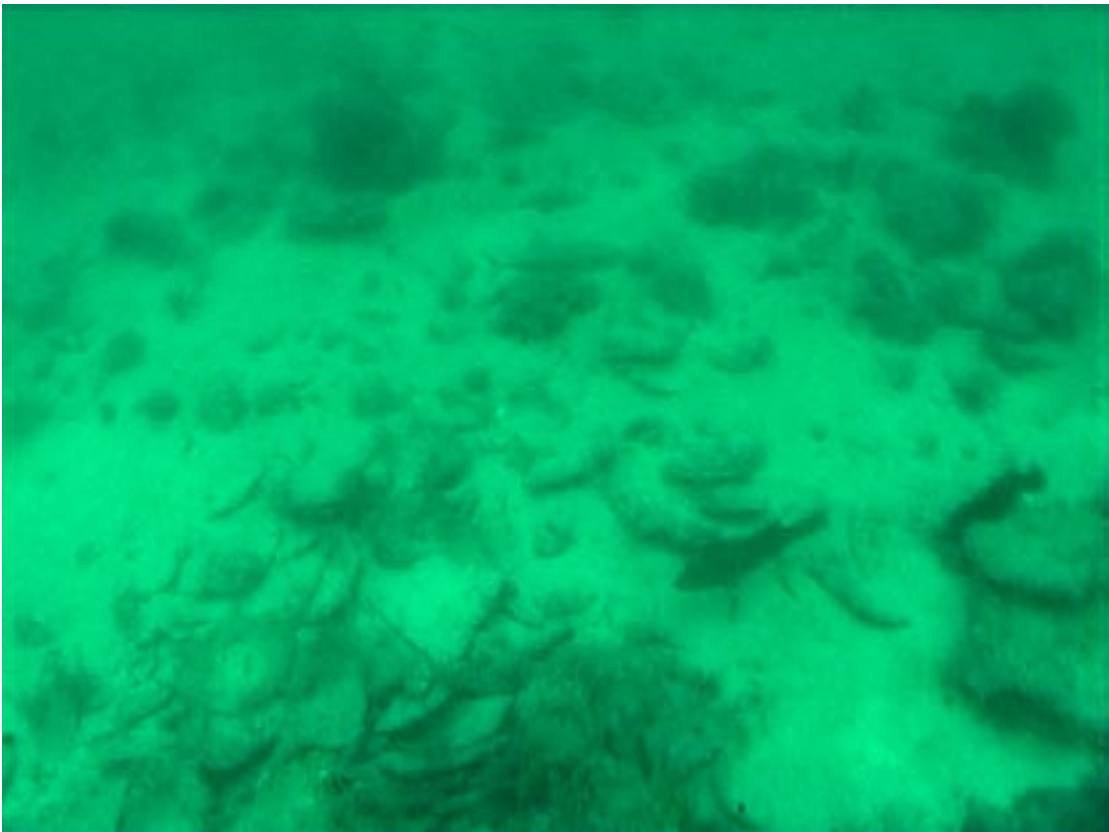
Figure 7. Piles of Pearl Shell (G. Kimpton)

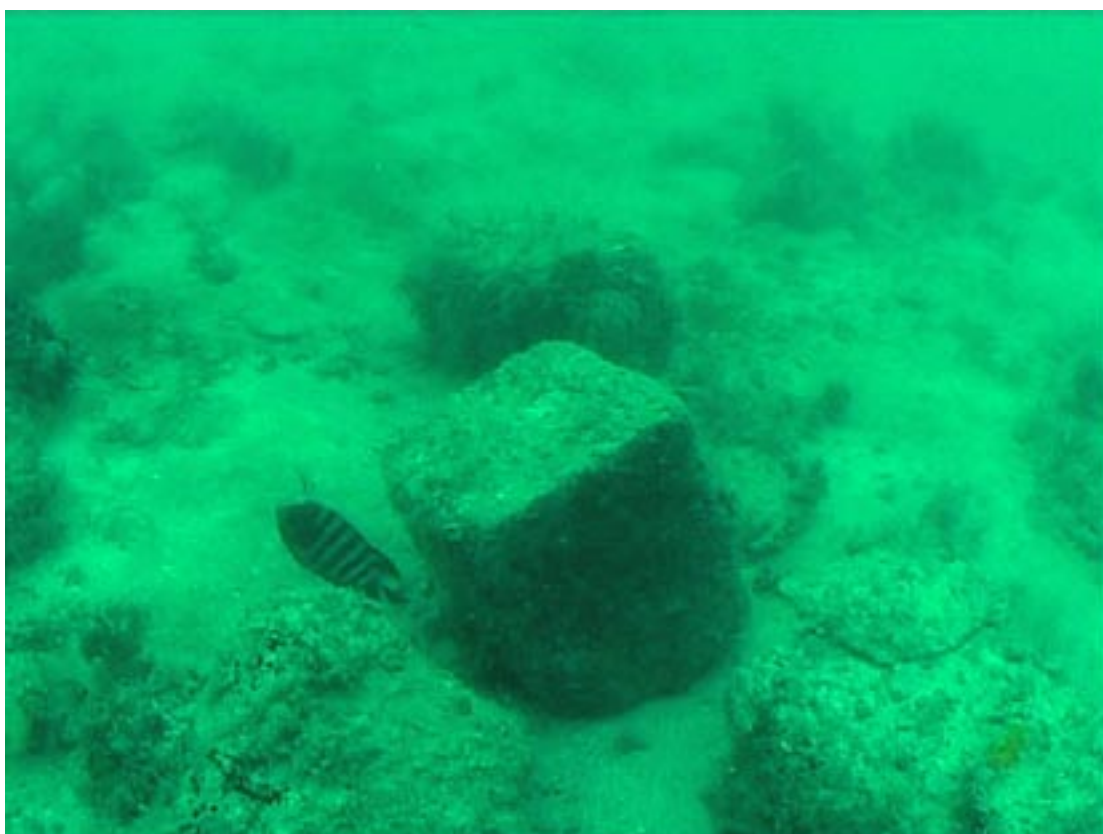
Figure 9. Stone blocks 300x200x200mm, which litter the site (G. Kimpton)

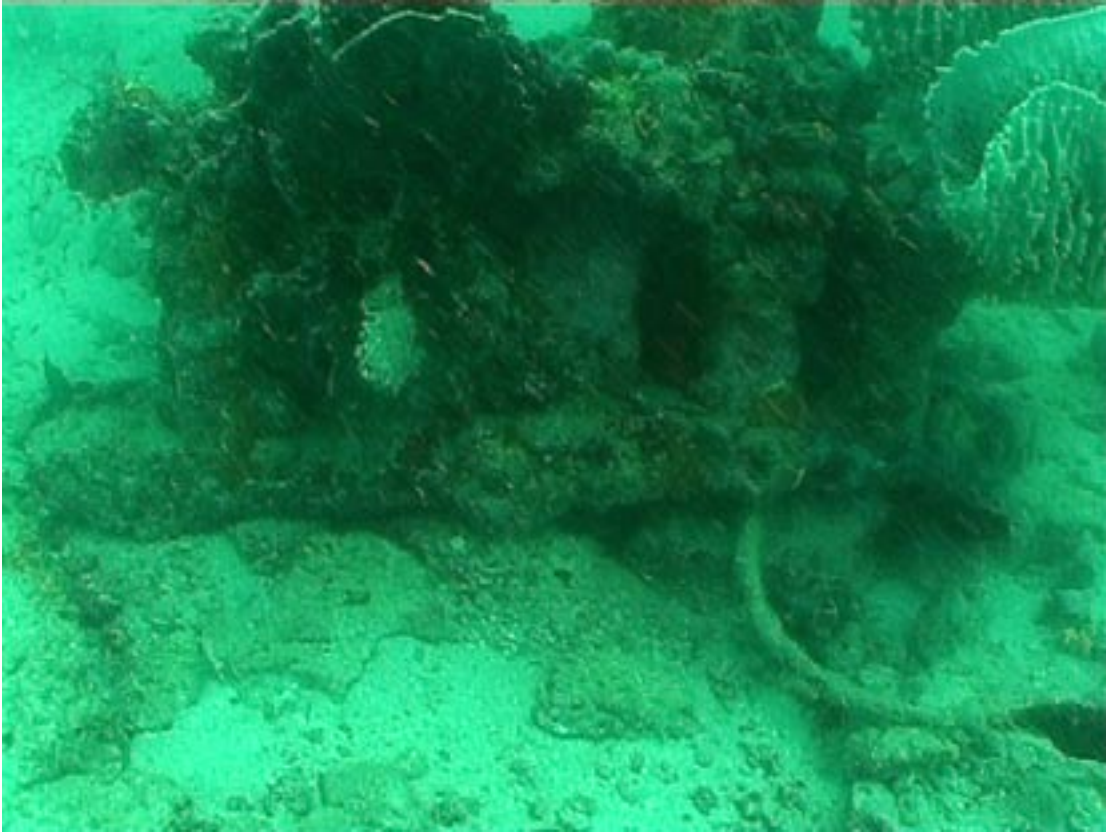
Figure 10. Unidentified wreckage (G. Kimpton)

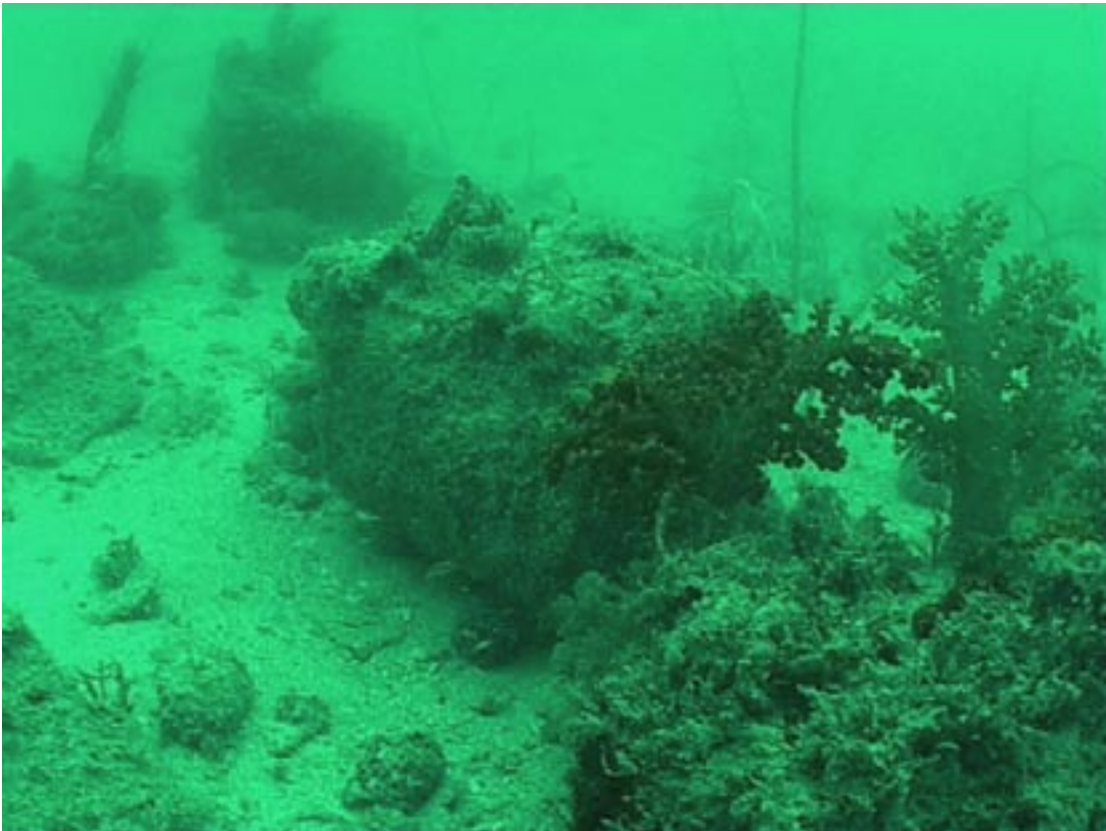
Figure 11. Piece of machinery, possibly a windlass (G. Kimpton)
