Glenfields Beach timber inspection and identification

Ross Anderson

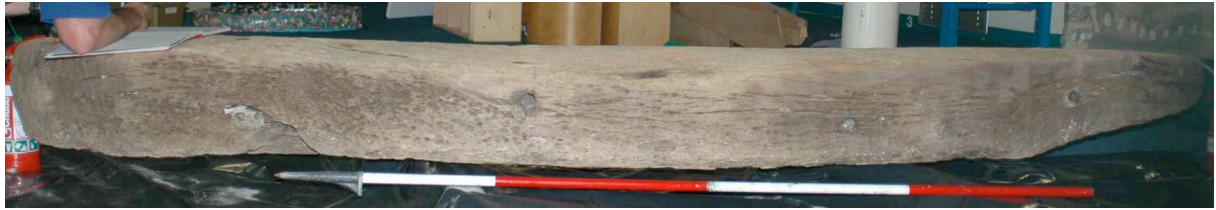
Overall length of the timber is 3418 mm, with a molding of 220–490 mm and siding of 140–270mm, with at least 18 fastening holes. Remaining fastenings consisted of five trenails and two copper alloy bolts. The type and size of the timber and fastenings indicate a large (400–900 tons) mid-late 19th century shipwreck. The fastening bore holes are 32–34 mm allowing for fastenings of 1 ¼ - 1 5/16 ” diameter.

Figure 2. View showing siding profile. Scale 2 m. (Jon Carpenter/ WA Museum)

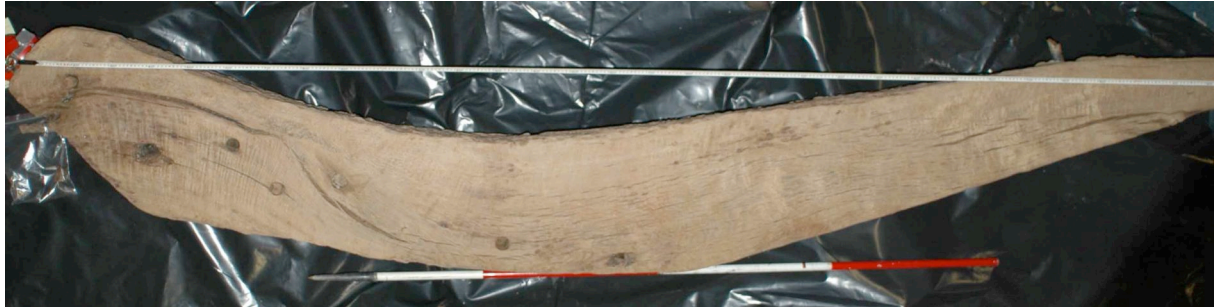
Figure 3. View showing molding profile. Note four distinct straight edges and direction of grain. Scale 2 m. (Jon Carpenter/ WA Museum)

The timber is shaped following the direction of grain of the wood, with heartwood visible at the butt end. Both the molding and siding is thicker and wider at one end than the other. Maximum siding is 270 mm (10.6 inches). There are fastening holes through both the molding and siding of the timbers. The timber has four distinct straight edges, unlike a ship's frame/ futtock that is usually shaped in the form of a curve to fit the shape of the hull.

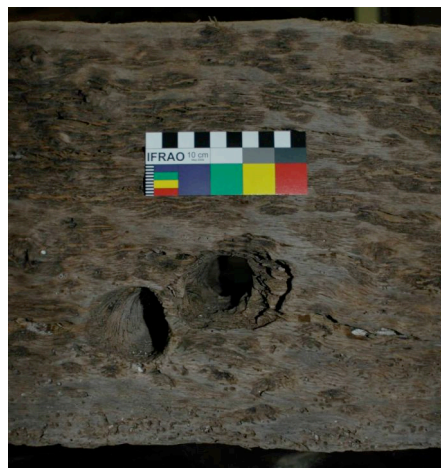
Figure 4. Fastening bore holes at oblique angle (Jon Carpenter/ WA Museum)

If the timber is a stemson knee or breasthook, the size of the fastening holes and fastenings is in the range of 32-34 mm allowing for fastenings of $1 \frac{1}{4}$ - $1 \frac{5}{16}$ " diameter, consistent with Lloyds specifications for heel-knee, stemson and deadwood copper alloy/ yellow metal bolts for a vessel between 450 tons ($1 \frac{1}{4}$ ") and up to 899 tons ($1 \frac{5}{16}$ ") (Desmond 1919: 21).

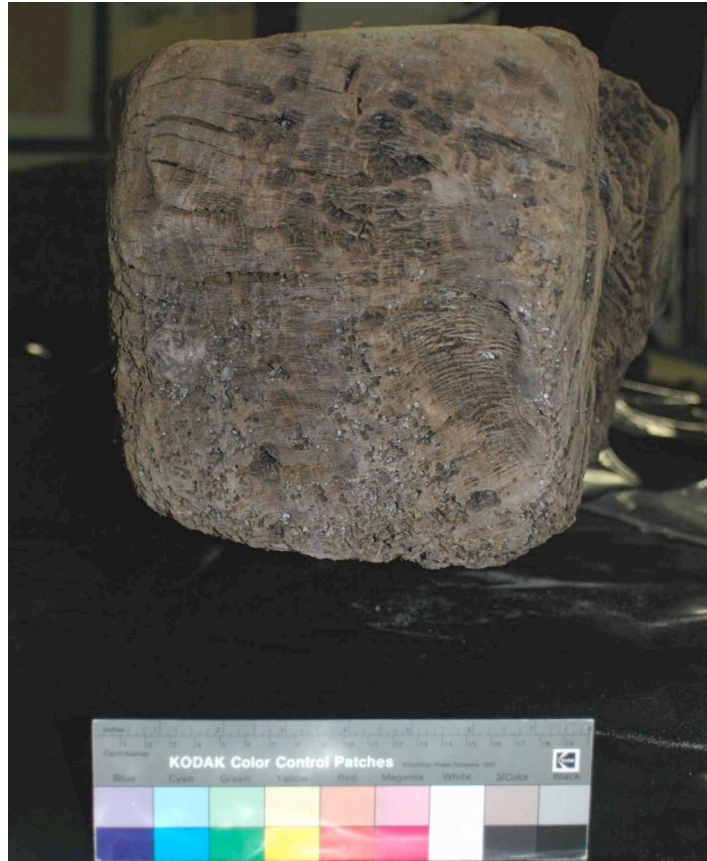
Figure 5. Heartwood visible at butt end (Jon Carpenter/ WA Museum)

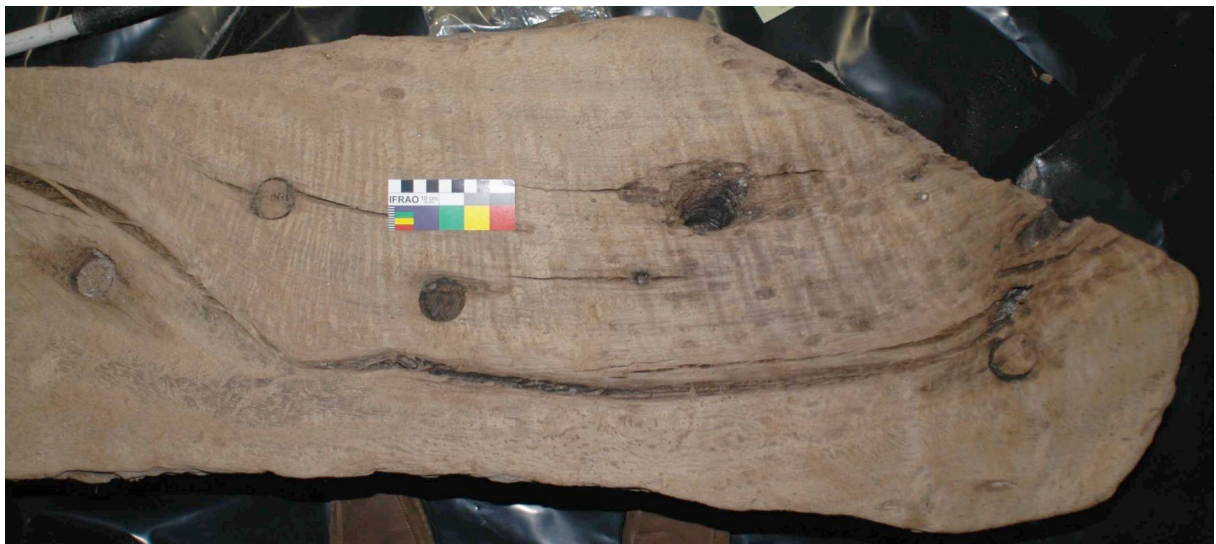
Some cracking has occurred to the timber that was not apparent at the time of initial discovery, indicating that the timber is adjusting to its change in environment. Conservation advice was to wrap the timber in polythene plastic to allow a controlled drying process to occur. Jonathan Pomeroy also said that since his discovery the protruding copper-alloy fastening appeared to have been damaged by somebody (unsuccessfully) attempting to hammer it out, presumably while it was lying on the beach.

Figure 6. Detail of butt end showing straight edges, trenail fastenings and recent cracking (Jon Carpenter/ WA Museum)

- 1) That the timber is monitored to assess its condition as per Department of Materials Conservation recommendations:
 - Brush away and/or carefully vacuum away sand from crevices and fastening holes.

- Insert pins in opposing positions across selected cracks, measure separation weekly to ascertain if the timber is still drying.
 - Inspect the wood after measuring the dimensions of the cracks to ensure that there is no mould activity while wrapped in polythene.

- To condition the timber to ambient storage or display conditions pierce a few holes in the polythene sheeting to permit gradual acclimatization.
 - In the event that the cracks in the timber are becoming wider and if fresh cracks occur then notify the Materials Conservation Department for advice (Carpenter 2010).

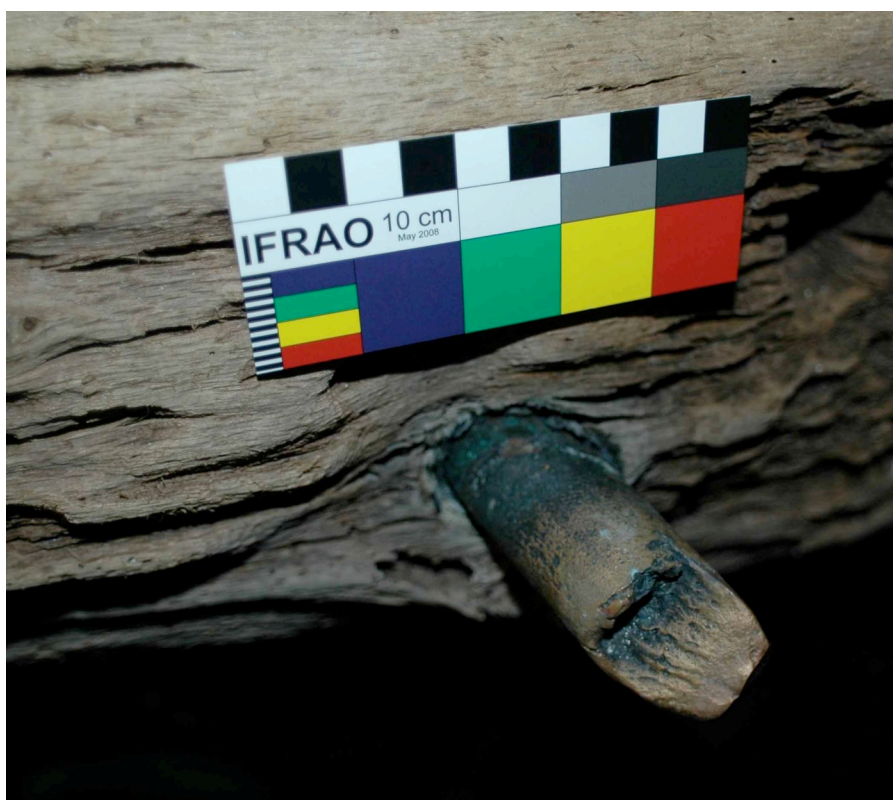
Figure 10. Detail of copper alloy bolt sampled for metallographic analysis (Jon Carpenter/ WA Museum)

The presence of 0.7% Pb suggests that the alloy was made following Muntz’s patent of 1846. Allowing for some variation due to the nature of XRF analysis and metal loss through aerobic and/or anaerobic corrosion, the concentrations of metal in the alloy are consistent with a post 1846 date for Muntz yellow metal.
