# 'Butterfly Bay' Site Inspection Report South of Yardie Creek, North West Cape

Report – Department of Maritime Archaeology, Western Australian  
Museum, No. 291

**Site Name:** Butterfly Bay Unidentified

**Date Inspected:** 17 June 2012

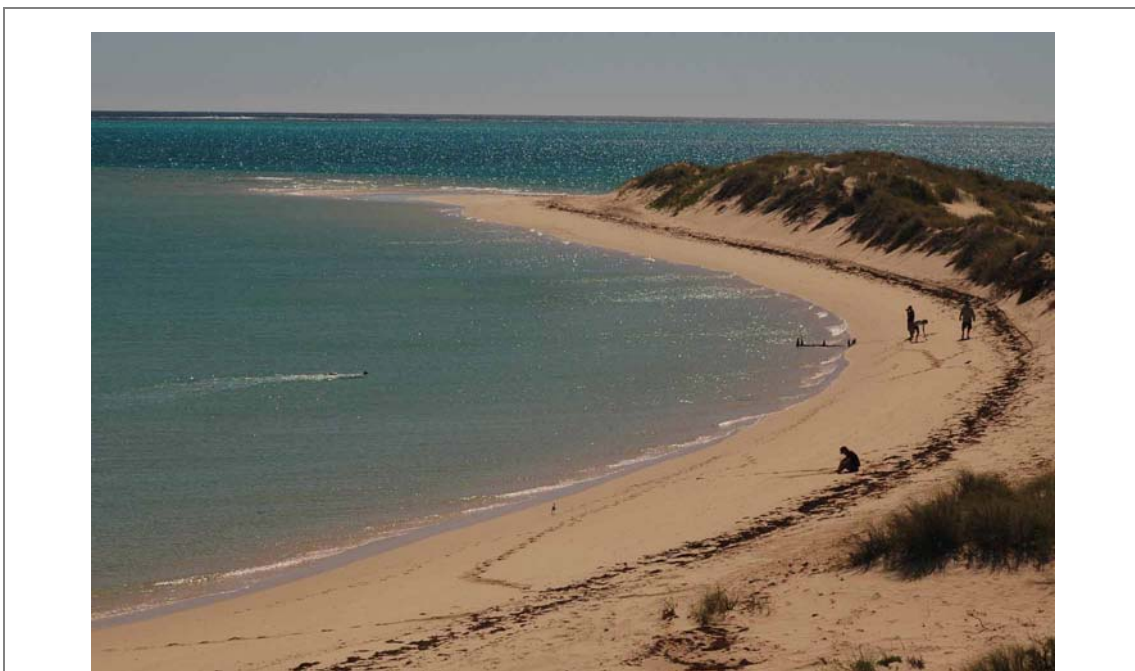
Figure 2. View north, showing unidentified structure and snorkeller returning from inspecting dark structure (J. Carpenter).

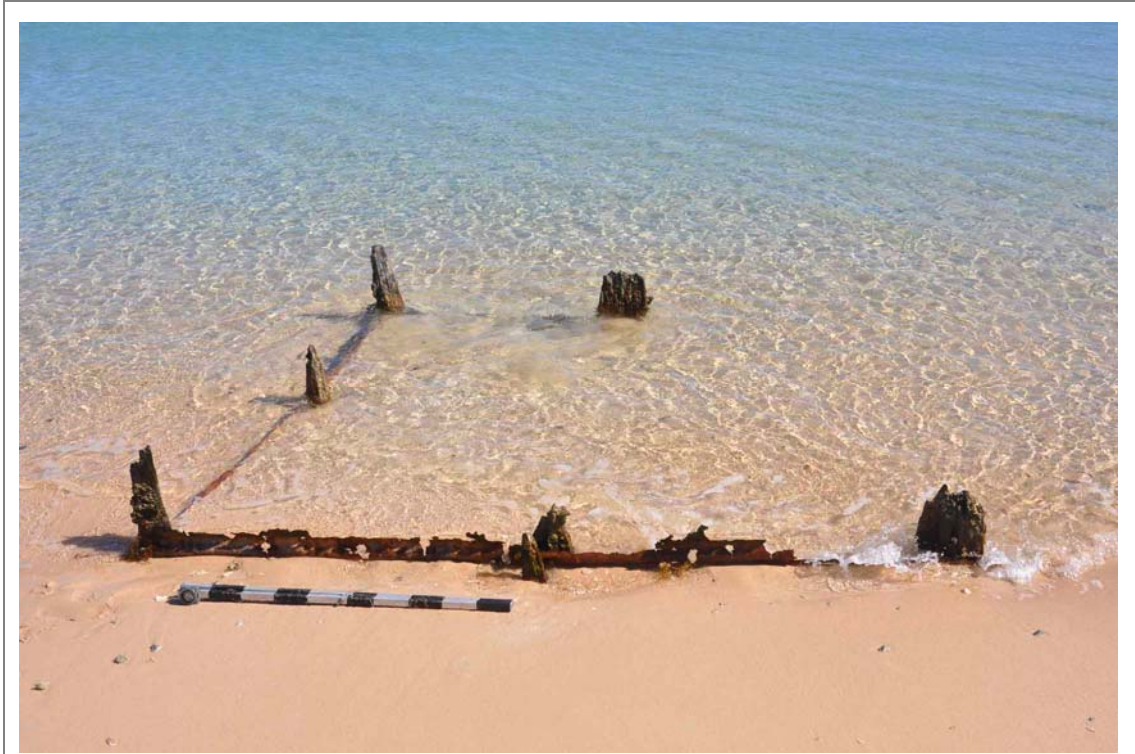
The square structure was inspected and recorded. It was buried quite deeply into the sand and was composed of timber posts (protruding above the ground to a maximum of 0.5 m) linked by corrugated iron fastened to the outside (see Appendix 2). Additionally, two longitudinal pieces of timber were visible 33.2 m south of the square structure in the intertidal zone. Large cattle bones were also observed along the shore line both underwater and within the intertidal zone

Figure 3. Unidentified timber and corrugated iron structure (N. Bigourdan).

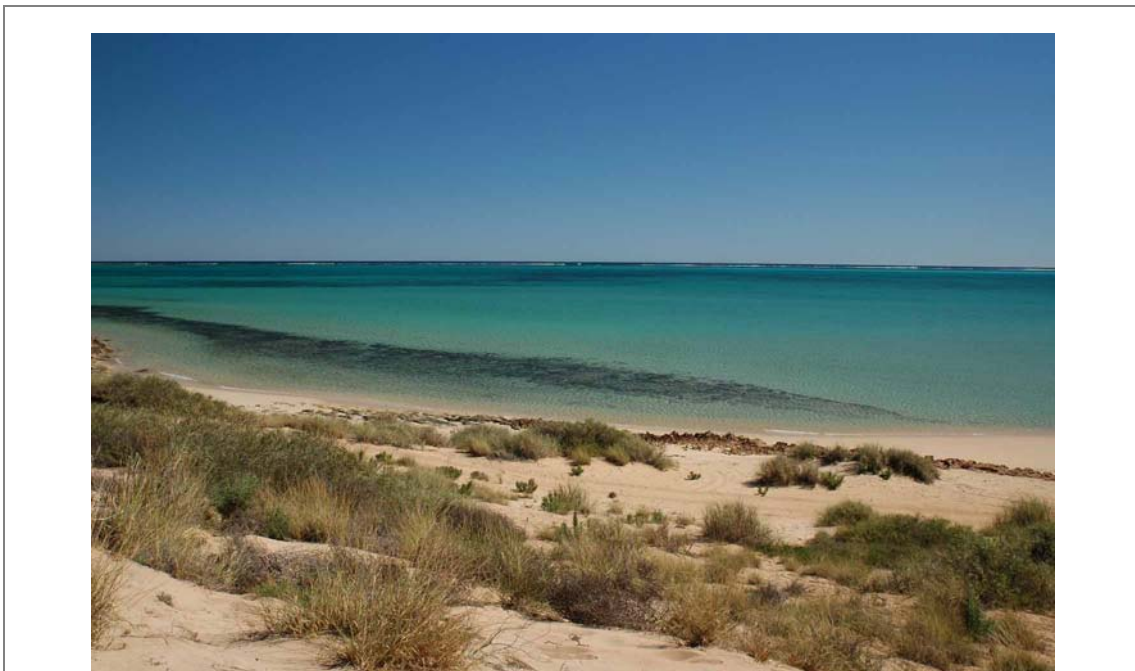
The reef area was indicated to have material spread throughout, including part of an admiralty pick anchor and chain. The search was conducted by three staff members, in a snorkel line survey (see Appendix 3). Only one large bolt was located at the north-east end of the reef (see Figure 5).

Figure 4. View south-west, showing reef area. (J. Carpenter).

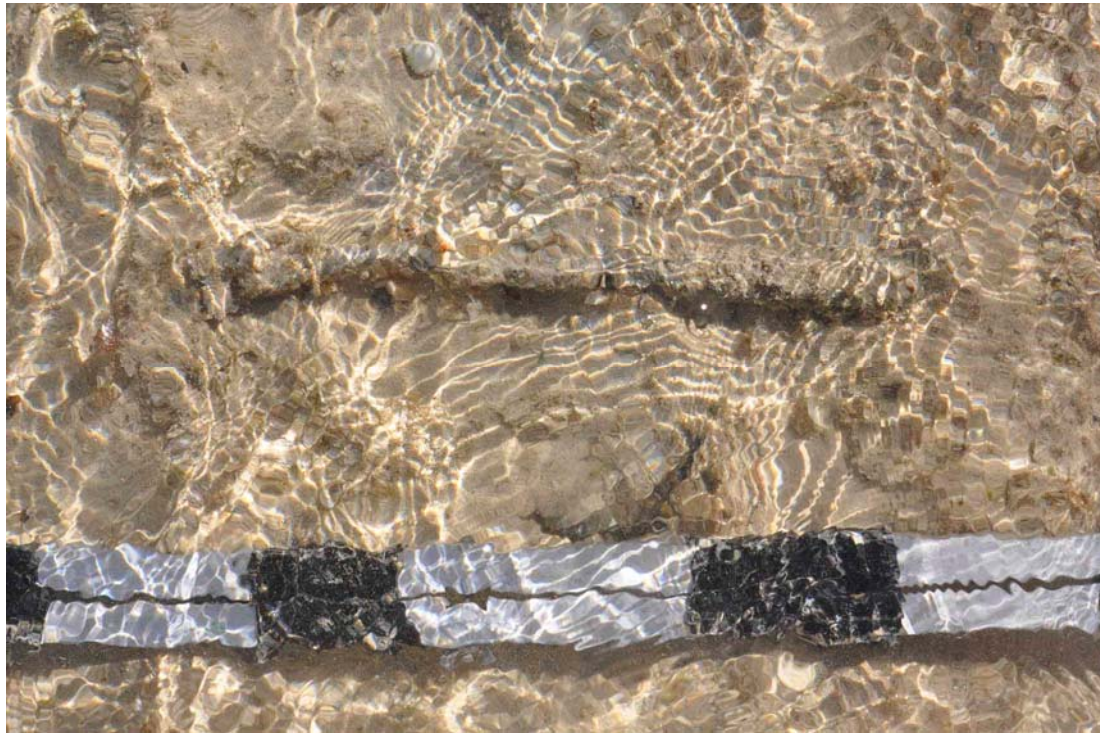
Figure 5. Concreted bolt, *in situ* at north-east end of reef (N. Bigourdan).

In conclusion, there were only minimal indications of a wreck site in the area, and hence no management is required for this site, nor any assessment of significance at this stage, although the identification of the material of the large bolt could yield some additional information.

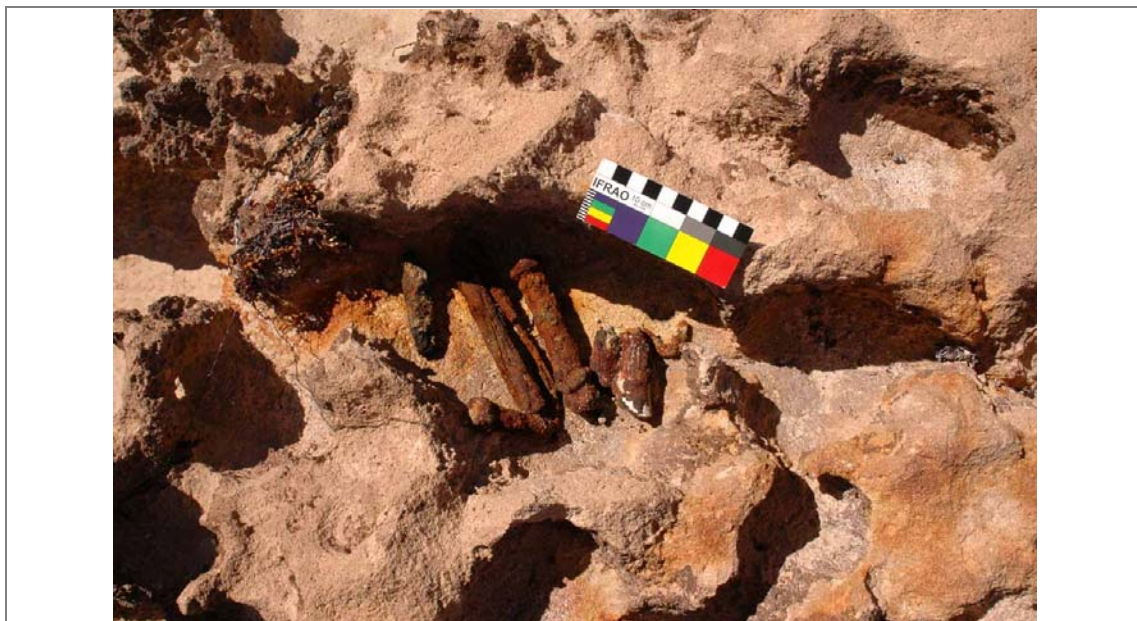
A small amount of fastenings were found together in a small depression by a rocky outcrop 5 m away from the shore line. These fastenings were photographed (see Figure 6), and appeared to have been collected and placed there. Additionally, thin metal pegs were scattered along this rocky outcrop, although they appear to be related to modern camping material.

Figure 6. Collection of fastenings on rocky outcrop (J. Carpenter).

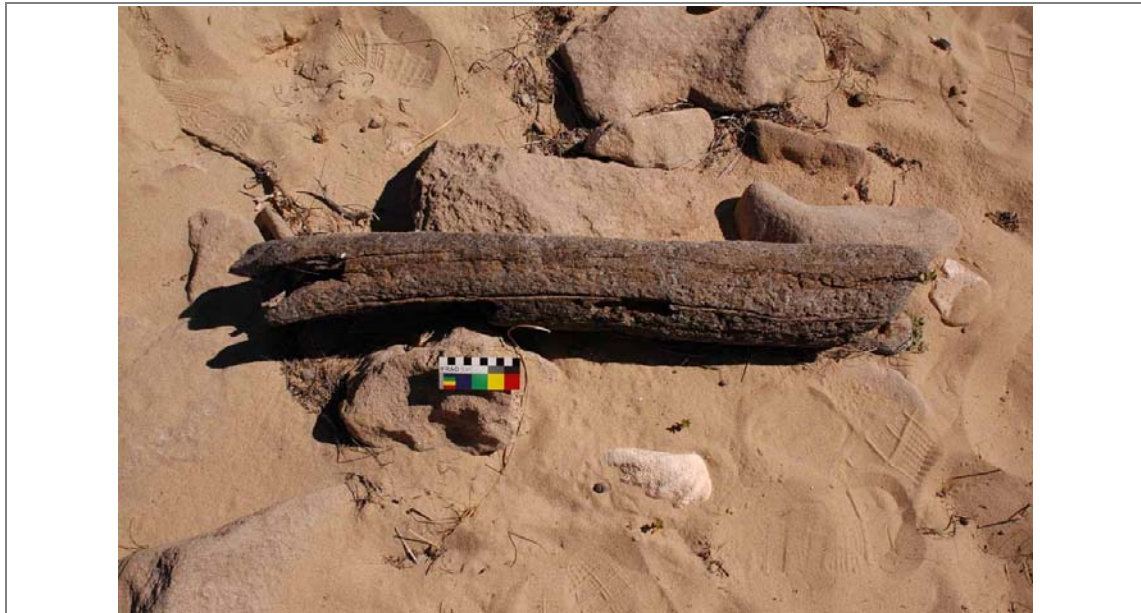
A survey of the area around the south-west point, in the next bay, was also conducted in order to locate additional artefact material, possibly an axe handle, also reported by the Callen family. Two pieces of timber were located and could be related to a wreck site (see Figures 7 and 8), one may be the axe handle timber.

Figure 7. Timber located in the next bay (J. Carpenter).

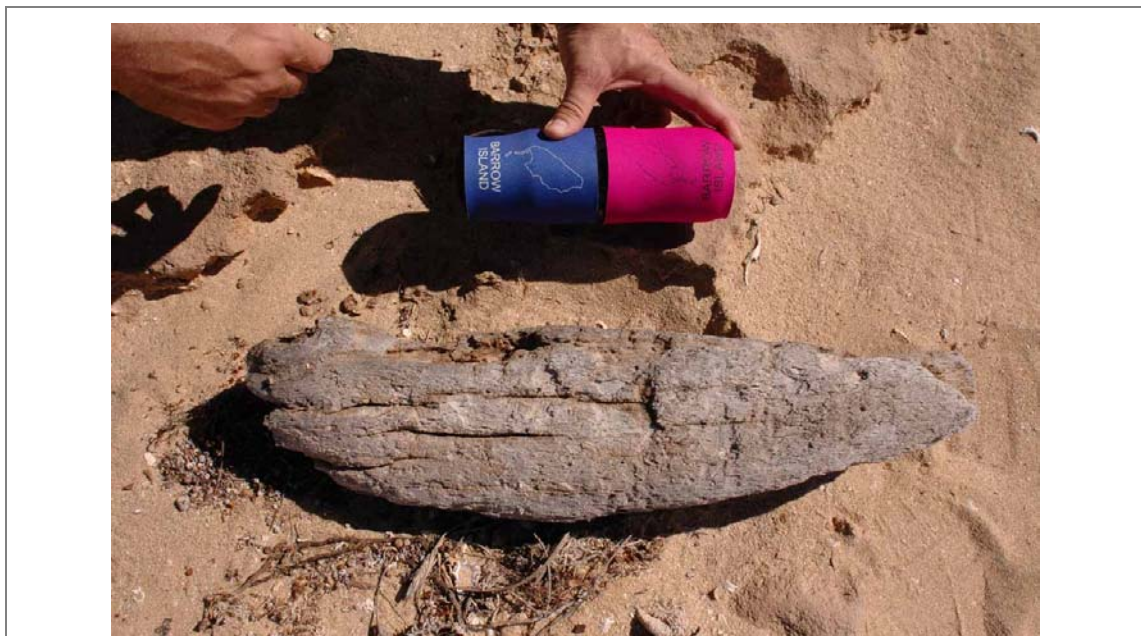
Figure 8. Larger timber located in next bay (J. Carpenter).
