THE NORTH MOLE  
DREDGE:

A SURVEY OF AN  
UNIDENTIFIED WRECK.

**CLASS OF 1990; GRADUATE DIPLOMA IN  
MARITIME ARCHAEOLOGY.**

Report —Department of Maritime Archaeology, Western Australian Museum, No. 46.

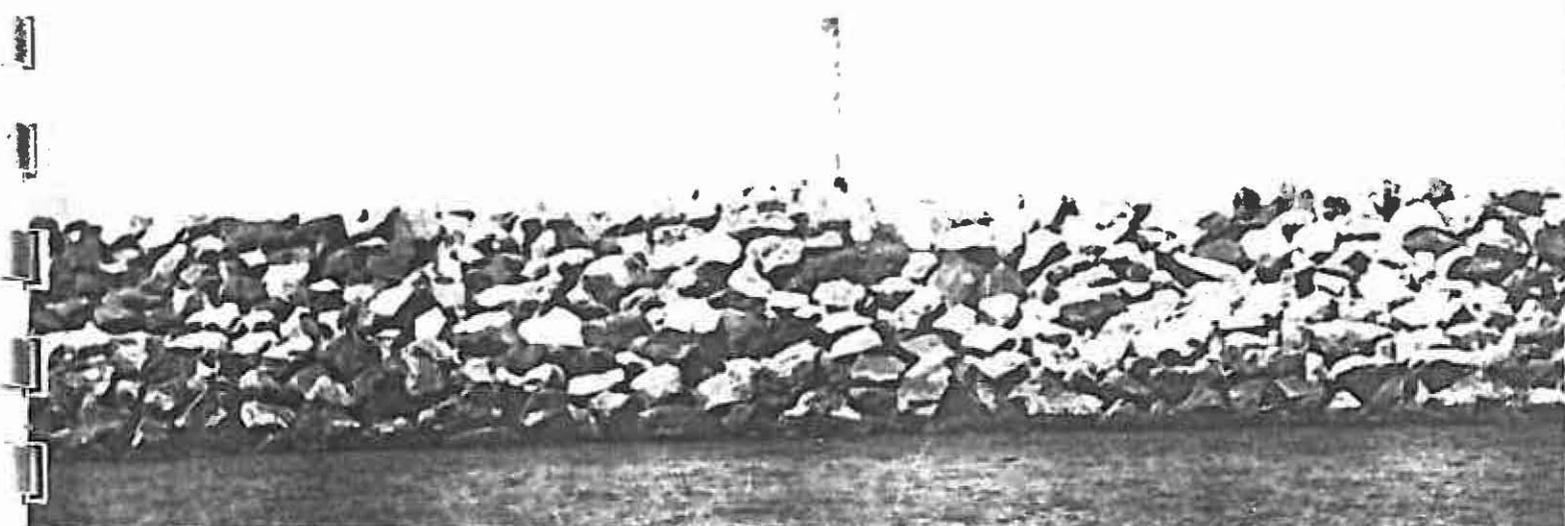
Pl. 3.1

Pl. 3.1, Looking east, shows the relative position of the incinerator stack with a large pale brown rock on the top of the new mole wall to its right.

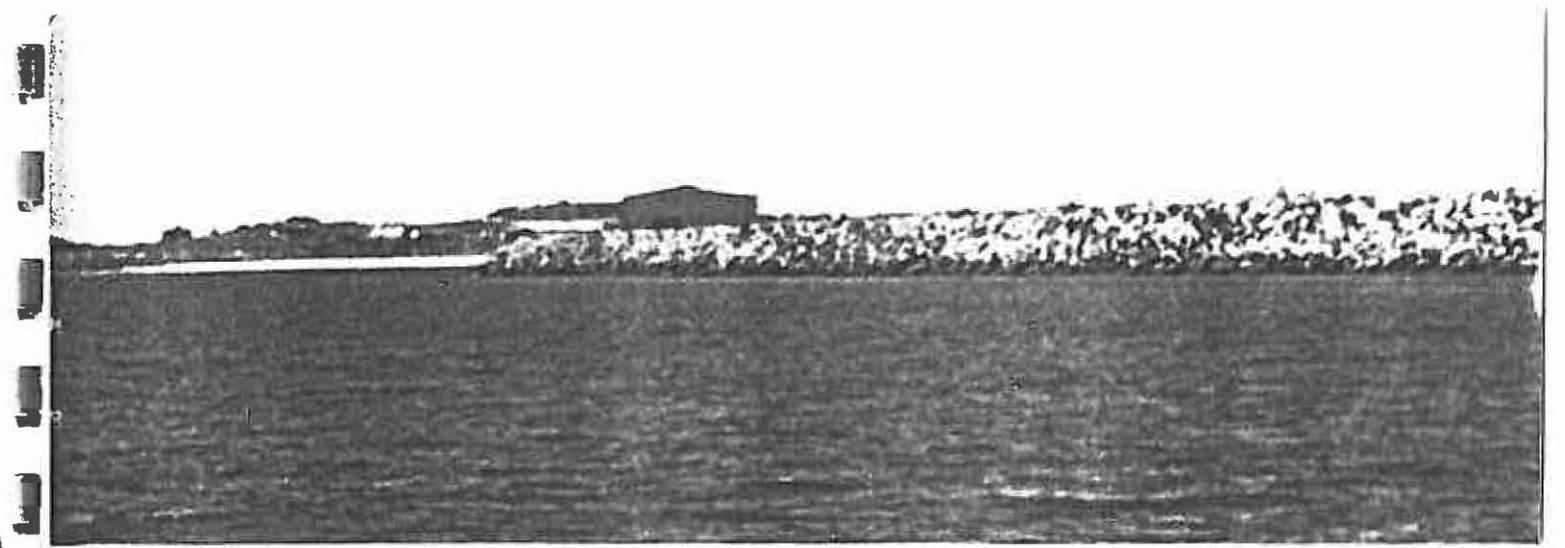
Pl 3.2

Pl. 3.2 , Looking north - east, shows the end of the groin corresponding to the base of Buckland Hill.

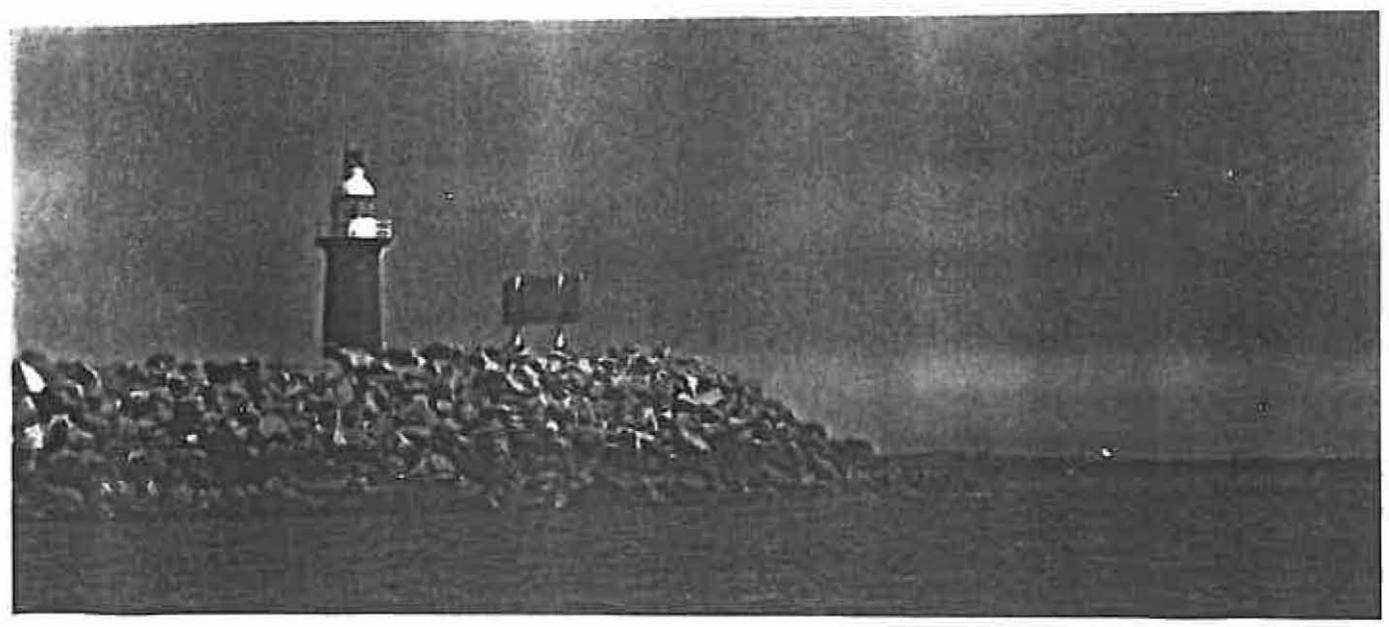
Pl. 3.3

Pl. 3.3, Looking south-west, the relative positions of the lighthouse, the sign and Garden island might also be of assistance

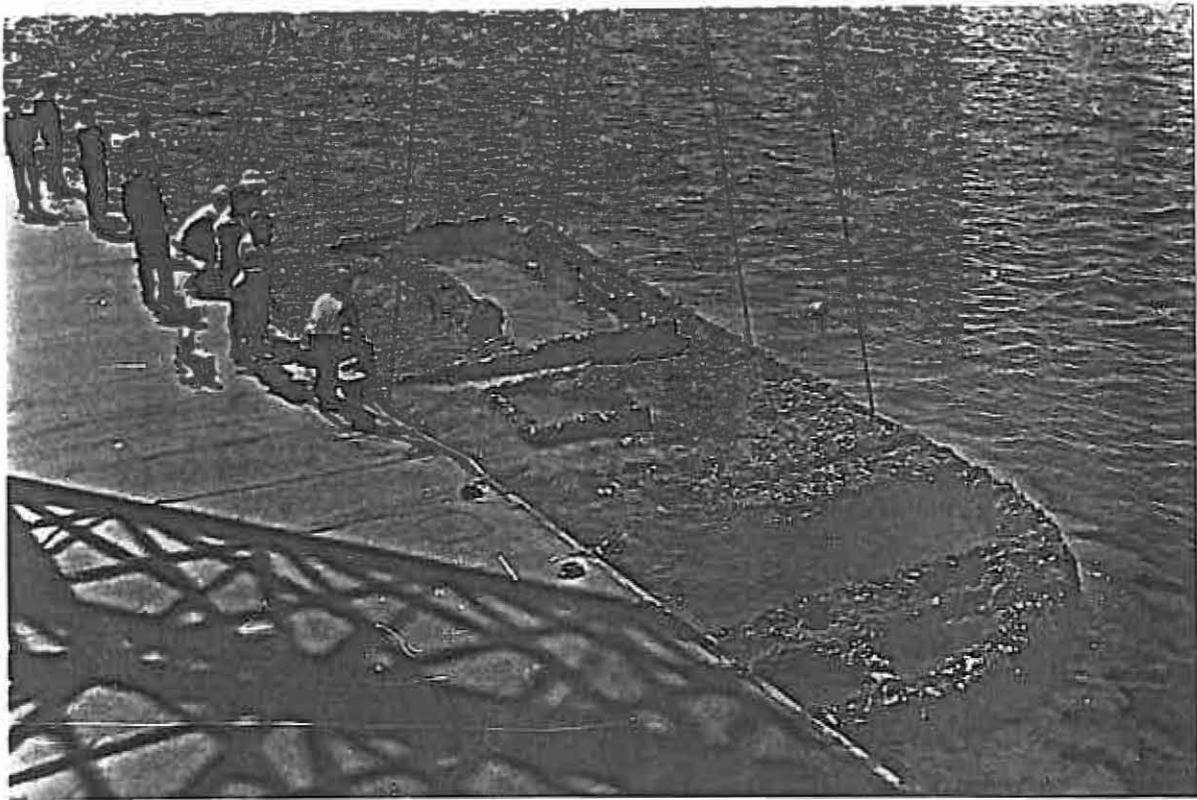
In 1988, with extensions being carried out in the area, the wreck was moved by the Department of Marine and harbours to its present location by request of the Western Australian Maritime Museum and local divers, so as to preserve it as a popular diving spot. It was moved by a floating crane which lifted the wreck partially out of the water (Figure 4.1) (Appendix III). As a result, the wreck is still in reasonable condition.

Figure 4.1 Lifting of North Mole dredge from original resting place. (D. Robinson)
