The Coral Bay to Exmouth wreck inspection trip

5–13 September 1992

Compiled by Jeremy Green

Report Department of Maritime Archaeology

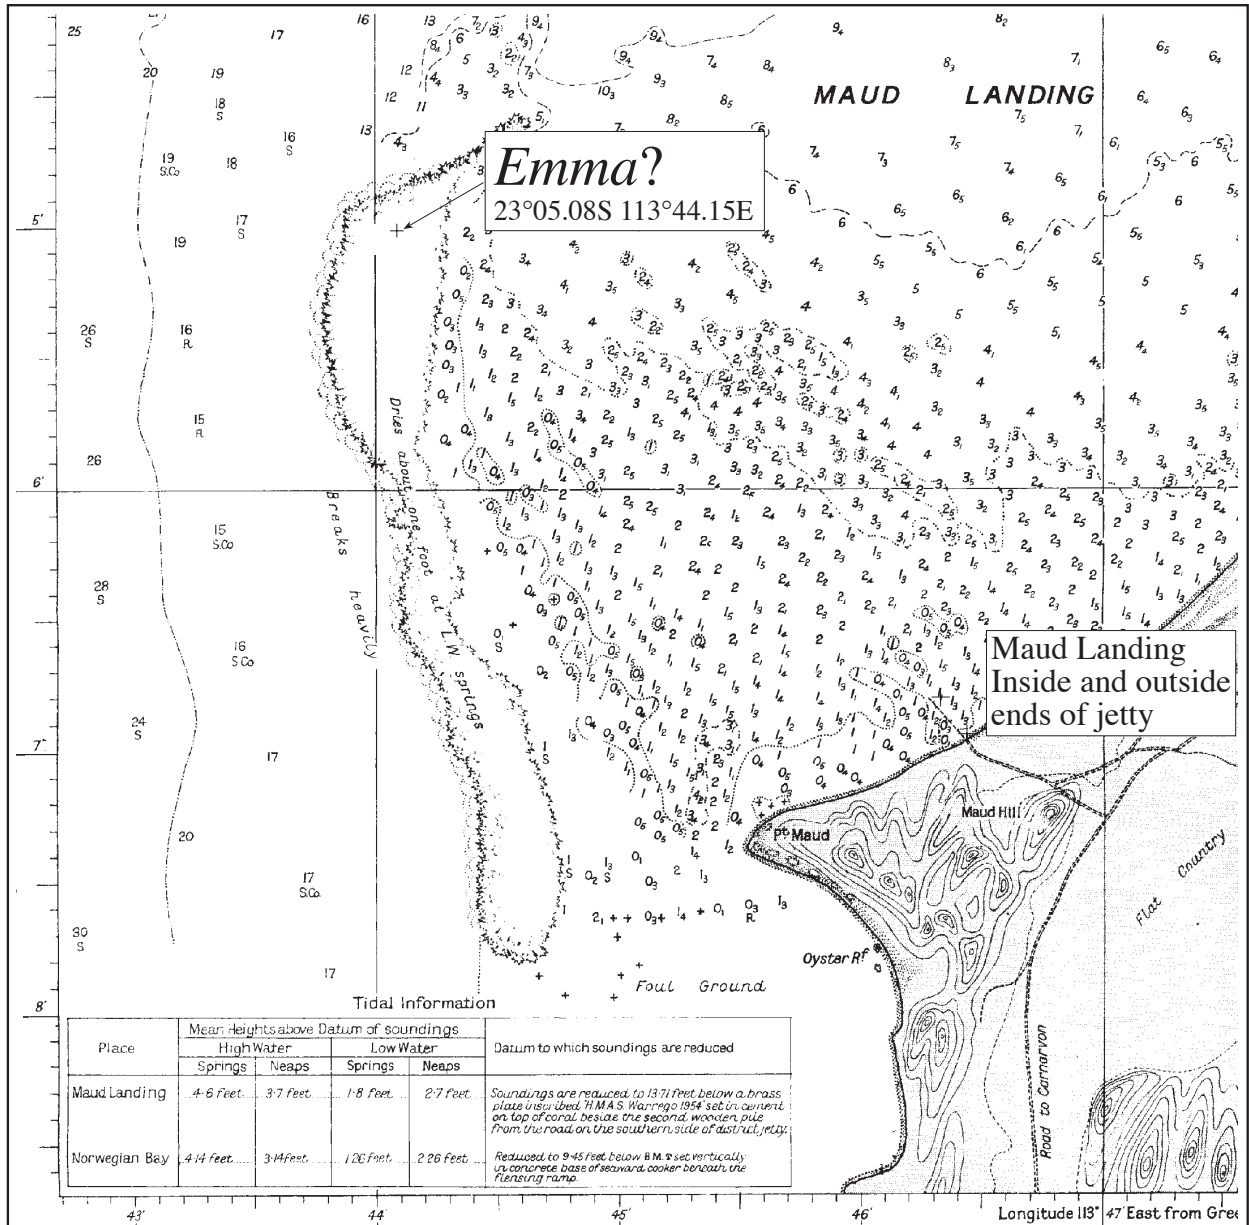
Depart Carnarvon 0745. Arrive Coral Bay 1130. Met Ian Godfrey. Depart to *Emma?* site 1330. Ian, Jon, Pat, John and Jeremy. Site located xEM1 (Note, all GPS positions are given an abbreviation and are listed in Appendix 1) is GPS position of sand hole to E of site (Figure 1). Return to Coral Bay.

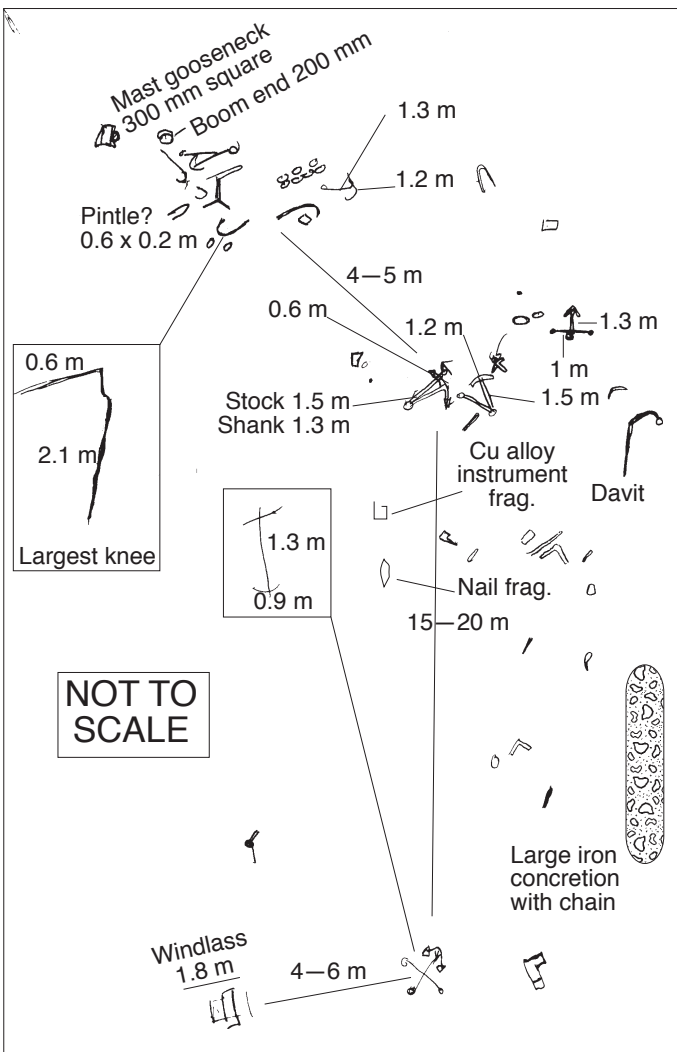
To the *Emma?* site. Proceeded between the reef and the break towards the rock. On a good day it would be possible to get very close to the site (See *Emma?* general area plan Figure 2). Then moved into the sand patch to where we anchored in morning. Colin on boat, Jon, John, Pat and Jeremy to the site. Measured the main anchors and features and measured the distance from site to boat (xEM4) 180 m bearing 295° N. Measured and recorded on Geoff Kimpton's plan a number of features (Figure 3). Collected small fragment of copper alloy instrument and nail head with wood fragments (for timber identification).

There seems to be at least six anchors, some have chain attached, others have iron stock in place others have stocks stowed. There may be collapsable and fixed anchors. The shanks all seem to be square sectioned. The pintle is questioned as one cannot see the

pin, but it is not a gudgeon. There are number of full-length keel bolts (copper alloy) some about 2 m long. Reasonable amount of stone ballast.

The two paper presses are both well concreted to the sea bed. Because the presses are unlikely to be recovered illegally and given the difficulty in getting them back to the boat given the tide and sea conditions it was decided not to attempt recovery. It would be possible on a good day at Spring tides to break the presses free at low tide and then recover them at high tide. It may be possible to get the boat over or close to the site and take advantage of the Easterly current.

This site requires a complete survey at some point in the future. It is recommended that the paper presses be left for the present as they are not at risk nor is it likely that they would have documents in them. The two presses were much more likely to be an order of some sort for the Northwest.

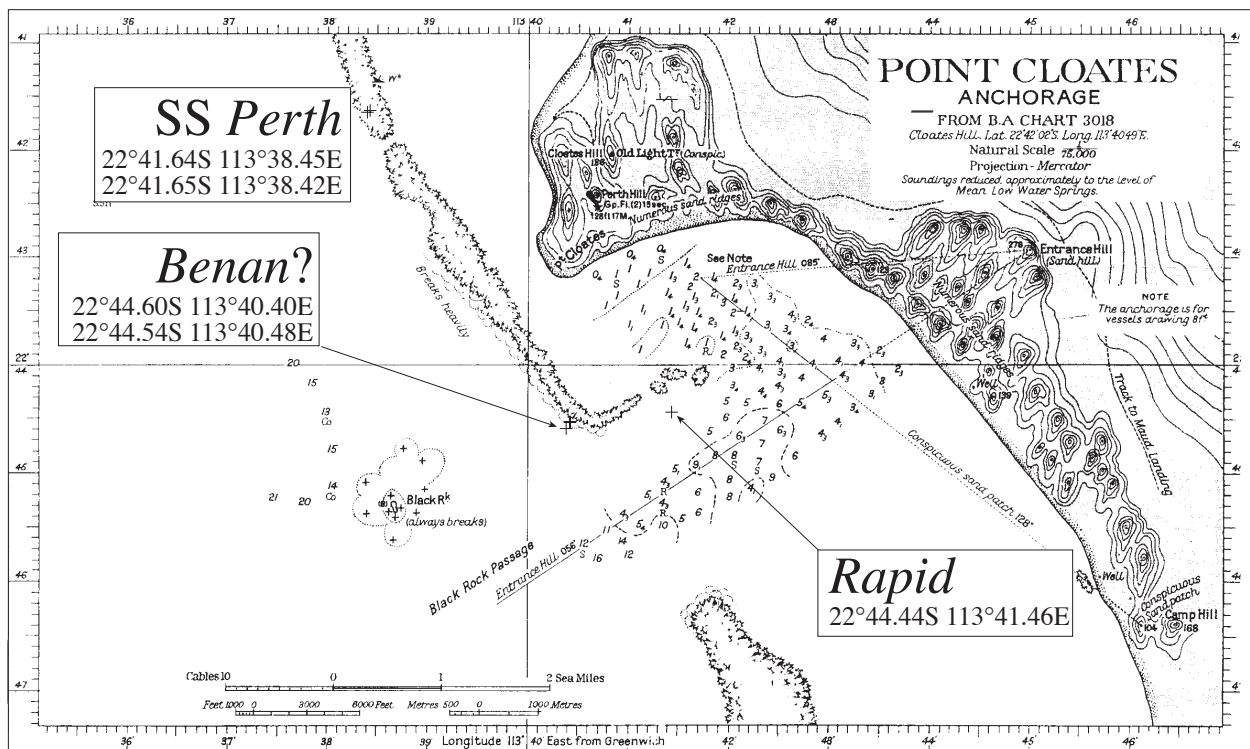
Lloyd Jones arrived to join the team. Boat departed Coral Bay 0830 for the rock on the chart (see Figure 4) position xROC (see GPS). Travelled along the inside of Ningaloo Reef from Bateman Bay along Boat Passage to rock. This is a large pinnacle of rock exposed about 2–3 m and another rock awash to the ESE about 50 m. It is surrounded by a large number of coral bommies about 10 m in diameter extending several hundred meters radius from the main rock. Pat and Jon snorkelled around the rock briefly. It is obvious that any work on this site will require a systematic survey, (magnetometer and visual). Jeremy hit a rock (again!) while entering a waystation on the GPS, had to replace two of the plastic prop blades! (quickly and easily done).

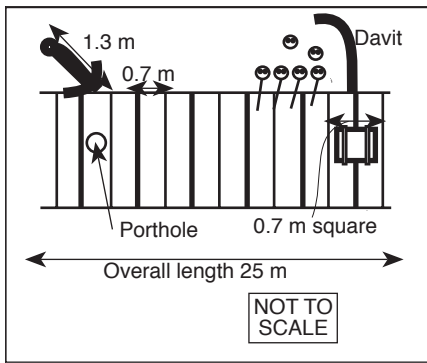
Figure 7. *Benan?* inside reef site plan

Site is very large iron vessel (*Benan?*). There is no evidence of a cargo of coal. Site 80 m long with two windlasses, 2 large anchors 1 small. Iron plates and masts. See plan and Jon and Pat's notes. Moved to inside reef area (xPT2). Several large sections of ship. Largest is bulwarks about 25 m long with 5 or 6 deadeyes, a davit, small collapsable stock anchor 1.3 m long, brass porthole, square scuttle? 0.7 x 0.7 m. The iron frames on this alternate thick and thin spaced 0.7 m appart.

This site needs a detailed survey. The site will be difficult to work on because of the exposed nature of the reef. It is recommended that the site be protected under the *Historic Shipwrecks Act* as the Ningaloo unidentified possibly the *Benan*.

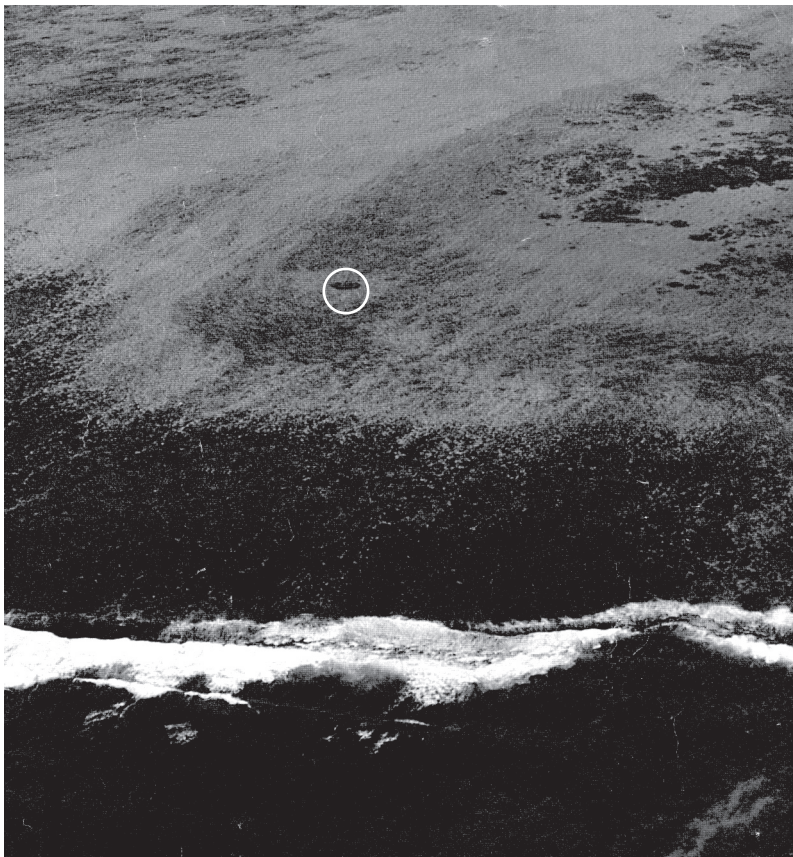
1430 to *SSPerth* for GPS. PER is the inside reef position, PER 2 is on top of reef S of site, PER3 is position of plates on the inside, PER 4 is the position of engine on outside of reef and the xPER is averaged position of engine. Went there at low water, very difficult to walk across the coral flats before the rock part of the reef was reached. Doug Myers (OIC CALM Exmouth) arrived late afternoon.

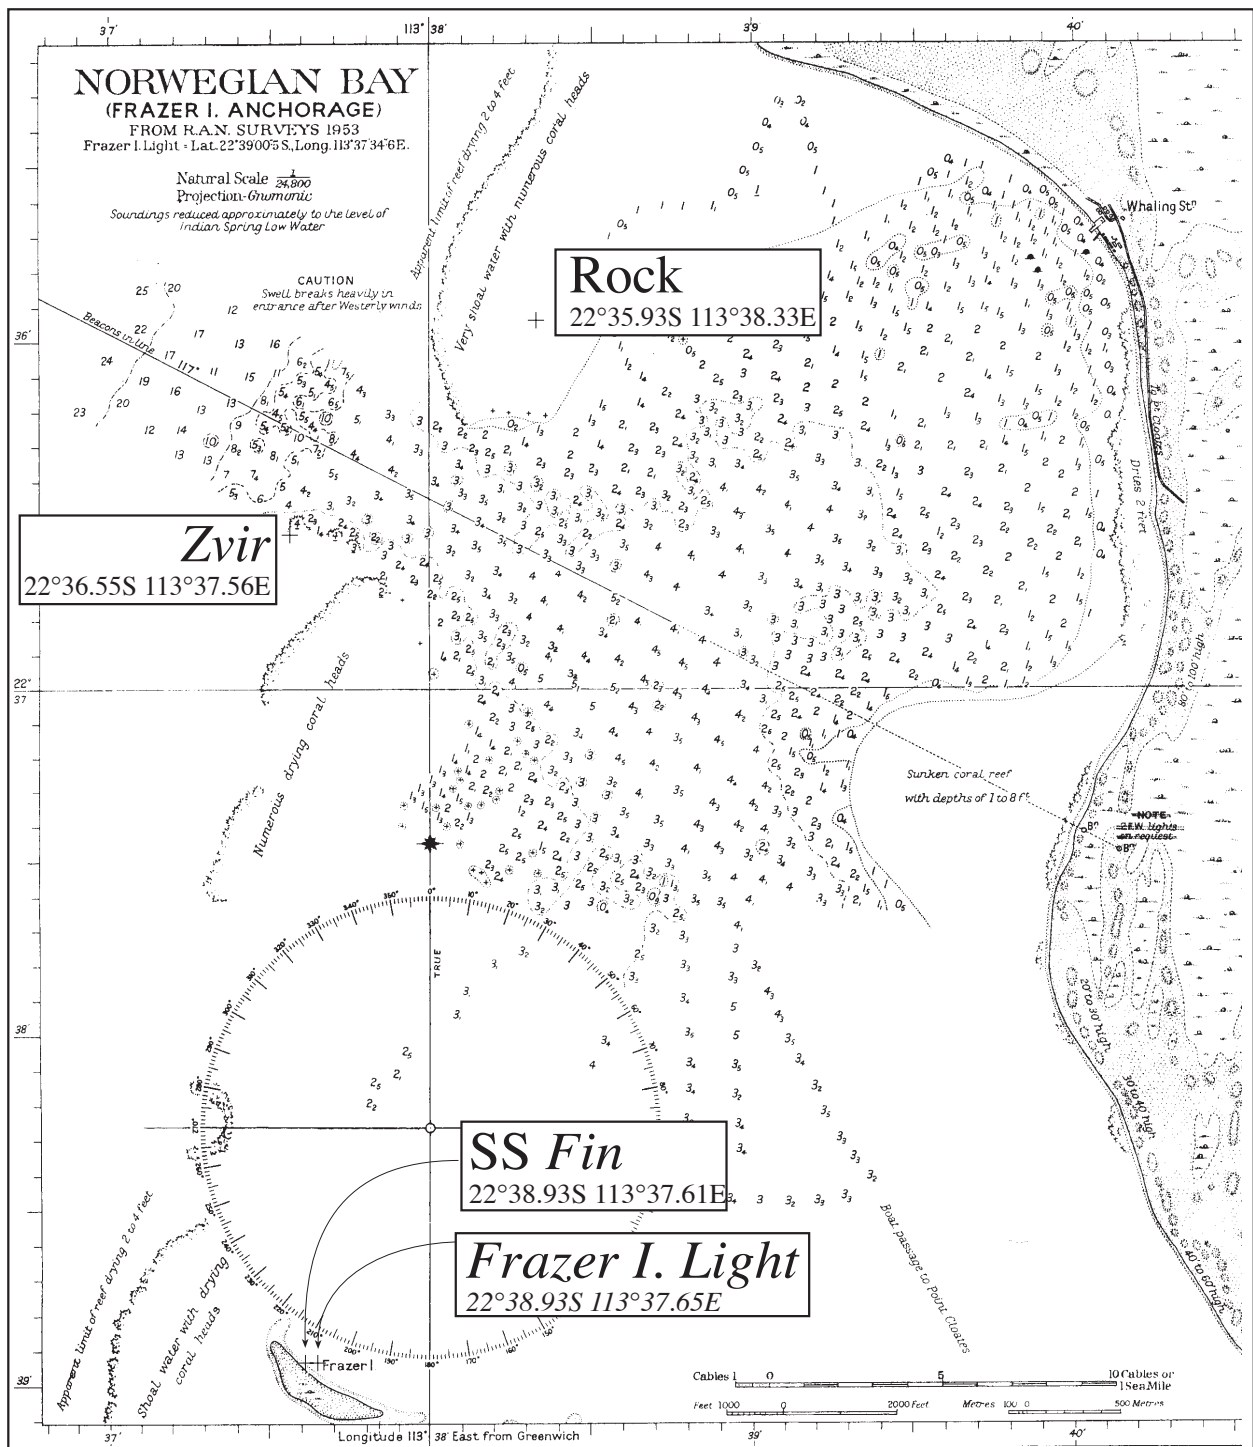
The site consists of a large iron wreck, 2 iron stockless anchors and

chain at bow. 3 iron boilers , a condenser with multipul brass piping about 1 inch, engine fallen over to starboard, drive shaft, spare propellor and main propellor all blades intact, rudder and quadrant. Vessel is stern to the reef.

No further work required although the site should be properly surveyed at some point in the future.

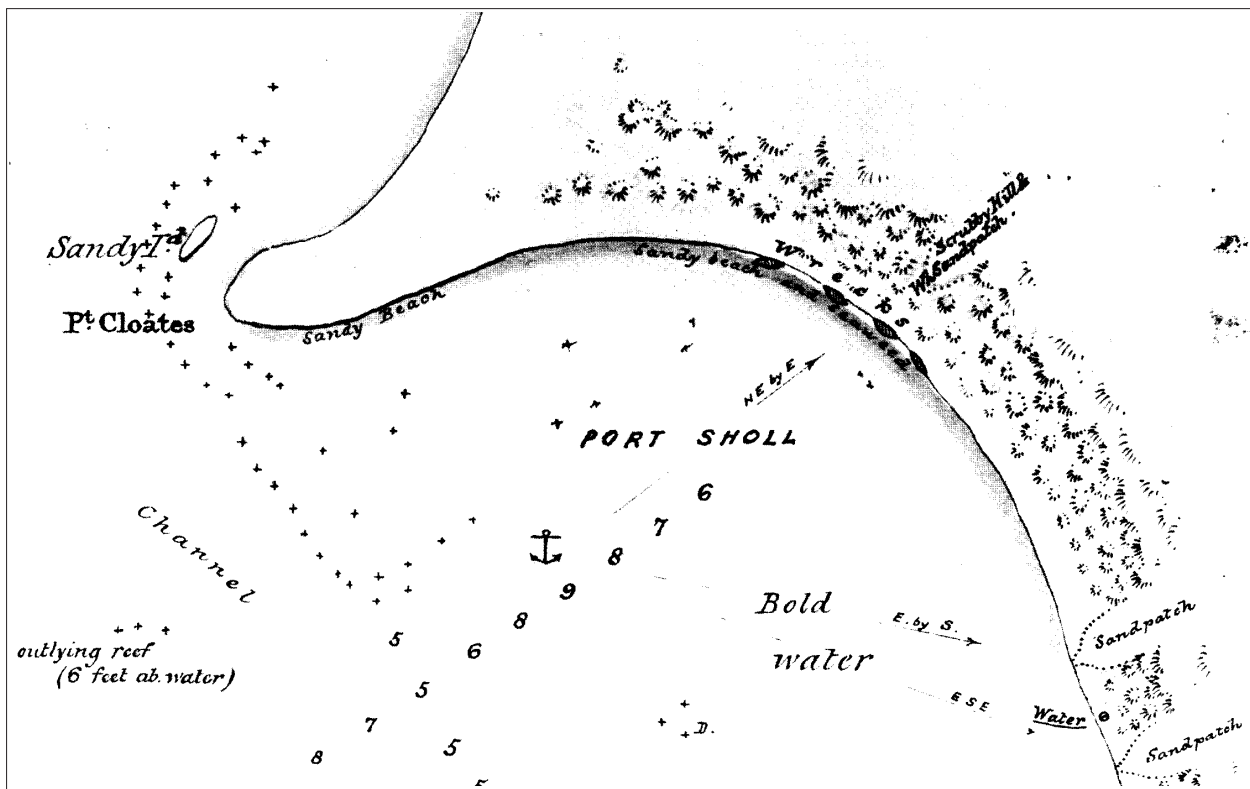
Figure 14. The Walcott map taken from Henderson & Henderson's *Unfinished Voyages, Western*

In 1876, Pemberton Walcott was given command of the schooner *Victoria* with orders to proceed to the Point Cloates area and search for survivors of the wreck *Stefano*. The accuracy of Walcott's report is questioned by Henderson & Henderson (1988) but it is quite clear that three if not four or five different shipwreck remains were sighted by Walcott. His sketch map, Figure 14 shows four separate wrecks, although it is likely that these were not complete wrecks, but rather remains of parts of the vessels that would have been wrecked on the outlying reefs.

These sites should be further investigated. This would require a small team using a small boat and a magnetometer to conduct a shallow water survey and then a small dune motor-tricycle to do the same thing on the beach.
