# *Streeter's Pearling Jetty*

## **Maritime Heritage Site Inspection Report<sup>1</sup>**

**Report Department of Maritime Archaeology, WA Maritime Museum, No 124.**

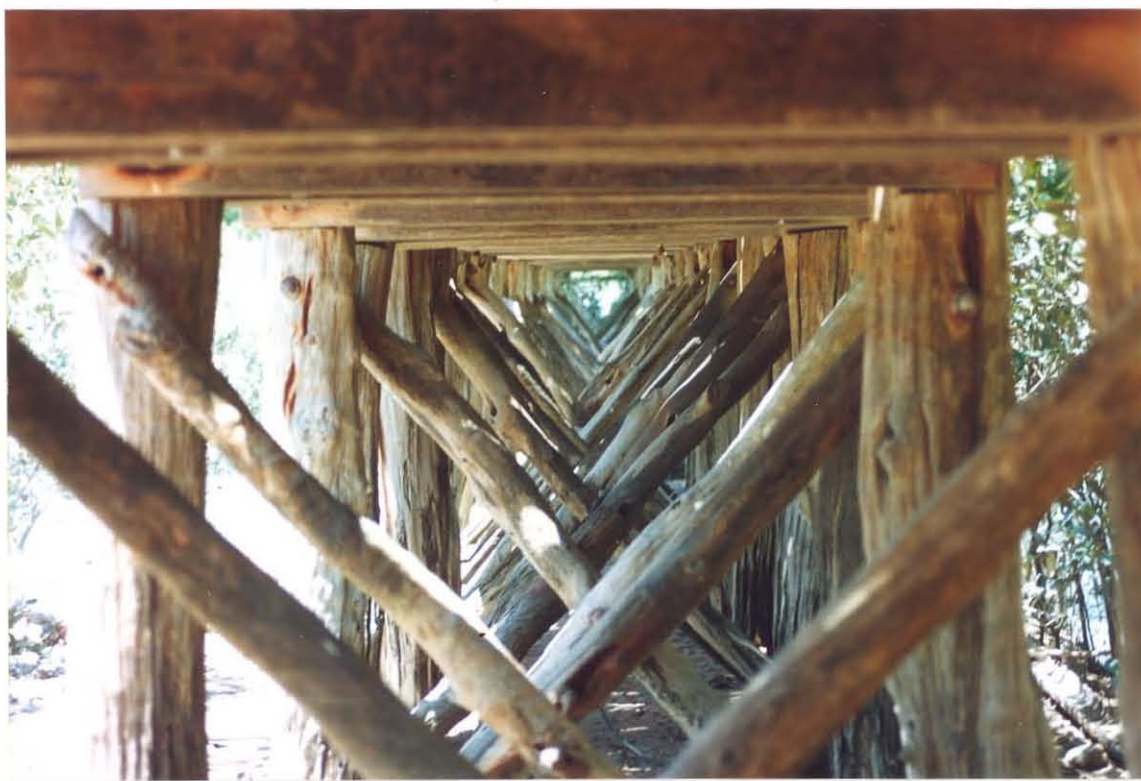
<sup>1</sup>Cover Photograph: A view under Streeter's pearling jetty in September 1995

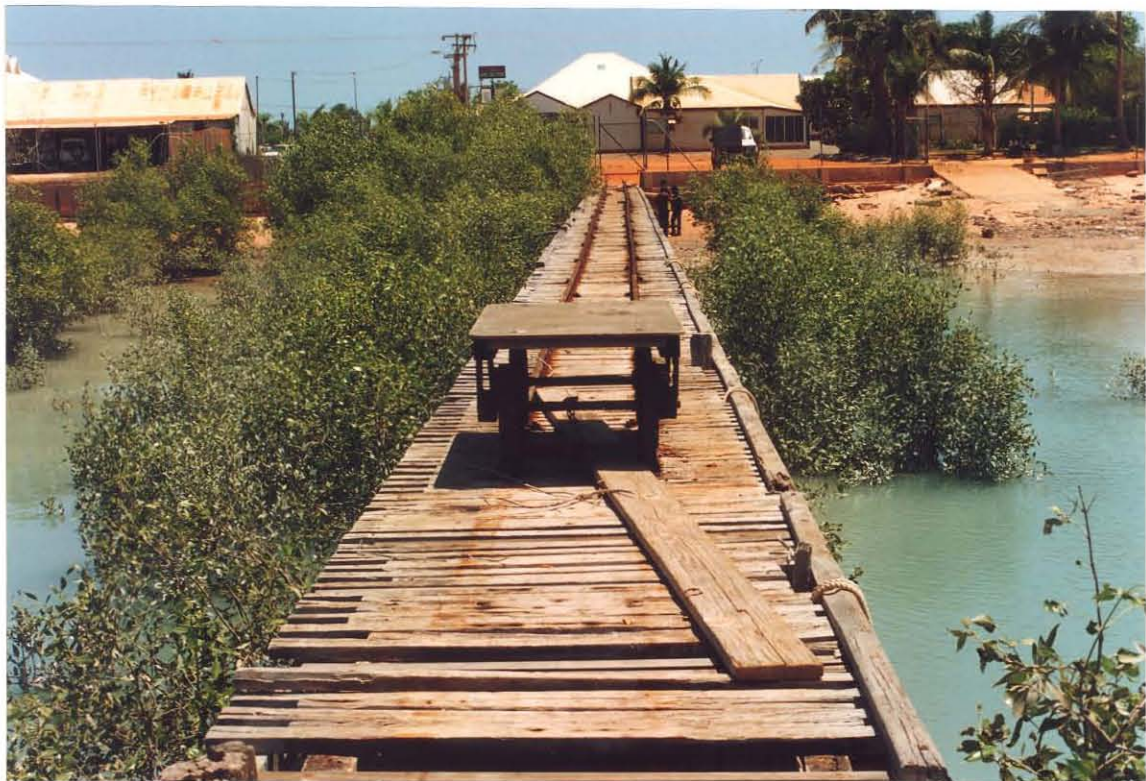
Figure 3:

Streeter's Jetty, showing the proximity of the town. The boatsheds are to the right of the photograph

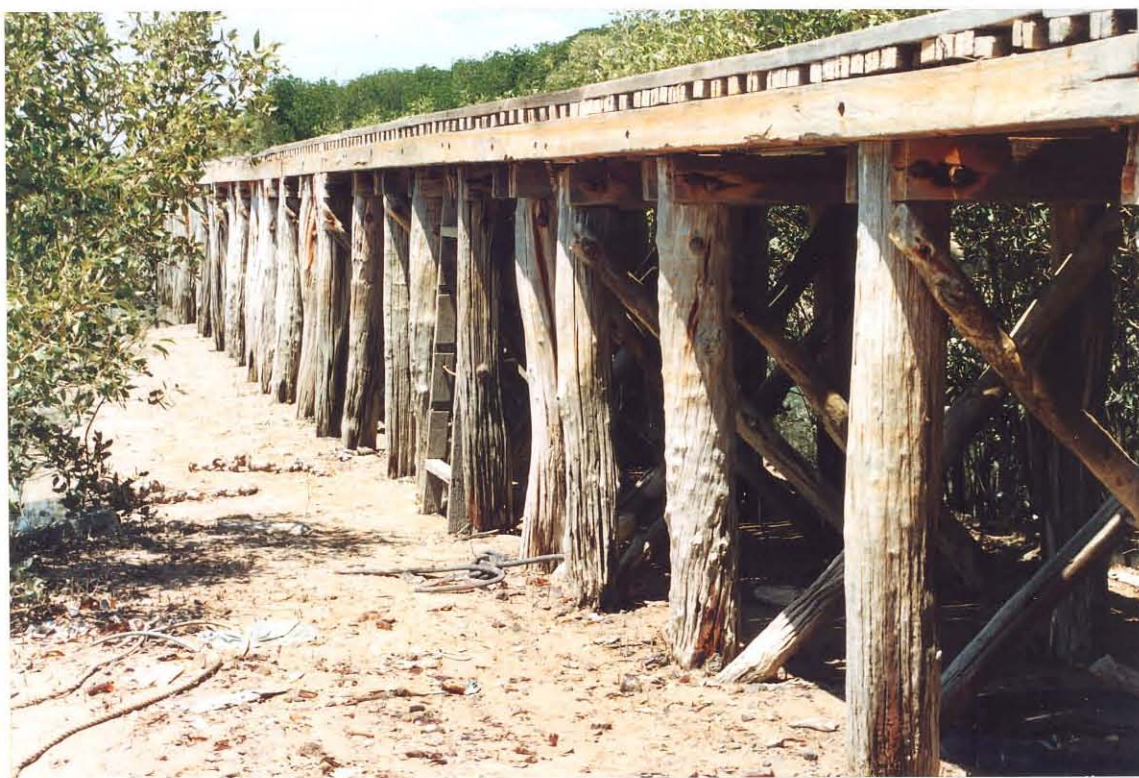
Figure 5: A view of the northern side of the jetty at low water spring tide.

The jetty is 6' wide by 220 feet long (c. 1.8m X 67m). It stands 8 feet (2.4m) off the sea floor at the seaward end and 5 feet (1.5m) at the land end. Mangroves grow close to the jetty on the southern side, while along its northern side the shallow channel cut through the vegetation to allow vessels to moor alongside is still clearly visible. At low water these vessels (mainly pearling luggers) rest in a slight depression in the seabed that serves to keep the hulls nearly upright and to prevent them falling onto their sides.

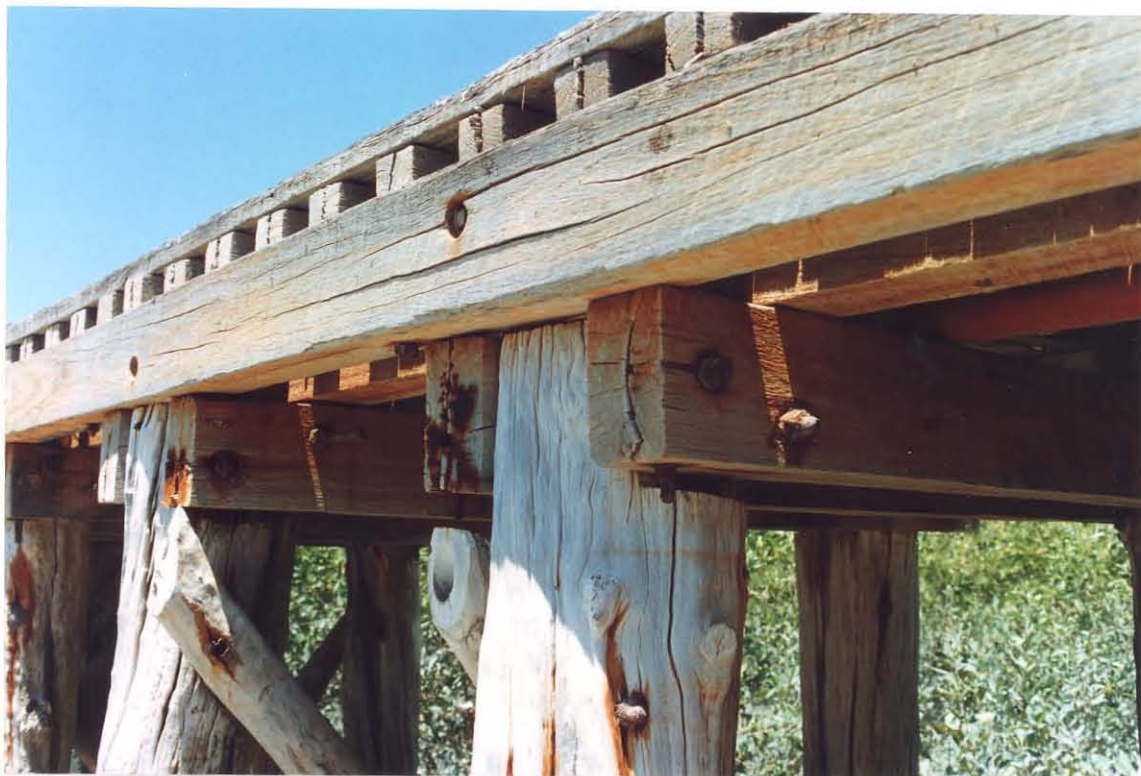
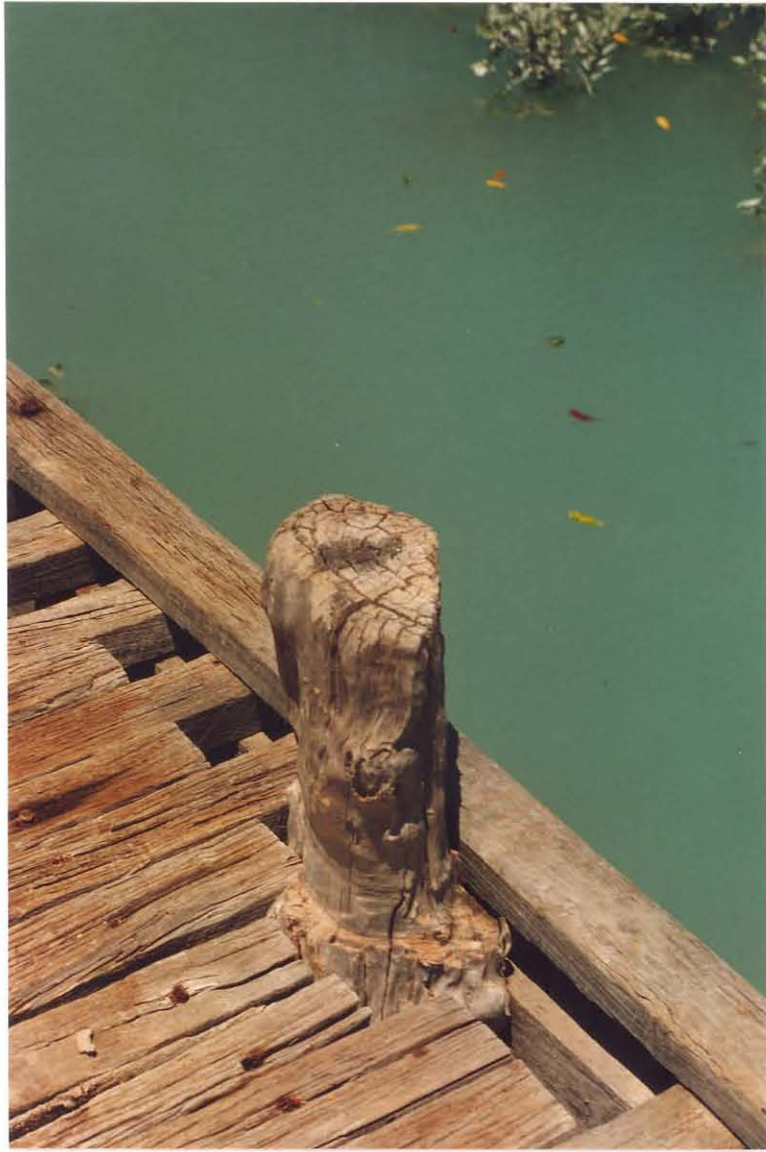
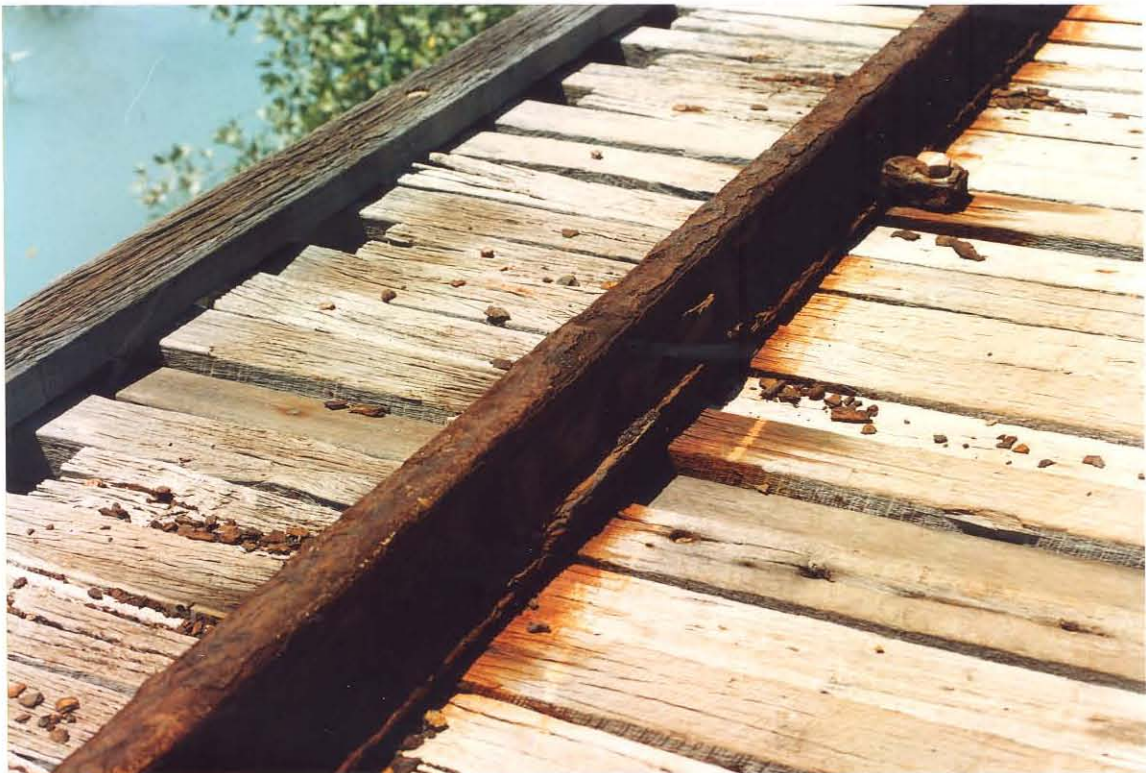
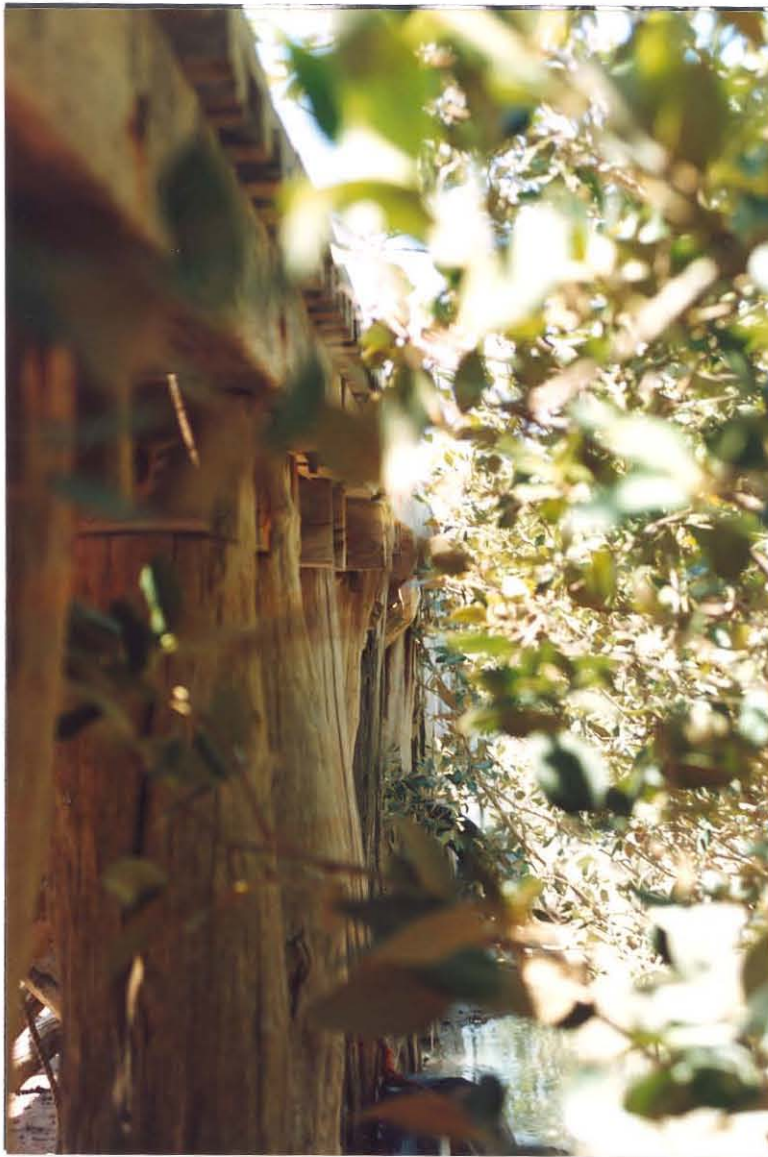
Figure 5-9 Views of the jetty.

The jetty has been constructed of natural wooden piles of varying thickness most around c. 8-10 inch diameter with dressed timber half caps, deck stringers, deck planking and kerbing. The piles are supported diagonally with braces of natural timbers c. 3-4" diameter locked with an iron bolt through a dressed timber block. All fastenings below the deck are of iron screw bolts, with washers, tightened with a nut at both ends. The remains of ladders (allowing movement from the seabed up onto the deck) formerly with wooden rungs are visible. The deck supports a 2' iron rail with a manually propelled 4 wheel trolley. The rail ends 29 feet short of the seaward end of the jetty and on the landward side it proceeds past the neck of the jetty to a point 76 feet away and possibly beyond. Bollards are visible on the seaward end. A solitary pile lies in the mangroves south of the jetty. Its purpose is unknown.

The deck and its support structure of deck stringers and half caps, the light rail on the deck, the ladder, the rail and trolley, a bollard, natural piles and braces.

The jetty has only recently become disused and though deck planks have sprung and all the fastenings are heavily corroded, it is still in a retrievable and potentially useable condition. The light rail on the deck is heavily corroded and the trolley is intact and in a strong condition<sup>3</sup>.

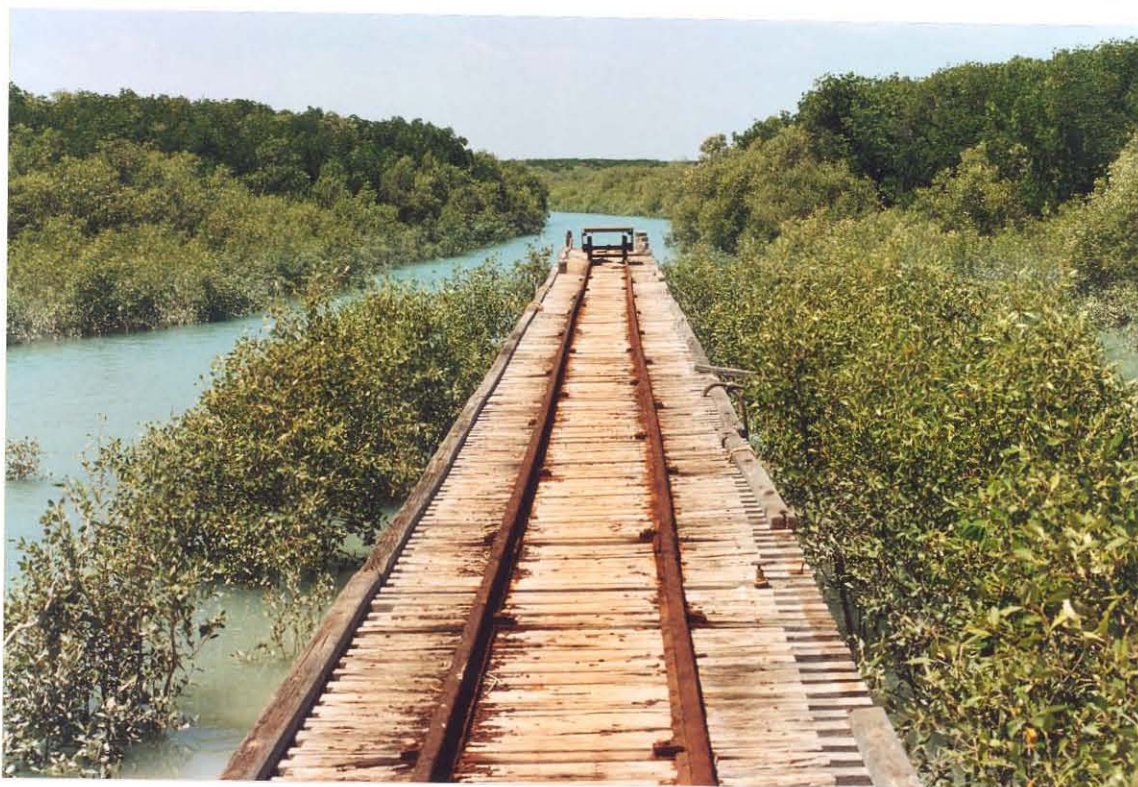
Figure 11: The mangroves protecting the jetty

(i) Natural Forces As can be seen from the illustration below, the jetty is protected on all sides by the vegetation and foliage of a very thick mangrove swamp which rises well above the structure itself. Revegetation of those mangrove plants usually kept low by the action of the boats mooring alongside the jetty is evident. As a result of this natural 'cushion', the usual deleterious effect of 'wind and wave' exacerbated by the occasional storm and/or cyclone common on these shores is minimised.

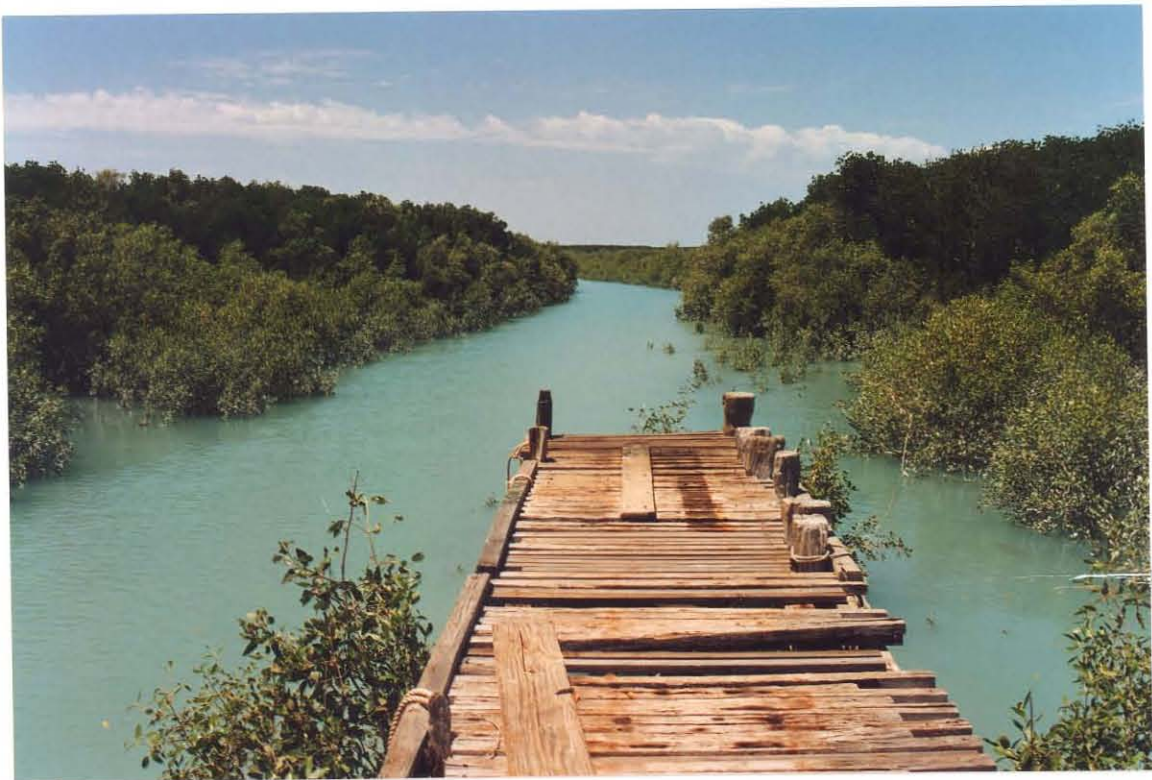
Figure 12: The deterioration evident at the seaward end of the jetty

Even though visitors are less attracted to the area now that the luggers are infrequently seen alongside, the safety of passers-by is an issue to the statutory authorities and those responsible for the structure given that the deck is beginning to deteriorate.

Streeter's Jetty is an asset to Broome, Western Australia and to the Nation. In the interests of those charged with public safety, it is considered that a more adequate fence be provided preventing access to the site until alternatives which will allow its preservation are found.

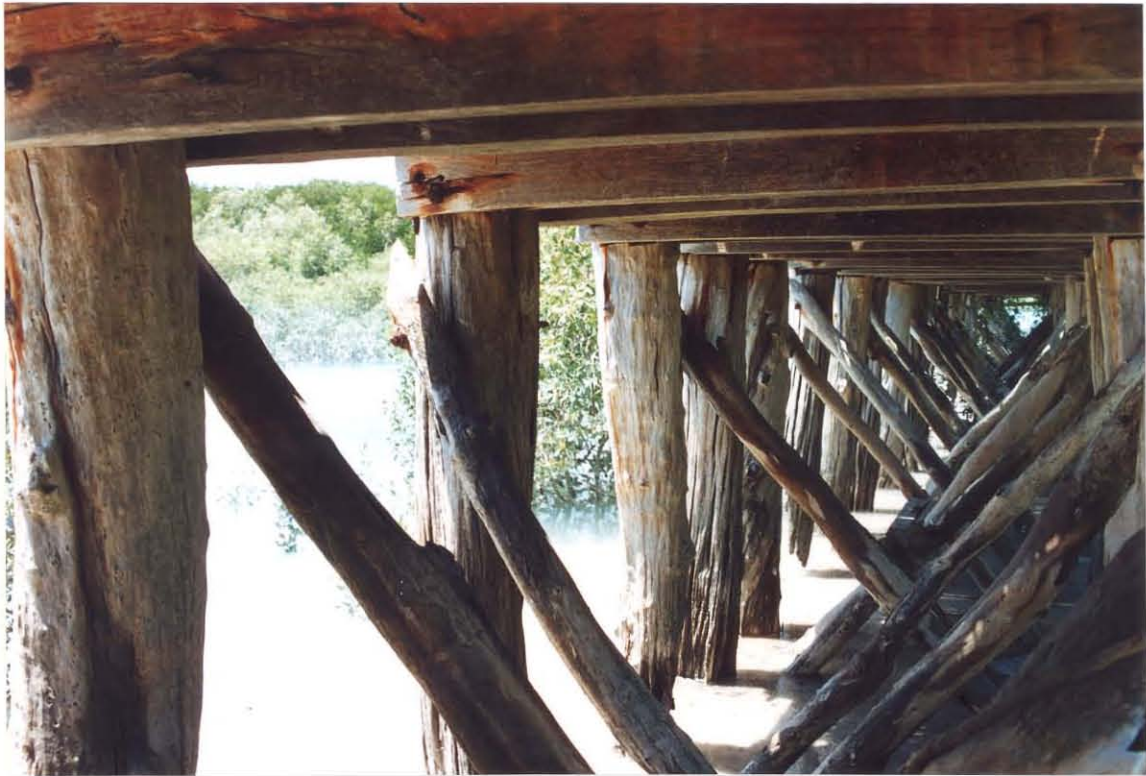
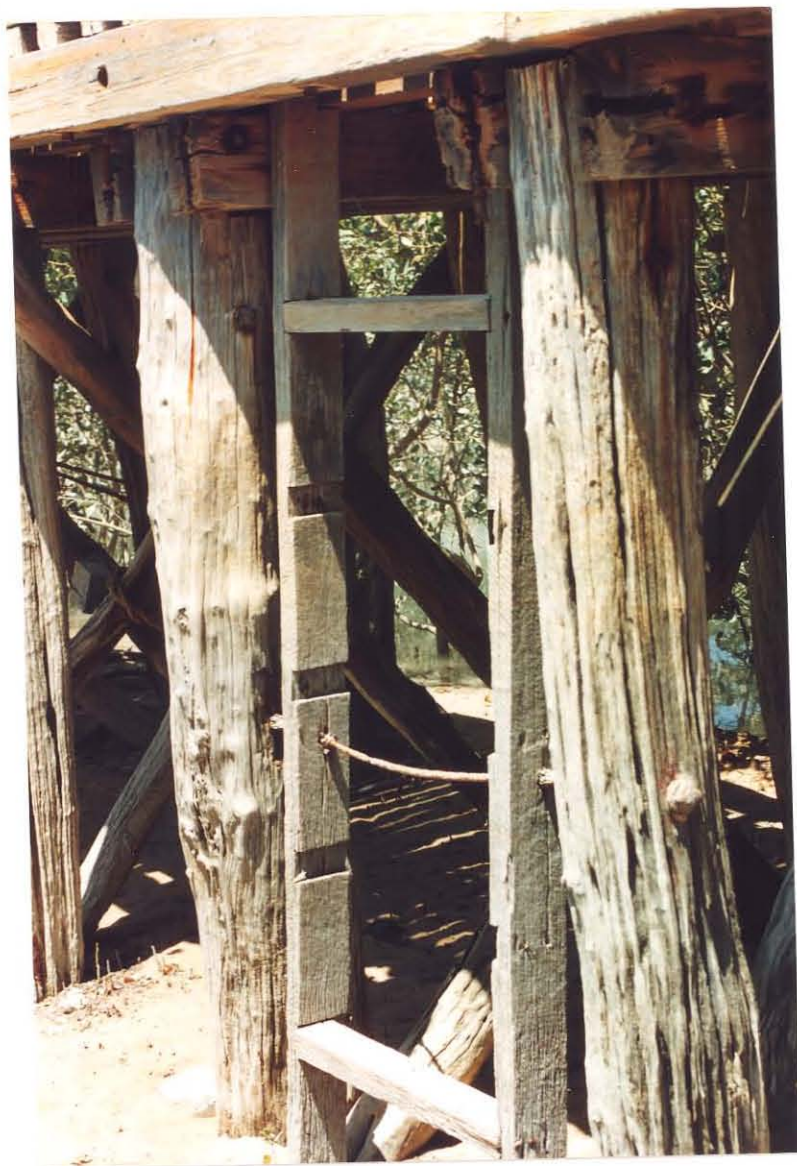
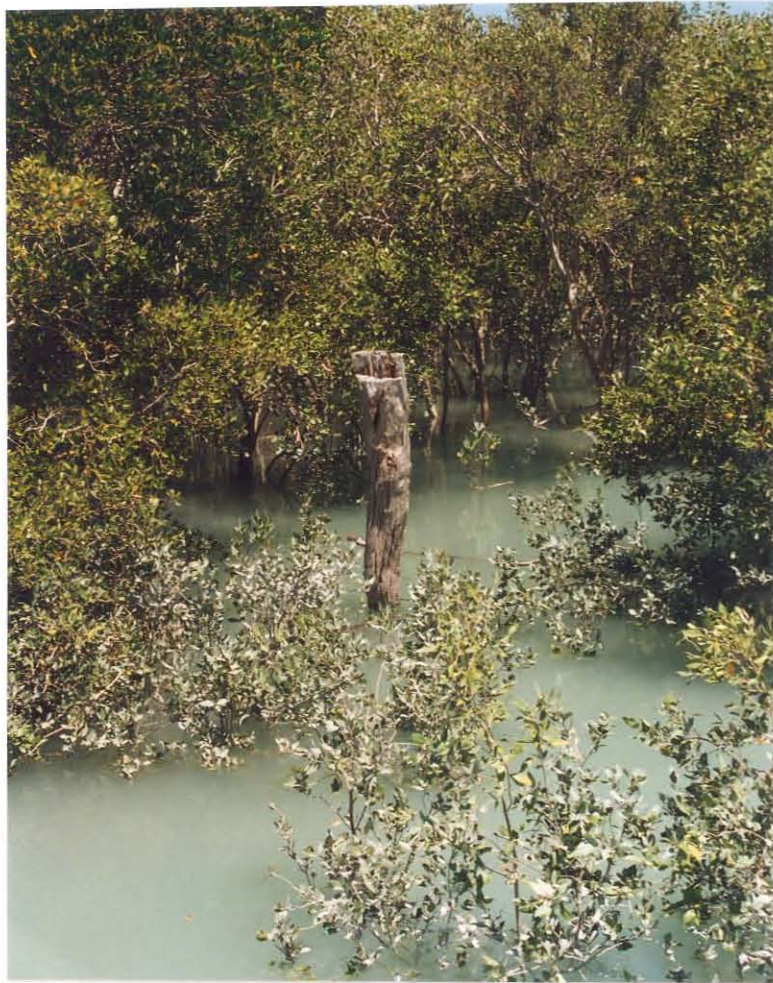
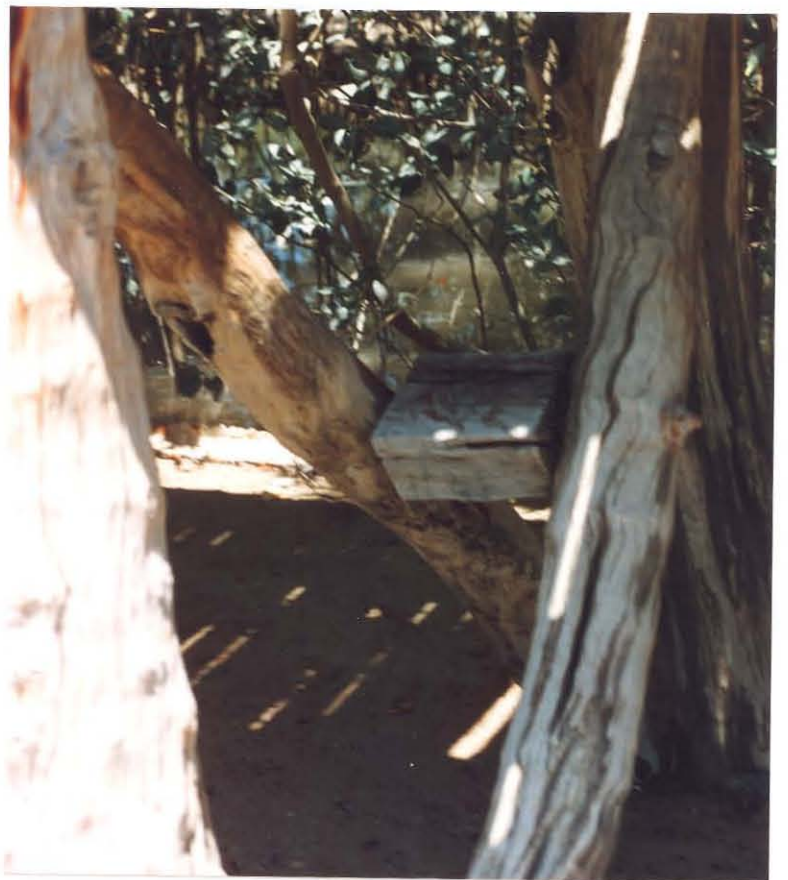
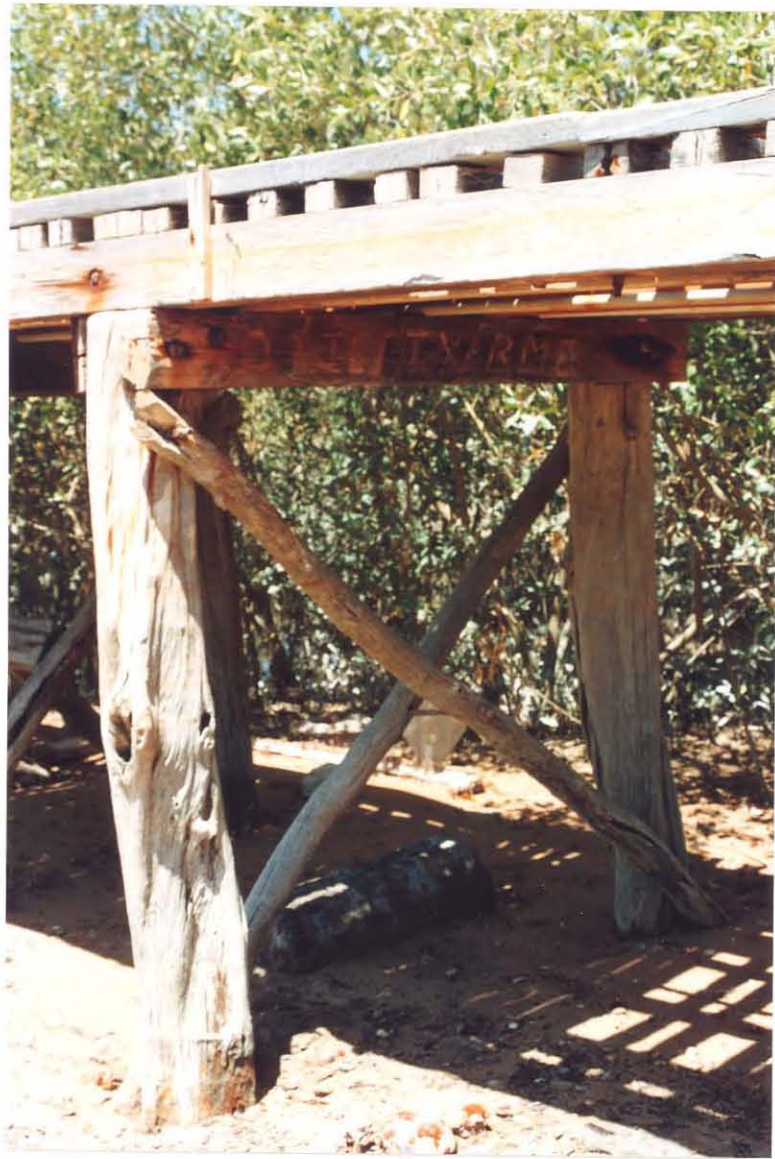
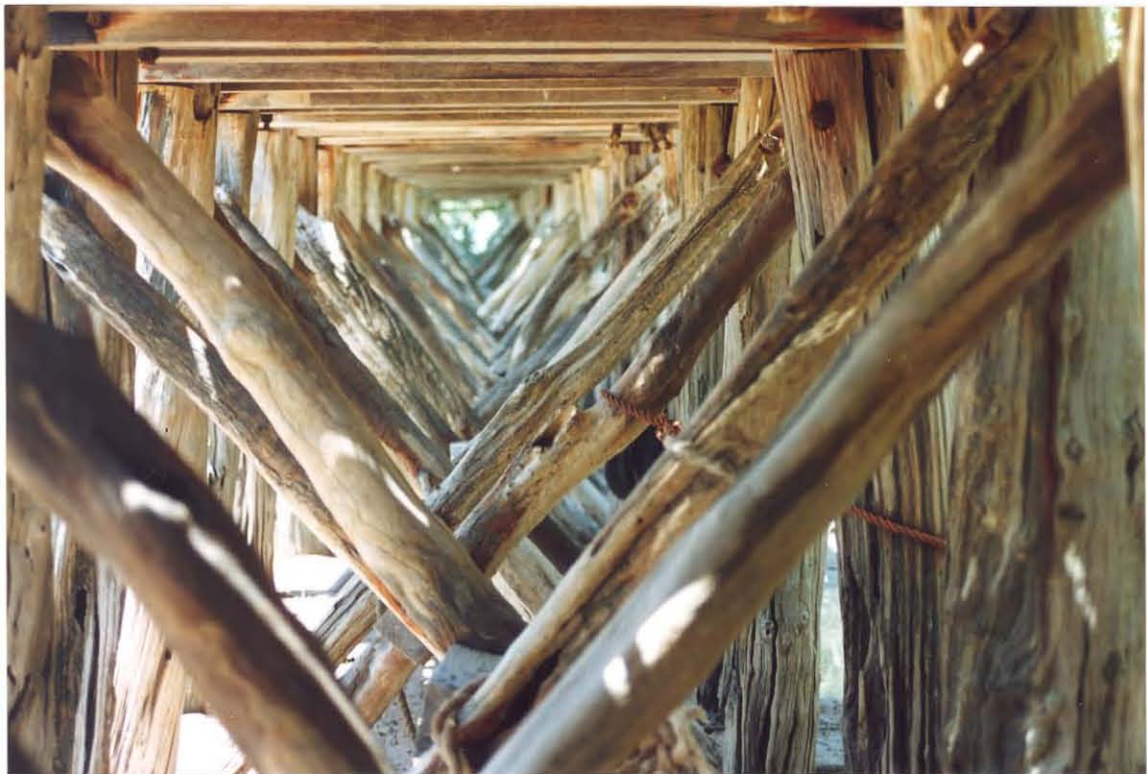
Further photographs taken of Streeter's Jetty: September 1995 (M McCarthy)

The seabed alongside  
Under the deck  
The ladder and piles  
Undeck  
The solitary pile to the south  
Braces and fastening block
