# **WRECK INSPECTION REPORT: Ningaloo MID-19TH CENTURY UNIDENTIFIED**

Report—Department of Maritime Archaeology, Western Australian Maritime Museum No. 186.

**Site Name:** Ningaloo 19th century Unidentified

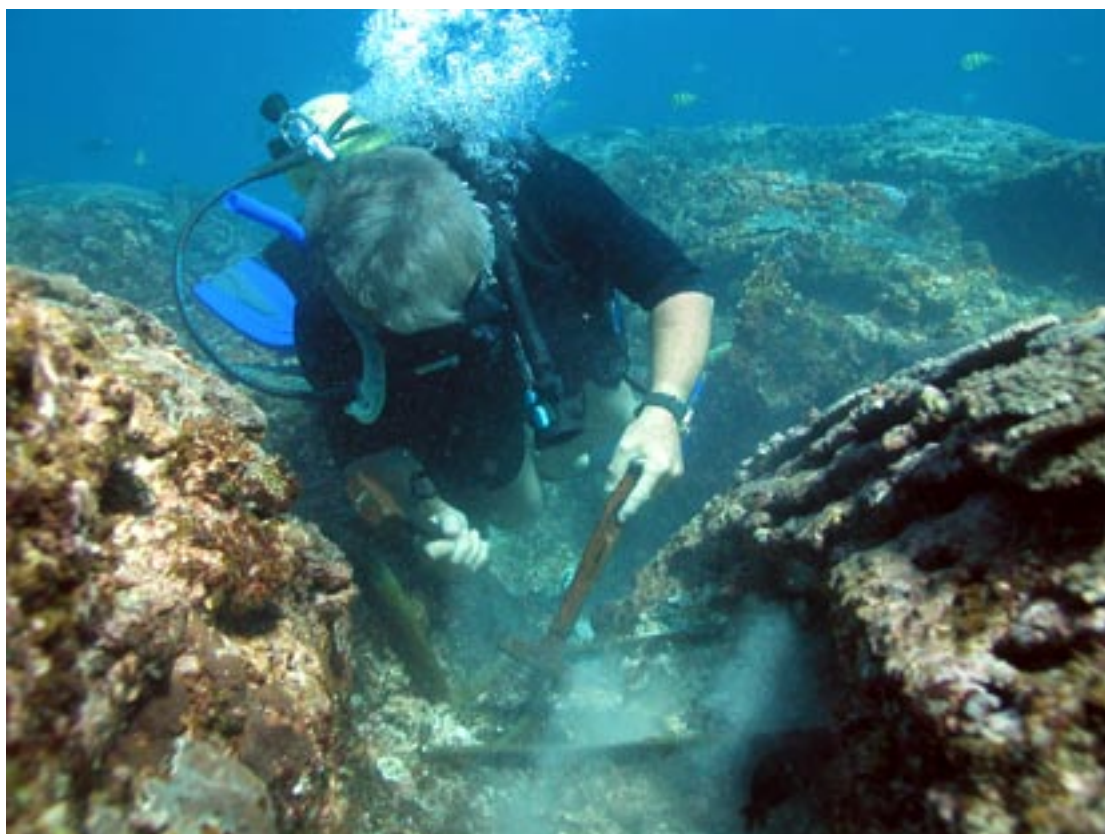
Jeremy Green excavating a Pintle

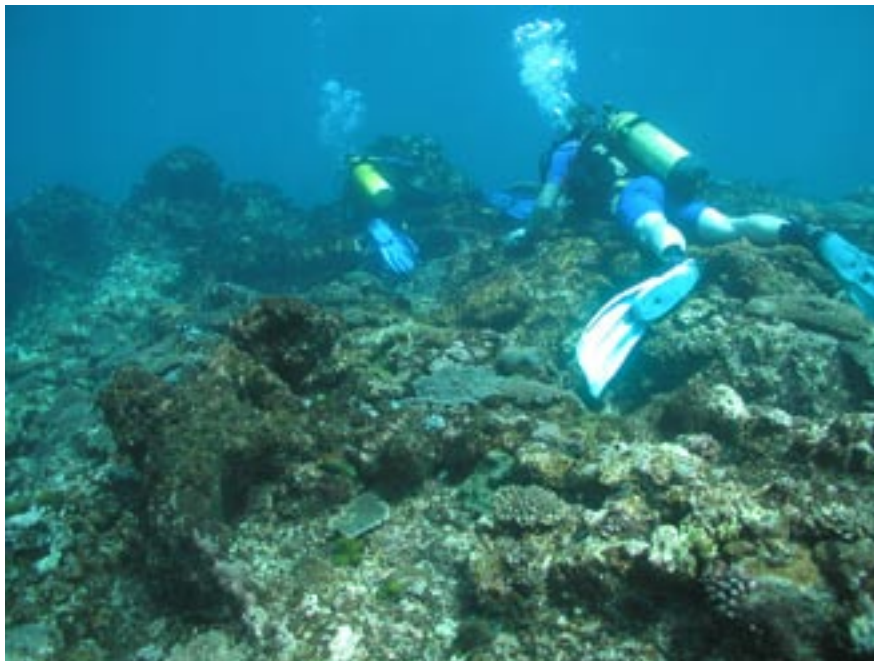
Figure 6. 19th Century Unidentified terrain

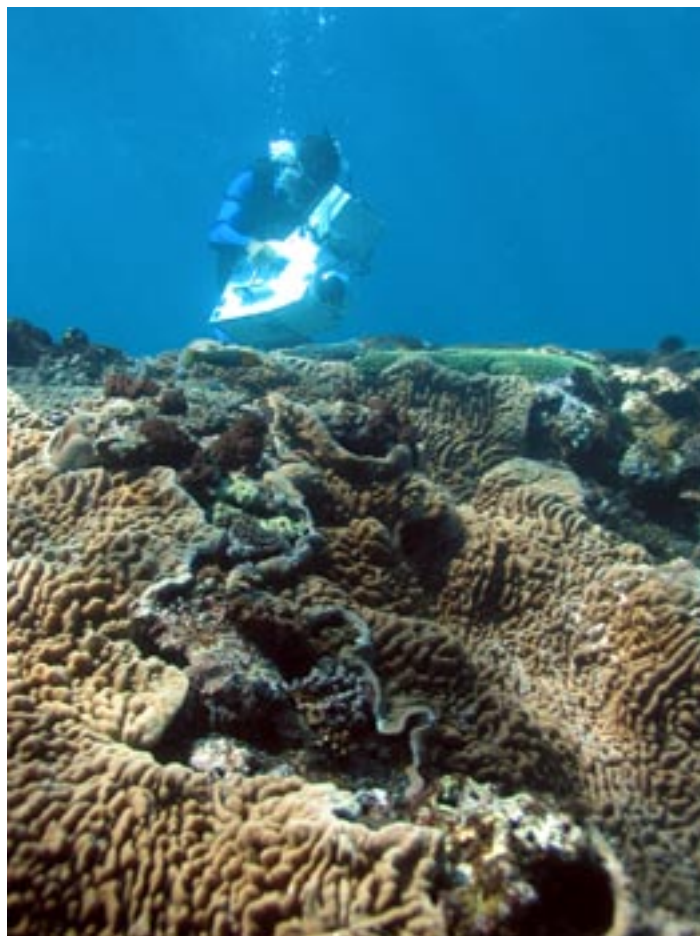
Figure 7. 19th Century Unidentified terrain

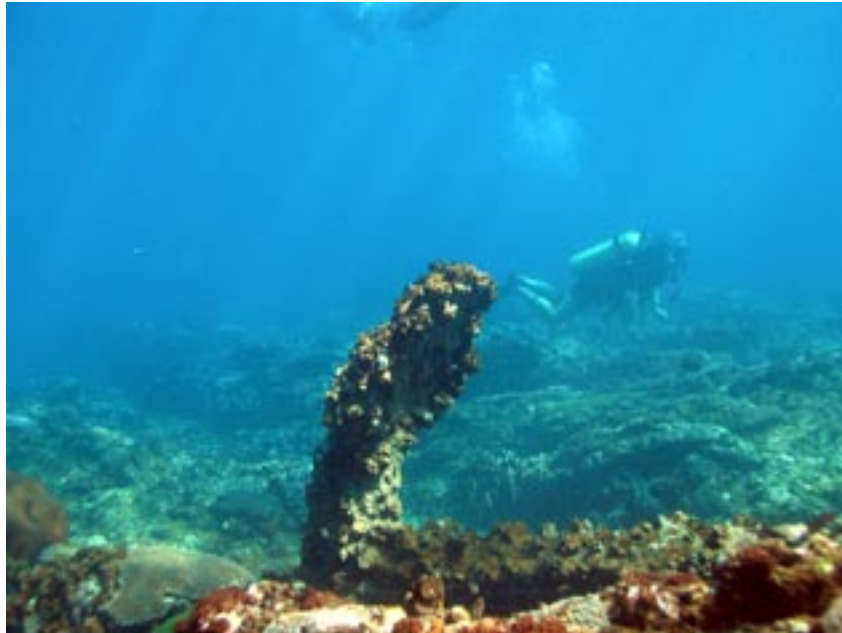
Figure 8. Anchor at the 19th Century Unidentified site

**Anchors:** Four anchors are located at the site. These anchors could provide us with information regarding the period of their use when examining style and their manufacturing techniques. The anchors are admiralty pattern anchors with curved arms. This curvature of the arms is significant because designs of older admiralty anchors during the mid 16th–18th century's had straight arms. There was a shift from these old 'Admiralty Longshank Anchors' (that had a long shank and straight arms) in the late 18<sup>th</sup> century to the new 'Admiralty Pattern Anchor' (that had a shorter shank, curved arms and a new process for forging) in the 19th century. The curvature of the arms and the new manufacturing techniques were in response to the large amount of

Longshank anchors that were shearing at the crown. In the period 1809–1812 approximately 350 were repaired and 150 were still outstanding (Curryer, 1999).
