Hamelin Bay Jetty

A study of the Hamelin Bay Jetty

Thesis submitted for the degree of
Masters of Maritime archaeology
at Flinders University of South Australia,
Department of Archaeology

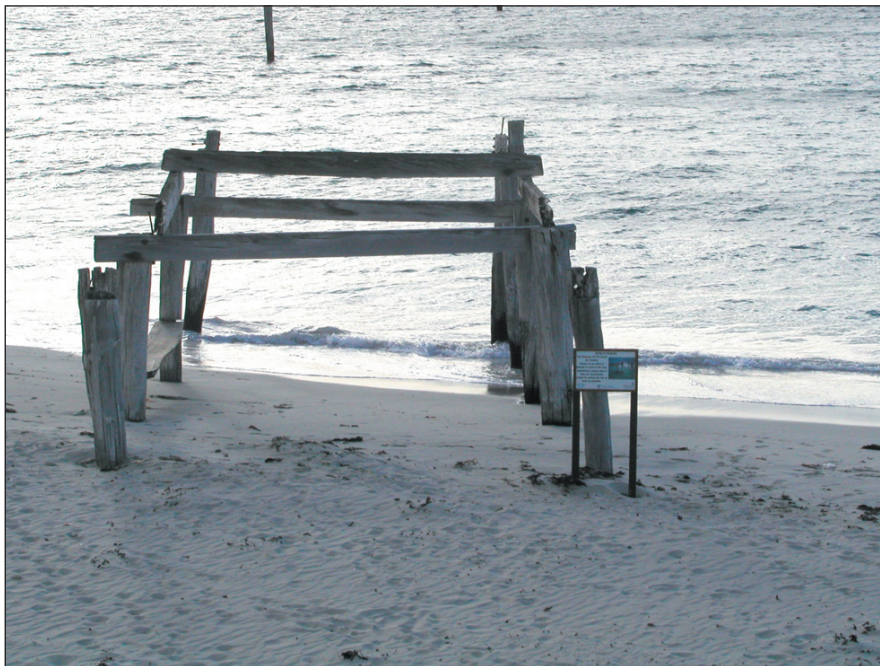
Figure 1. Remains of Hamelin Bay Jetty 2004. Photo: M. Gainsford.

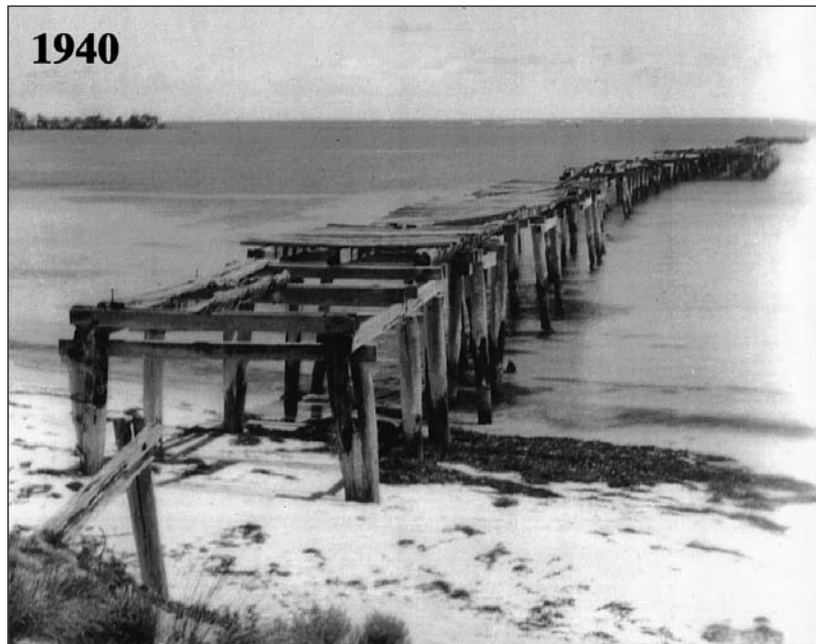
It appears that the shore remains represent the basic structure of the jetty. Analysis of historical photographs has led to the conclusion that the jetty was probably built with a two pile bent system (see Figures 16–19). These bents consist of two piles with a halfcap joining them together horizontally and longitudinal beams (crossheads) between bents. There appears to be no cross bracing evident at the site and perhaps this is one reason for the limited remains of the structure. In addition to the piles, fenders were also incorporated in the structure of the jetty. These were used to stop vessels from damaging the main jetty structure (fenders are placed alongside piles of a jetty as sacrificial piles) however, none of these are visible today (Ford 2000:75; Wolfe 1996:9).

Figure 16. The Jetty slowly degrading, c. 1940. Photo: courtesy of MAAWA.

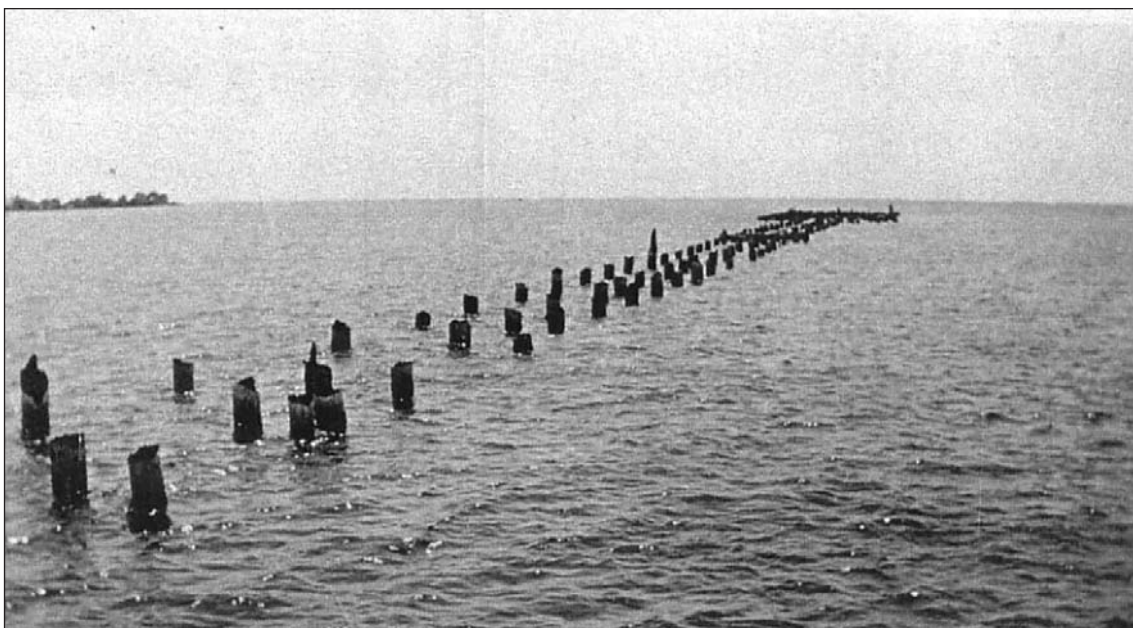
Figure 19. Layout of the piles, date unknown. Photo: courtesy of MAAWA.

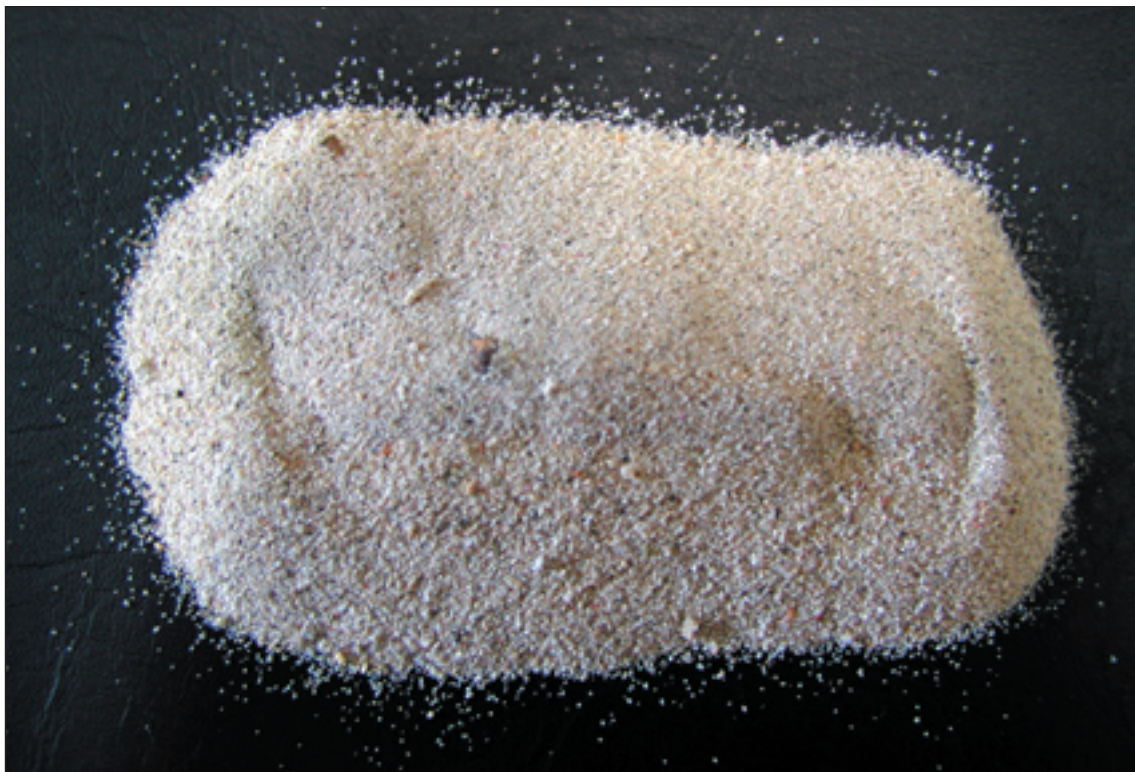
Sediment in the bay is light coloured medium to fine grained and has the ability to be highly mobile at certain times of the year (see Figure 22). During fieldwork sediment was evident throughout the water column, and visibility was reduced to c. one–two metres. At the site it can be highly mobile with little evidence of anoxic (oxygen deficient) sediment. This pattern is evidenced in modern day Cockburn Sound, Western Australia, where one-metre sediment cores failed to demonstrate any anoxic environment (Richards, V., 2004, pers. comm., February). This highly mobile sediment has the ability to both protect (slightly, dependant on depth) and uncover remains depending on season: it also influences artefact preservation. If sediments are mobile and provide a more oxygenated environment, artefact degradation and movement across the site are significantly increased (Pearson 1987:74–75).

Figure 22. Sediment sample, 2004. Photo: M. Gainsford.
