**Construction of the World War II Cockburn Sound naval base and boom defences**

### **Dolphin No. 60**

### 2010 site inspections

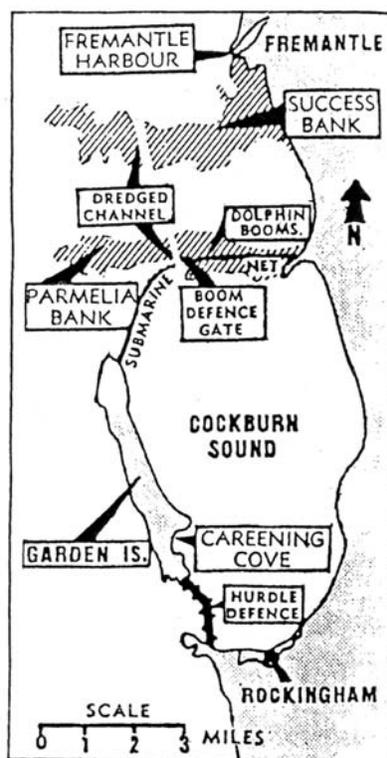
Figure 1: Map of area and Cockburn Sound boom defences (Jeffery 1988)

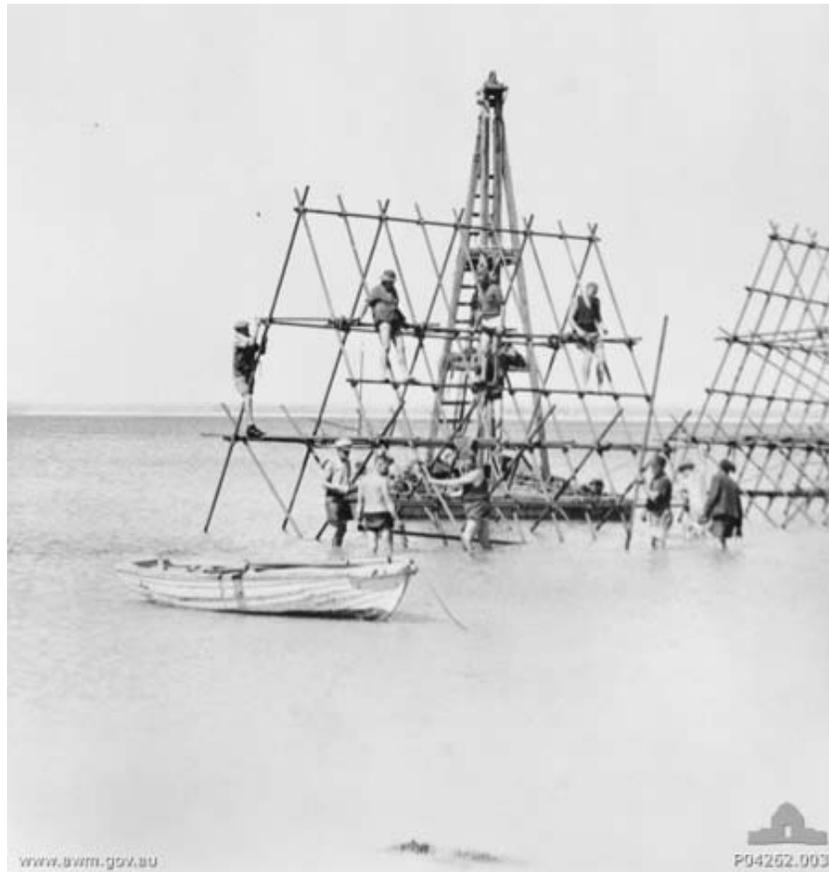
Figure 2: Type 'A' anti-boat scaffolding under construction in Cockburn Sound (Australian War Memorial P04262.003)

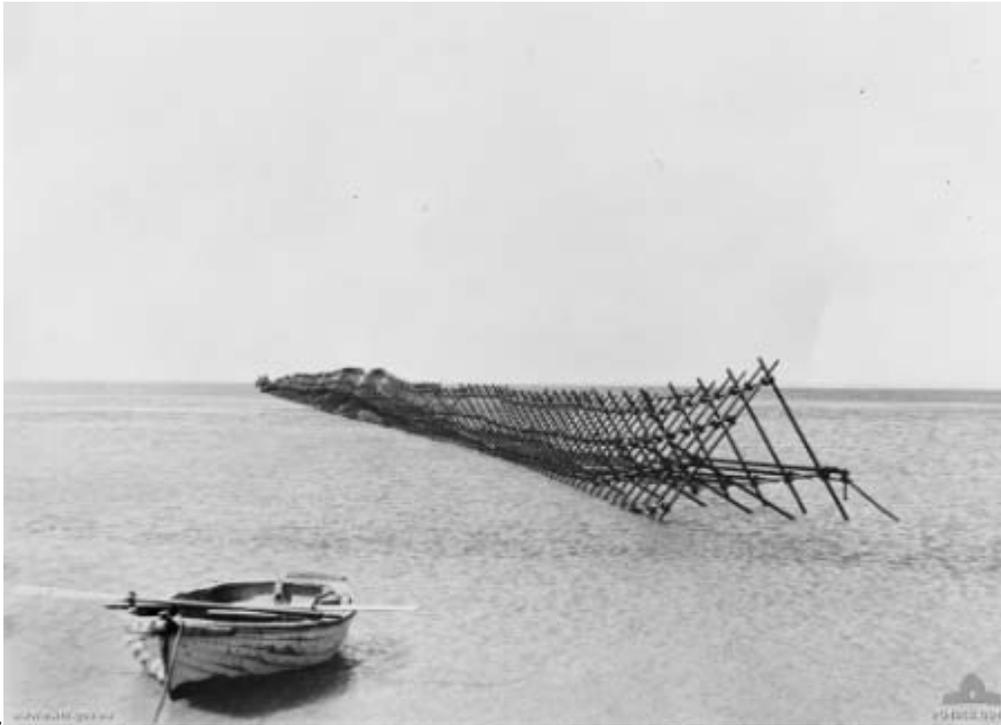
Figure 5: Type 'A' anti-boat scaffolding in Cockburn Sound  
(Australian War Memorial P04262.004)

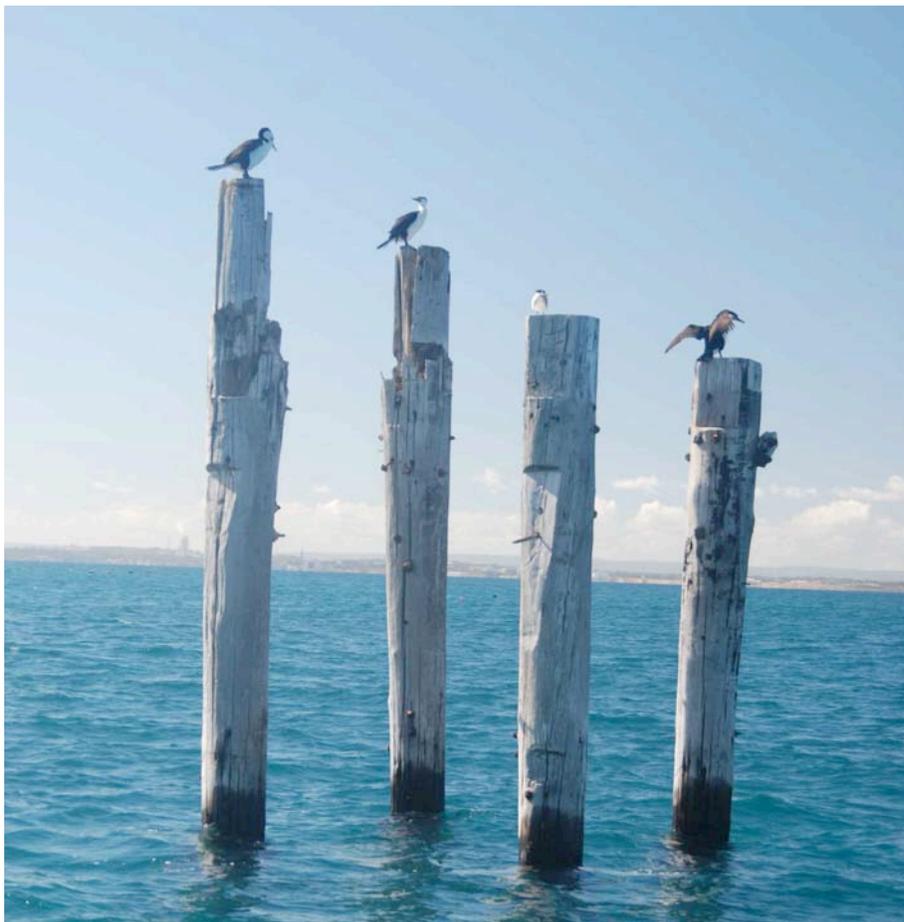
Figure 6: Timber pile structure off Garden Island since identified as Dolphin No. 60 in April 2007 after loss of timber platform bracing in a storm in 2006, view looking southeast. (Patrick Baker/ WA Museum)

In February 2007 the Fremantle Port Authority approached the WA Museum's Department of Maritime Archaeology (DMA) with concerns about deterioration to the timber piles off Garden Island, and the risk of the structure or piles breaking off in winter storms and becoming a navigation hazard. As the structure was constructed for defensive purposes in WWII the Fremantle Port Authority had initially approached the Department of Defence asking them to demolish what was believed to be their structure. The Department of Defence noted that the structure was outside the Commonwealth Naval Waters of Cockburn Sound and therefore no longer their responsibility but agreed to assist. Prior to demolition Defence requested advice from heritage consultants Environmental Resources Management Australia (ERM).

In March 2007 the DMA undertook a site inspection of the timber pile structure. The structure is located at GPS position 32° 09.2106S and 115°40.7066E (GDA94) in 6.5m of water on a sandy seabed surrounded by seagrass beds, approximately 500m off the northeast end of Garden Island. The structure presently lies within a mussel farm aquaculture zone. Underwater elements of the structure include collapsed timber piles, cut off or collapsed pile stumps, collapsed timber platform bracing and the Type 'A' anti-boat hurdles made of steel scaffolding. In the resulting site inspection report some of the issues associated with the structure and a range of recommendations were presented (Anderson 2007).

1. That the Dolphin No.60 structure be stabilised and retained for its significance as the last visible above water remnant of the World War II Cockburn Sound boom defences.

7. That further underwater surveys are carried out to record the features and extent of the site.
8. If the Dolphin No.60 is not going to be stabilised then it should be left as a ruinous structure, and allowed to naturally collapse and deteriorate to form an underwater cultural heritage site, in preference to demolition and removal of fabric.

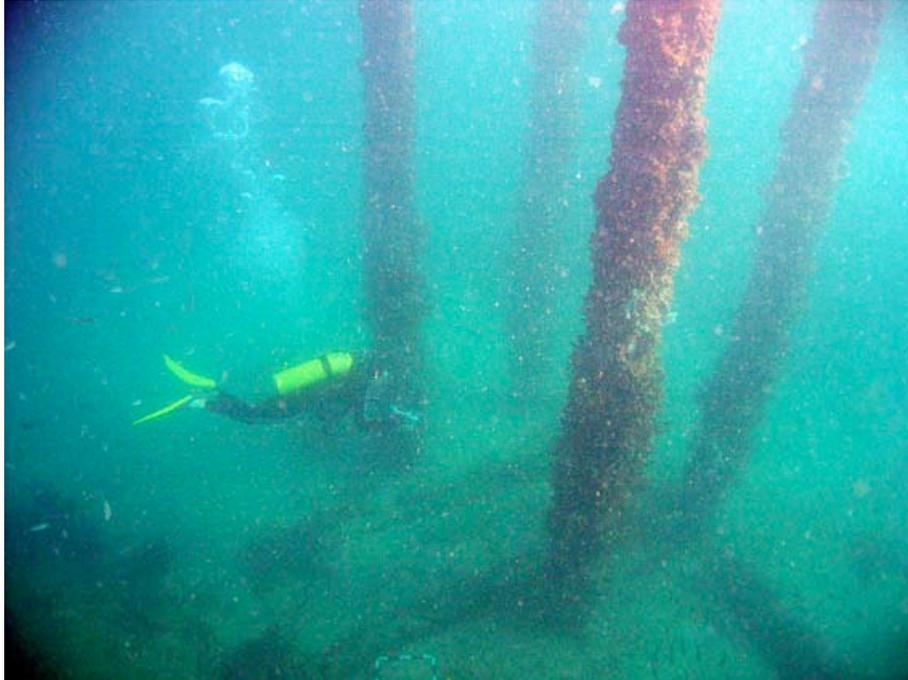
Figure 7: Diver and piles of Dolphin No.60 underwater in April 2007. Note collapsed timber beams and piles on seabed (Patrick Baker/ WA Museum)

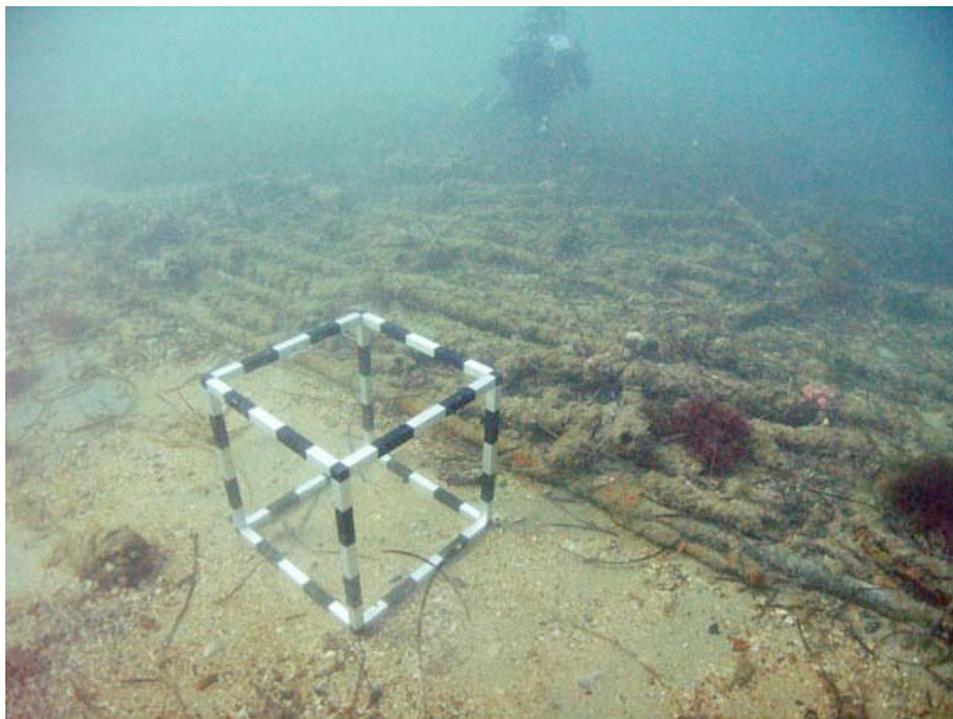
Figure 8: Collapsed Type 'A' anti-boat scaffolding on the seabed south of Dolphin No.60 (Patrick Baker/ WA Museum)

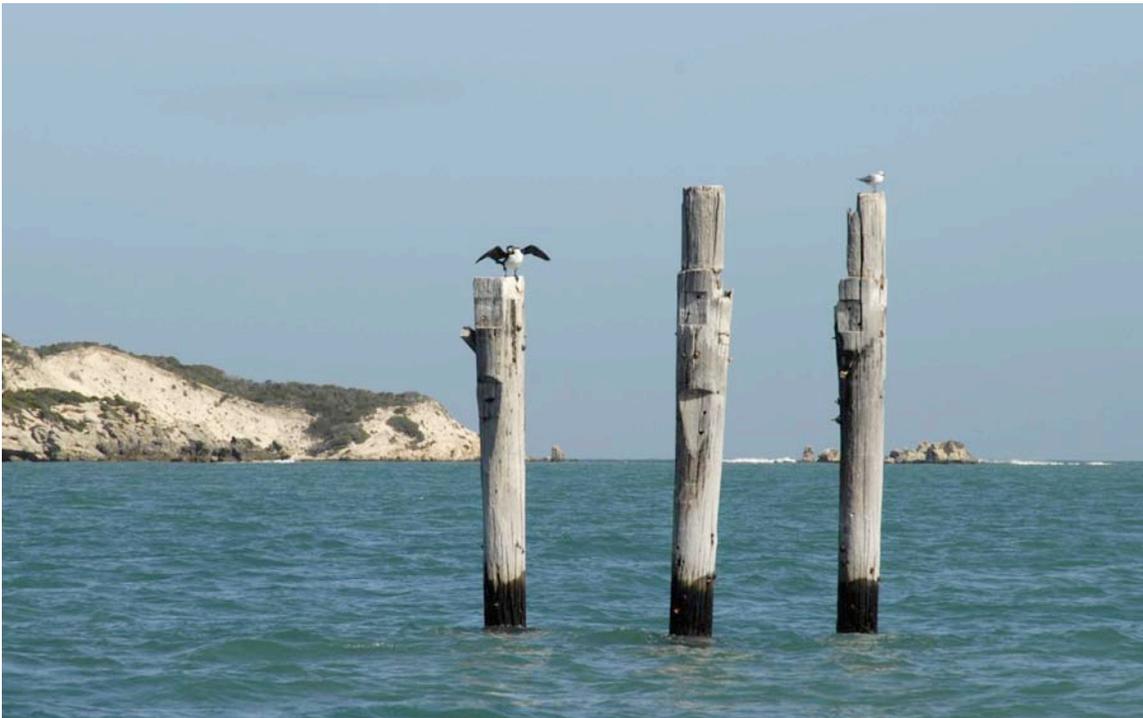
Following the DMA site inspection, in June 2007 Seaforce Marine Diving Services Pty Ltd were contracted by Fremantle Ports (on behalf of the Heritage Council of WA) to conduct a non-intrusive site survey on the remains of the 'Department of Defence Submarine Netting Pylons 0.5 miles WNW of Beacon Head, Garden Island'. Seaforce noted that the original supporting platform that joined the pylons was displaced by a storm in 2006 and since then the remaining four pylons had been left freestanding without mutual engineering support. Seaforce noted that the loss of the supporting platform had weakened the overall engineering of the pylons which they believed may accelerate failure. By May 2008 when the DMA next inspected the site, the south-east pile had collapsed to the seabed, leaving three standing piles still visible above water as at March 2010.

Figure 9: Dolphin No.60 structure in May 2008 after collapse of southeast pile, view looking west. (Patrick Baker/ WA Museum)

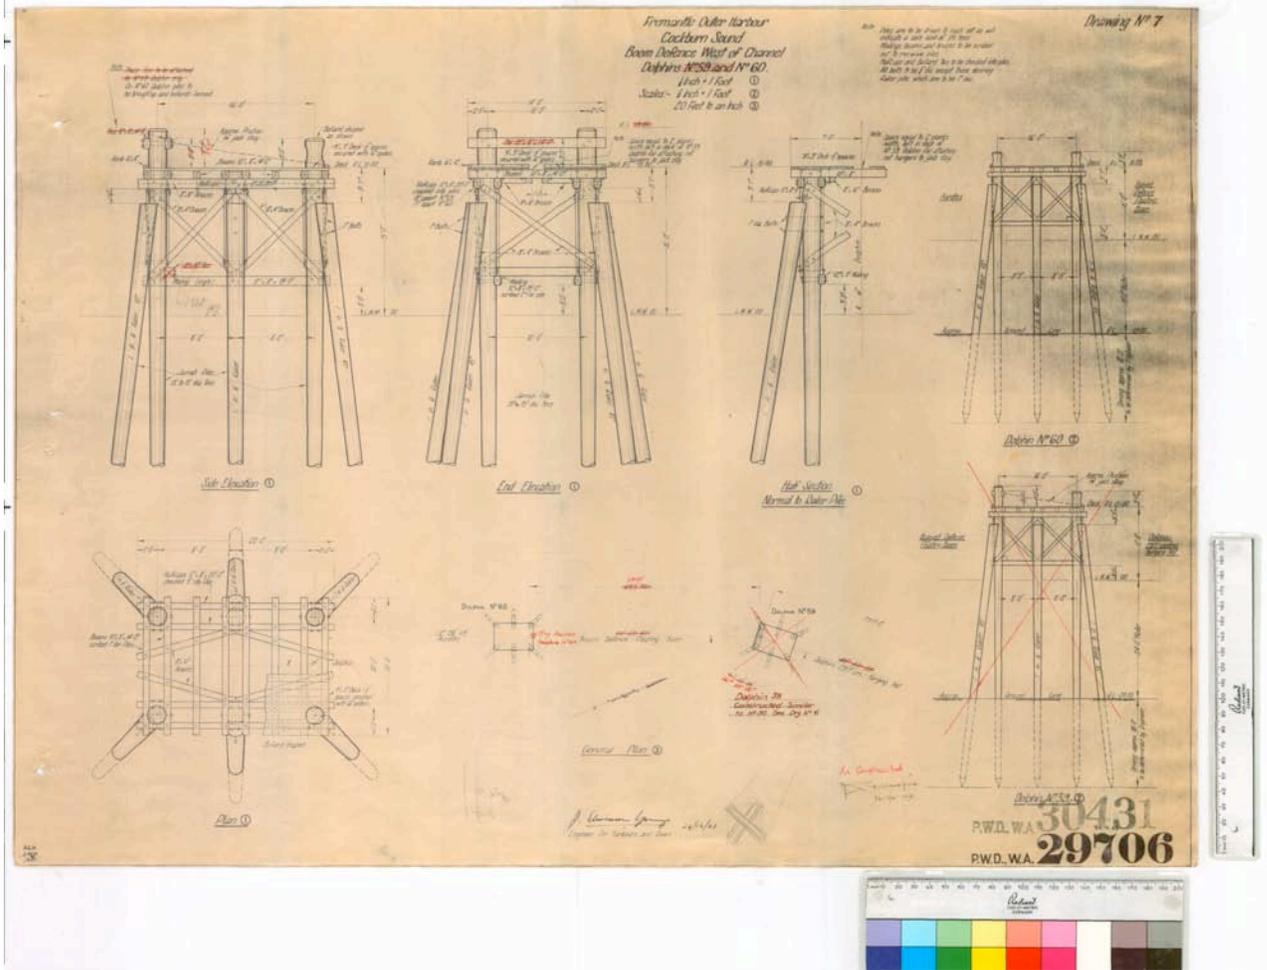
Meanwhile the Heritage Council of Western Australia commissioned a report by historian Lindsay Peet, the principal objective of which was to 'identify the existing piles and conserve them'. As a result Peet identified the structure as most likely being the remains of Dolphin Number 60 (Peet 2008: 6).

Figure 10: Public Works Department Plan 29706 of Dolphin No.59 and 60. Note 'No.59' has been crossed out and text added 'Dolphin 59 constructed similar to Dolphin 50 see Drawing No.6' (National Archives of Australia)

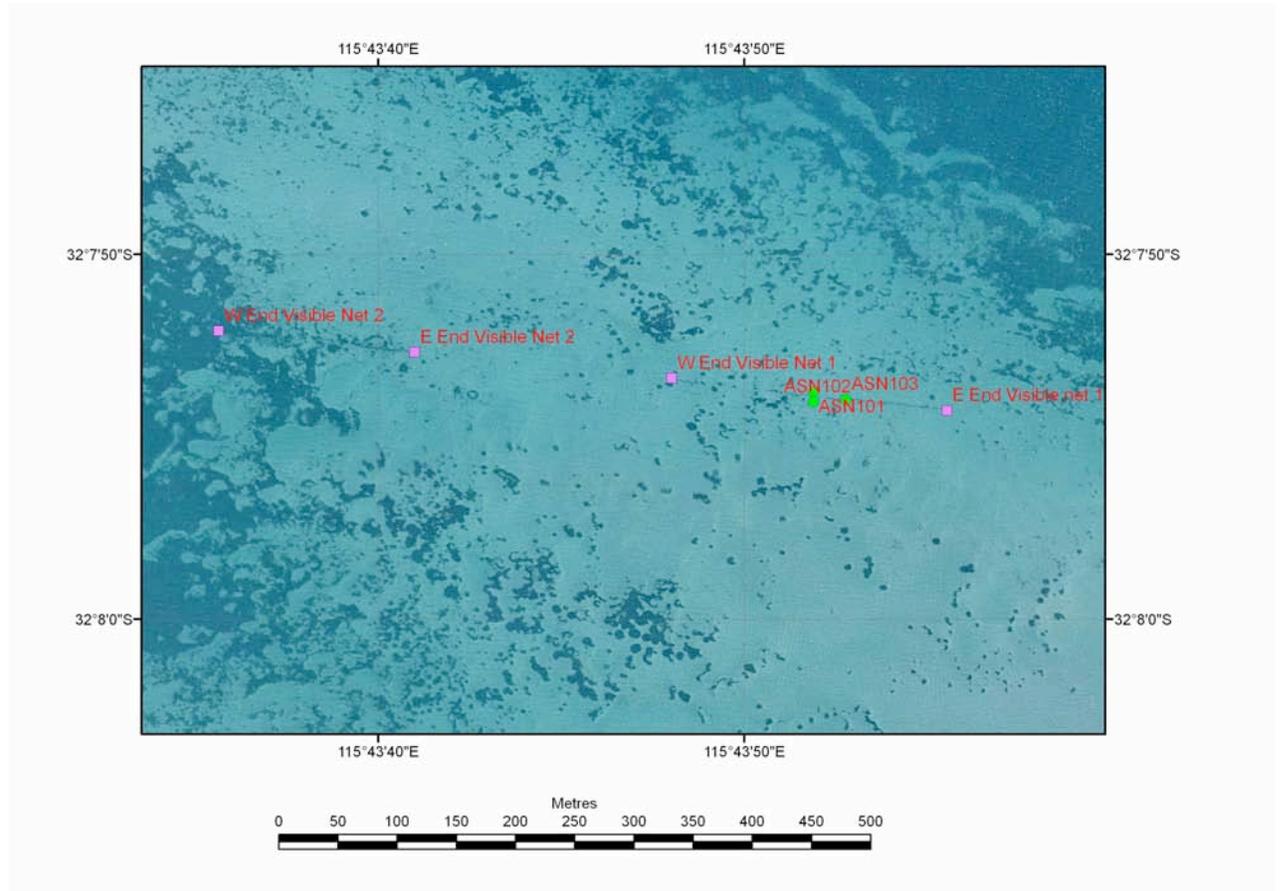
Figure 11: Detail of aerial photograph showing visible lines of collapsed anti-submarine net on seabed with GPS points. (Jeremy Green/ WA Museum)

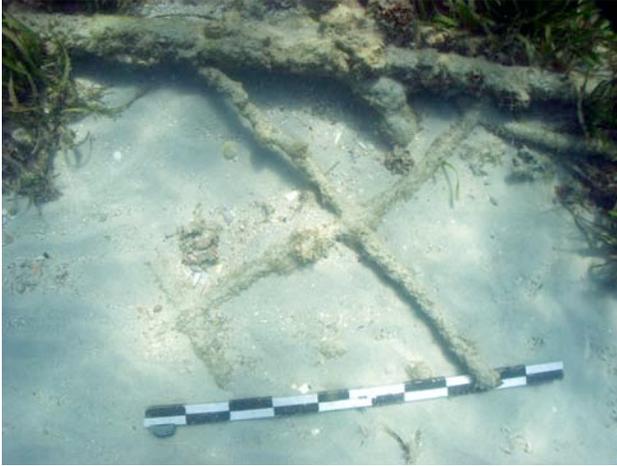
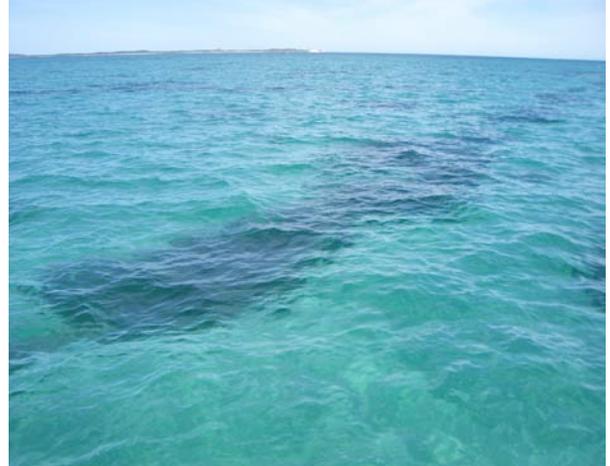
A linear feature of anti-submarine net visible on aerial photographs on the Parmelia Bank in 2.5-3m depth, east of the channel and near Woodman Point. Consists of a length of anti-submarine net with square mesh netting attached at either end to a thicker cable. This site extends for approximately 80 m on a sand

and seagrass bottom. Sand has built up along the southern side of the net creating a mound which is heavily covered in seagrass beds, although the northern side is exposed. At the western extent of this waypoint two piles were found which had been cut off approximately 60cm above the seafloor. These piles are likely to be the remains of an intermediate dolphin.

Figures 12 and 13: Close-up of anti-submarine mesh underwater and view of the collapsed net near Woodman Point from the surface at site ASN101.  
(Ross Anderson/ WA Museum)

5. That underwater interpretation is provided along the section of exposed boom mesh net at Woodman Point, and that it is promoted as an underwater cultural heritage dive site.

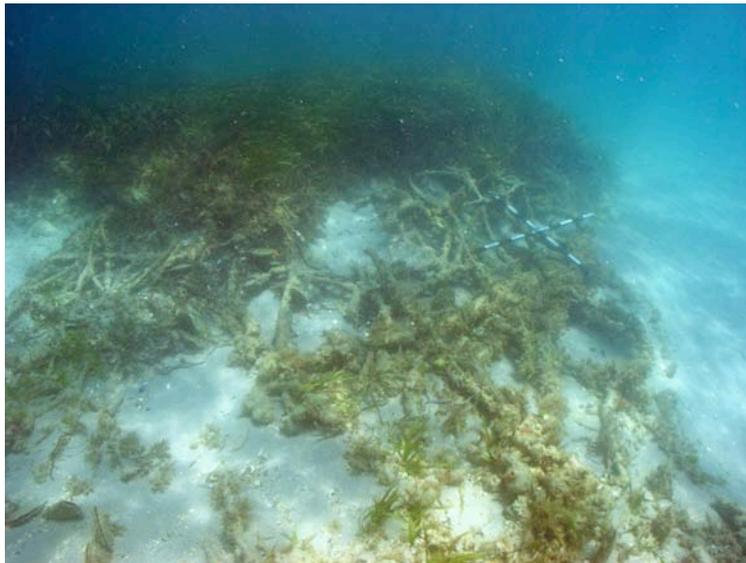
A linear feature of anti-submarine net visible in aerial photographs approximately 40m in length in 3.5m depth, on the Parmelia Bank east of the channel.

Figure 14: Collapsed section of anti-submarine net at site ASN103  
(Jeremy Green/ WA Museum)

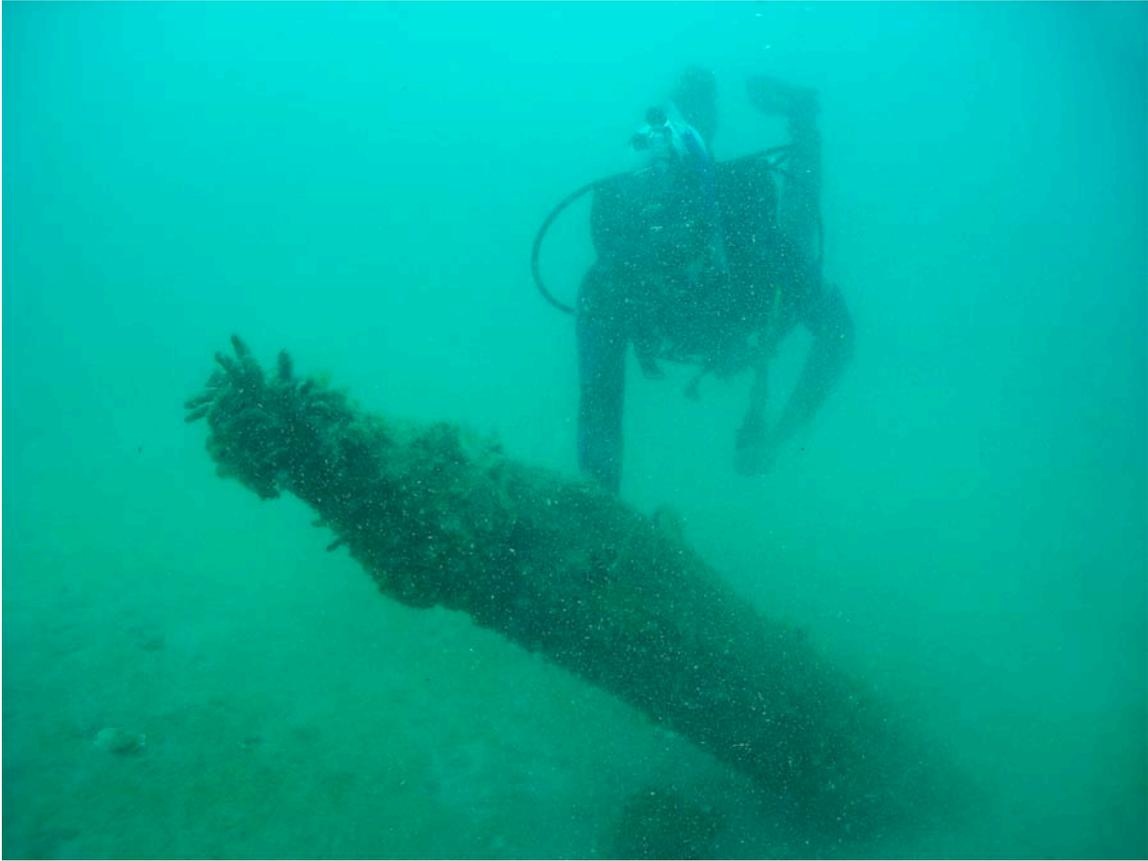
A single pile from an intermediate dolphin was located 27m NE of the GPS point, and was protruding from the seabed at an angle, upside down with its steel shoe attached in 8m depth. Ten metres to the south of the pile was a small fragment of concrete that is potentially the remains of a net weight. The damage to the two components of the site is consistent with demolition using explosives by the

navy, and possibly subsequent limestone sand dredging in the area, evidence of which is apparent from large hollows in the surrounding seabed

Figure 15. Upended dolphin pile, note steel pile shoe on end  
(Ross Anderson/ WA Museum)

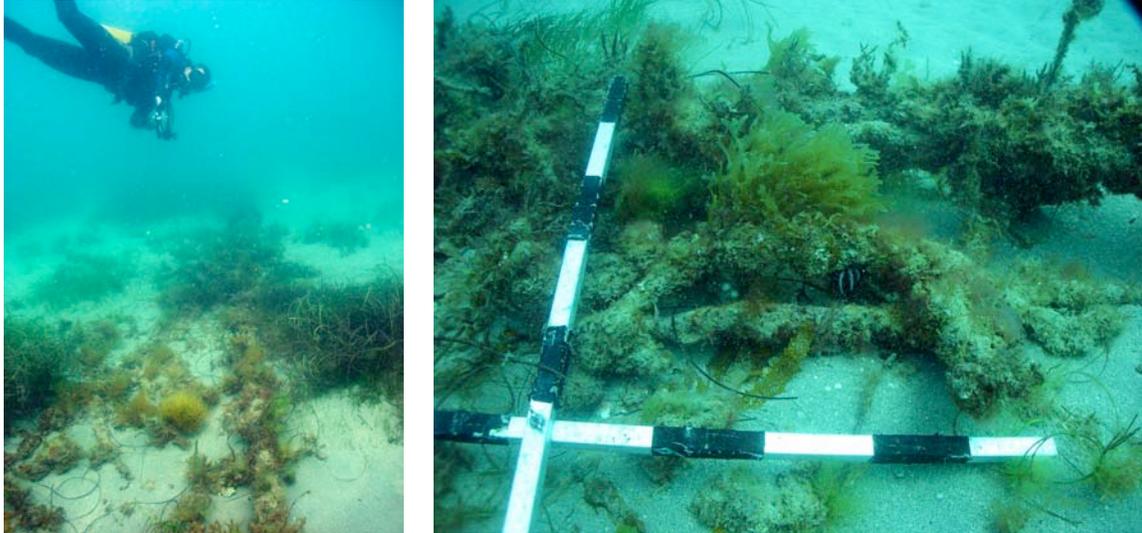
Consists of a 30m length of netting and cable oriented W-E with two thick parallel cables in one part, west of the channel in 6.5m depth. Two parallel cables, one thick and one thin, are running in parallel on the seabed in one section.

Figures 16 and 17: Thick steel cable with anti-submarine mesh attached at ASN007  
(Ross Anderson/ WA Museum)

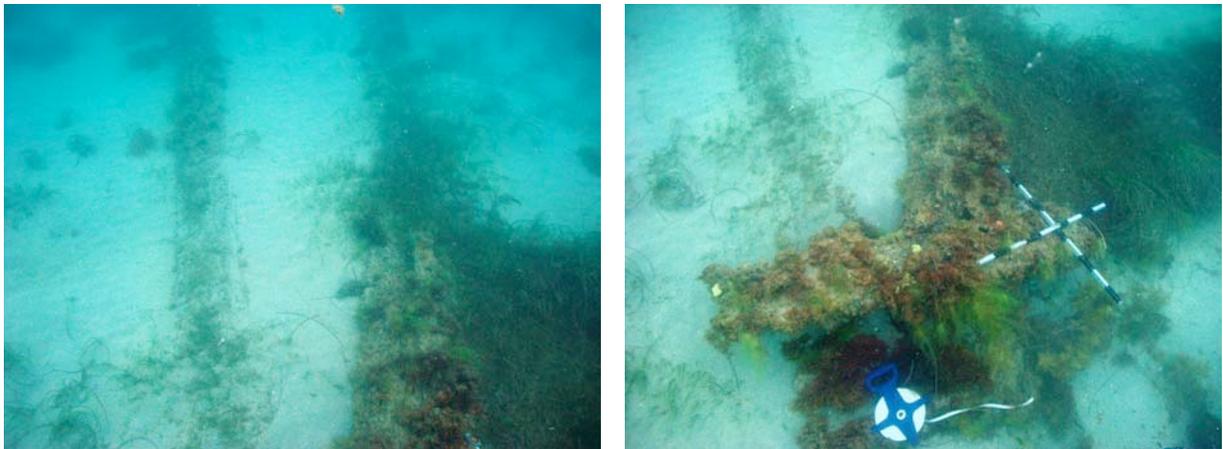
Collapsed partial remains of a four-pile intermediate support dolphin, consisting of the remains of two large timber piles held together with a timber cross-brace. The visible extent of the piles measured 12.6m long with the ends buried in sand, and 38cm diameter .

Figures 18 and 19: Two large timber piles from a collapsed intermediate support four pile dolphin, with detail of cross head timber bracing at ASN005.  
(Jeremy Green/ WA Museum)

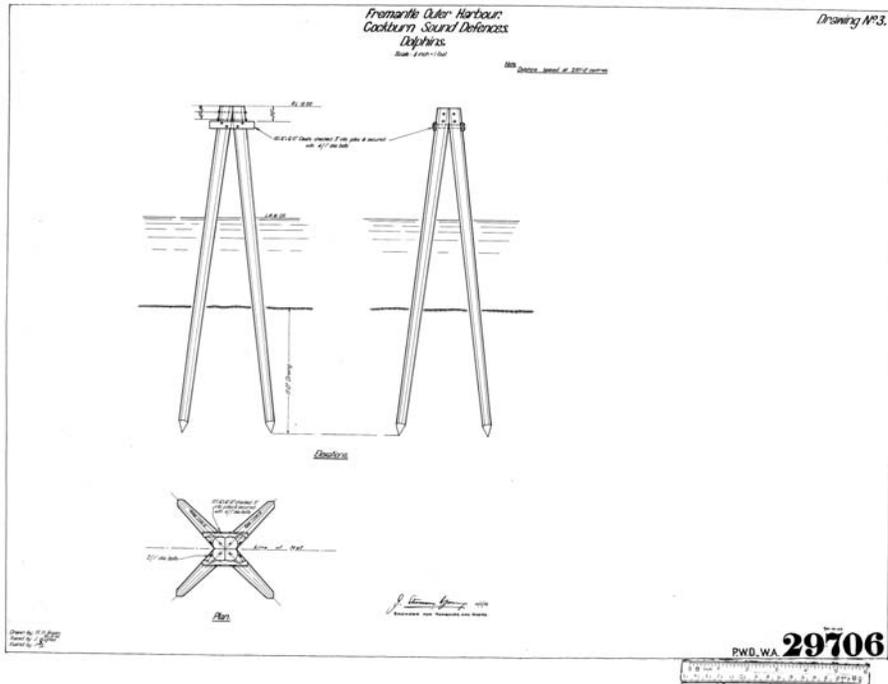
Figure 20: Public Works Department Plan 29706 Drawing No.3 of four piles intermediate supporting dolphin. (National Archives of Australia)

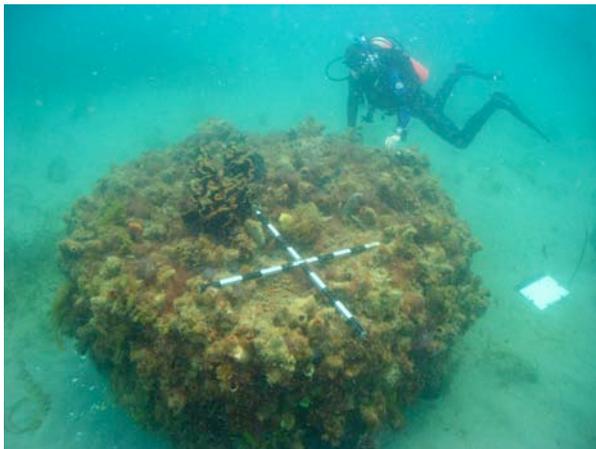
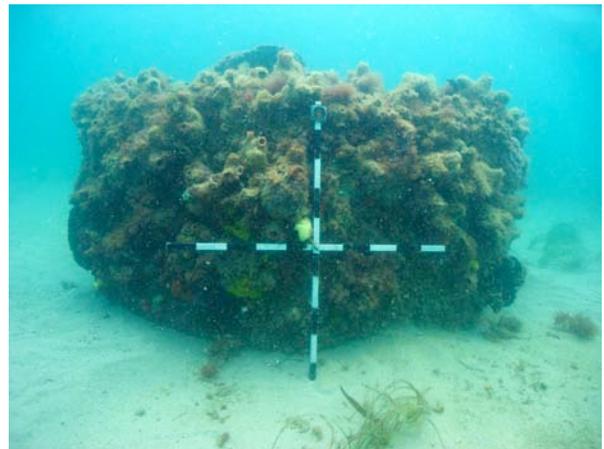
Consists of a cylindrical concrete net weight 2.3m in diameter and 1.0m in height. Approximately 2.5m NNE of the net weight was the remains of a timber pile cut off at the seabed while 2.5m further NNE of this pile was a pair of timber piles also cut off at the seabed. This feature is in the location of the Dolphin No.59 as marked on the PWD works plan, but on PWD Drawing of Dolphins No. 59 and 60 the 'No.59' has been crossed out with a double line and text added 'Dolphin 59 constructed similar to Dolphin 50 see Drawing No.6'.

Figures 21 and 22: Concrete net weight Dolphin No.59 position (Ross Anderson/ WA Museum)

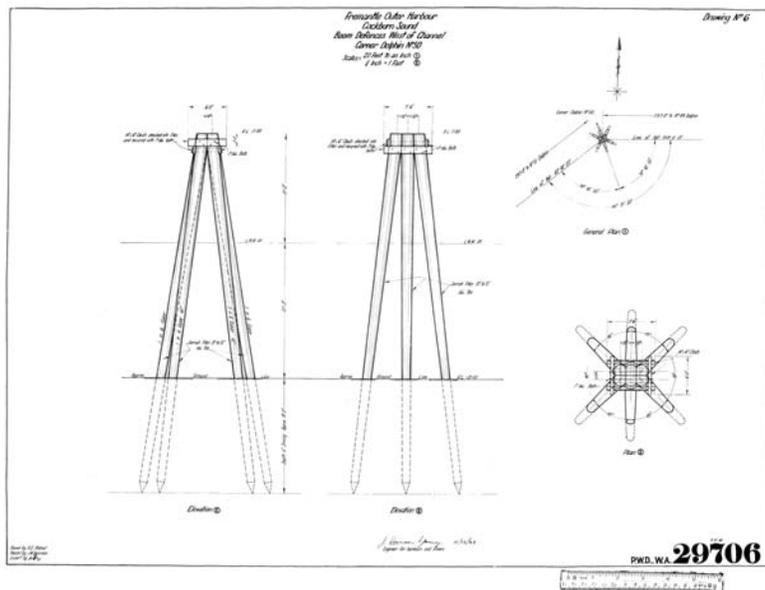
Figure 23: Public Works Department Plan 29706 Drawing No.6 of Dolphin No.50 constructed of six piles. Dolphin No.59 was constructed following this plan instead of Dolphin No. 60. (National Archives of Australia)

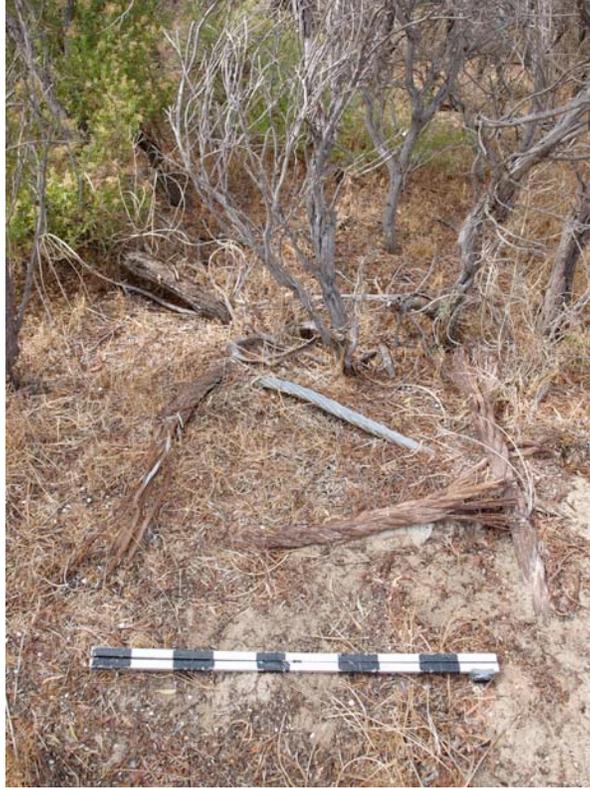
On 26 February 2010 a visit was made to Woodman Point Quarantine Station with Mr Earl Seubert (Secretary and Historian, Friends of Woodman Point), Mr Gary Marsh (ex-resident whose father was Officer in Charge of Quarantine Station) and Mr Matthew Hayes (Operations Manager, Woodman Point Recreation Camp). Gary guided the group to a site near the foreshore consisting of three deteriorated and insect damaged timber piles, and some corroded remnants of steel cable from the boom net. Gary described a number of piles having been previously removed and burnt. The site appears to be the location of dumped material, either the remains of clusters of piles and nets that were recorded to have 'washed ashore' on Woodman Point in storms in 1963, or resulting from demolition activities in March-April 1964.

Figure 24: Corroding steel anti-submarine net cable at Woodman Point in February 2010. (Matt Carter/ WA Museum)

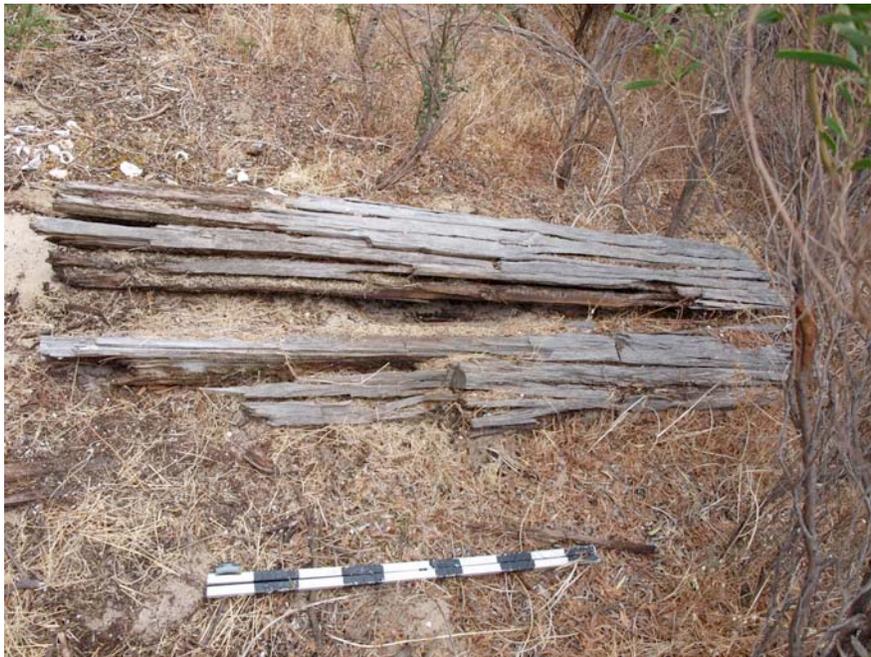
Figure 25: Deteriorated remains of anti-submarine defence timber pile at Woodman Point in February 2010. (Matt Carter/ WA Museum)
