## **SITE INSPECTION REPORT**

### **GOVERNMENT HOUSE JETTY THOMSON BAY, ROTTNEST ISLAND**

**Report—Department of Maritime Archaeology  
Western Australian Museum—No. 255**

**Ross Anderson  
3 November 2009**

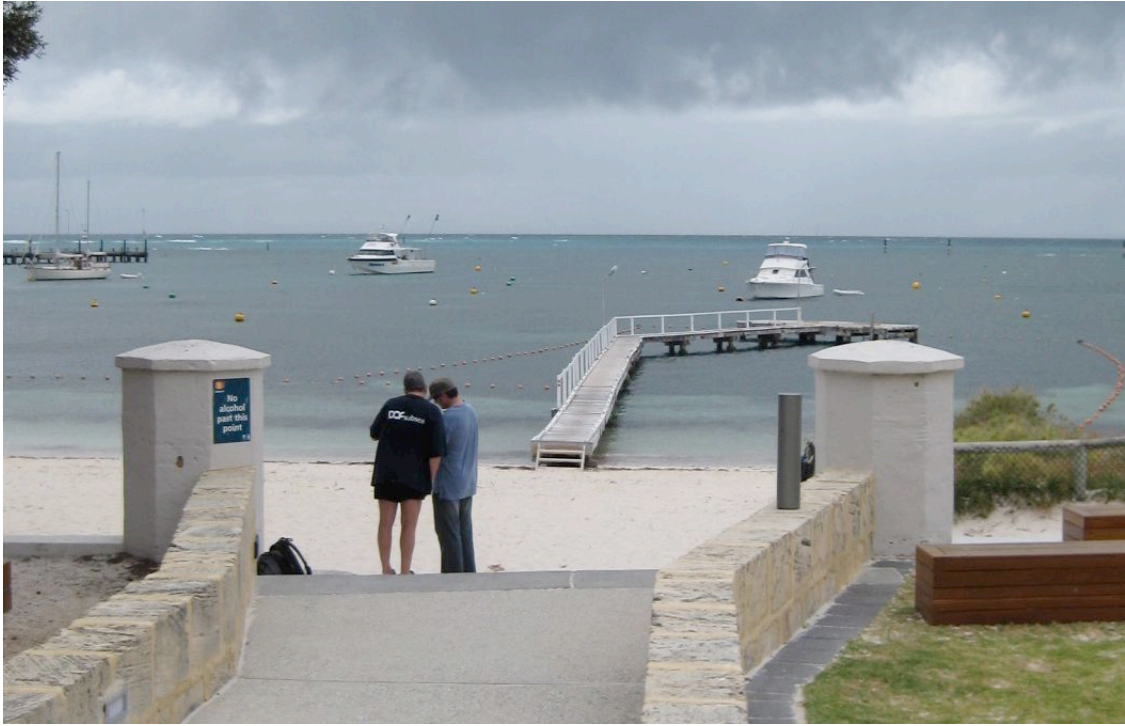
Figure 2: Current Rottnest Hotel jetty built 1953 and modified in 1960s, with historic Rottnest Hotel stone perimeter fence gateposts. View looking NE into Thomson Bay. (Photo: Patsy Vizents/ RIA)

The Rottneest Island Authority (RIA) contacted the WA Museum Department of Maritime Archaeology to request assistance with surveying the site of the 19<sup>th</sup> century Government House jetty preparatory for finalisation of works plans for a replacement Rottneest Island Hotel jetty to be constructed in 2009. The survey was to see if there were any remains of the 19<sup>th</sup> century Government House jetty visible on the seabed in the vicinity of the current 1950s Rottneest Hotel landing jetty (Figure 2).

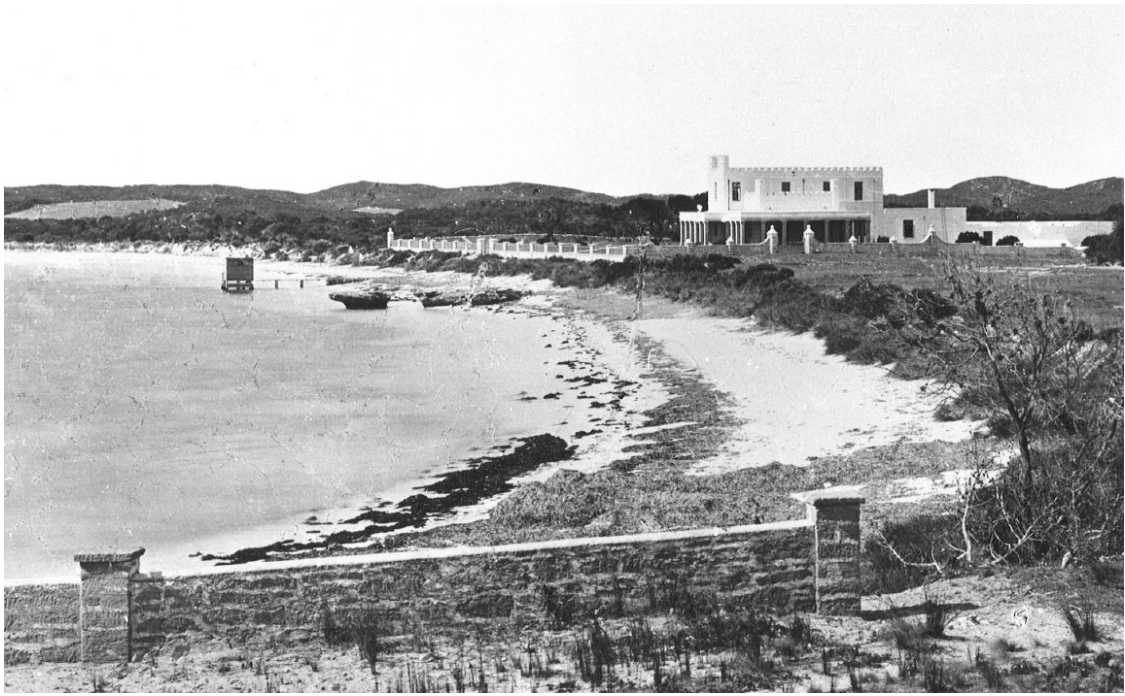
The historic photo dated 1870 shows a worked stone or remnant rock/ reef platform at the approximate high tide mark of the beach with a timber jetty extending from it. A bathing box structure and a landing are on the end of the jetty (Figures 3 & 4).

Figure 3: Government House jetty and bathing box 1870 (Rottnest Island Authority)

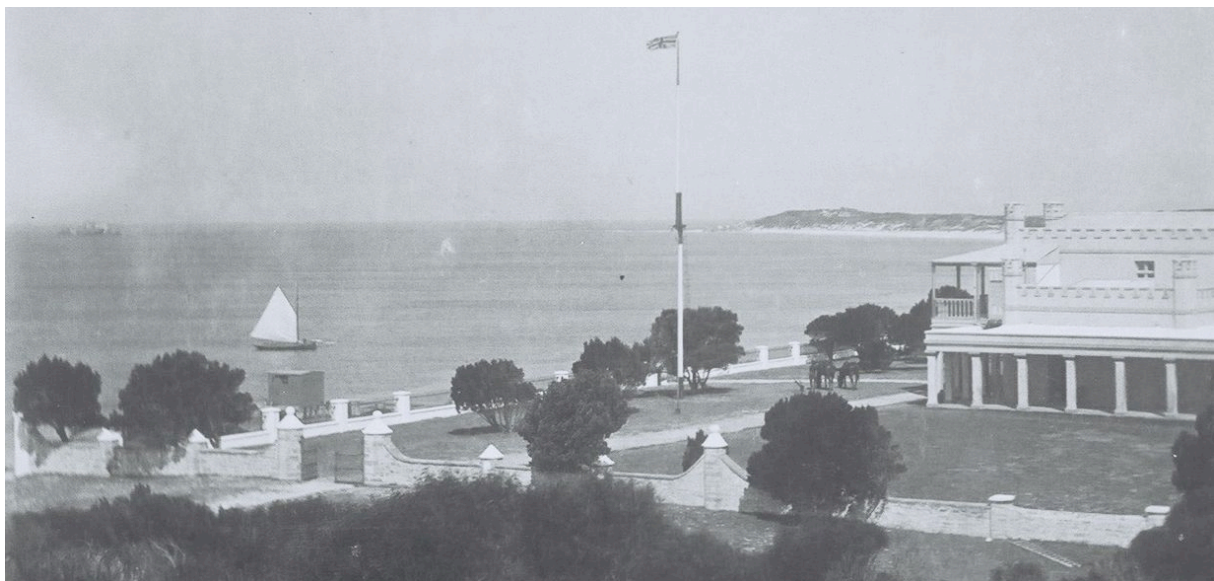
Figure 6: Government House showing bathing box c.1898 (Angelo Collection, RIA)

Figure 6 shows another view of the bathing box that gives an indication of its proximity to Government House. Comparison of the historic photographs with the modern beach profile shows that the 1960s construction of the stone groyne for the ferry wharf has resulted in the sandy beach south of the groyne prograding eastwards. Limestone pavement reef visible in the 1870 historic photograph is now covered with sand. Limestone rock outcrops visible in the historic photograph have since been blasted (in the 1960s?). A modern concrete pathway, sand and pine fencing surrounding vegetation now separates the original stone fence from the present day beach intertidal zone and jetty.
