# **Motorised Submersible Canoe (MSC) 'Sleeping Beauty' Project**

**Report on background and maritime archaeological survey for a Motorised  
Submersible Canoe (MSC) or 'Sleeping Beauty' lost 1945, HMAS *Stirling*,  
Careening Bay, Cockburn Sound**

**Report—Department of Maritime Archaeology—No. 261  
Western Australian Museum**

**Ross Anderson  
April 2010**

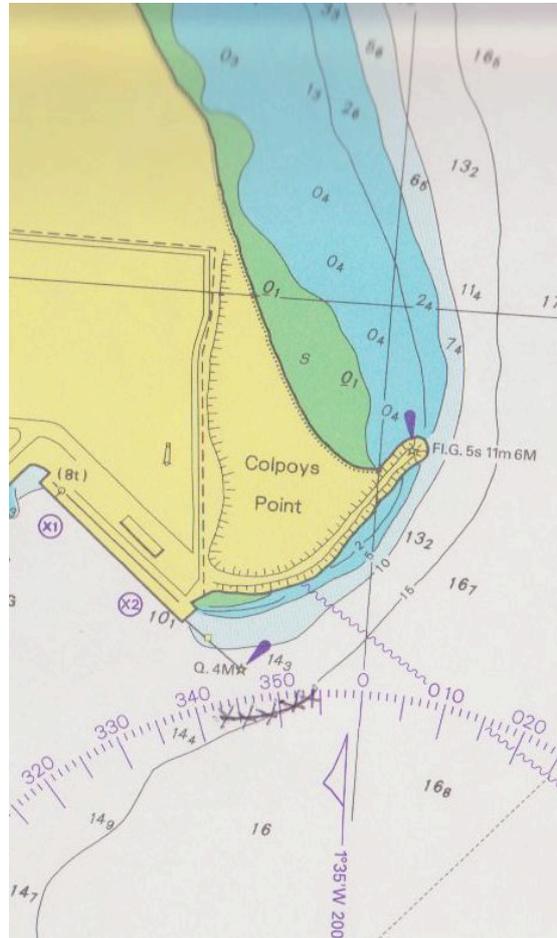
**Figure 2: Approximate location of MSC wreck site in Commonwealth waters, Careening Bay as marked on AUS111 chart by Jack Sue.**

Jack Sue provided an approximate location based on his personal contact with the crab fisherman who recovered the MSC aluminium console. A copy of AUS111 Careening Bay chart was provided to Barry Sue, and Jack was able to mark the approximate position on the chart, off the southeast end of Colpoys Point on the 15 metre contour.

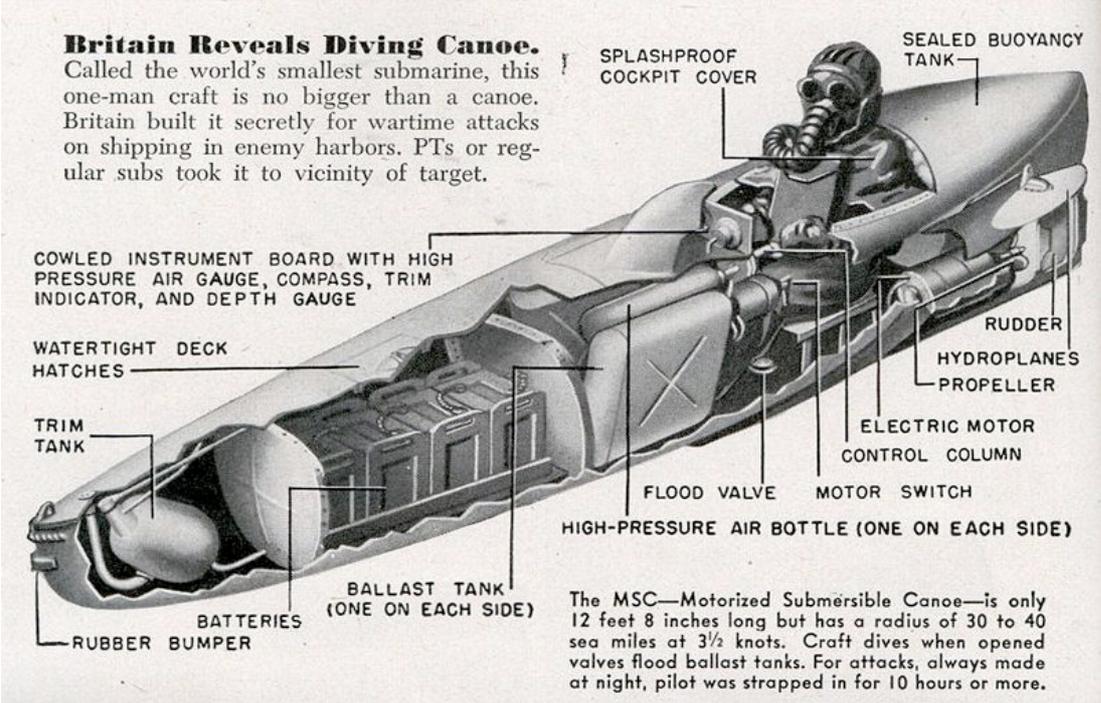
Figure 3: Schematic diagram of MSC (*Popular Science*, March 1947)

The MSC hulls were lightly constructed of mild steel sheet welded together with mild steel stiffeners. The high pressure air bottles used for the ballast system are aluminium alloy, and the cowlings, deck hatch covers and rudder are aluminium. Questions remain as to the exact nature of other fittings and materials that include the propeller (copper alloy?), compressed air piping (copper alloy?) and seat (timber? aluminium?).

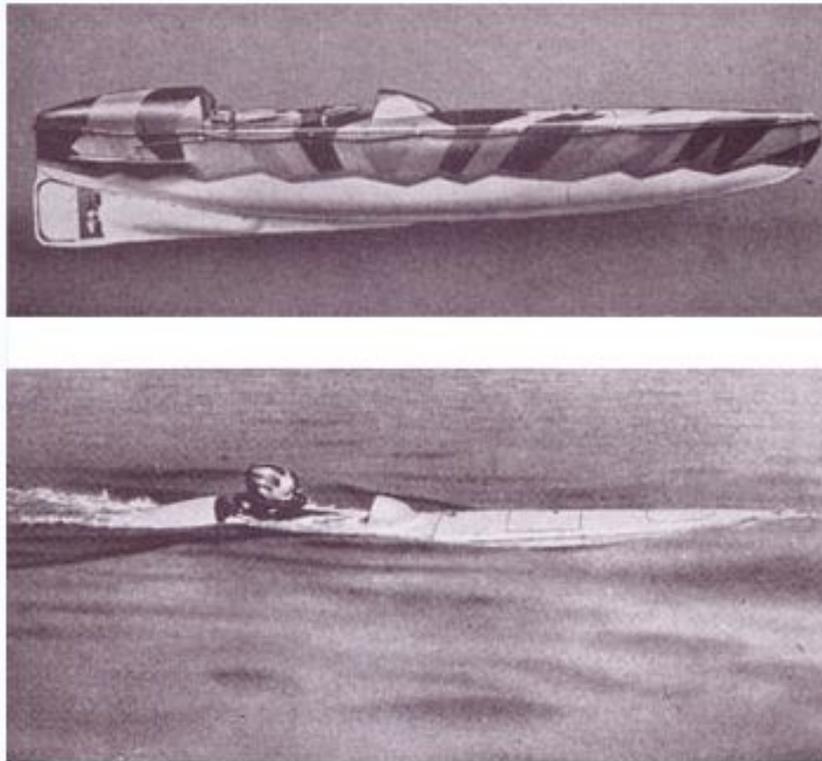
**Figure 4: MSC in profile, and showing 'trimmed down' position on the surface (National Archives UK)**

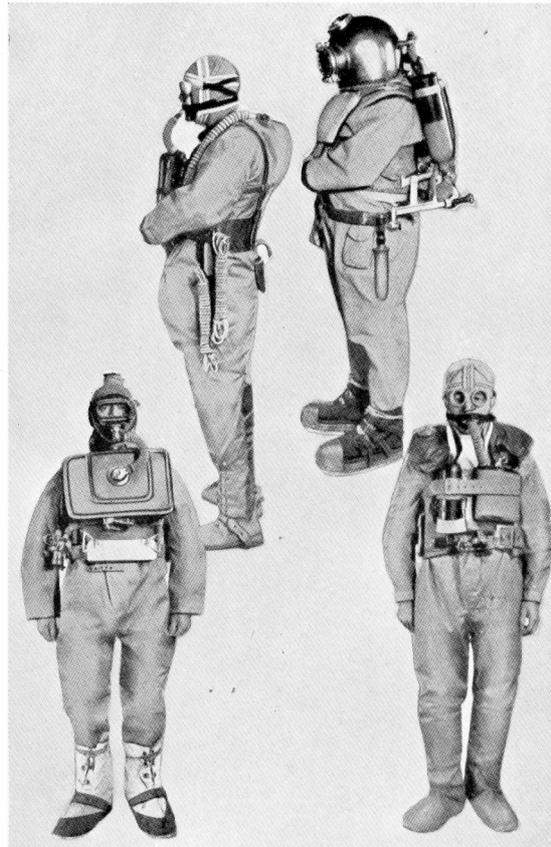
Fig. 305

*Bottom Left:* Suit worn by crew of "Human Torpedo".\*

*Bottom Right:* Amphibian Mark II suit for shallow-water work and special operations (submersible canoes).

\* This is an enlarged version of the D.S.E.A., i.e. larger cylinders and CO<sub>2</sub> absorbent chamber, and with a reducing valve on a neck extension of a cylinder, as in the Davis "Proto" apparatus.

**Figure 5: Bottom right diver is shown wearing the Amphibian Mk II suit designed for 'shallow-water work and special operations (submersible canoes)'. Bottom left is the 'Charioteer' human torpedo type dress (Davis 1955: 321)**

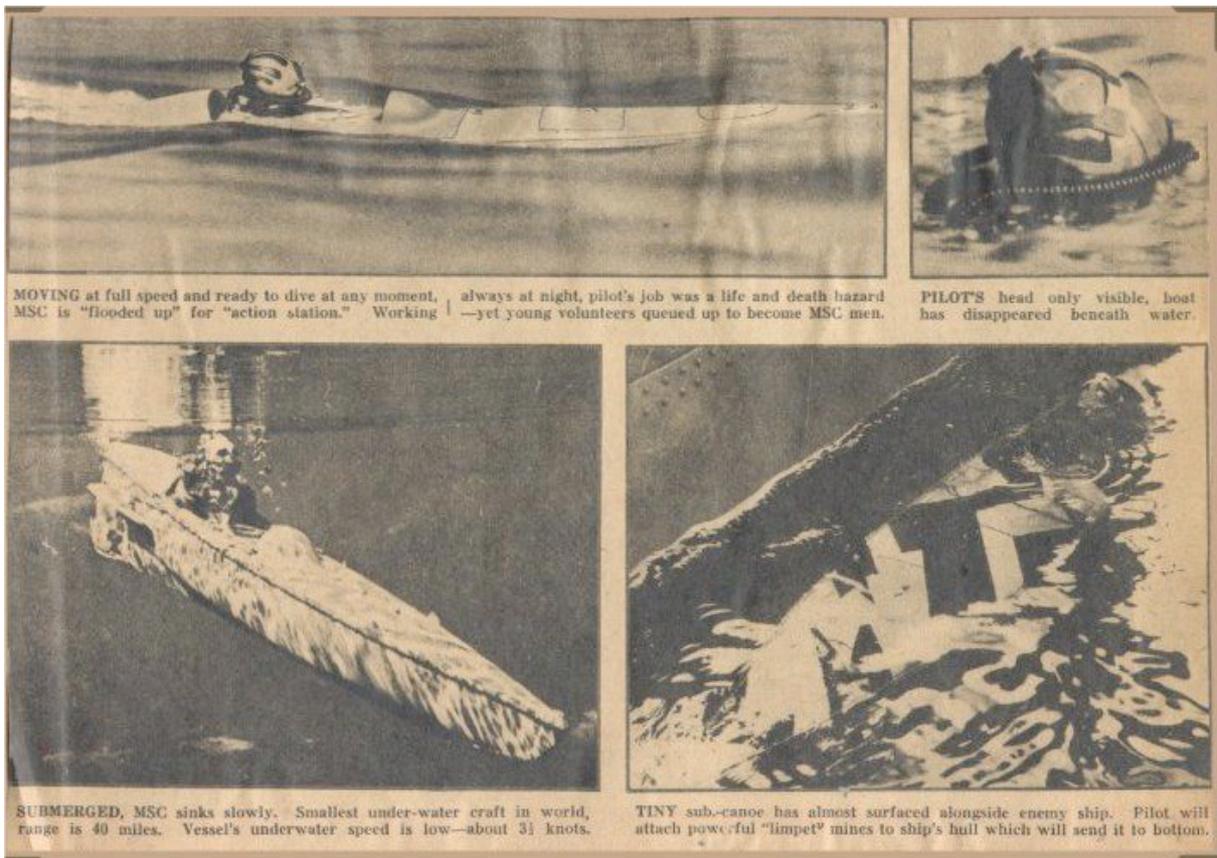
Figure 6: Various photographs of MSC and operator in diving dress.

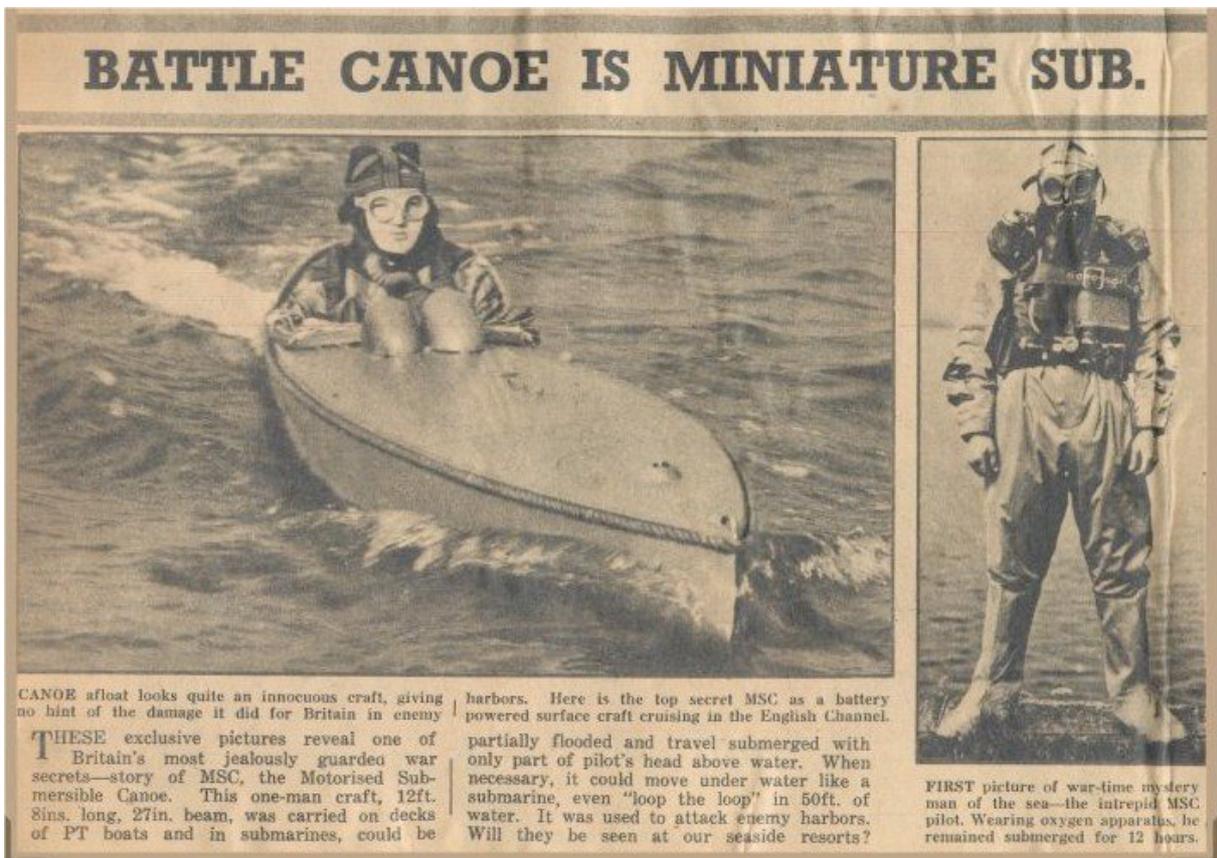
Figure 7: MSC and operator in Mark II Amphibian diving dress

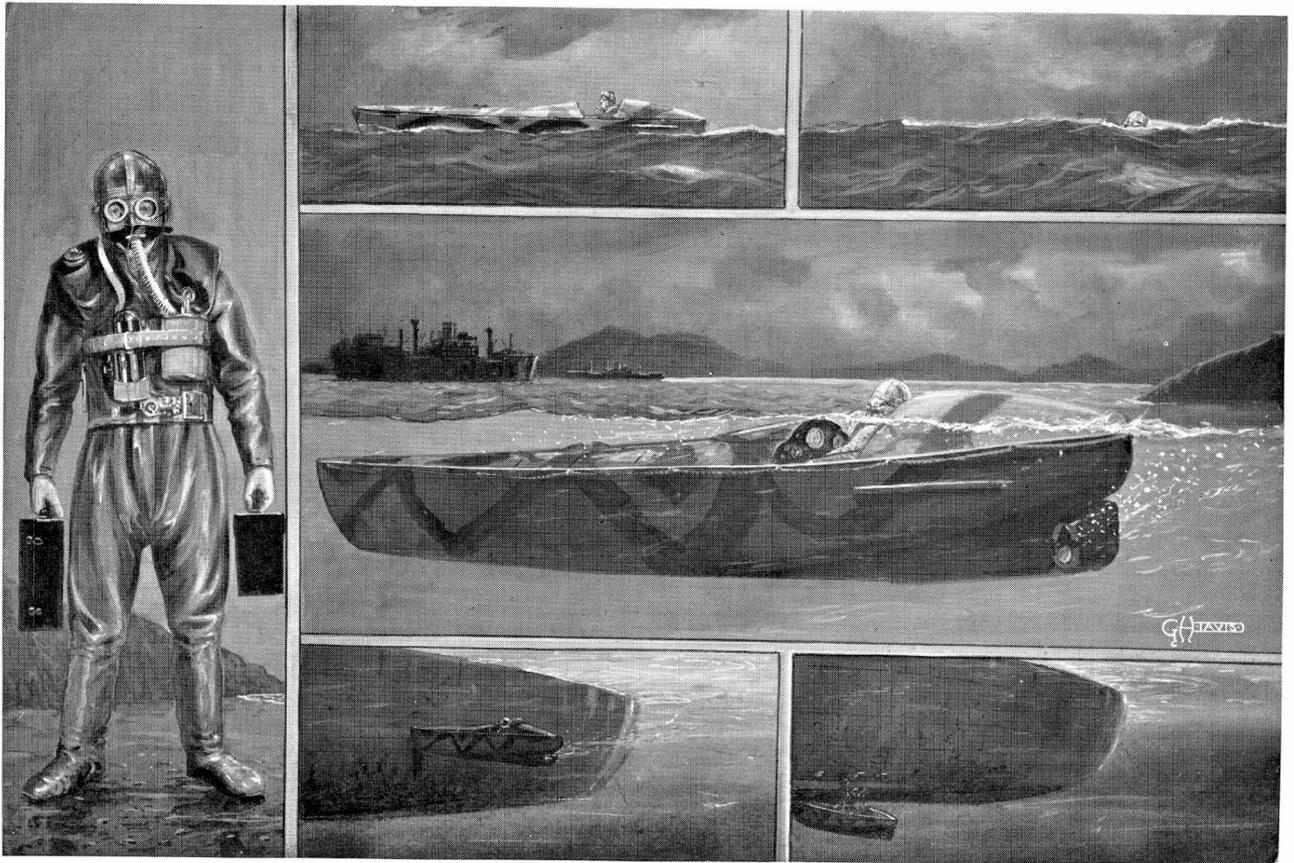
Fig. 302. Siebe, Gorman & Co.'s Amphibian Mark II apparatus as used in submersible canoes

**Figure 8: Siebe Gorman and Co. diagram of MSC and operator in diving dress (Davis 1955: 317)**

Figure 8 shows a diagram of the operator in a Dunlop rubber suit wearing the Amphibian Mark II apparatus and carrying explosive charges. He is fitted with a twin eyepiece mask and hood with spiderbands. The mouthpiece for the single hose rebreather is held on by a strap.

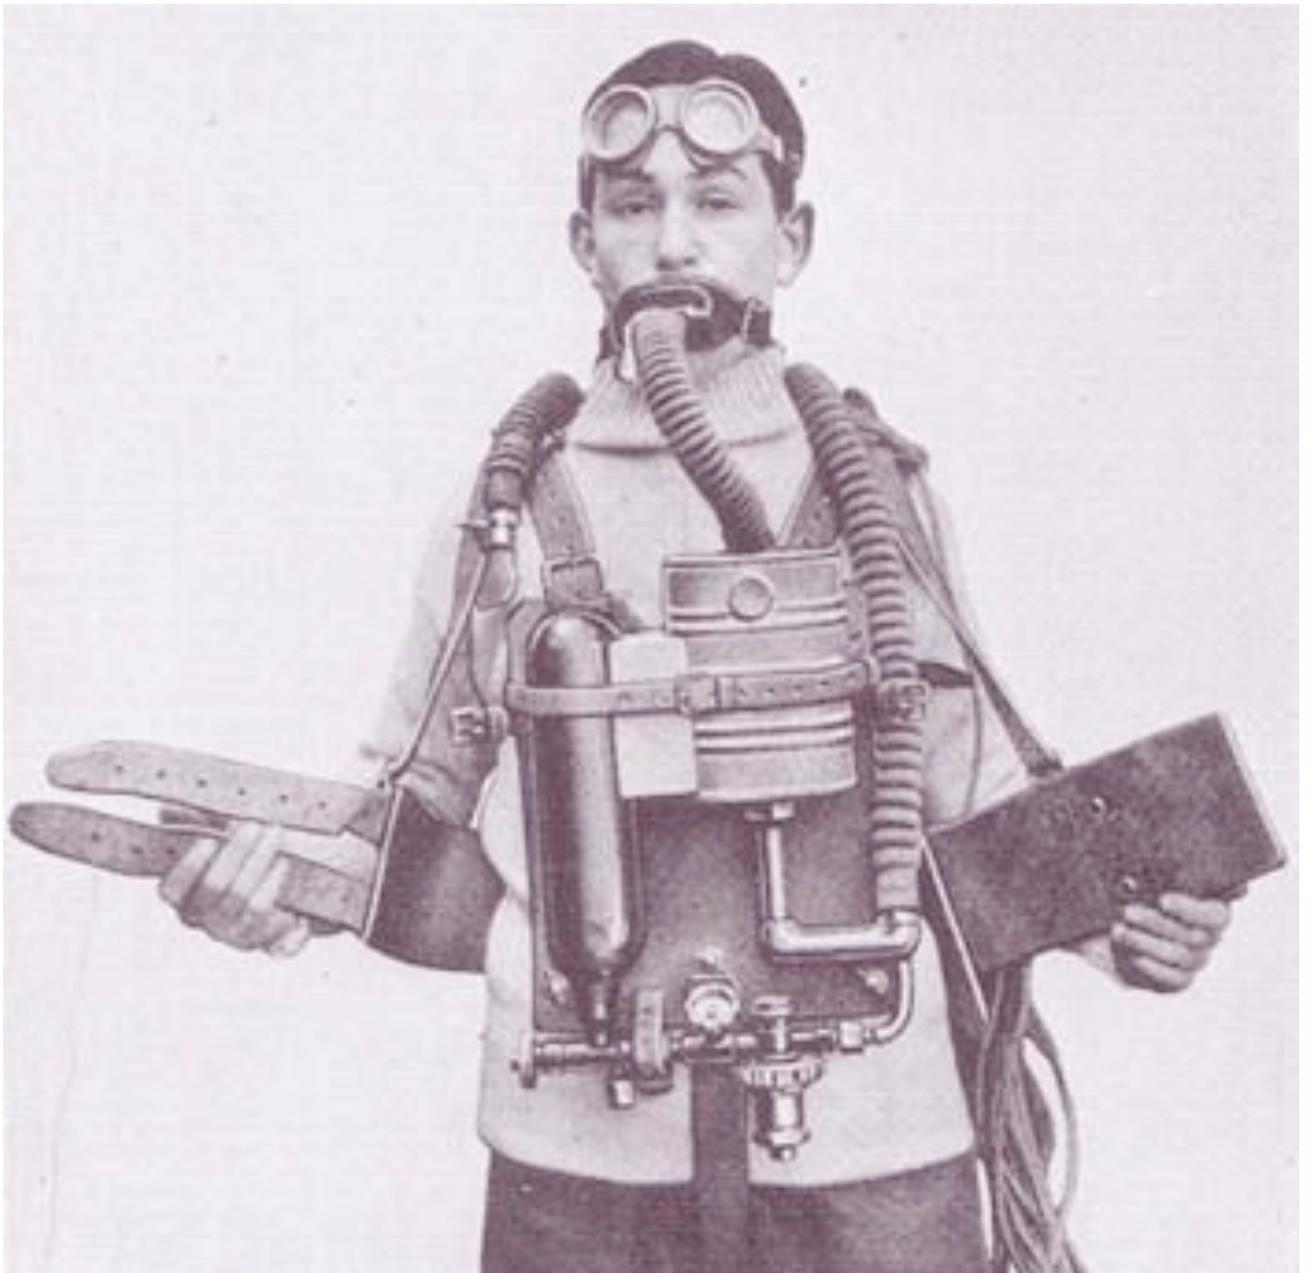
**Figure 9: Detail of layout and components of Siebe Gorman & Co. Mark II Amphibian rebreather (Source unknown)**

Figure 9 shows the oxygen diluent bottle and carbon canister. The bottle was steel, mounted on the front with the scrubber and a modified exhaust valve. The backpack contained the counter-lung. The rebreather automatically added oxygen to the circuit and had a maximum operating depth of 30 feet (9.14m).

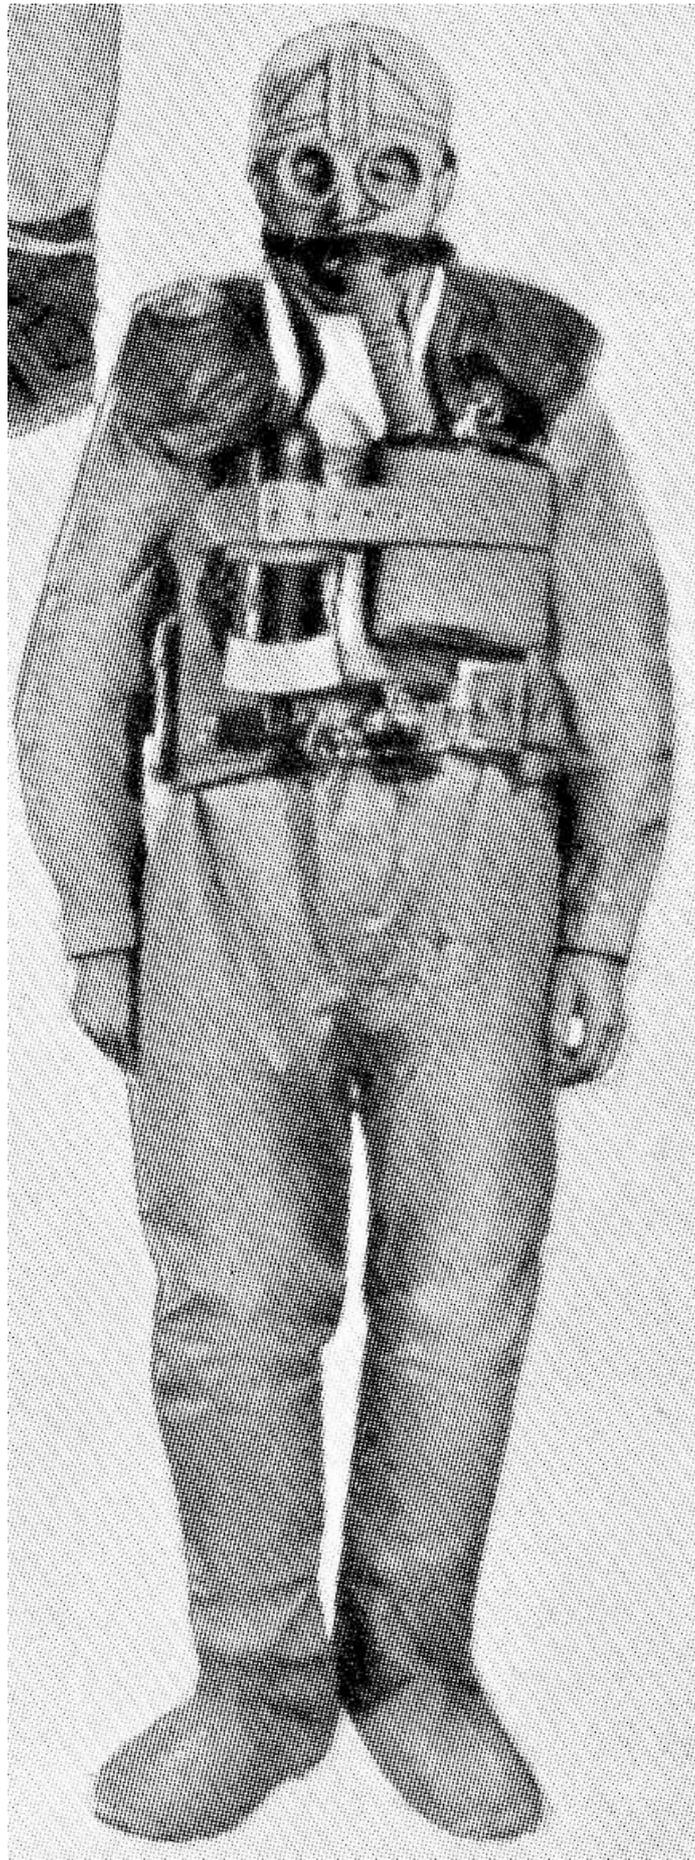
**Figure 10: Detail of operator wearing Amphibian Mk II rebreather and Dunlop suit for shallow-water work and special operations (submersible canoes) (Davis 1955: 321)**

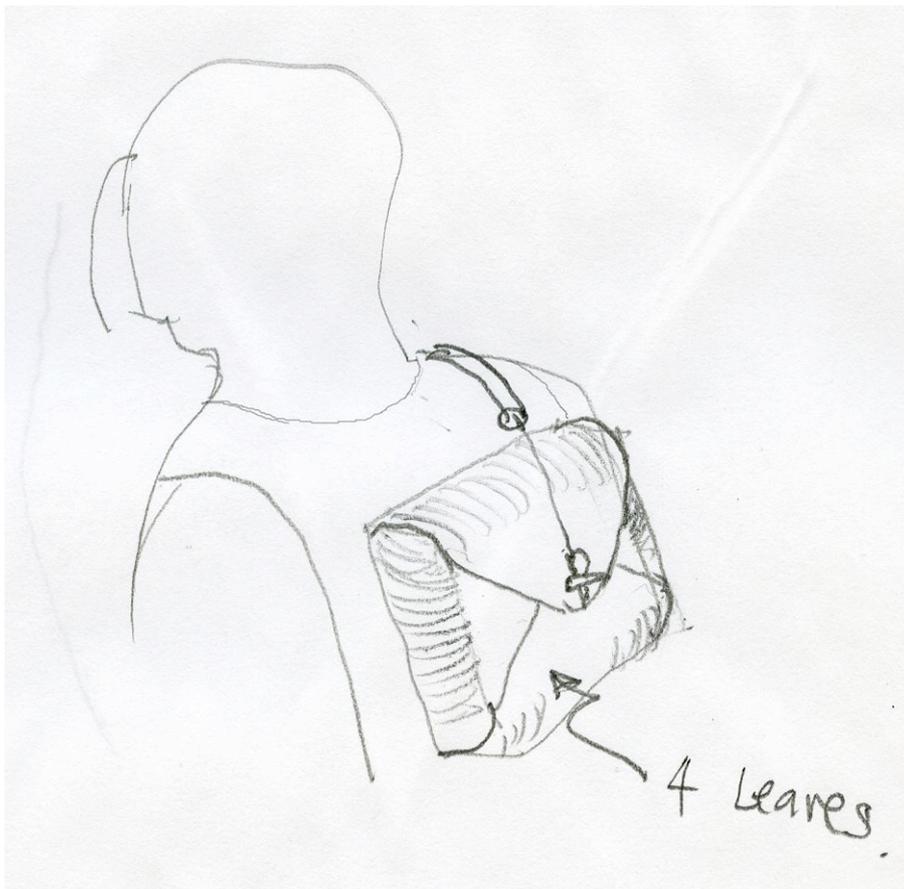
My quick crude diagram shows how I remember they were held together - each leaf with a hole at the extremity which went over a vertical post. The leaves were sprung loaded, so they were held in place by a wire split ring through a hole in the pillar.

**Figure 11: Diagram of weighting arrangement for MSC operators (Drawing Peter Dick)**

The ring was connected to a string which went into a tube that, in earlier models went down to the waist and in later ones terminated at shoulder level, in a pull ring. Pull it and the pouch sprung open to drop the weight.

The Dunlop gear came late in the war and Dunlop also built the later post-war CDBA (Clearance Diver Breathing Apparatus). Therefore, it is reasonable to assume that the weighting arrangement remained the same. Both Rob and self have used the CDBA, myself a long time ago. Nonetheless I remember the weights being 16oz lead balls contained in a pouch, say 10x8 inches, placed high on the diver's back. That is, counterlung and cylinders were on the front, the diver's head went through a hole in the rubberised fabric which reached down to the waist at the back. With the nitrox sets, there were two cylinders in the small of the back supported by this harnessing.
