# Koombana Bay Foreshore Excavation - Structural analysis

Madeleine McAllister  
Report – Department of Maritime Archaeology,  
Western Australian Museum, No. 293

This structural analysis is part of an overall report on the Koombana Bay foreshore maritime archaeological survey and test excavations carried out by the WA Museum and the City of Bunbury on 21 - 28 November 2011 (Anderson and McAllister, 2012). Three separate sites were identified during test excavation of radar anomalies detected during the ground penetrating radar survey conducted by Cardno Spectrum for the City of Bunbury. This report focuses purely on the analysis, refer to the Department of Maritime Archaeology Report No. 286, 'Koombana Bay foreshore maritime archaeological survey and test excavations, 21-28, November 2011', for historical background, excavation aims, results, discussion and recommendations.

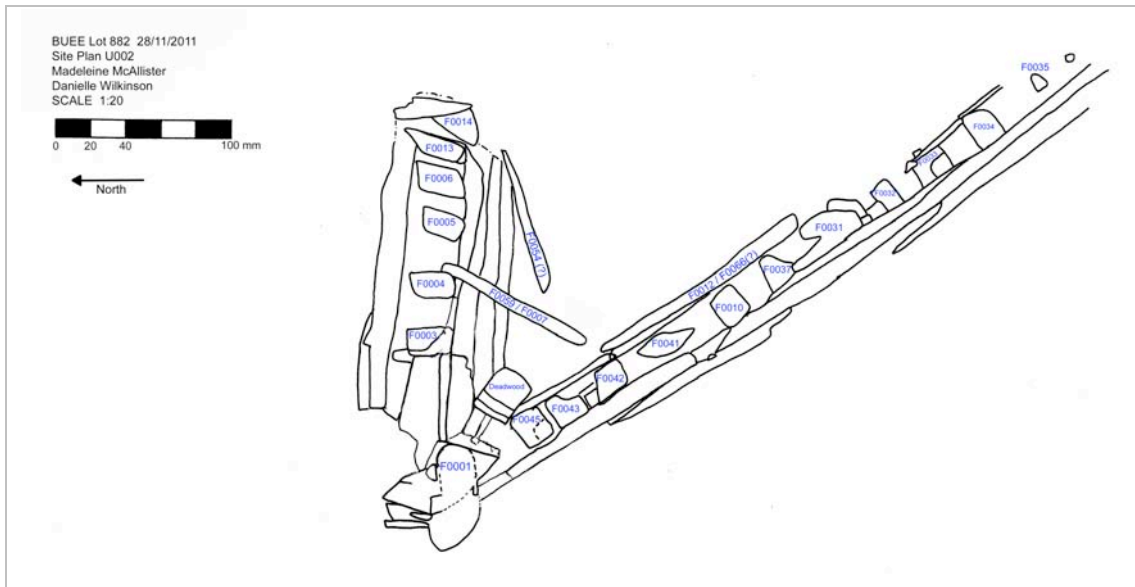
Image: Site plan of BUÉE Lot 882, frames, stem and iron reinforcements labelled with feature numbers

Knowing that the site has previously been unearthed and damaged by machinery and salvage of material, the spacing between the frames, such as on the southern side of the wreck, were affected by the site formation process and tilt of the wreck. Despite this, Lloyd's Scantling Table (1919: 21) indicates that the frames dimensions (sidings of 5.5 inches (in) to 7.9 in) would match the dimensions of a vessel of approximately 300 to 600 tonnes (t).

It is most likely that F0006 and F0043 represent 'filling frames'. A filling frame is a short timber that sits between two frames and reaches from the keel to the turn of the bilge (Desmond 1919: 53). This indicates that the frames that were measured are most likely 2<sup>nd</sup> or 3<sup>rd</sup> futtocks.

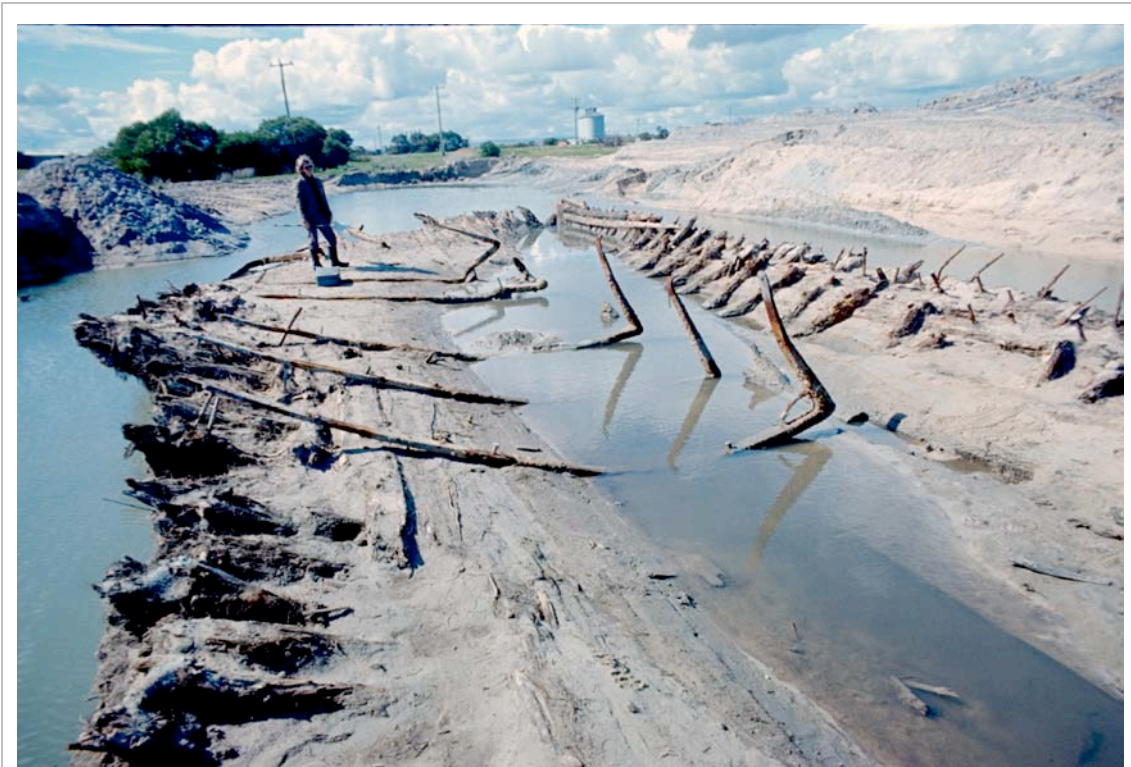
Image: Upper port hull section of *Solglyt*, found in 1973 before being removed. (NOTE: the iron knees)

The iron knees are very similar to that of the *Solglyt*, an 875 t barque built in Norway in 1888. Wrecked in Koombana Bay 1901, *Solglyt* was uncovered during excavation of the southern “cut”, now Koombana Channel in 1973 (McCarthy 1982: 9), as it was not protected by legislation at this time the wreck was broken up and moved out of the way. However, it is recorded that the owners of the wreck were ordered to move it from its wrecking place (MA File 405/71) and only the port side was found in 1973. This presents the highly likely possibility that there are substantial remains of *Solglyt* still buried beneath the beach.

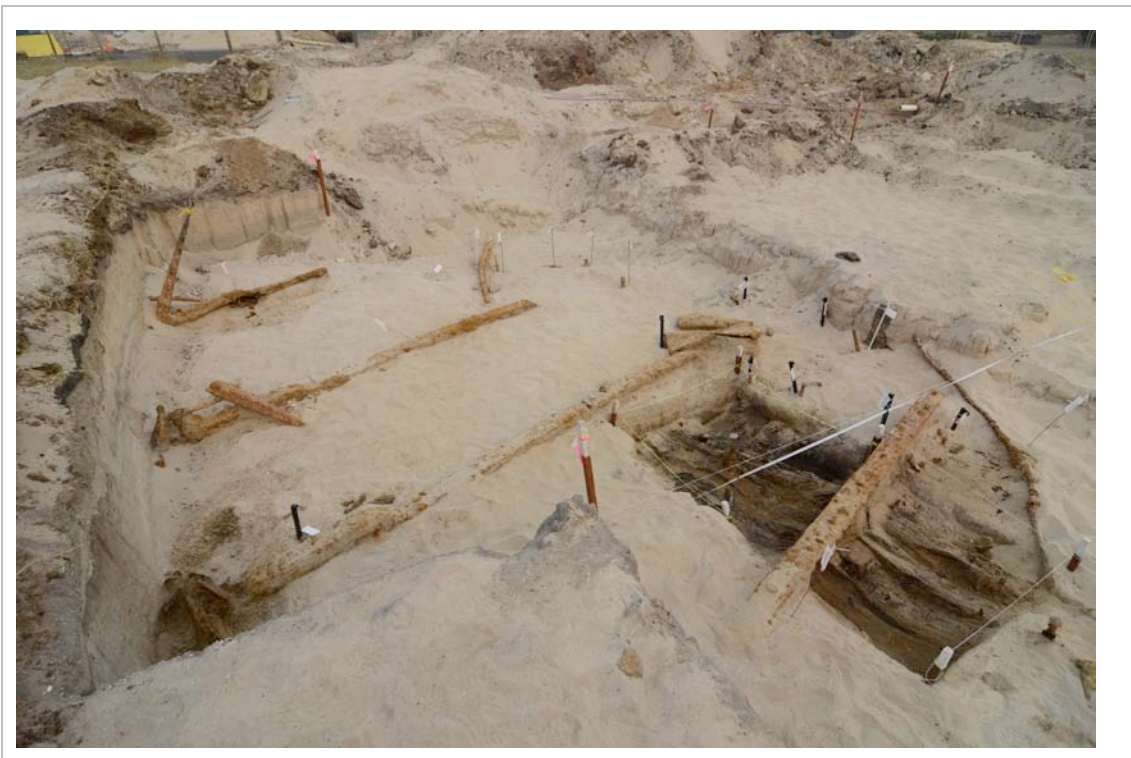
Image: Wreck features located in Trench 1. Lot 881 (P. Baker)

The structural features recorded in Trench 1 of BUEW Lot 882 most likely represent the upper side of a vessel that has fallen onto its outside hull as the site degraded.

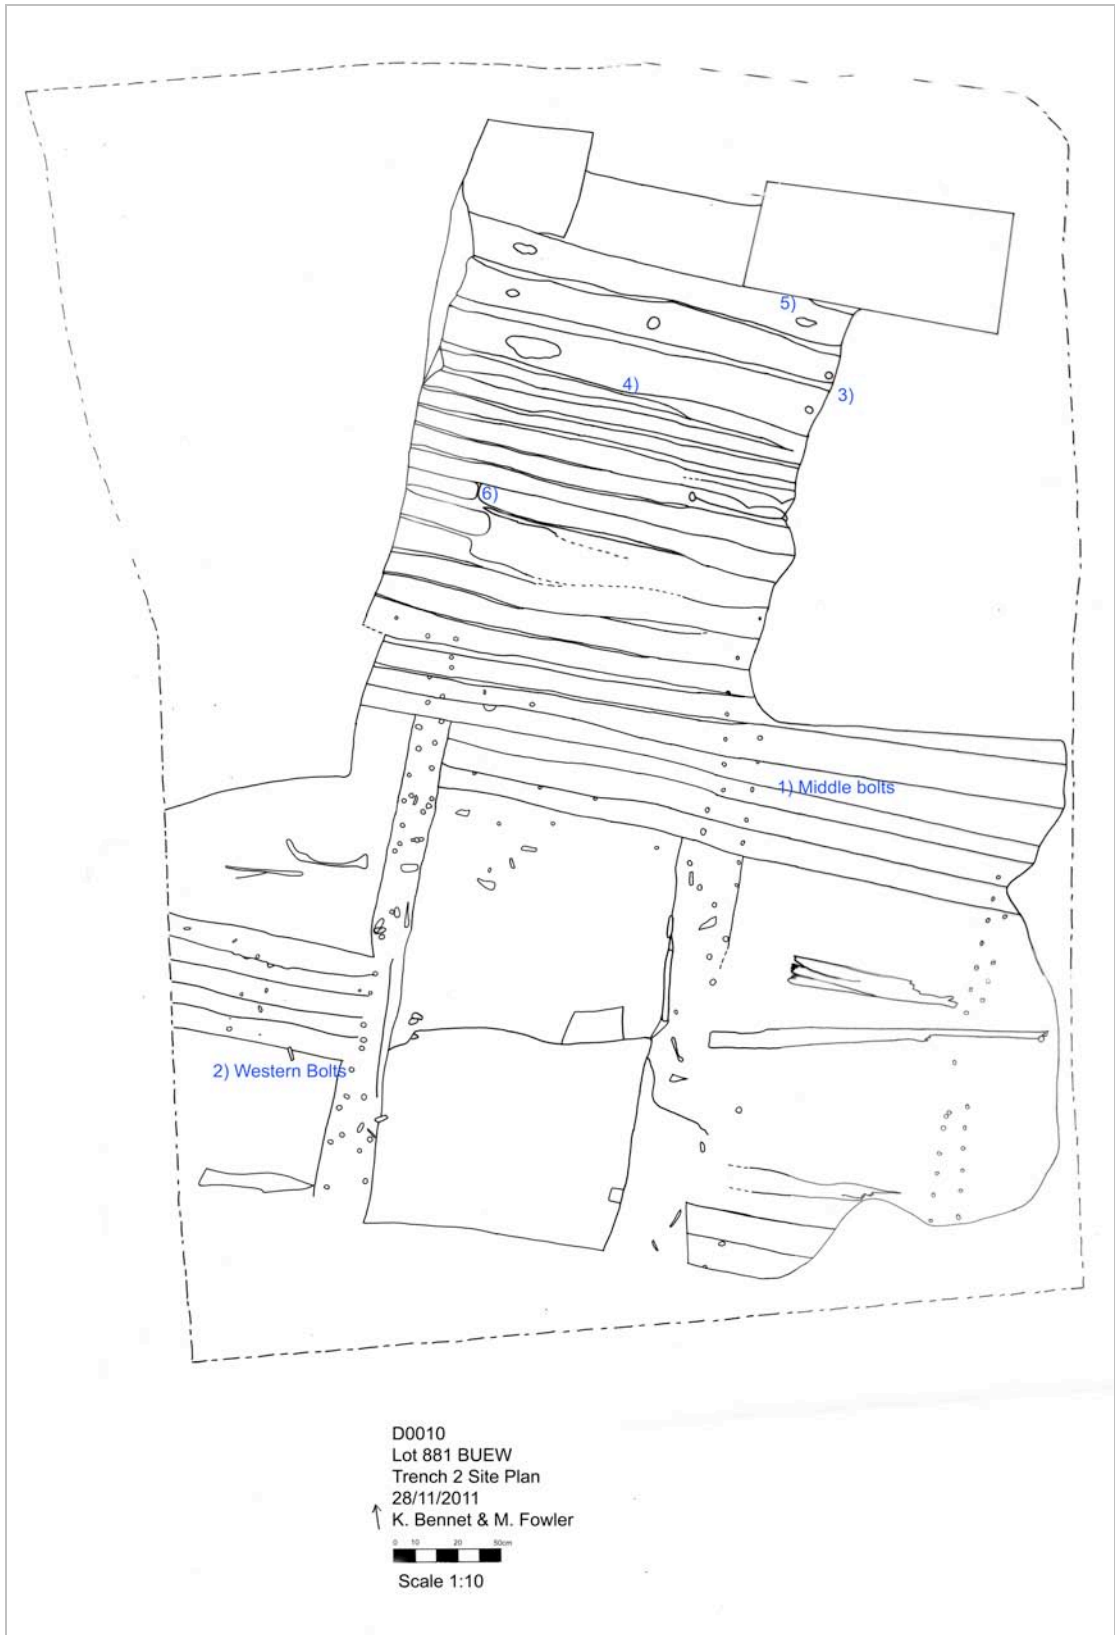
The image below shows where the bolts and treenails recorded were located in the site. (All measurements of fastenings in the following tables)

Image: Site plan of BUEW Lot 882 (WA Museum)

Fastenings	Diameter	Distance between centrepoints (N-S)	Distance between centrepoints (E-W)	Distance between
1. Middle bolts (iron)	25 mm (1")	110 mm (4.4")	160 mm (6.3")	NA
2. Western bolts (iron)	25 mm (1")	130 mm (5.1")	105 mm (4.2")	NA
3. iron bolts	25 mm (1")	NA	NA	210 mm (8.3")
4. bolts	40 mm (1.6")	NA	NA	740 mm (29.3")
5. treenails	45 mm (1.8")	NA	NA	450 mm (17.8")
6. iron bolts and treenails	25 mm and 20 mm (1")	NA	NA	60 mm (2.7") and 50 mm (2")
