Report on the First Season of Excavation of  
an Unidentified Shipwreck at Point Cloates  
Western Australia

Graeme Henderson  
Curator,  
Dept. Maritime Archaeology,  
Western Australian Museum

August 1979

Report—Department of Maritime Archaeology  
Western Australian Museum No. 14

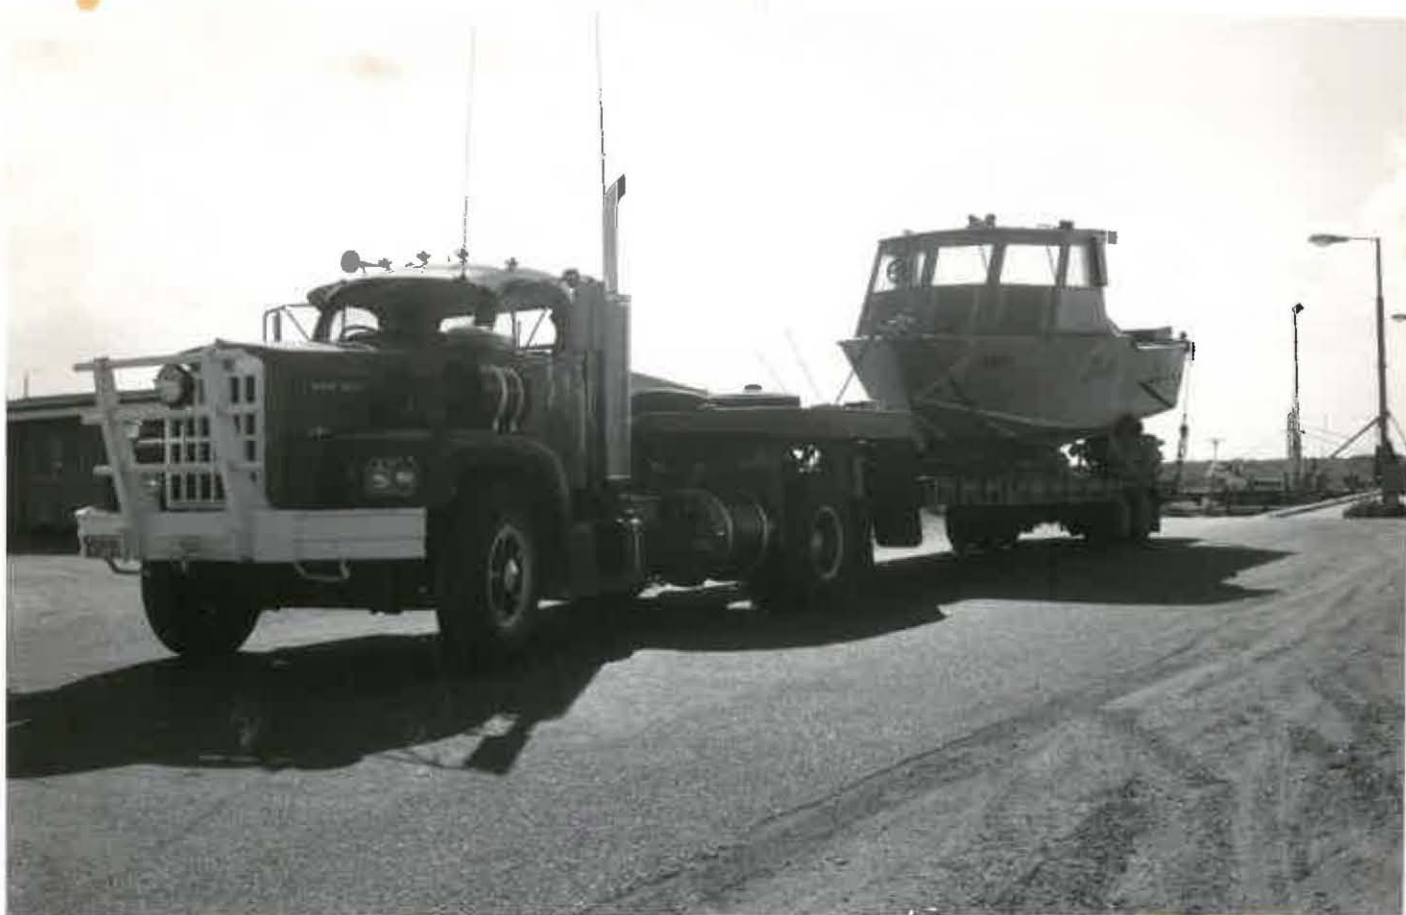
Fig. 3. Beagle is loaded on to a semi-trailer for the journey to Carnarvon. Photo Pat Baker.

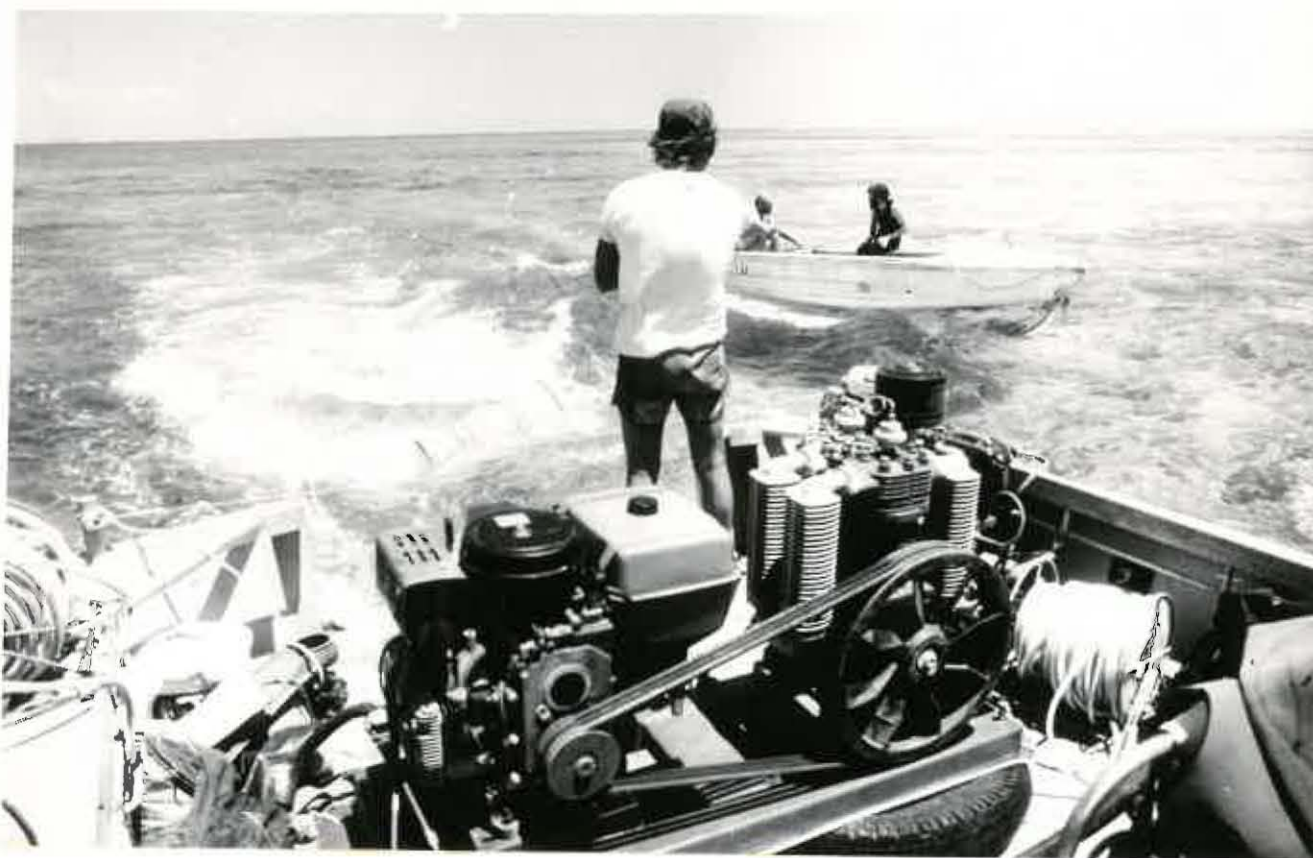
The nature of the work necessitated the constant use of an air-lift compressor on the Beagle. To sit comfortably on the vessel during an extended season in relatively open waters the compressor had to be more compact than the hire units normally available. For this reason, a unit was specially built for the job. This consisted of a 20hp Kawasaki petrol engine powering a 50cfm compressor mounted on a tubular base which acted as a reservoir.

Fig. 4 The airlift compressor fits snugly on the deck of Beagle  
Photo Pat Baker

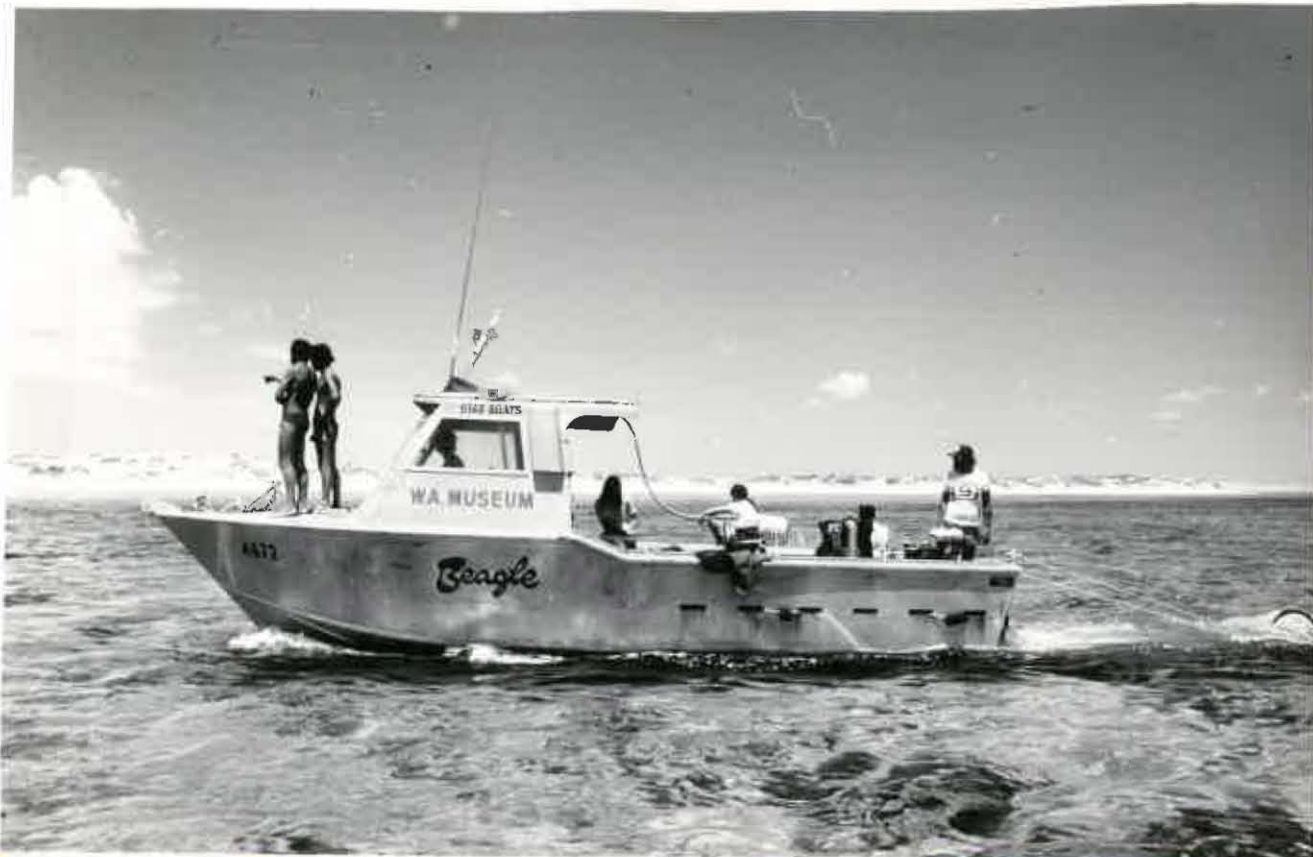
Fig 5 Beagle towing a cannon through the shallows. Photo Pat Baker

The lifting of larger heavy items was complicated. The Beagle has no lifting gear so such items were towed to the inshore anchorage. The shallow water en route made it impossible to use lifting bags for the towing, so large items such as the cannons and the oven were lifted using 200 litre fuel drums. Even so, the cannons touched bottom several times en route and one had to be re-tied closer to the surface. The oven, which was lifted on a pallet base, was damaged when it struck bottom not far from the site. More sophisticated equipment will be used for lifting the remaining heavy anchors and cannons.

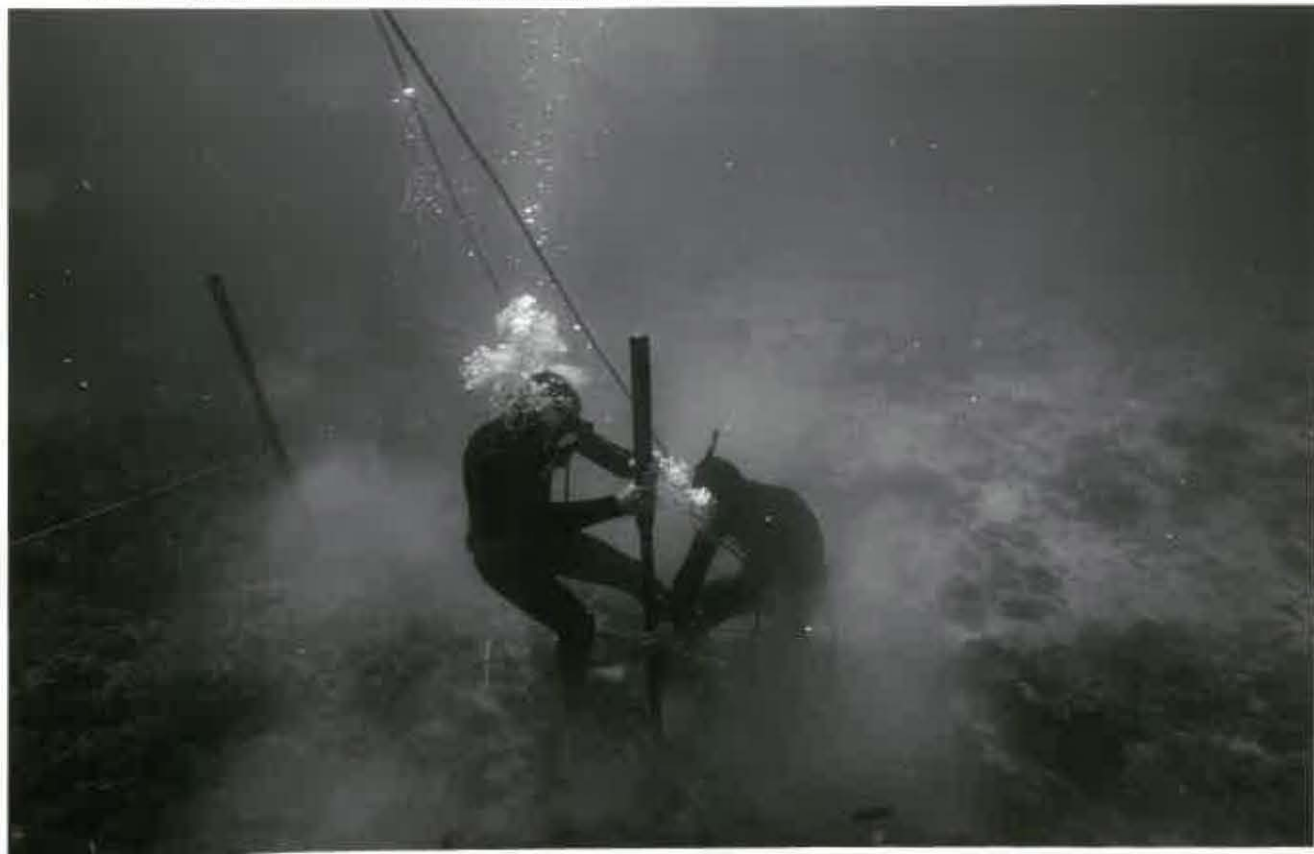
Fig. 8. A concussion tube devised by Bob Richards facilitated the positioning of survey pegs. Photo Pat Baker

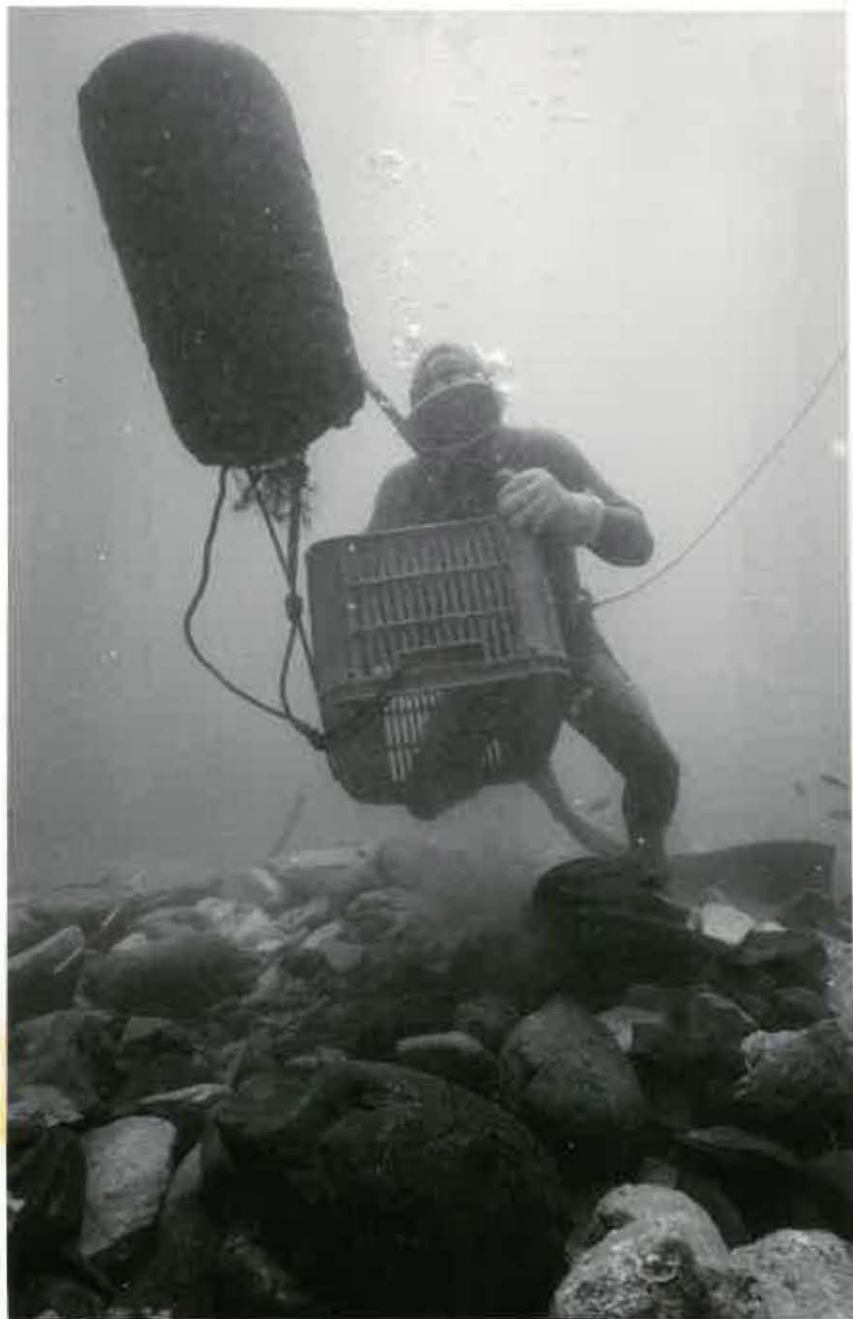
These had to be removed to expose the timbers for recording. The system of removal involved rectangular plastic baskets (c1m x 0.5m x 0.5m) which were filled with stones to weigh c3cwt. A plastic water barrel (c20 gallon capacity) was inverted and tied by its ears to the basket. The lid was cut out of the barrel, and diver's demand valves used to fill it with air. This did not lift the basket but did make it a comfortable load for two divers to carry from the site.

Fig 11. The ballast removal system. Photo Pat Baker

At the spoil heap the barrel was tipped over, releasing the air, and the basket inverted to spill the stones. The two items were then taken back to the site for a fresh load.

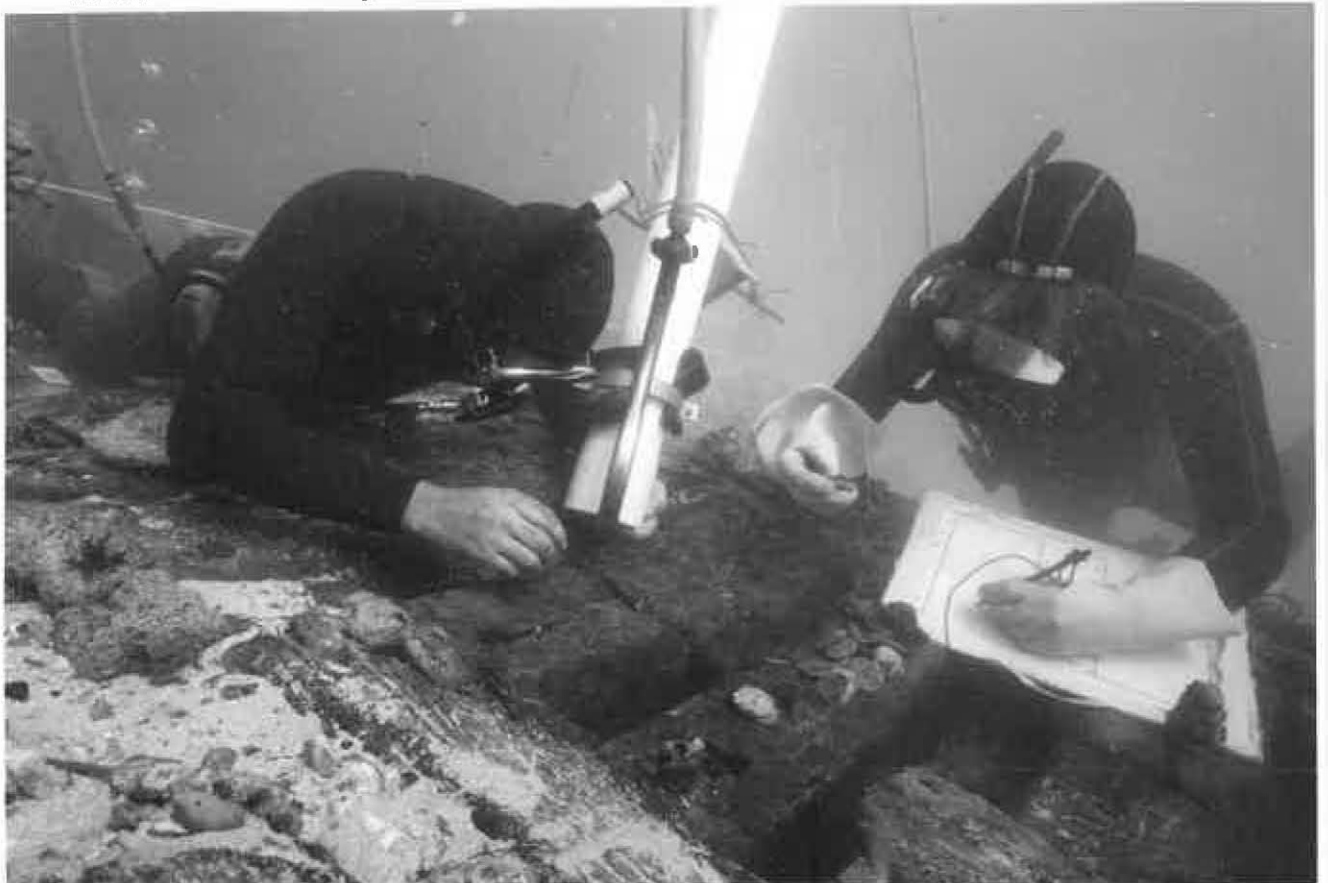
Tapes were laid along the two 16m sides of the 2m x 16m strip being excavated. One diver carried a drawing slate on which the grid strip had been laid out. As the diver operating the air lift exposed material the recording diver plotted the objects on the slate and then placed them in plastic bags according to type.

Fig 14. A diver records coin positions on a distribution sheet.  
Photo Pat Baker

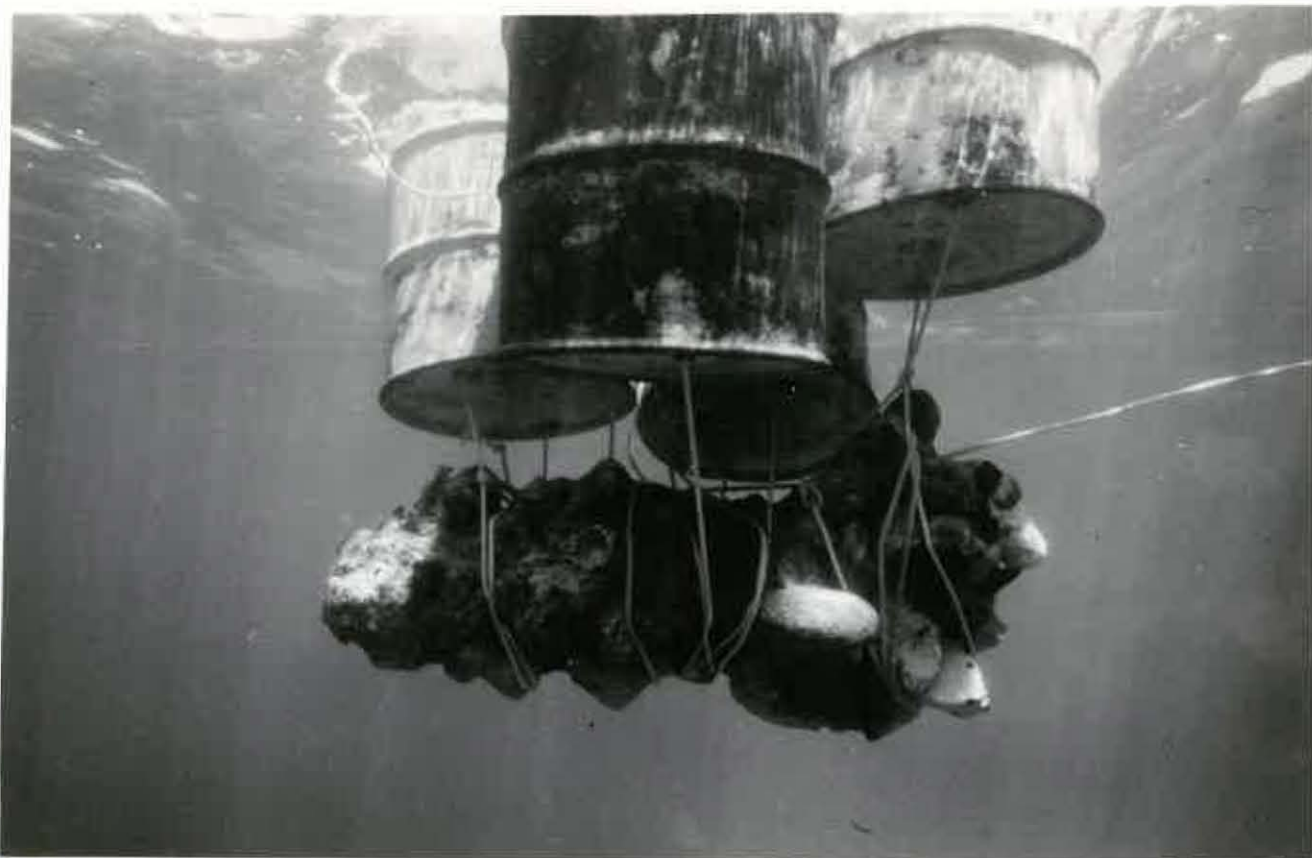
Fig. 16. A cannon is raised complete with its protective concretion  
Photo - Pat Baker

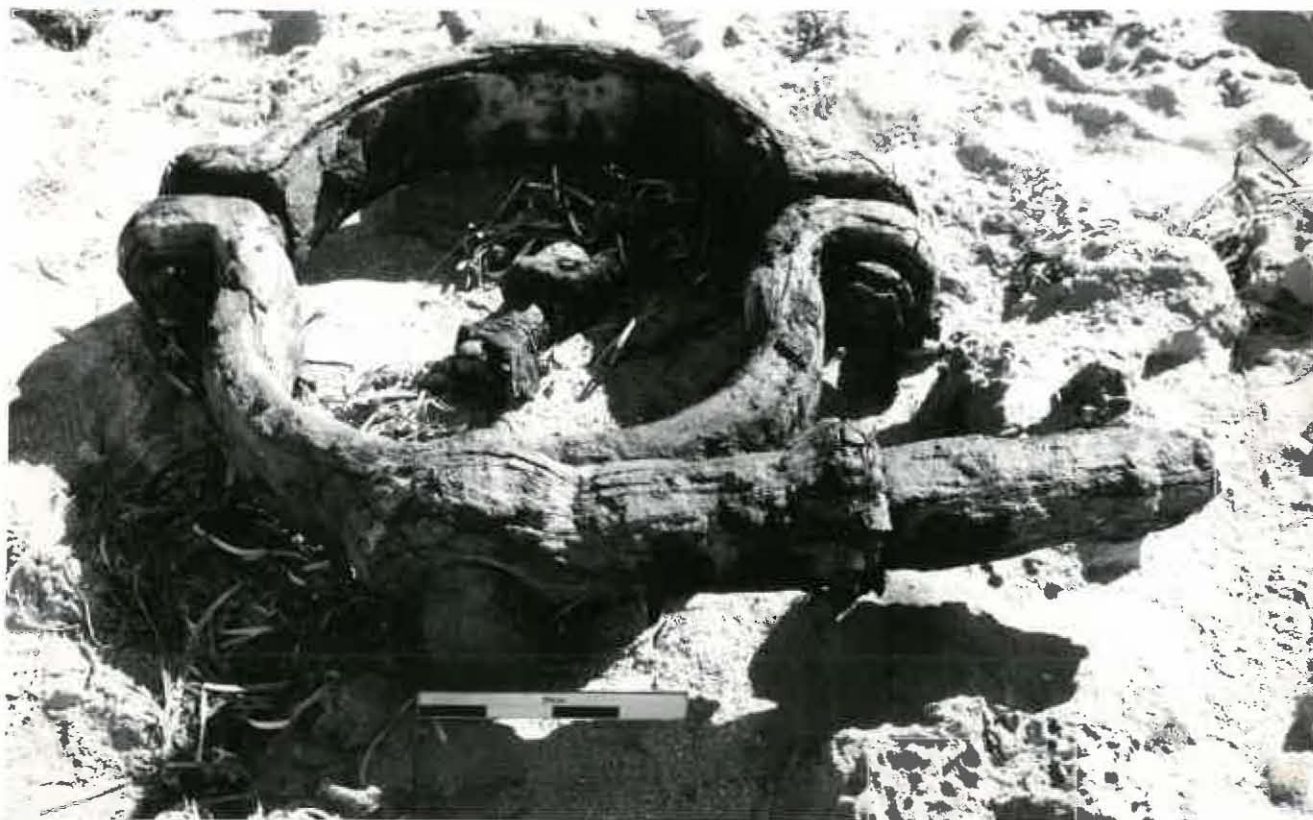
Little time was available for carrying out surveys in the coastal dunes. A mast hoop was inspected on the shore some 15 miles south but it is not likely that fitting would have come from the wreck site.

Fig 17. Mast hoop with boom fitting near Coral Bay. Photo Pat Baker

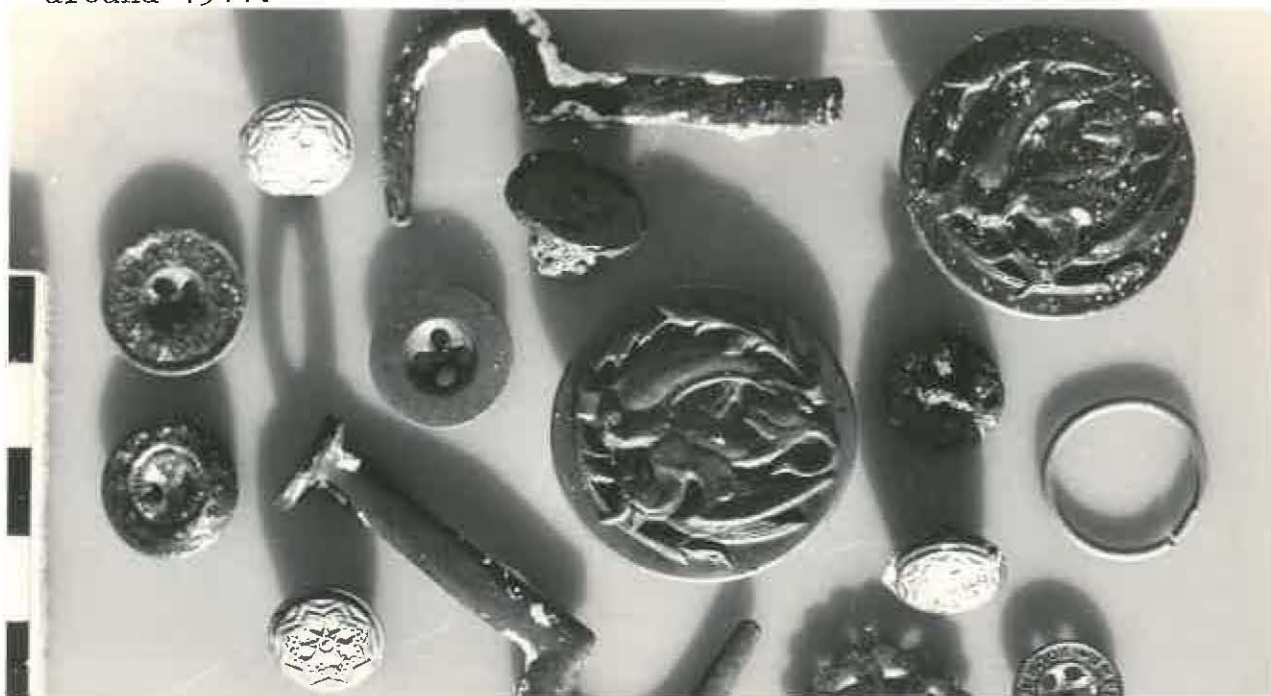
Fig 19. Buttons found in the dunes. Photo Pat Baker

On the north side of the Point an area was examined which in the past has yielded a collection of buttons. In the same area glass fragments from the early 20th century, iron fragments, and part of a fence were seen. The material may have originated from the Station, established in the 1890's, or the lighthouse, built around 1911.

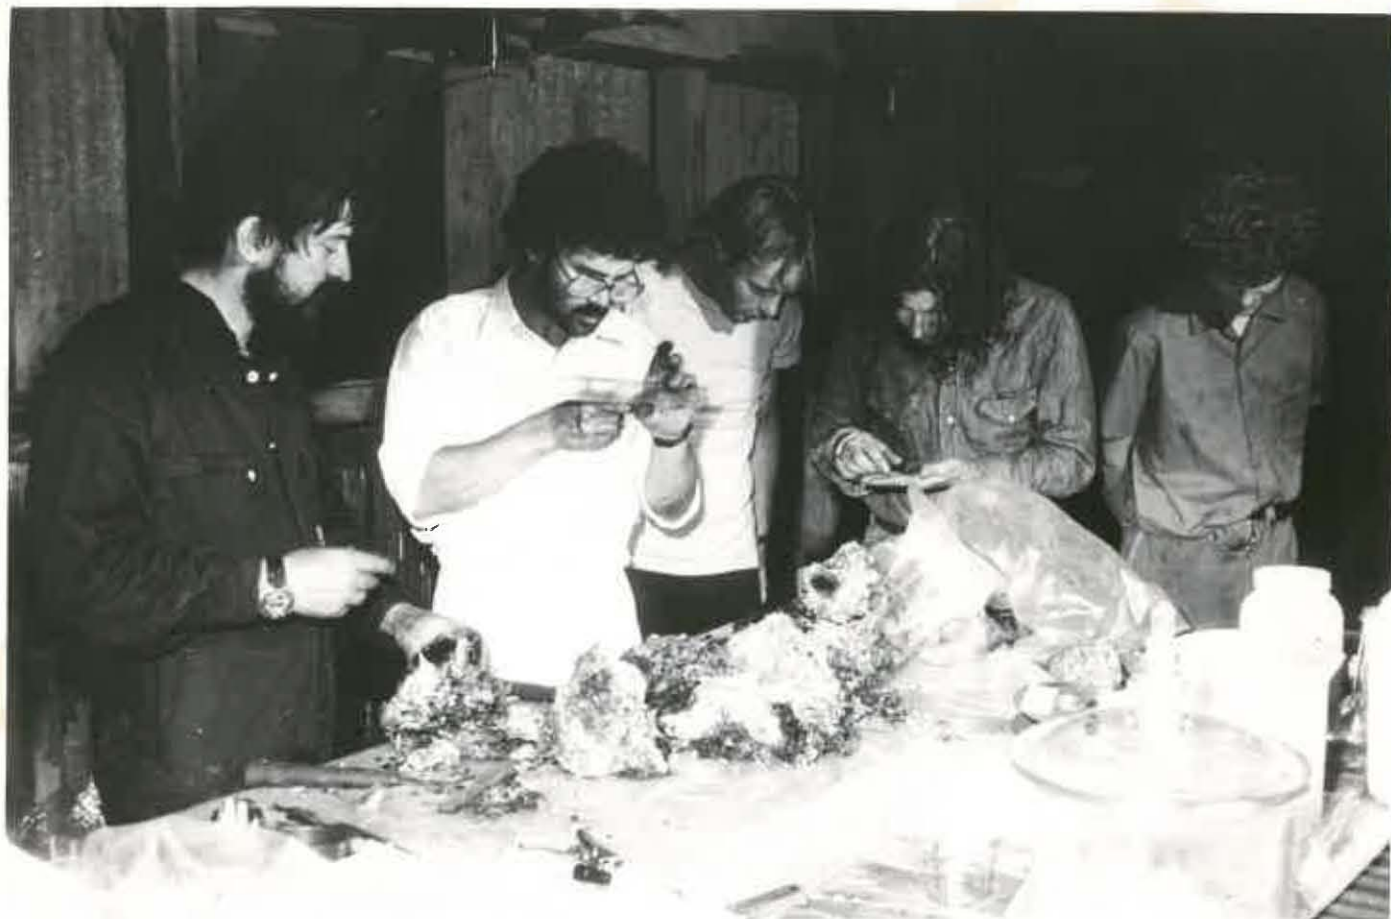
Fig 20. Conservators deal with a day's finds. Photo Pat Baker

Two Conservators, often assisted by volunteers, took the baskets of material brought in by the divers each afternoon to a sorting table. Then the material was more fully sorted and concretions were removed. The material was then registered and packed either in solution or dry (depending on type) for transport to Perth. Coralline encrustations were carried out to sea and dumped.

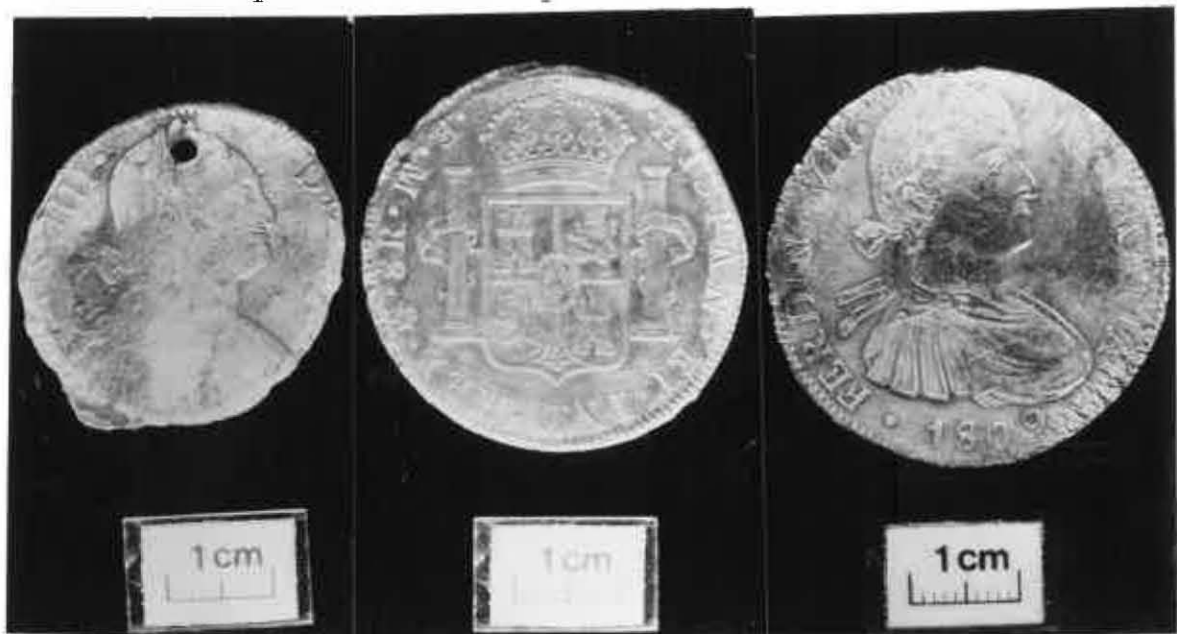
Fig 21. a) A Carlos IV coin with a circular punched hole  
b) Reverse of a Mexico mint 8 real piece  
c) A Fernando VII coin dated 1809

Some 15,879 silver coins have been raised from the wreck and counted. The exact number cannot yet be given because some are fragmentary, and others are still concreted together but the total is probably close to 19,000. The cleaned coins range in date from 1766 to 1809. All but 11 of the cleaned identifiable coins are Spanish 8 reale pieces.

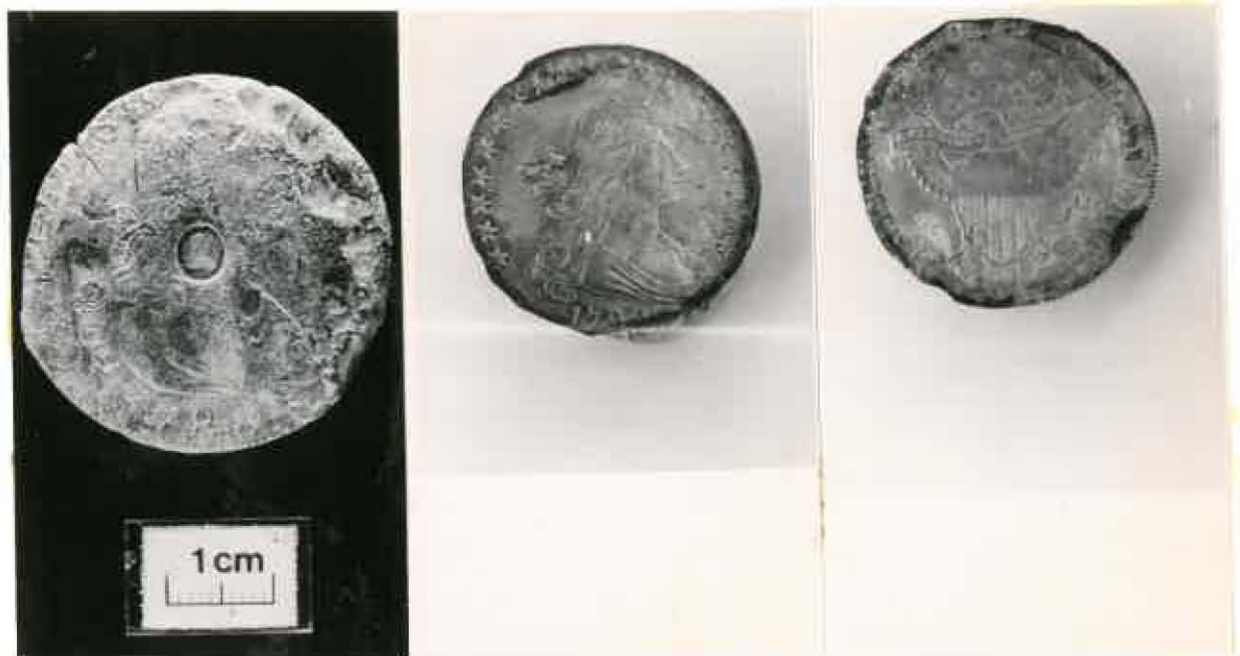
One of the Spanish coins was counterstamped with the head of the British monarch George III enclosed in an oval border. During a time when Britain was short of coinage the Bank of England had counterstruck large numbers of Spanish dollars in this manner and put them into circulation in Britain at 4/9d in value.

Fig 23. a) The head of George III counterstamped on an 8 real piece  
b) Obverse of a 1799 United States dollar  
c) Reverse of a 1799 United States Dollar

Until a coin has been stabilised and polished it is uncertain that any numismatic information will be gained. A good example of this is the badly worn dollar of Carlos IV counterstamped with the head of George III (see report by S.J. Wilson, Curator of Numismatics). Until final polishing and careful excavation of the counterstamp the significance of this find was not apparent. Of the 1400 coins cleaned only about 2% of them are in anything like mint condition. The average weight of Spanish dollars of the period 1766-1809 was about 27.6 grams and a weight distribution of the cleaned coins gives a mean of 13.5 grams which represents a 50% weight loss from corrosion and erosion. - See figure I. The majority of the treated coins have some information on them which enables general classifications to be made; for example the mint masters initials can often place a coin of unknown date to within a range of ten years.

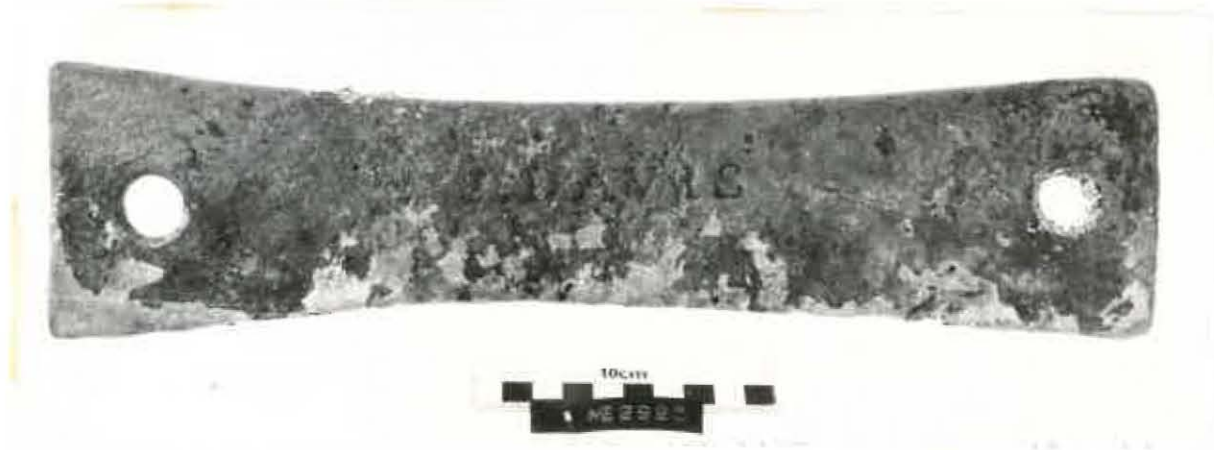
A number of copper fittings from the keel and the sternpost of the wreck bore the stamped name 'J. DAVIS'

Fig 24. A copper hull fitting bearing the name J.DAVIS Photo Pat Baker

The immediate question which arises is that of what sort of person the name J. Davis represents. Is he a bronze founder, a ship's chandler, a ship-builder or a ship-owner? Or could the name represent that of the ship itself? The fittings of British naval vessels were stamped with the Admiralty's mark. In the case of the barque Day Dawn, sunk near Fremantle in the late nineteenth century, the vessel's name was found burnt into timbers. However, a ship's chandler is the person who would see most commercial advantage in having his name appear on hull fittings for a merchant vessel.

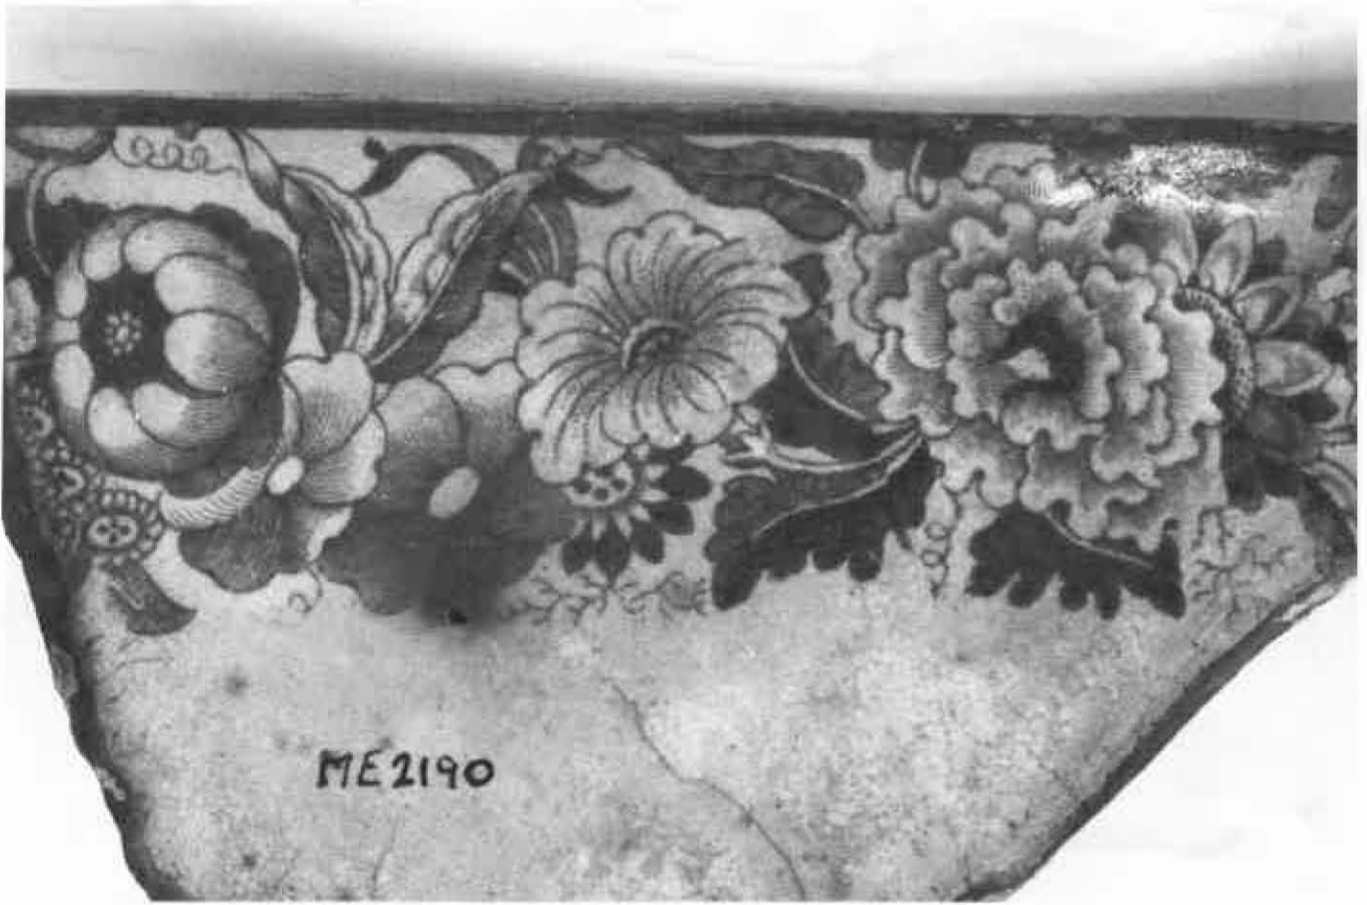
Fig 26. Floral pattern transfer earthenware in greenish-yellow  
Photo Pat Baker

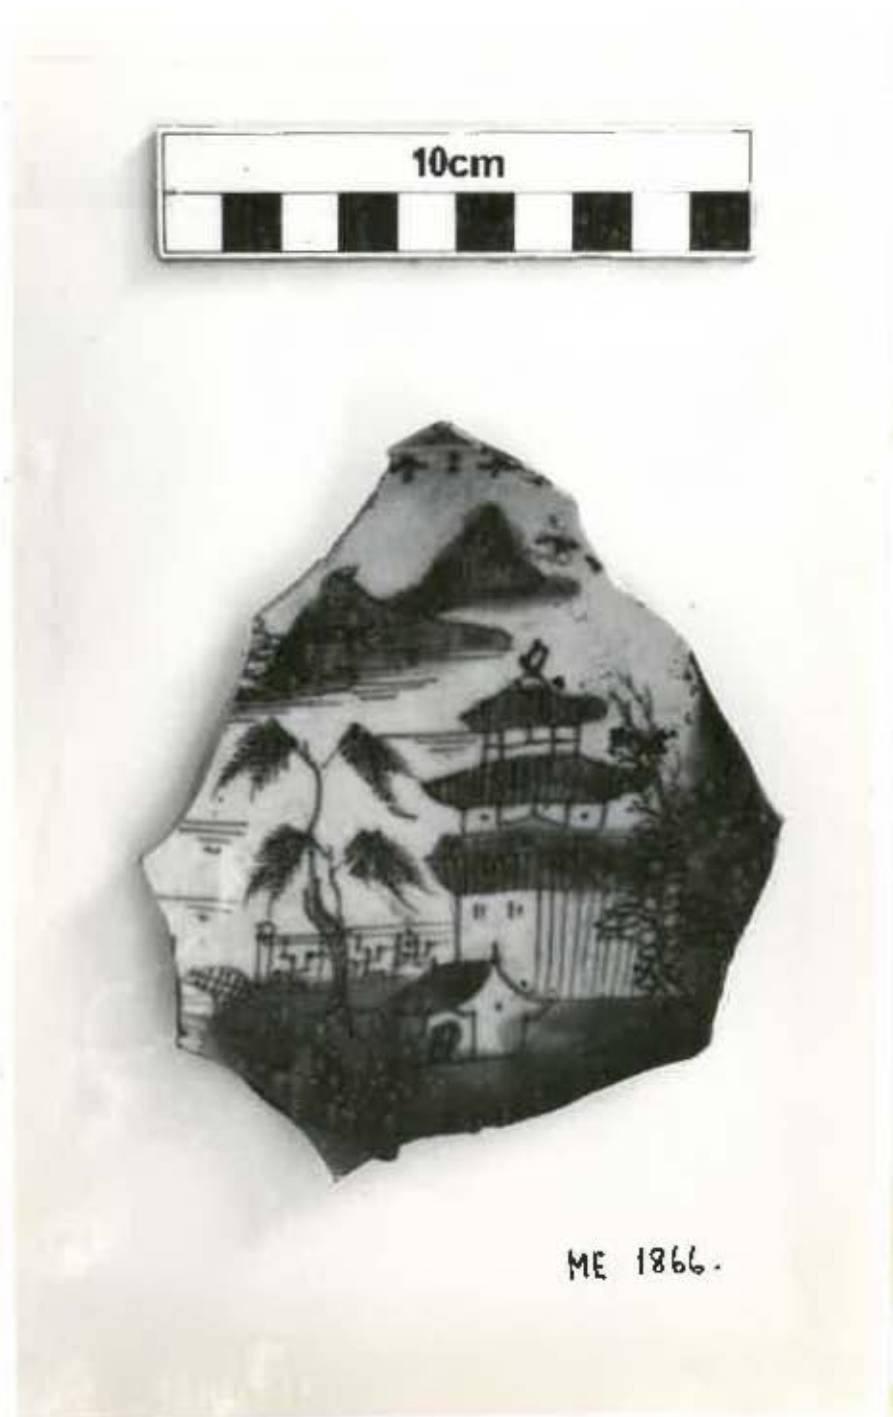
Fig 27. Blue painted porcelain sherd, Photo Pat Baker

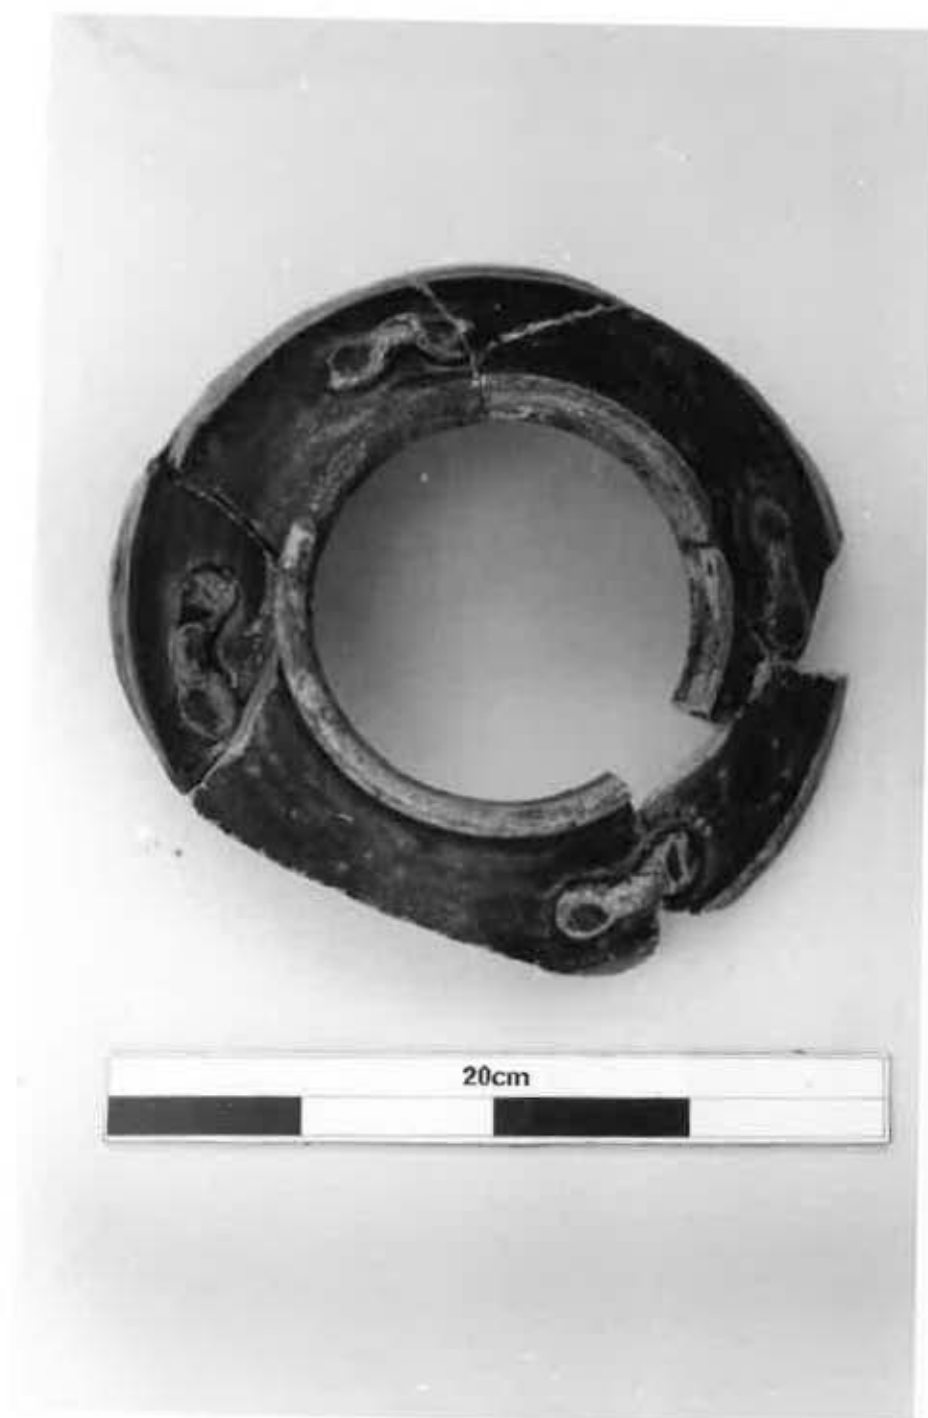
Fig 28 Brown glazed earthenware sherd with four ears

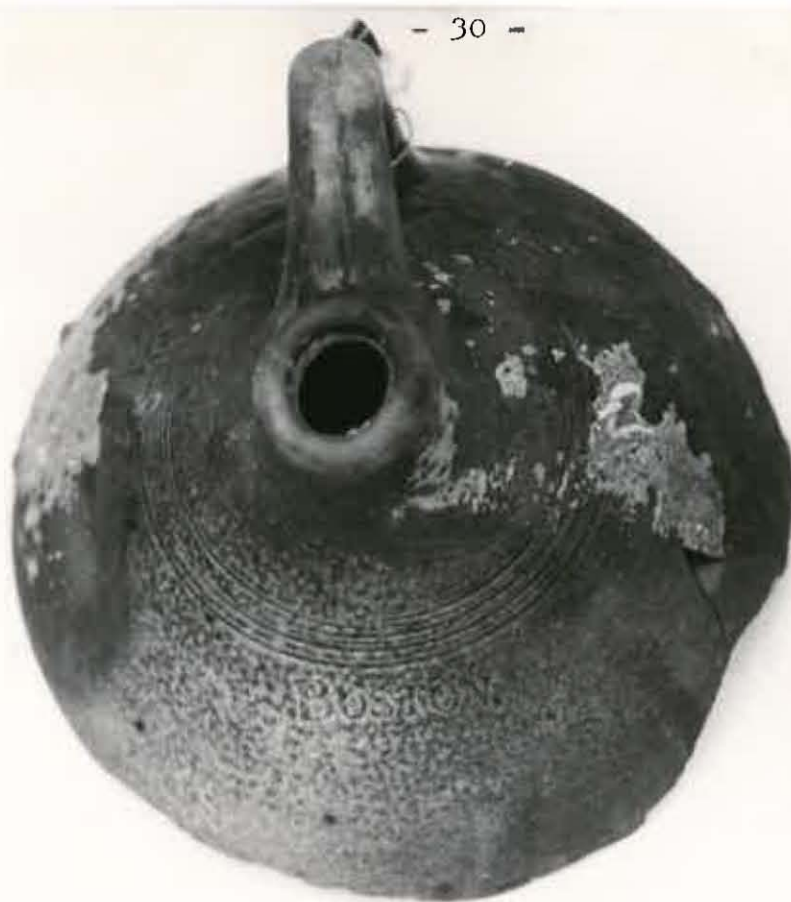
Fig 29.

The most interesting of the stoneware is a fragment of a jug, stamped with the word 'BOSTON'. Stoneware was being produced at Boston as early as 1743 (Ketchum, 1971).

A salt-glazed  
stoneware jug  
stamped 'BOSTON'

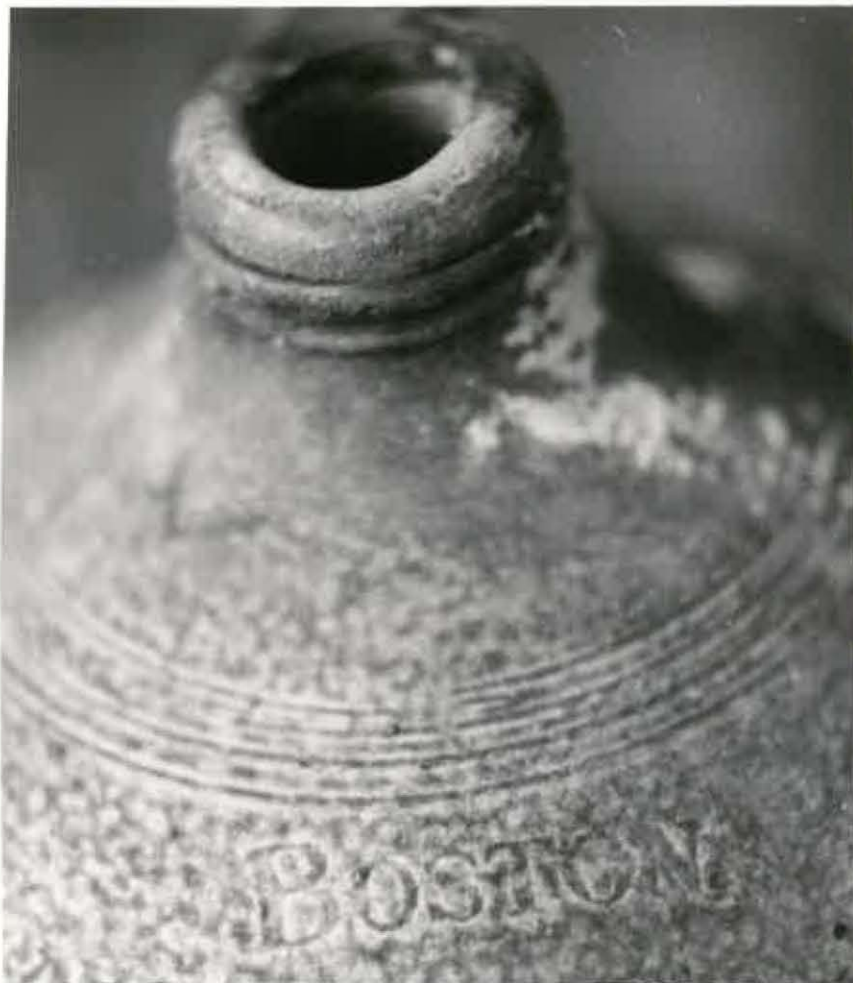
Fig 30

Detail of stamped  
'BOSTON'

At the very beginning of the nineteenth century there appeared a variety of ocher-stained stoneware (mostly crocks and jugs) marked 'BOSTON 1804'. It is believed that some of these pieces were made by Jonathan Fenton, active in Boston in the late 1790's.

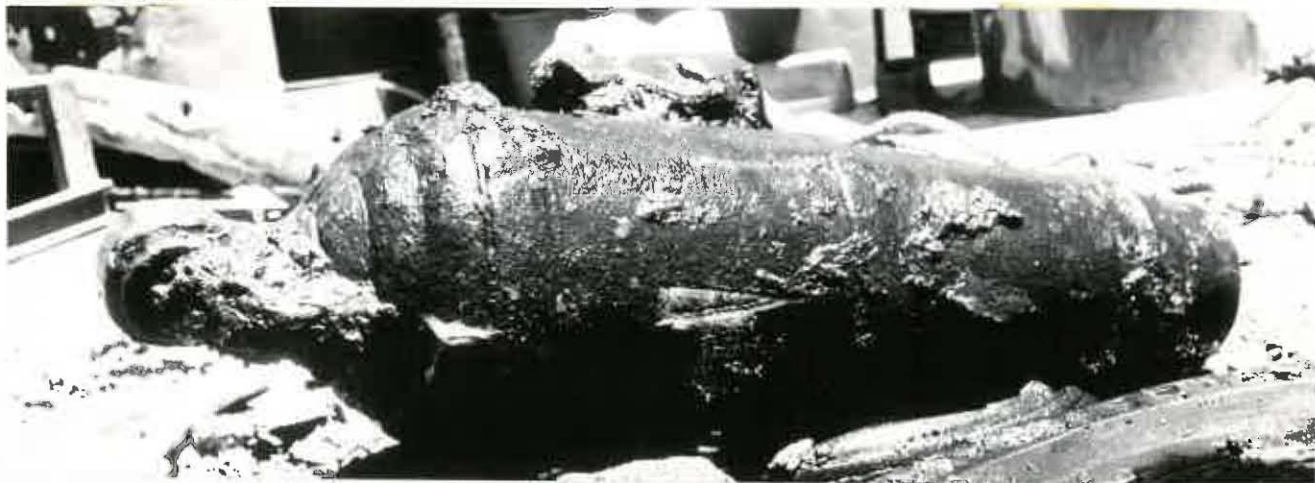
(a 12pdr) and bearing an incised narrow triangle (to the left of the sighting line) pointing forward behind the first reinforce. It is cast with a lug under the gun, instead of trunnions. A heavy pin fastens the lug to a slide, which would originally have been held in a slotted carriage. No other markings are visible on this piece, but chemical tests have indicated that the triangular incision contained the remnants of a copper implant.

Fig. 33. A carronade is cleaned at the laboratory Photo Pat Baker

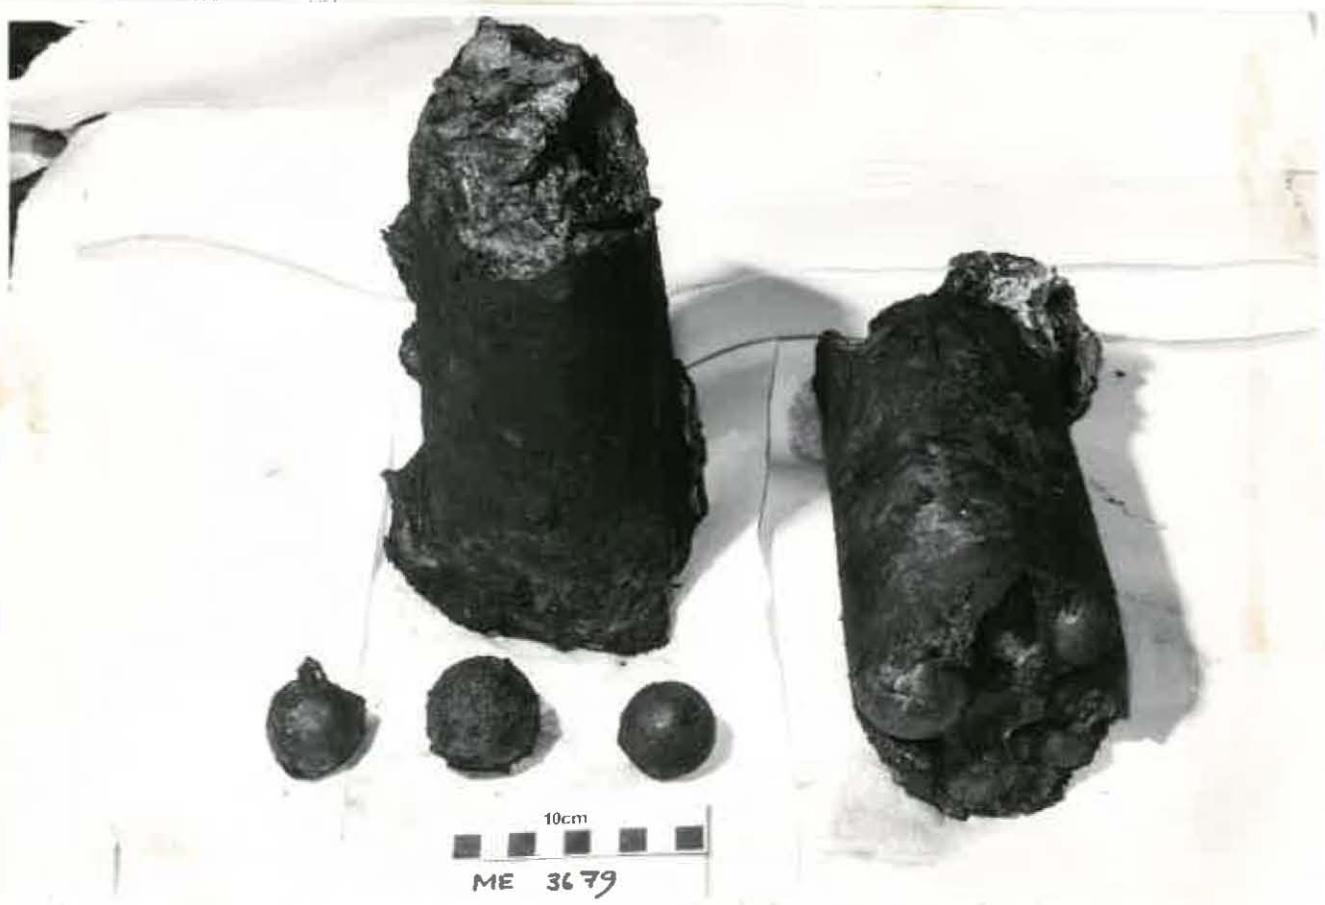
A quantity of shot was found on the wreck, close to the main-mast step where the shot locker would have been. The shot was in canisters; tins of cast iron balls of small assorted sizes which would have had the effect of a large shotgun type blast. It was a short range projectile; after some 200 yards the shot spread so widely that it lost its effect. As such it would have been most suitable as an anti personnel weapon, a likely requirement on the Sumatra coast.

Fig 34. Cannister shot from the wreck - Photo Pat Baker
