Report on the First Season of Excavation of  
an Unidentified Shipwreck at Point Cloates  
Western Australia

Graeme Henderson  
Curator,  
Dept. Maritime Archaeology,  
Western Australian Museum

August 1979

Report—Department of Maritime Archaeology  
Western Australian Museum No. 14

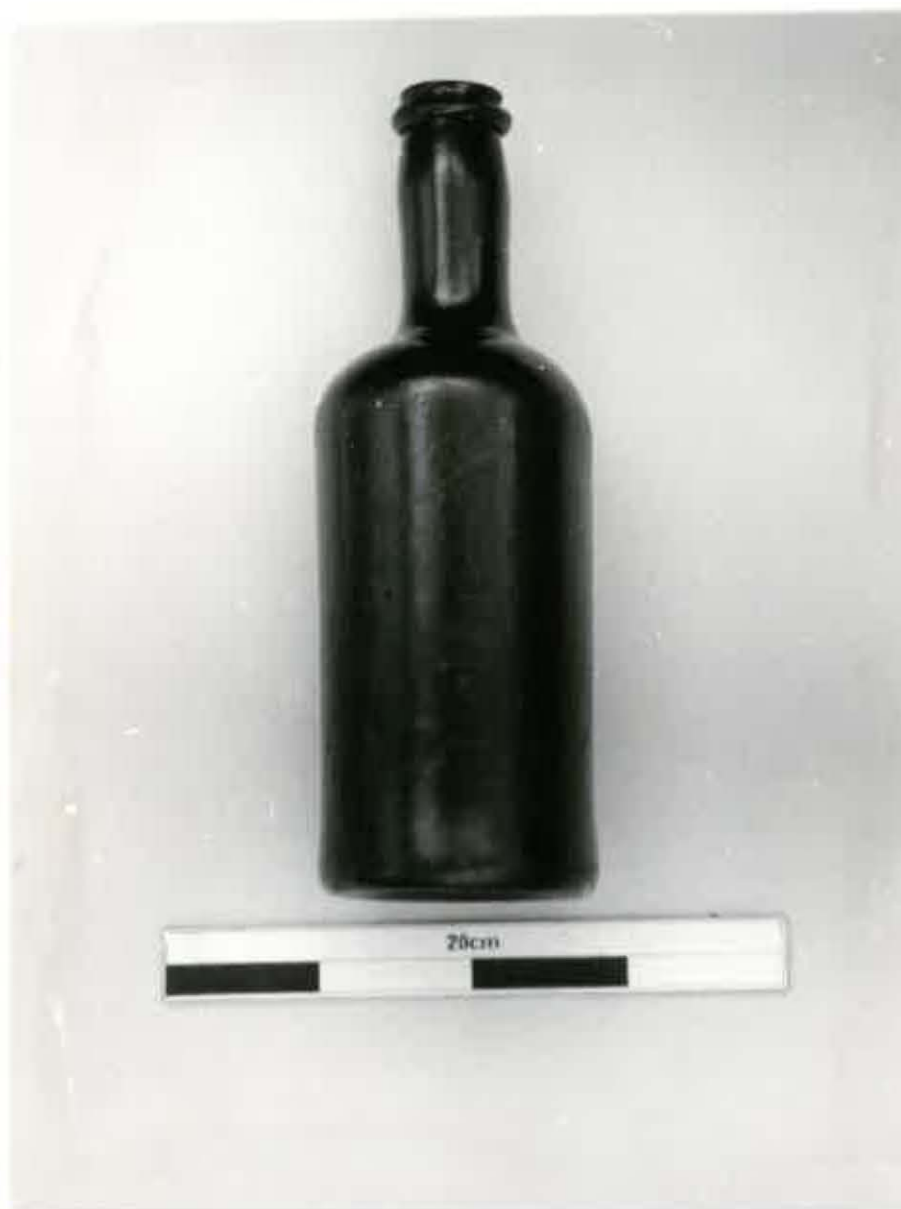
The glass bottles and sherds found on the site varied in size but were generally slightly squat, cylindrical, with the mouth everted above a string rim. Similar bottles have been dated to the 1780's and 1790's

Fig 35. One of the complete glass bottles

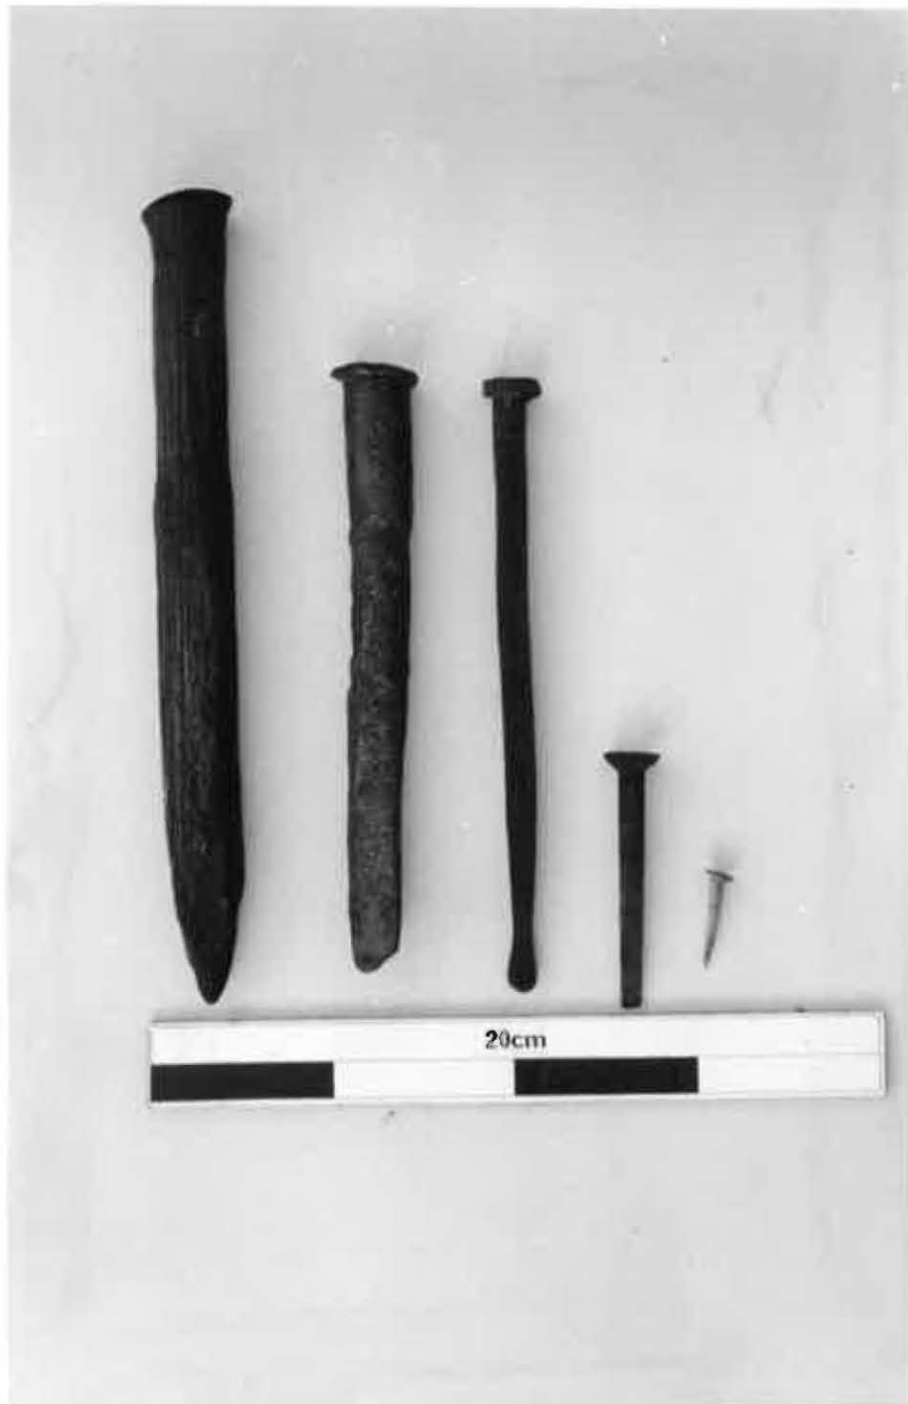
Excavation revealed a large component of copper fastenings in the hull of the wreck at Ningaloo. The frame was held together with copper bolts, and the planking was held together with copper nails featuring hammered chisel points and four-sided rose heads. The vessel had been sheathed in copper, and although little of the sheathing itself has survived, the sheathing tacks were to be seen.

Fig 36. Copper hull fastenings

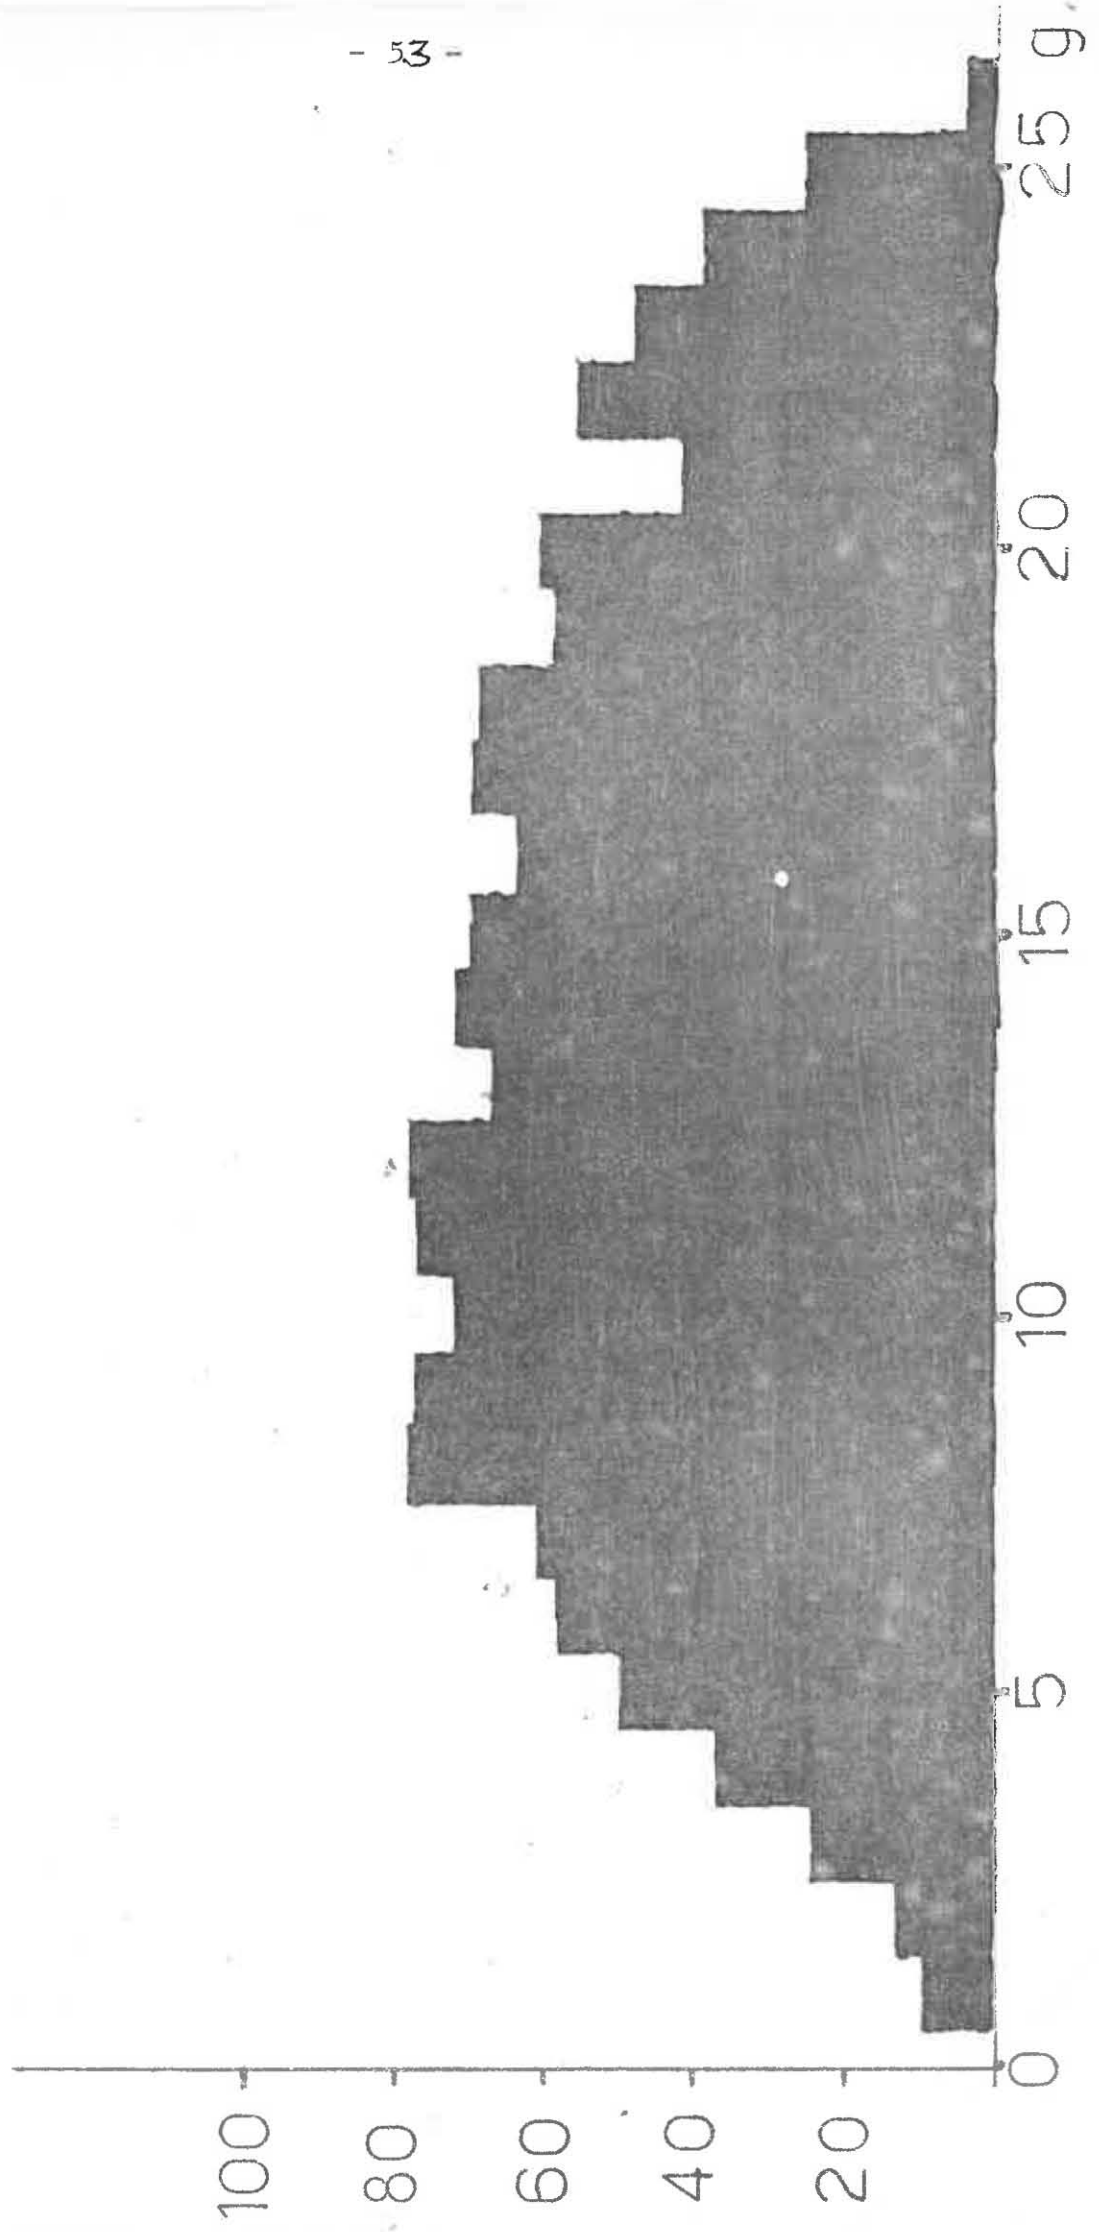
No. of coins vs. weight in grams
