# THE ALBANY REPORT

THE AWHINA SURVEY

THE ATHENA (?) WRECK INSPECTION

submitted as a course requirement for the  
Graduate Diploma in Maritime Archaeology  
November 1990

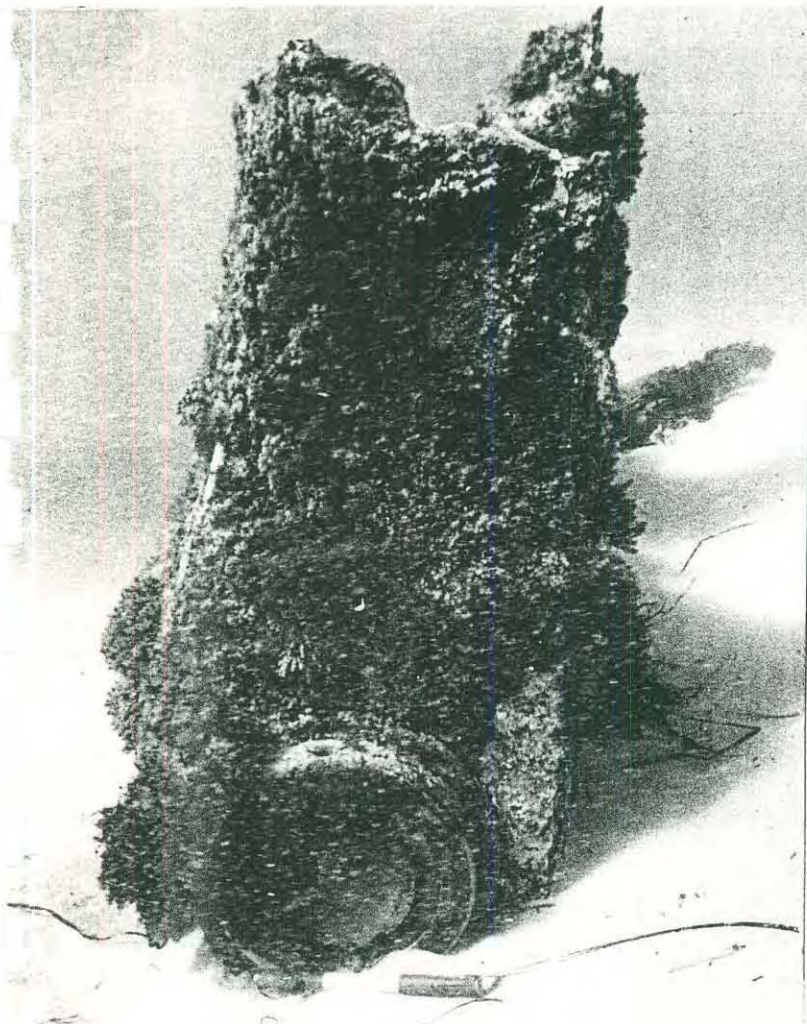
The feature designated Propeller Block stands to a height of approximately 1.5m. The propeller shaft opening is intact and the lignum vitae lining is still in situ. Traces of sheathing exist on the right edge.

*Awhina* Propeller Block  
Figure 14 (above) and  
Figure 15
