**Archaeological watching brief for New Maritime Museum Site
Forrest Landing, Victoria Quay, Fremantle**

Report—Department of Maritime Archaeology, Western Australian Maritime Museum, No. 150

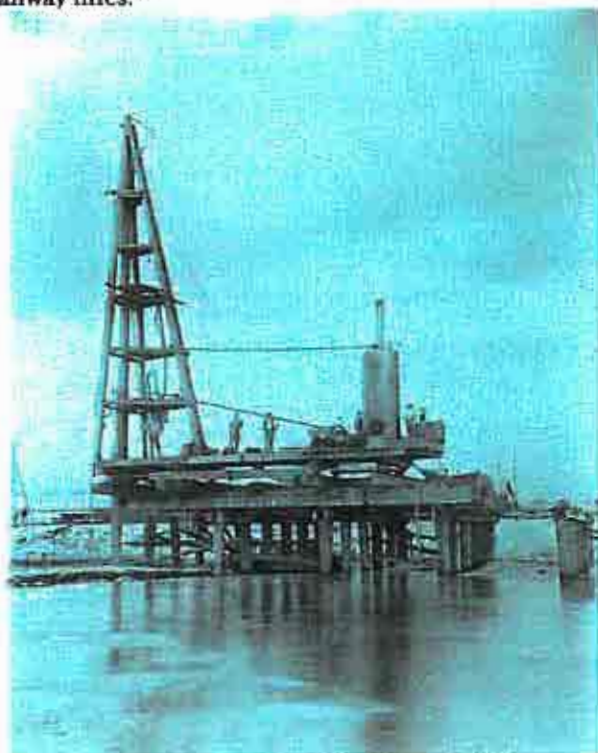
Fig 1 Victoria Quay pile driving c 1895

Victoria Quay was constructed of timber half-caps, corbels, beams and decking on a jarrah pile sub-structure.¹⁵ The completion of the work was celebrated with the arrival of the mail steamer *SS Sultan* of the Western Australian Steam Navigation Company, on May 4, 1897.

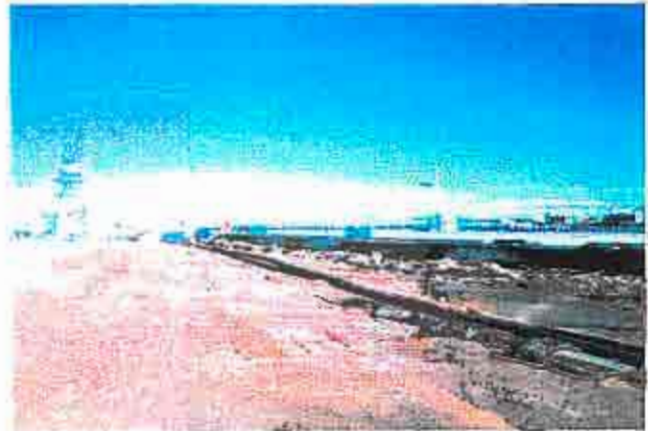
Contractors removed the disused rail line that ran to the end of the concrete wharf, west of A shed. Approximately 62 metres of rail was removed. The rail was supported by single jarrah railway sleepers, modern in appearance. It was noted that they did not have any protective coating of creosote or the like. The rail was attached by single dog spikes and some representative examples have been collected (NMM 1). Two periods of asphalt cover are associated with the rail, distinguished by the coarseness of the matrix of the earlier layer. The rail was located over modern road base and incorporated with the latest layer of asphalt.

Fig 3 Area A with rail still present

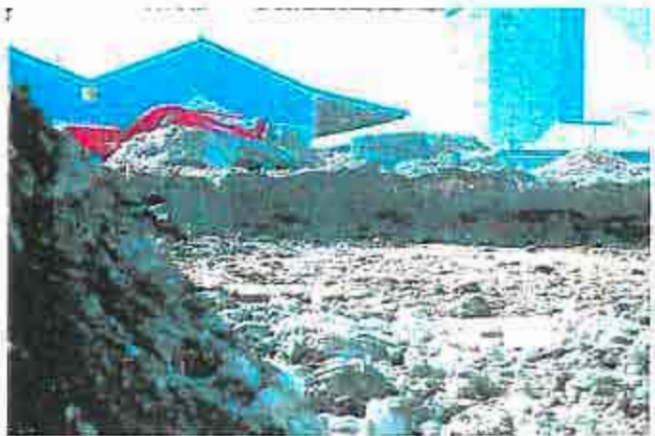
Fig 4 Area C post excavation

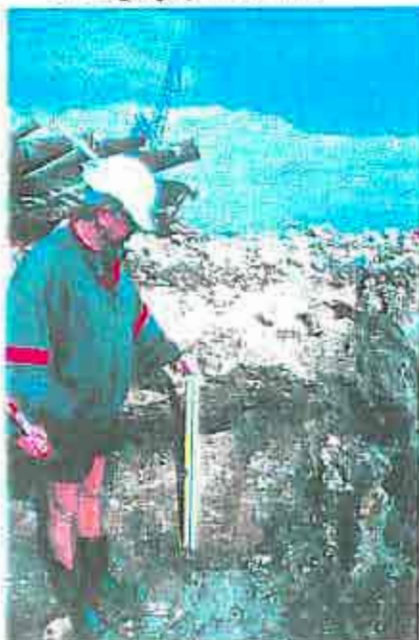
Fig 5 Area C west wall profile

Layer	Average Depth
Concrete cap	0-10cm
Mixed deposit/rubbish	10-30cm
Limestone fill	30-60cm
Dark soil w/limestone rubble	60-125cm
Limestone rubble base	125cm

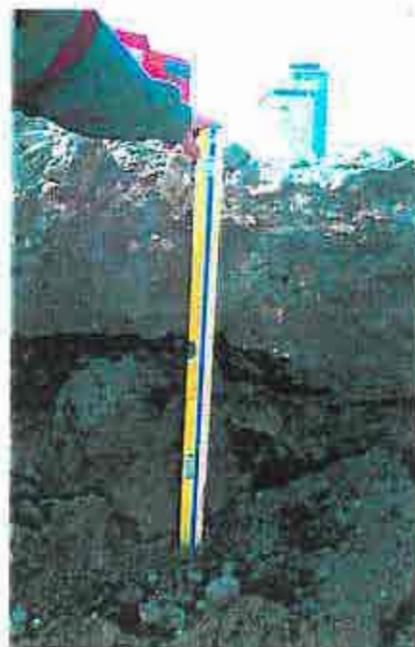
Layer	Average Depth
Concrete cap	0-10cm
Mixed deposit/rubbish	10-30cm
Limestone fill	30-50cm
Dark soil w/limestone rubble	50-80cm
Original Road level	80-85cm
Limestone road base	85-95cm
Dark soil	95-125cm
Limestone rubble base	125cm

Fig 6 Area C east wall profile

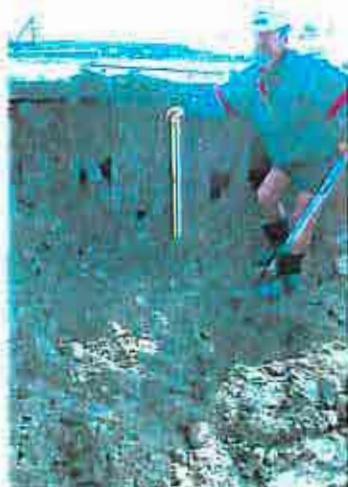
The corrugated iron 'sea wall' was the northern boundary of C2. This was heavily corroded and punctuated with holes. The 'sea wall' is probably contemporary with the original Forrest Landing wharf which is constructed from jarrah timber and later overlaid with asphalt/concrete either during or after WWII. The southern boundary was excavated at an angle approximately 60° to the vertical, meeting the 0.3m excavation area with no definitive stratigraphy. C2 was bound at the western periphery by the original shoreline. The artefact assemblage consisted of bricks; glass sherds; nails; bolts; miscellaneous fastenings; fragments of limestone with limestone solution pipes indicating original shoreline level; and unidentified iron work. Collected material included a bottle neck with applied top (NMM5) and a copper nail (NMM6). An applied top bottle (NMM7) was discovered in the East wall of C2 in the dark soil w/ limestone rubble layer 50-80cm below the surface. Sherds of green 20th century bottle glass, bolts, timber fragments and other fastenings were also observed but discarded, having already collected representative examples.

Fig 7 Area C corroded sea wall

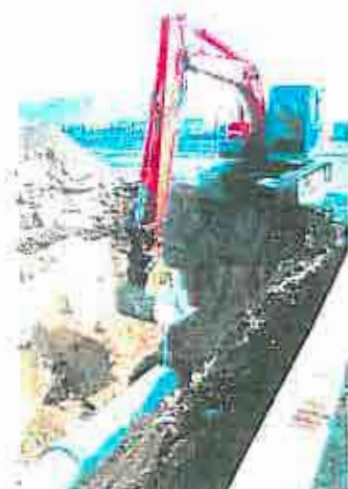
Fig 8 Area D at iron sea wall interface

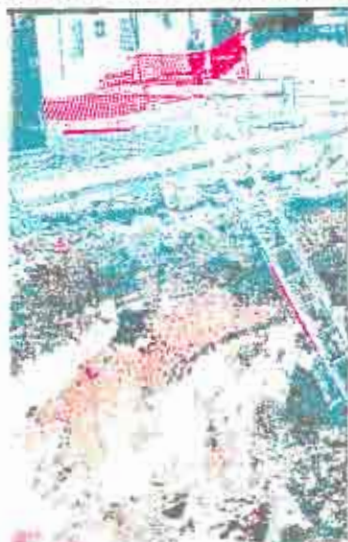
Fig 9 Area D west wall

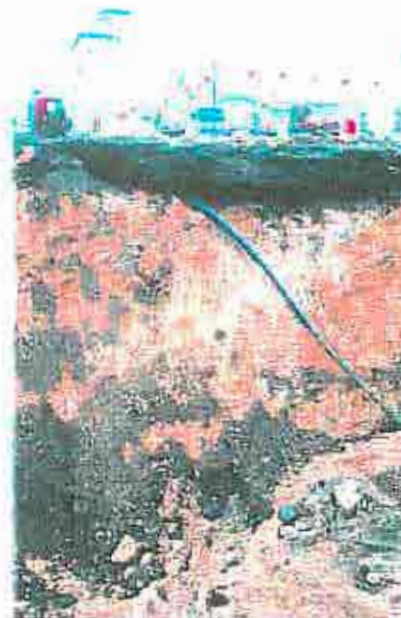
Excavation to 0.3m revealed road base overlaying clean limestone fill. A trench from the fire hydrant to the slag contamination (I) in order to remove an asbestos pipe also contained modern detritus. Notable objects included a deck spike (NMM 9) on the surface from western extremity of the area.

Fig 10 Area E profile showing modern electrical services

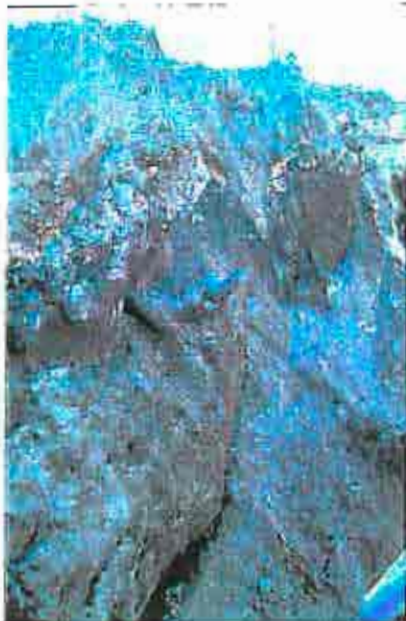
The 600 ton slip rails were removed to facilitate truck access to the land reclamation area. They will be replaced at the completion of construction. The previously noted exposed limestone wall along the northern side of this slip was destroyed by heavy machinery. It was quite thin in section and residual traces of the headland appear to be visible elsewhere in the area. The northern walkway of 600 ton slip was excavated to base foundation level of 1.4m. Modern electrical services were located at approximately 1m and these overlaid imported soil base approx. 20cm thick which in turn, overlaid the original limestone rock platform. At the south eastern end of the slip the services are laid directly on original limestone. The area was of little archaeological interest, having been disturbed on various occasions for the installation of these services post 1942. Bolts and various fastenings were found at the surface and identified as industrial rubbish. Although the 600 ton slip area has been covered with limestone fill to facilitate access to the reclamation site and the slip trolleys removed, the area is to be returned to it's original state at the conclusion of the works. Cranes and other ancillary machinery, including the winder shed remain.

Fig 11 Area F chain *in situ*

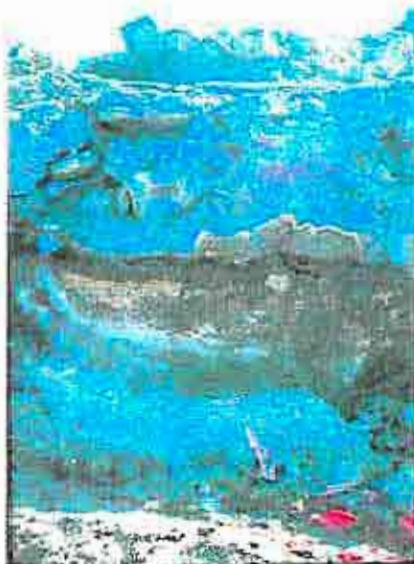
Fig 12 Area F profile

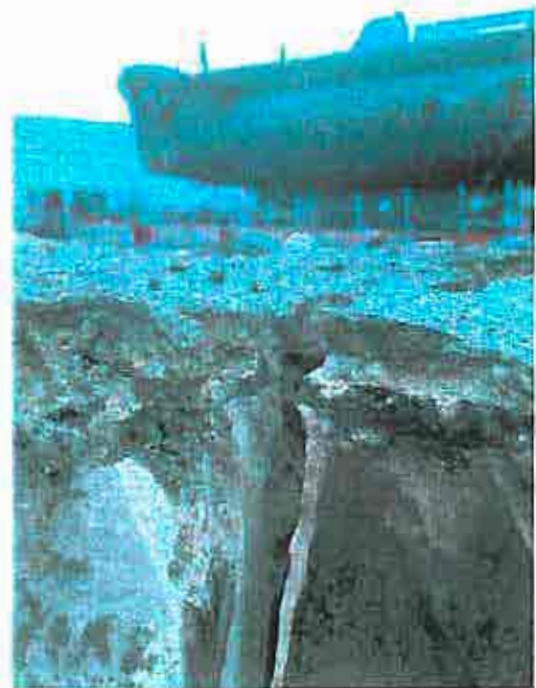
Excavation of Area H began in the south west corner, with the soil profile noted as road base overlaying soil/limestone fill, overlaying the original limestone headland. The presence of the headland in this area made it impossible to excavate a level surface.

Fig 13 Area H showing limestone headland

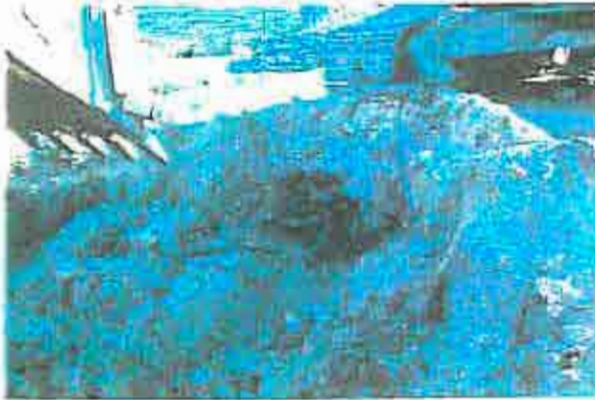
The limestone headland was evident NW of contamination spoil (I) but no significant cultural material was observed. Material was predominately industrial rubbish probably associated with the occupation of the slipways. Significant material recorded in Area H included a 'Goldfield's black' bottle (NMM 27) found in the spoil heap; a flensing/boning tool from the whaling industry (NMM 28) found at 30cm in fill located approximately in the middle of Area H.

Fig 14 Area H industrial rubbish

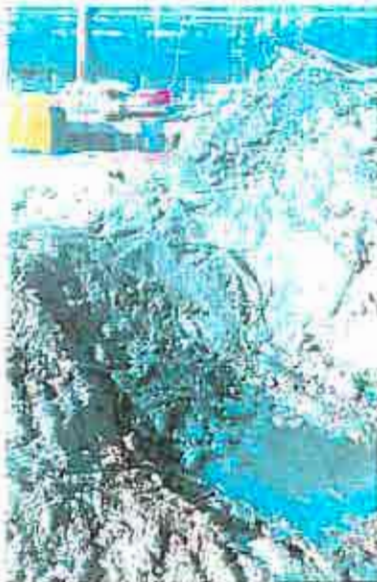
Excavation in the area west of contamination pit (I) revealed several rubbish deposits. Very dark soil interspersed with various iron and steel industrial rubbish including cables from the slip and possible condensers characterised the majority of the deposit. Large limestone blocks (0.5m square) with an iron ring in middle of one side were noted. These may have been deliberately dumped over the edge of the sea wall as reinforcement, along with the other material. Reinforced concrete piles were also found dumped over the edge of the sea wall dating from the 1922 re-piling of Victoria Quay. At approximately sea level, a corked but badly broken up bottle (NMM 36) was found concreted in a section of corroded pipe which was also in a pocket of an unidentified oily substance seeping from the trench. Subsequent to this discovery, the environmental consultants, Sinclair Knight Mertz, called a cease to excavation until samples were analysed. Preliminary observations were that the area should be classified Class 4 waste. NMR spectrum analysis gave a broad categorisation of the material as a high boiling point, aromatic petroleum product (possible poly-aromatic hydrocarbon like coal tar).

Fig 15 Area H west of contaminated Area I

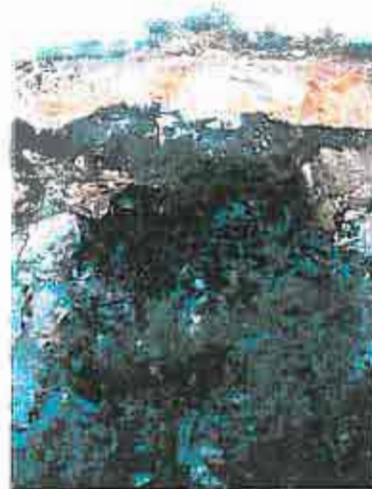
This area, at the south western end of site contained above acceptable levels of copper and lead in the fill. Contamination was excavated in excess of the original 1.4m as a pocket of foundry waste was discovered. This overlaid a storm water drain possibly dating from the 1920's when the area was used for industry. The majority of material, in particular, bottle fragments were post 1920 which also supports this conclusion. Included in this spoil was an earlier rubbish dump characterised by stoneware vessel fragments. There was also iron cable, steel girders and similar material which is most likely associated with the slipway and WWII/post WWII activity. Representative examples of material from these three periods were collected. The original headland cuts through the eastern side of the contamination hole as anticipated and the slag contamination has continued into some of this level fusing metallic oxide residue to the limestone.

Fig 16 Foundry waste

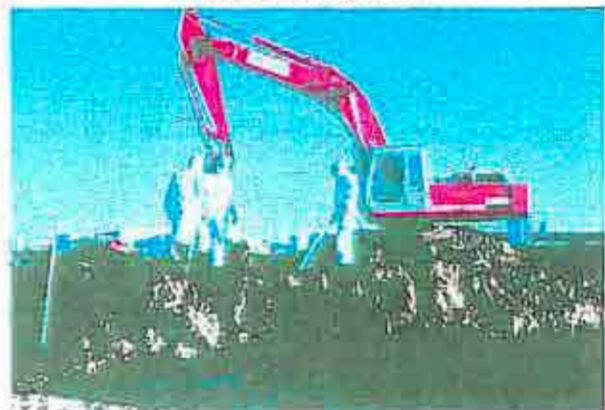
Fig 17 Contaminated Area I excavation

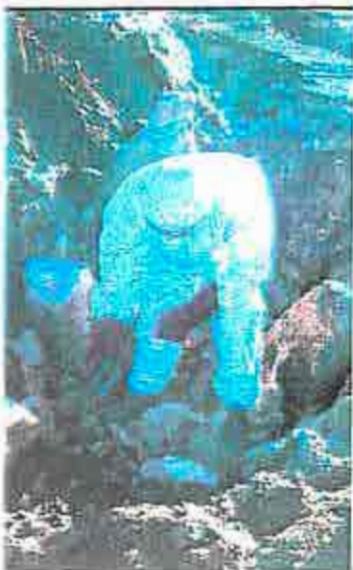
Fig 18 Retrieving bottle from Area I

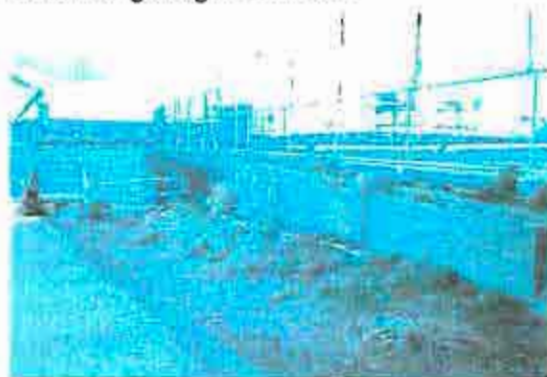
Although the majority was incorporated into Forrest Landing, part of the original headland of Arthur Head is still visible at the new Maritime Museum site. The formation runs parallel to the western end of the existing wharf at Forrest Landing in a north south direction for approximately 5m. The line of the original headland continues below the surface across the museum building site to the north west corner of the 600 tonne slip and has been exposed during excavation.

Fig 19 Residual headland

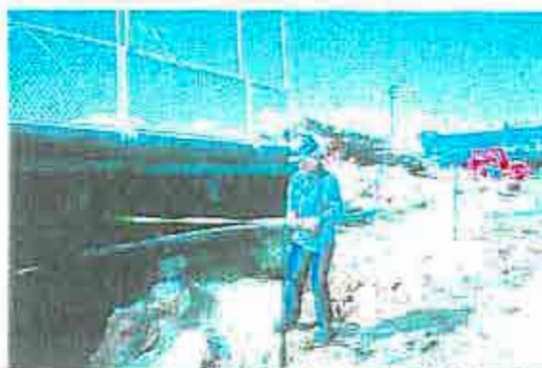
Fig 20 Sectioning off headland earmarked for preservation

This is a significant for the following reasons;

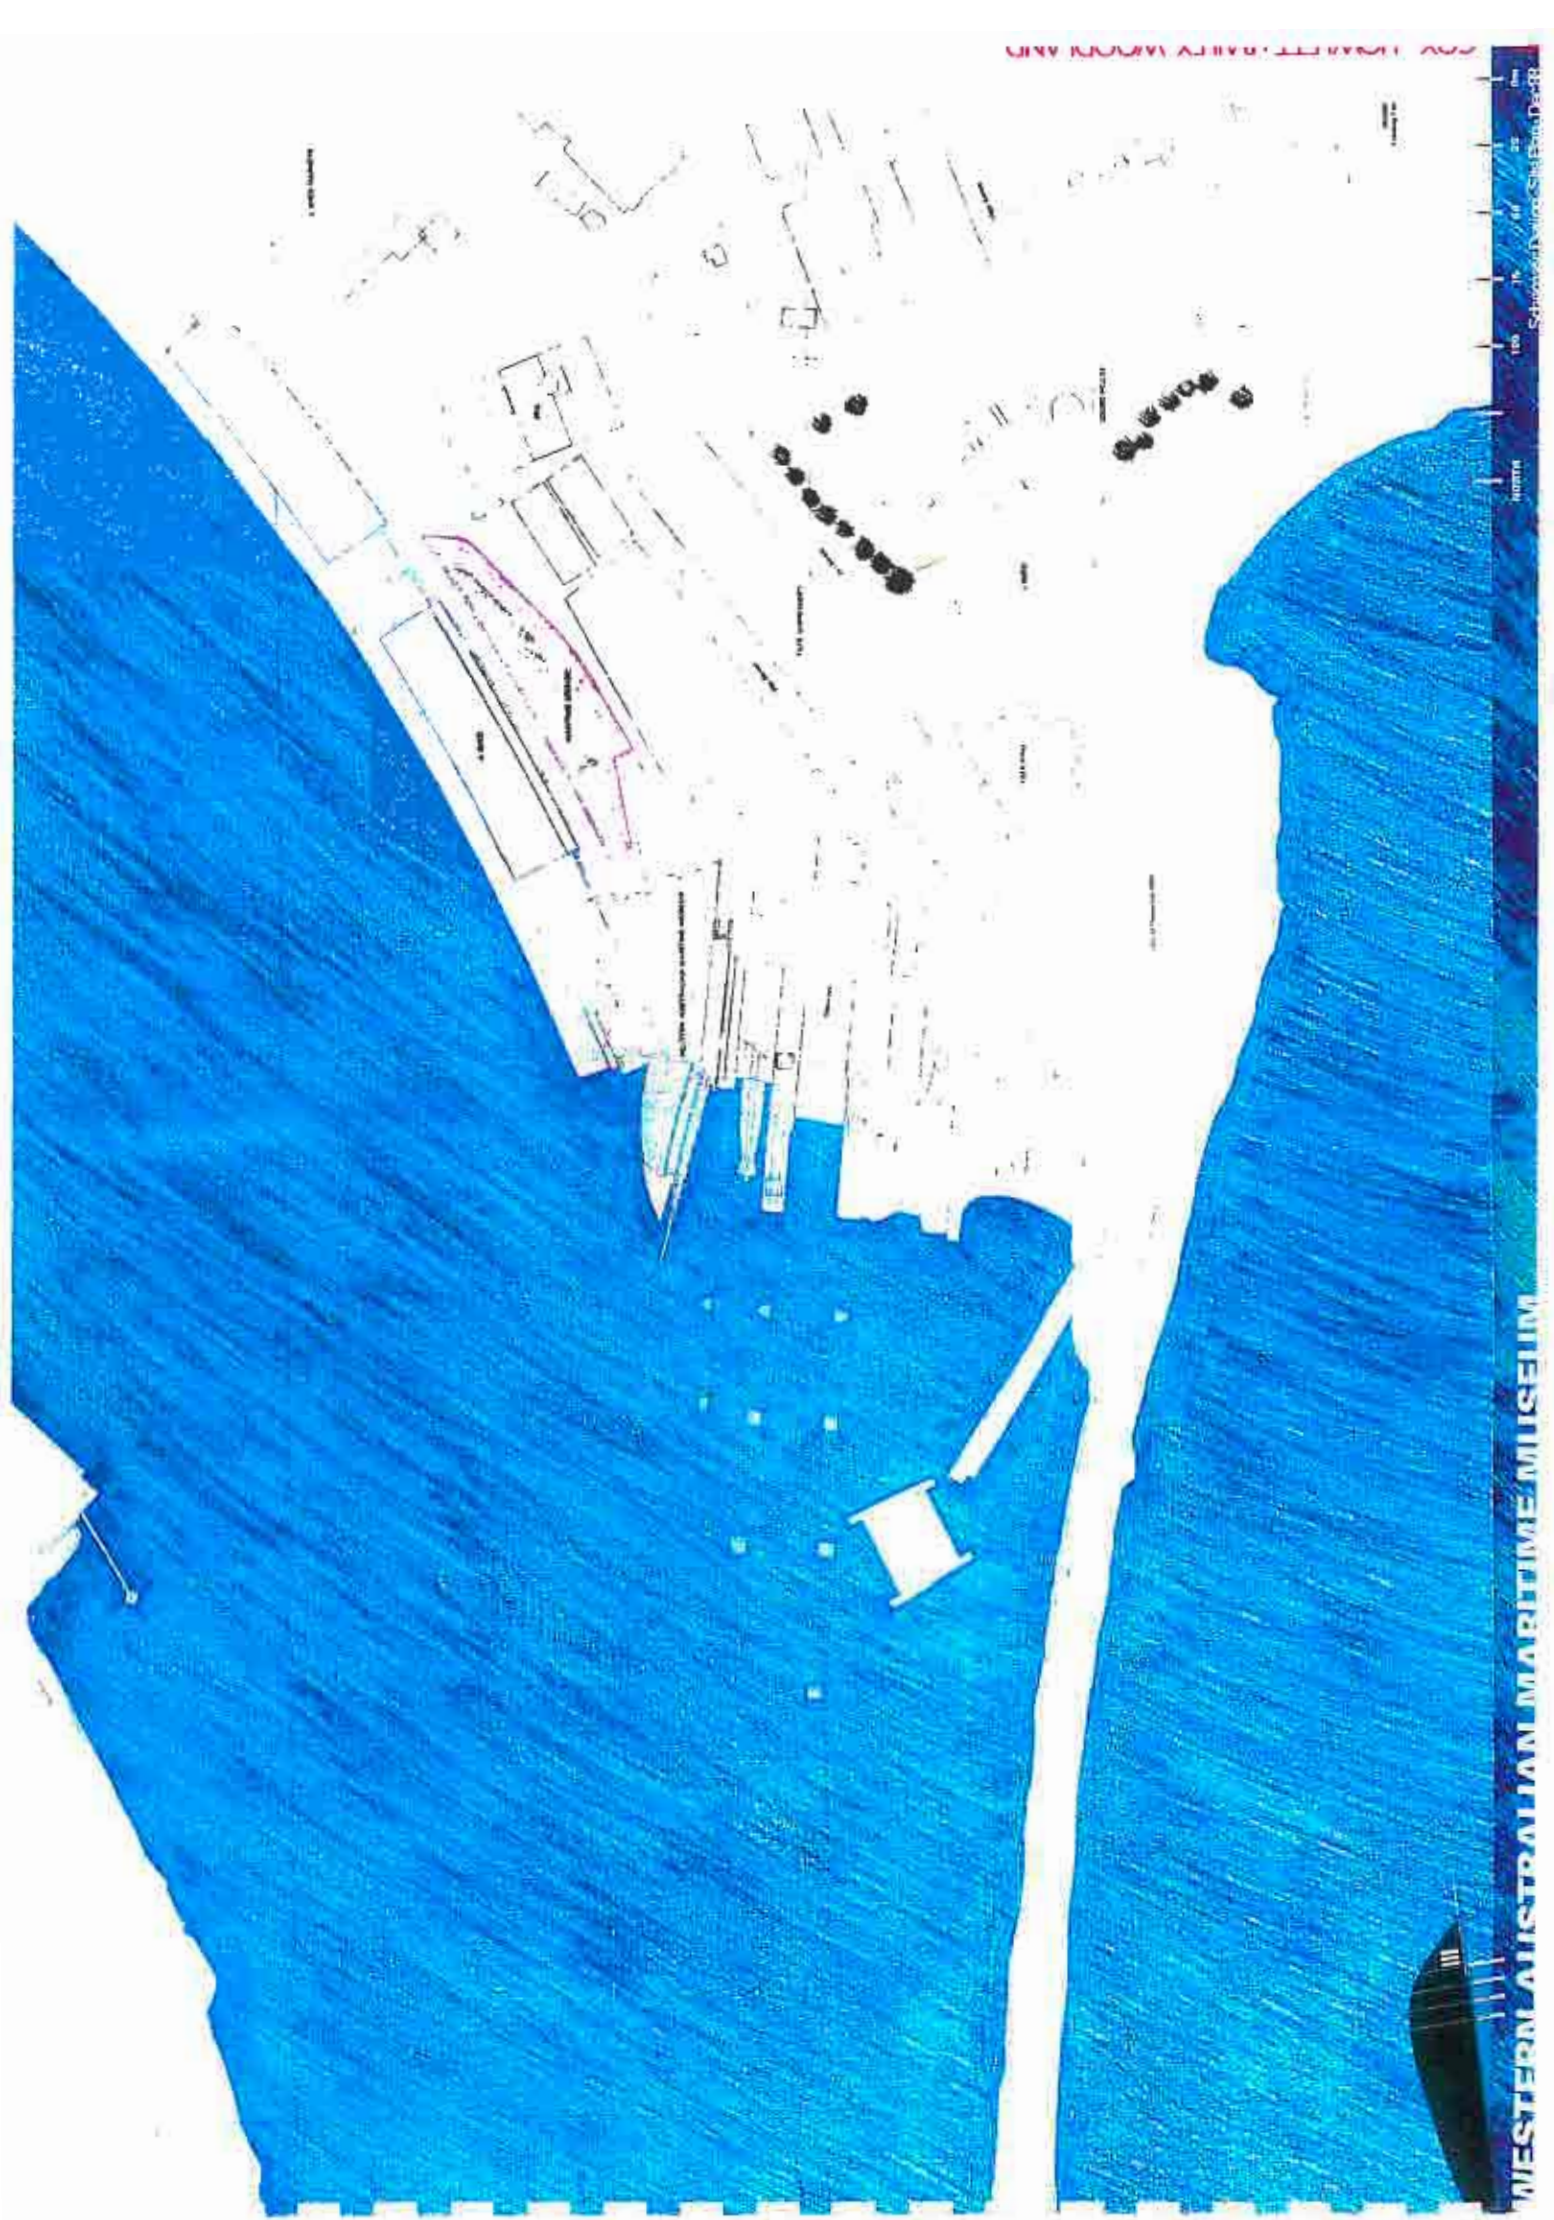
EXCAVATION AREAS

- A Surface of entire site prior to excavation (incorporating existing rail), 0m
- B Truck wash and fire hydrant drain, 1.9m
- C SW corner of concrete wharf, 0.8m
- D Drain, 3.5m
- E SE shallow excavation area, 0.3m
- F Northern 600 tonne slip walk way, 1.4m
- G SE corner of concrete wharf, approx. 0.1m (removal of concrete cap only)
- H SW excavation area, 1.0m
- I Contaminated fill (slag/foundry waste), 1.4m
- J Contaminated fill (petrochemical), 0.3m

as monitored as part of
Archaeological Watching Brief
July / August 2000
