Albany Foreshore Project Stage Two Interim Maritime Archaeological Survey Report for Landcorp

Ross Anderson, Jessica Berry, Jon Carpenter, Jeremy
Green, Michael McCarthy, Tracey Miller, Vicki Richards,
Corioli Souter & Wendy van Duivenvoorde
2008

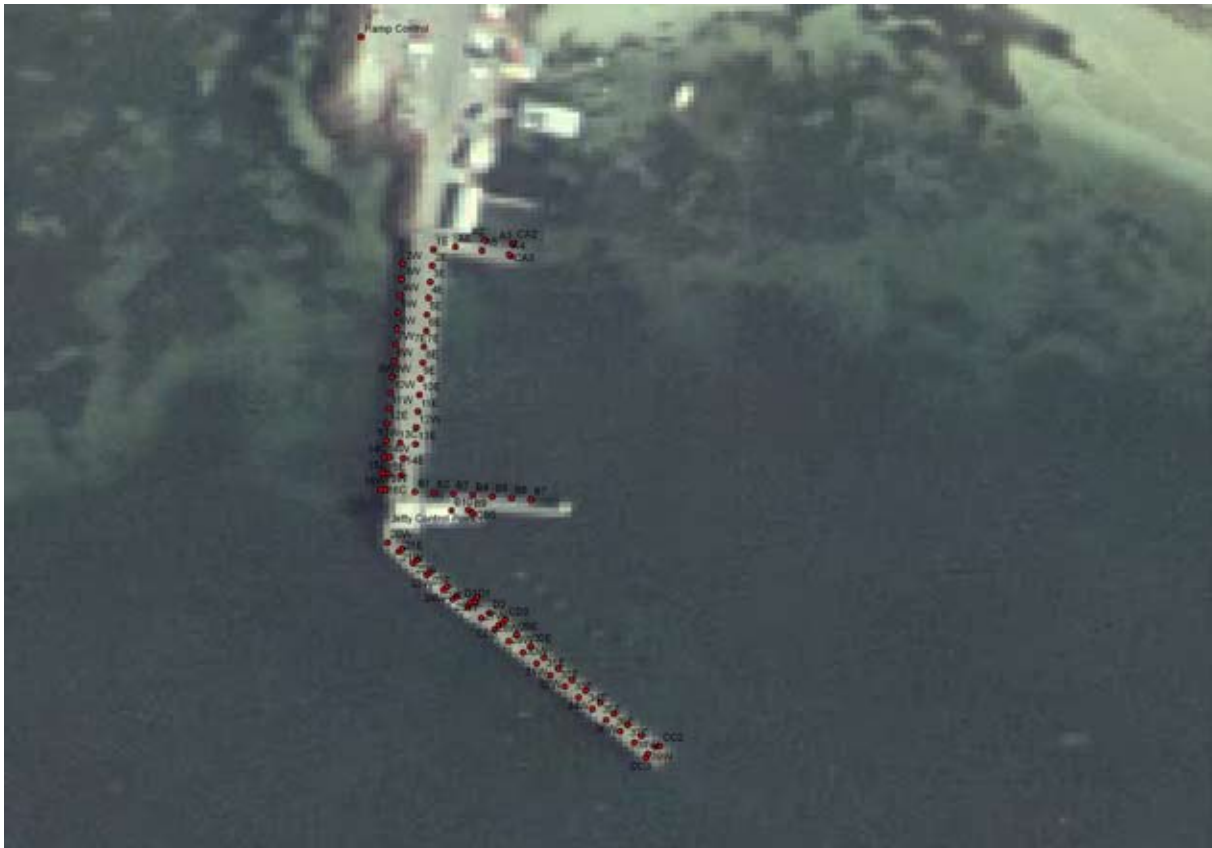
Figure 2. Total station survey of the existing Town Jetty piles.

Each of the jetty pile points was then mapped using the Leica total station and the data subsequently entered into an Arcview GIS programme. Note all the coordinates recorded during this survey were geographical latitude and longitude GDA94 datum. The resulting GIS overlay is a permanent record of the location of the modern jetty piles that can be viewed in relation to rest of the modern and historic Albany foreshore, based on aerial photographs and historic map overlays Figures 19 & 20.

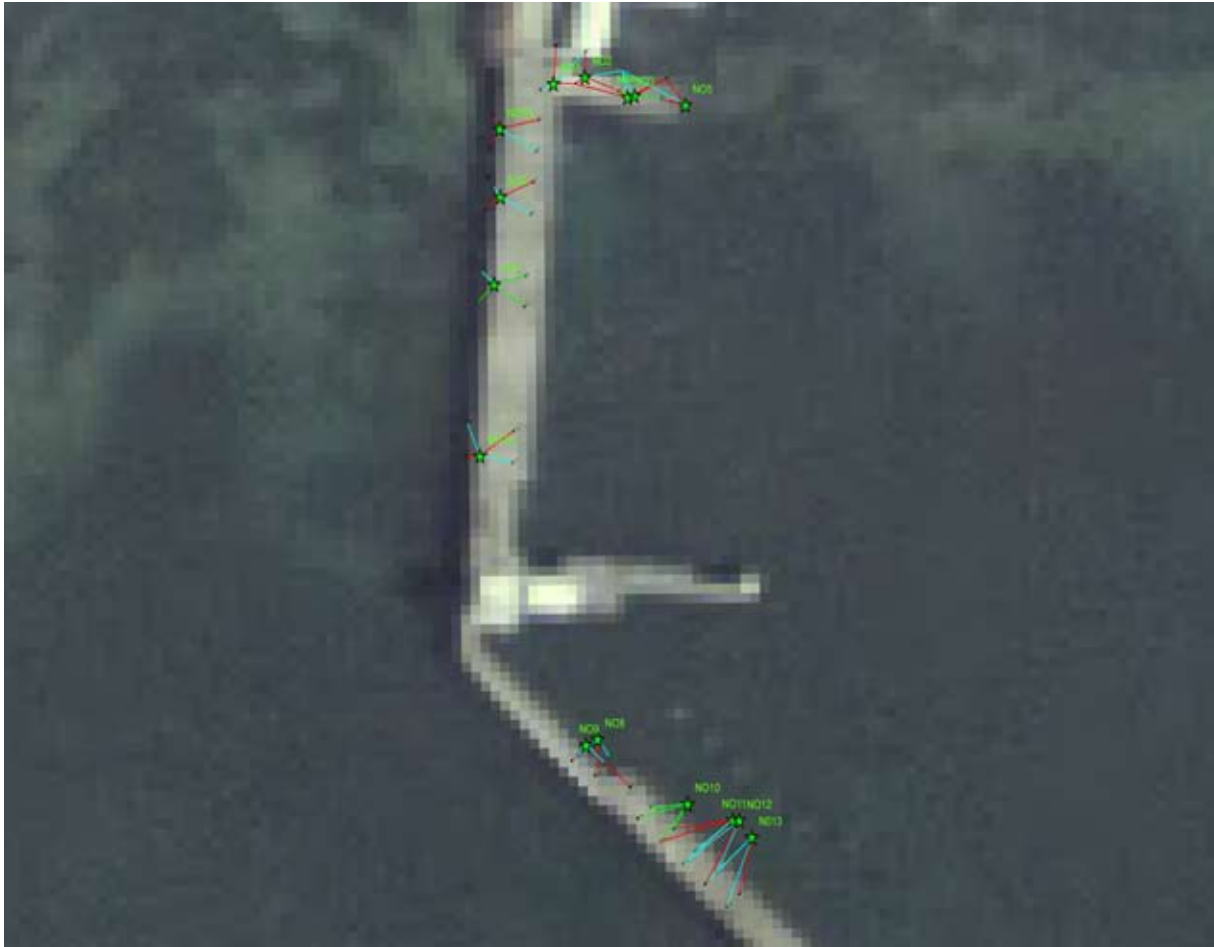
Figure 6. Survey positions of historic piles.

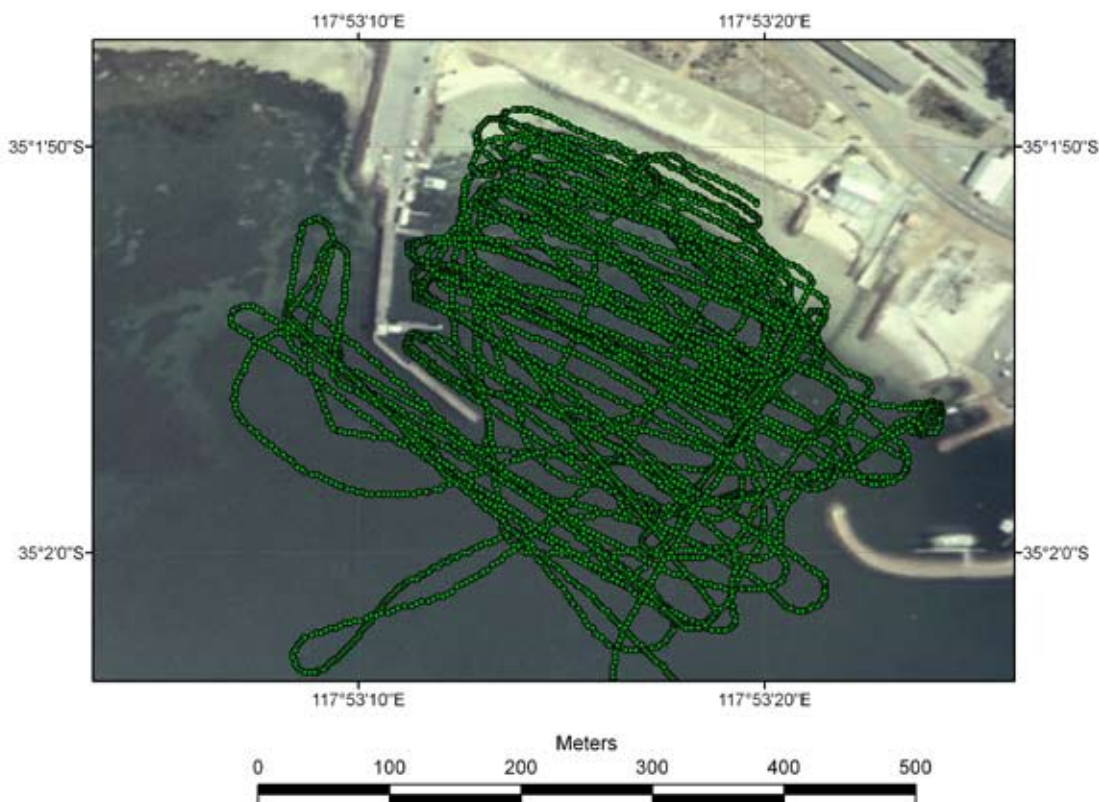
Figure 9. Plan of the track of the survey vessel during course of the three-day survey.

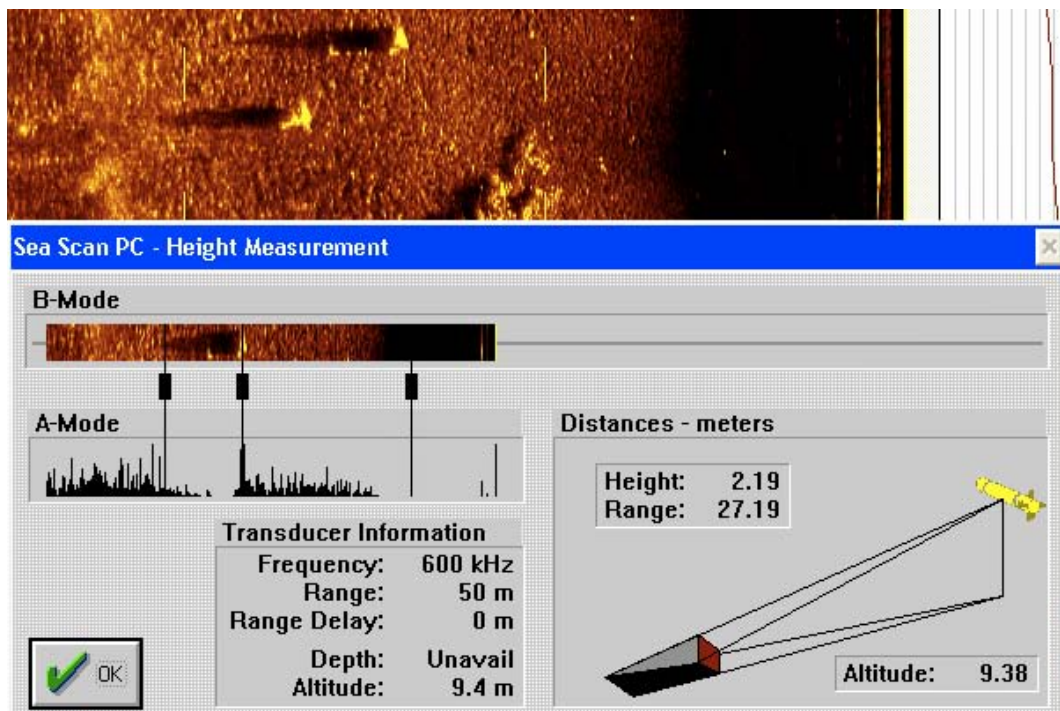
In Figure 9 a number of small targets can be seen in the centre of the image, using SeaScanPC software it is possible to measure the height of these objects. Figure 7 shows two small objects with acoustic shadows to left, by measuring length of shadow against the height of tow-fish above sea bed it is possible to determine the approximate height of the object, in this case the object is 2.19m high.

Figure 11. Screen grab of Sea Scan PC software showing the height measuring feature. In the sonar trace two small targets with acoustic shadows can be seen. The analog height measuring software places one of the three markers on the top of the object, one on the end of shadow and on the seabed (mid left). The analog shows how this operates in relation to the towfish (lower right). Target height estimated to be 2.19 m although the precise location of sea bed is not clear in this case, making measurement uncertain. Note magnetometer trace on upper right.

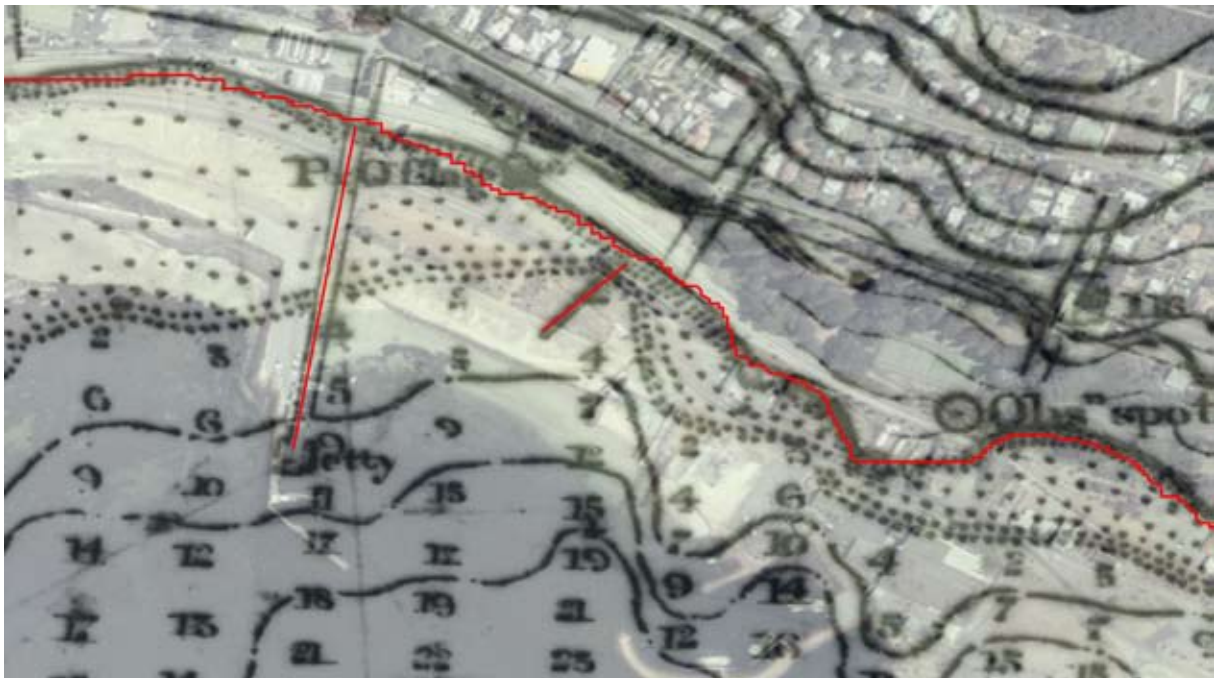
Figure 23. Trace of the original shore line taken from a semi-transparent georeferenced 1873 chart and superimposed over a contemporary aerial photograph.

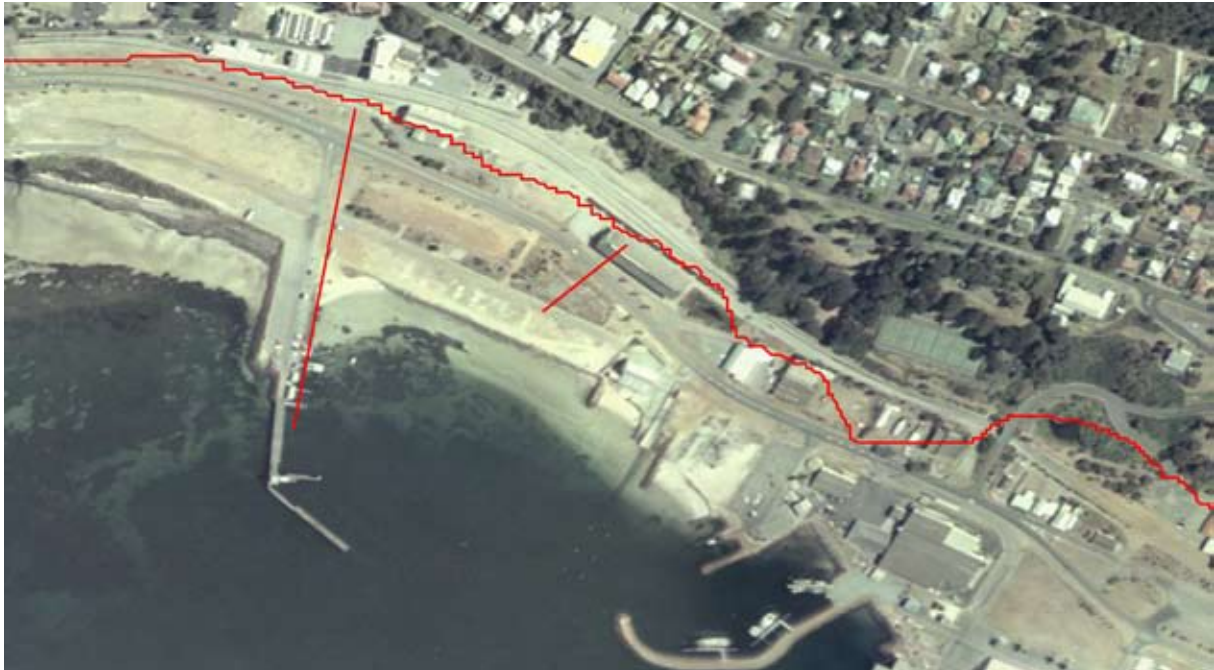
Figure 26. Trace with the semi-transparent chart removed.

4. Targeted test excavation and monitoring should be carried out in the area of the winch shed where the remains of the P&O floating dry dock are most likely to be found (see Fig. 26), prior to any development in this area.

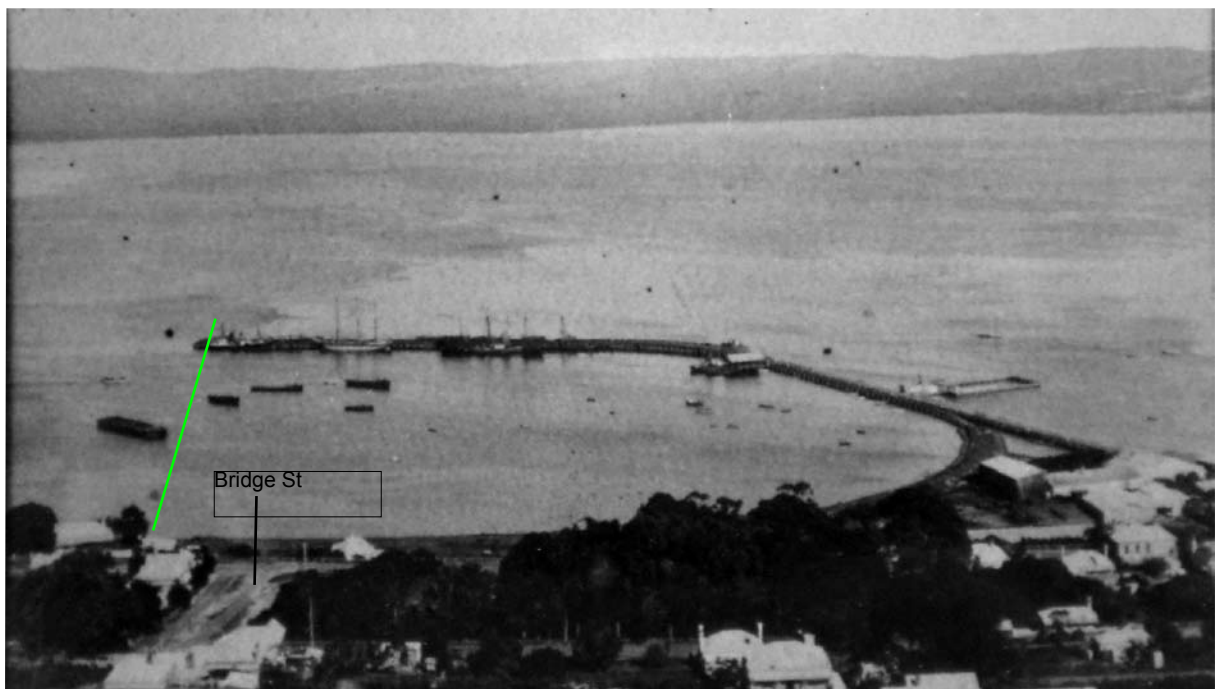
Figure 28. Undated view of harbour showing position line from end of the Whalers Jetty to slightly east of Bridge Street. Note the Whalers Jetty was demolished and the extent demolished can be seen by comparison with the modern situation in Figure 24.

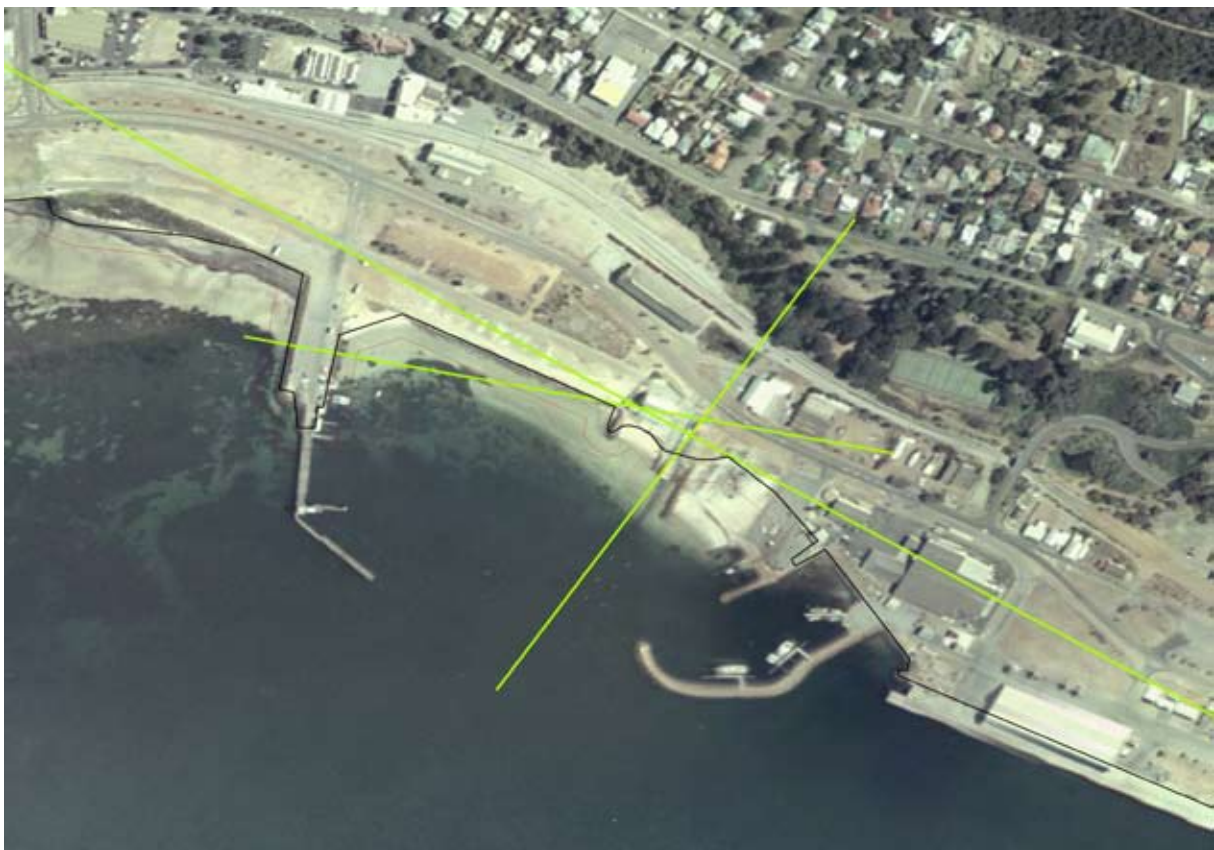
Figure 30. Position lines taken from following three historical photographs.

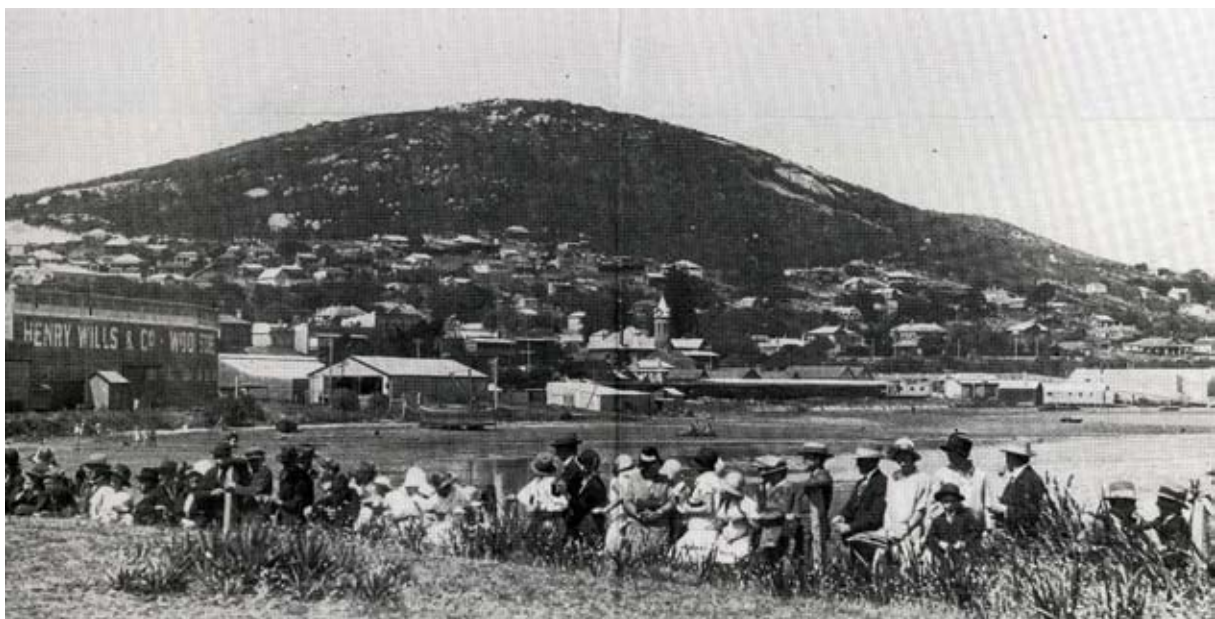
Figure 31. View from Residency Point 1927 (Albany Foreshore Development Project 1994)

A photograph taken from the Residency Point in January 1927 looking across the shallow flats fronting Albany shows the shallow seabed prior to its reclamation. The sea grass and shell layers encountered in both of the excavation grids were at the deeper end of the shallows as the seabed sloped into deeper water.

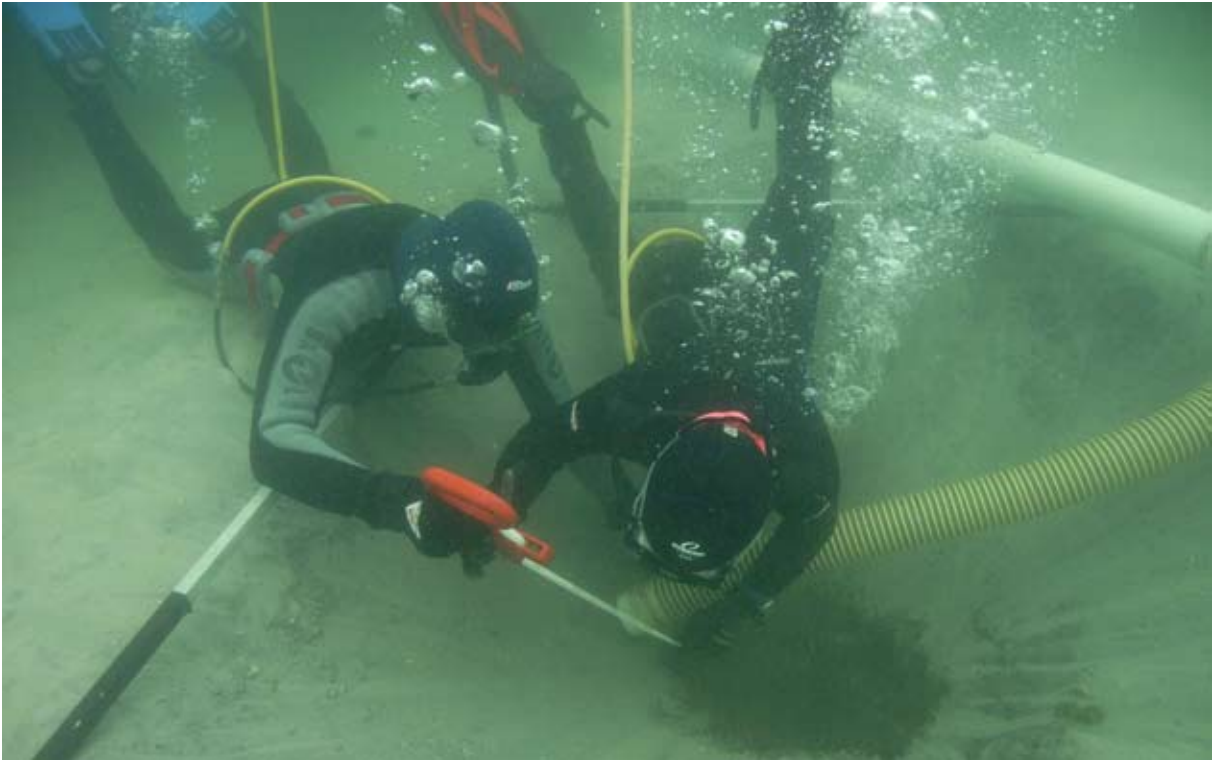
Figure 34. Archaeologists excavating test square.

In addition to referencing those test pits and test trenches dug in 1994, in 2008 two two-metre-square areas were selected for excavation. These were in shallow water (<2m depth) on a sand and weed bottom, close in to the sandbank fronting the existing stone harbour revetment wall east of the Town Jetty. The shallow sandbank itself was not selected for excavation as horses were being exercised in this area on a daily basis, and the possibility of accidental injury caused by a horse walking into an unattended deep excavation hole was considered an unacceptable risk.

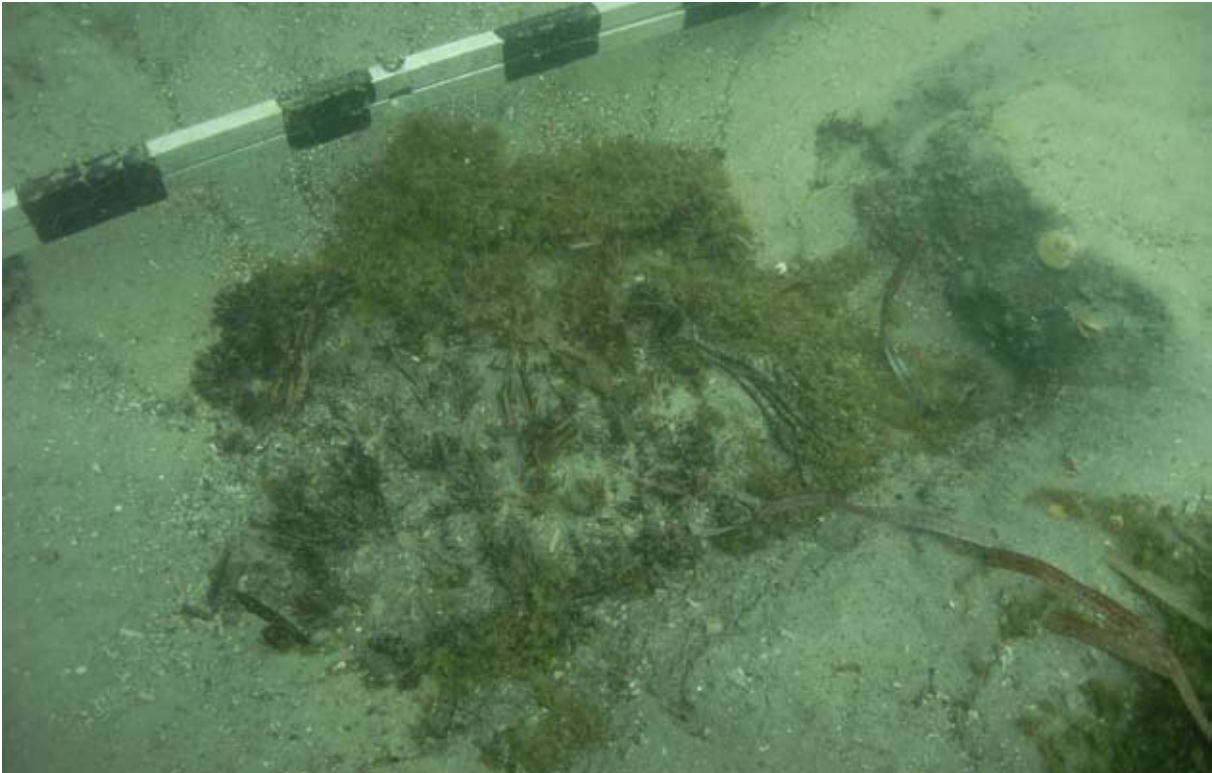
Figure 35. Seagrass mat.

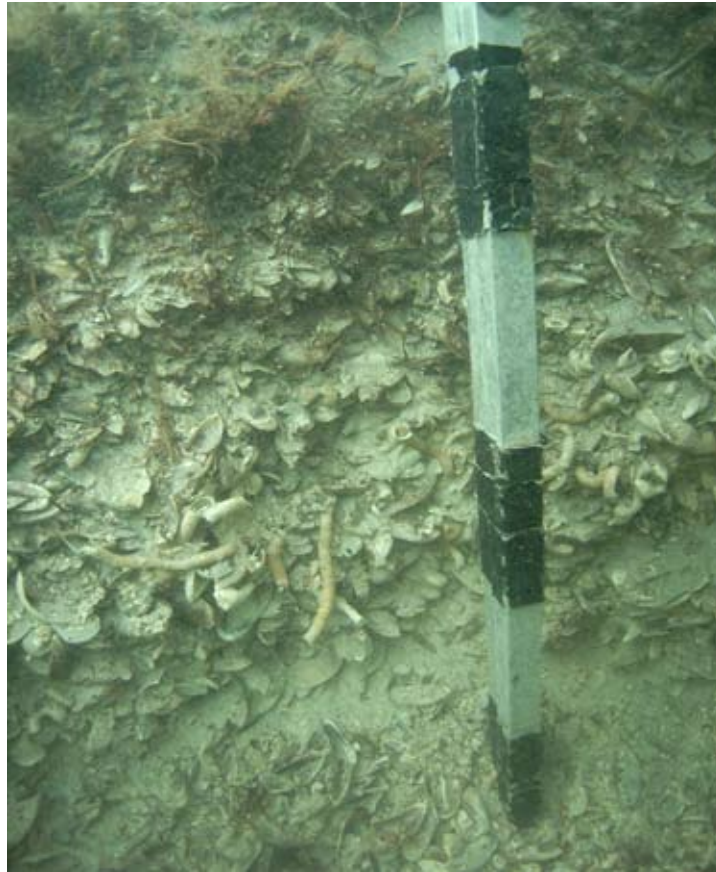
Figure 36. section through side of trench, showing differences in shell concentration.

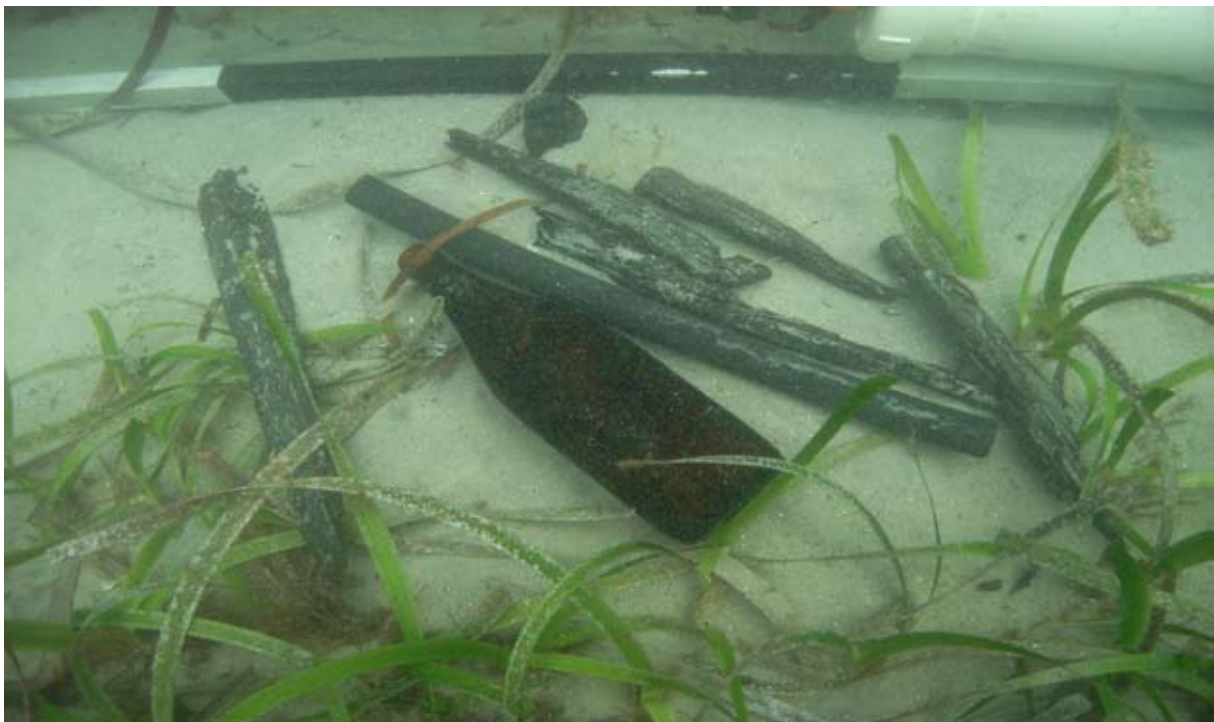
Figure 37. Modern artefacts on the sea bed.

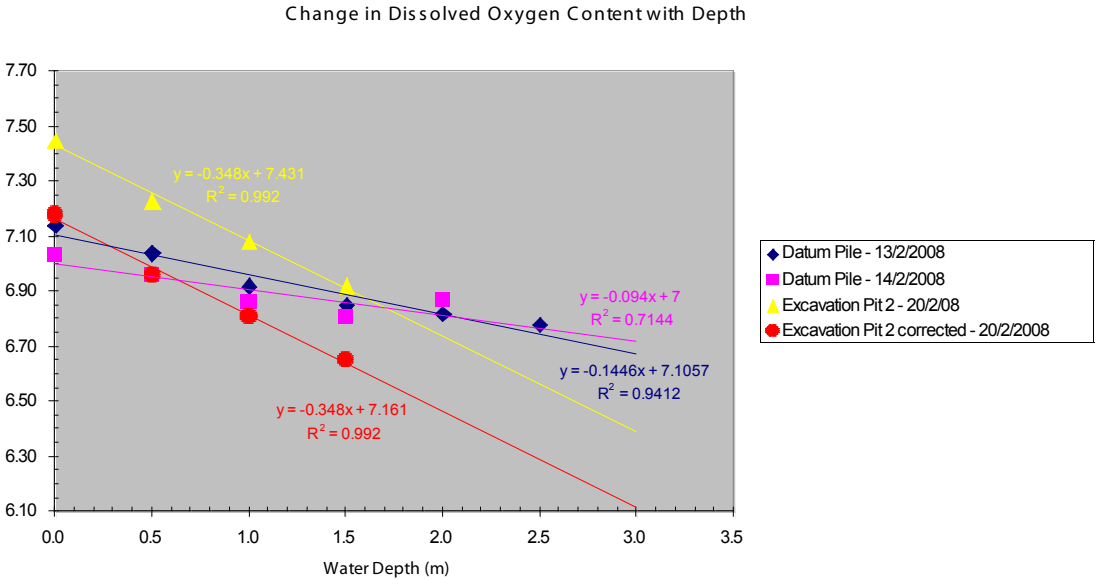
Figure 38. Change in dissolved oxygen concentration with increasing water depth on the Albany Town Jetty site.

It can be clearly seen from Figure 30 that when the dissolved oxygen contents are corrected for the temperature difference there is very little variability between the dissolved oxygen concentrations of the water column measured at different times and positions during the investigation period. Changes in these physical parameters can affect the corrosion and degradation rates of inorganic and organic materials in the marine environment, however the Albany Town Jetty site was relatively stable with respect to these parameters.

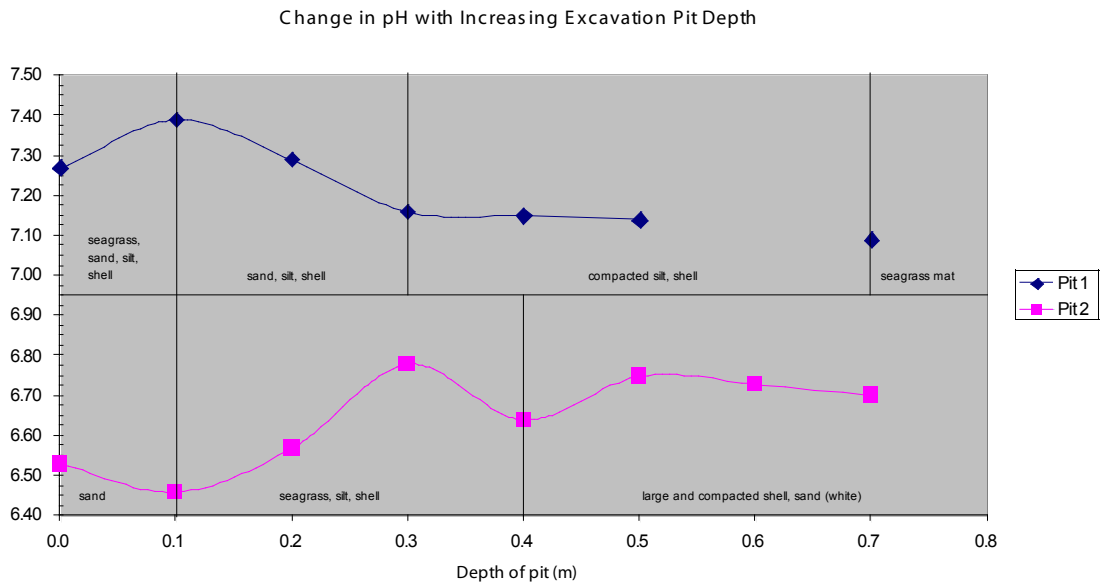
Figure 39. The pH of different sedimentary layers in the excavation pits as a function of increasing sediment depth.

The lower pH of the surface sediments (~7.27) compared to the pH of the aerobic seawater at 7.80 was to be expected due to the aerobic degradation of organic detritus concentrated in the surface fractions (Figure 31). The pH then decreased until it stabilised at approximately 7.15 in the compacted sediment layer at a depth of 0.3m. The pH then decreased slightly again when the dead seagrass layer was reached at the base of the pit due to the anaerobic decomposition of the plant matter by facultative and near-anaerobic bacteria producing weak acids and polysulphides.

The average pH of the surface sediments (0.2m) was approximately 6.50, which increased to an average pH of 6.70 in the compacted sediment (Figure 31). This sharp increase in pH would be due to significantly less quantities of deteriorating seagrass and increasing amounts of calcareous material present in this compacted layer. In addition, the pHs of the sediment measured in pit 2 were significantly lower than the those recorded in pit 1. This general increase in the acidity is simply due to the larger concentrations of degrading plant material in pit 2 as compared to the relatively sterile nature of the sedimentary layers in pit 1.

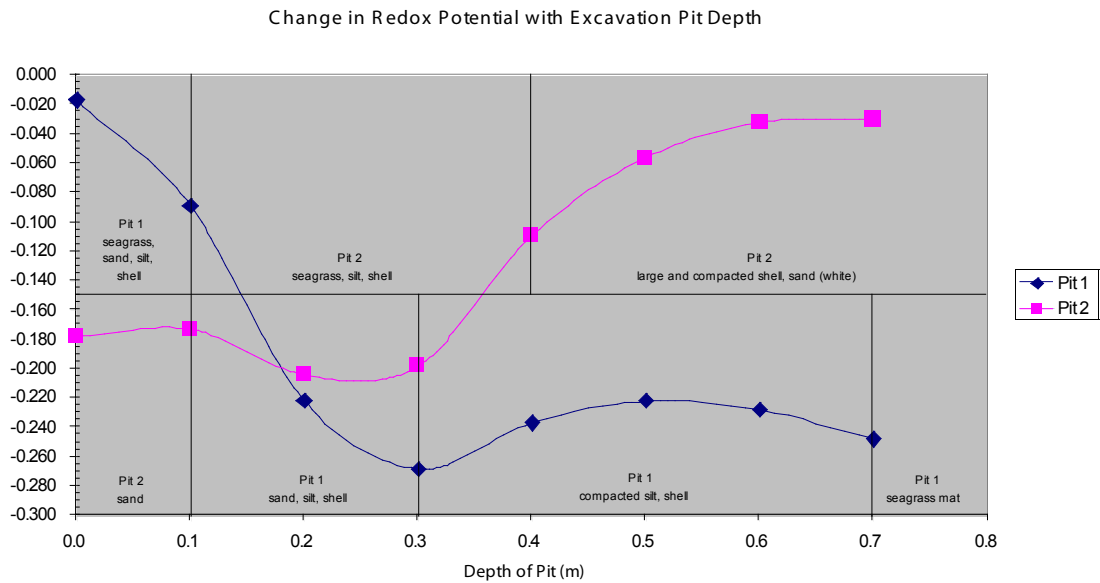
Figure 40. The redox potential of different sedimentary layers in the excavation pits as a function of increasing sediment depth.

The average redox potential of the seagrass layer in pit 2, which extended to a depth of 0.4m, was about -0.188V, indicating that this area was reducing in nature (Figure 32). Increased biological deterioration of the detrital plant matter would deplete dissolved oxygen concentrations in this layer, thereby producing a more reducing environment in this relatively shallow depth range. Below this depth, where the compacted shell and sand layer was observed, the voltage increased quite rapidly to a maximum potential of -0.030V, indicating that this layer was significantly more oxidizing in nature. The white appearance of the sand in this layer also supported a more oxidizing microenvironment as sediments in more reducing environments tend to become grey in colour. This can be explained by the absence of large quantities of organic matter in this sedimentary layer. Microbial activity decreases significantly with a decrease in the quantity of organic matter present in a sediment and therefore less dissolved oxygen is utilised in metabolic processes and a concomitant increase in redox potential ensues.

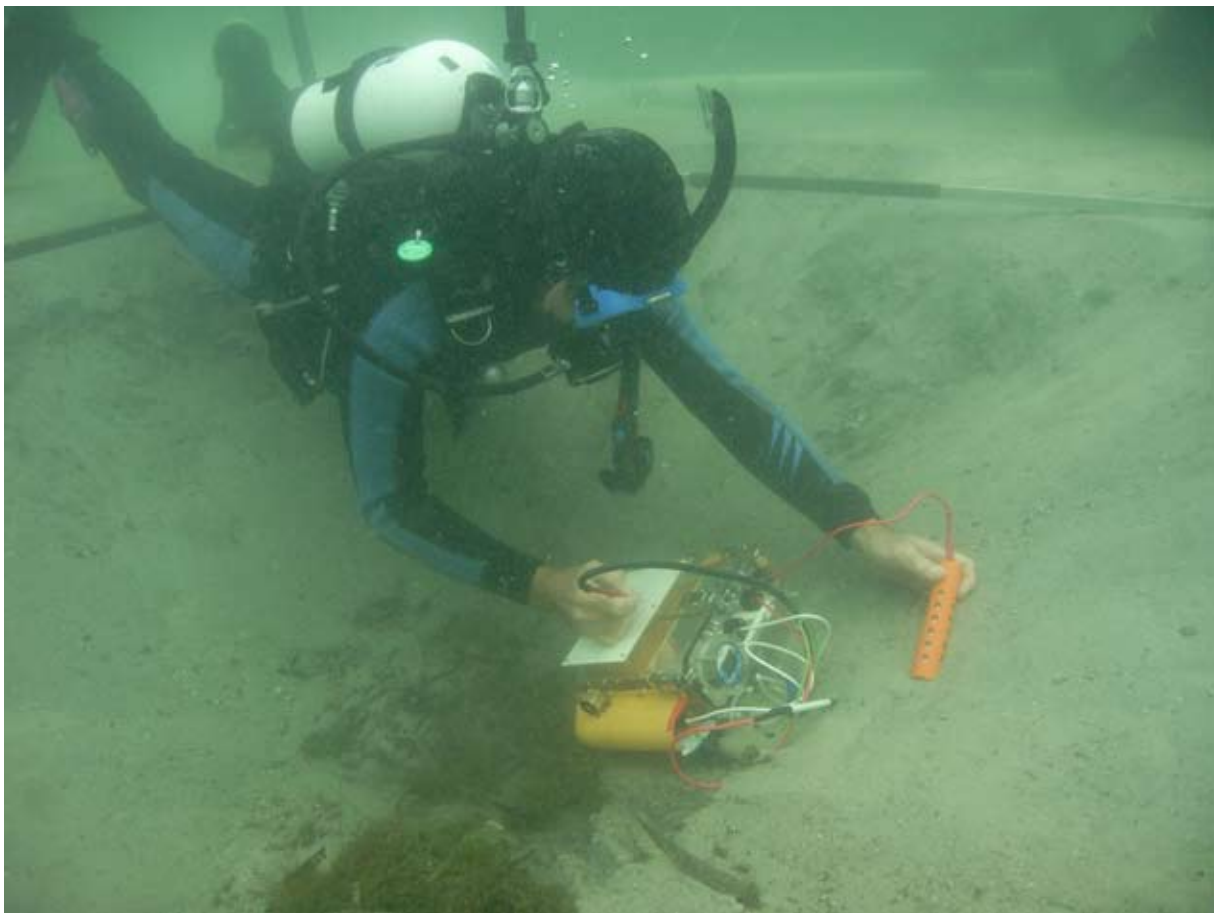
Figure 41. Conservator recording data in test pit.
