Survey of the *Solveig* (1903) shipwreck site, Point Samson

Report—Department of Maritime Archaeology, Western Australian Museum,
No. 296

August 2012

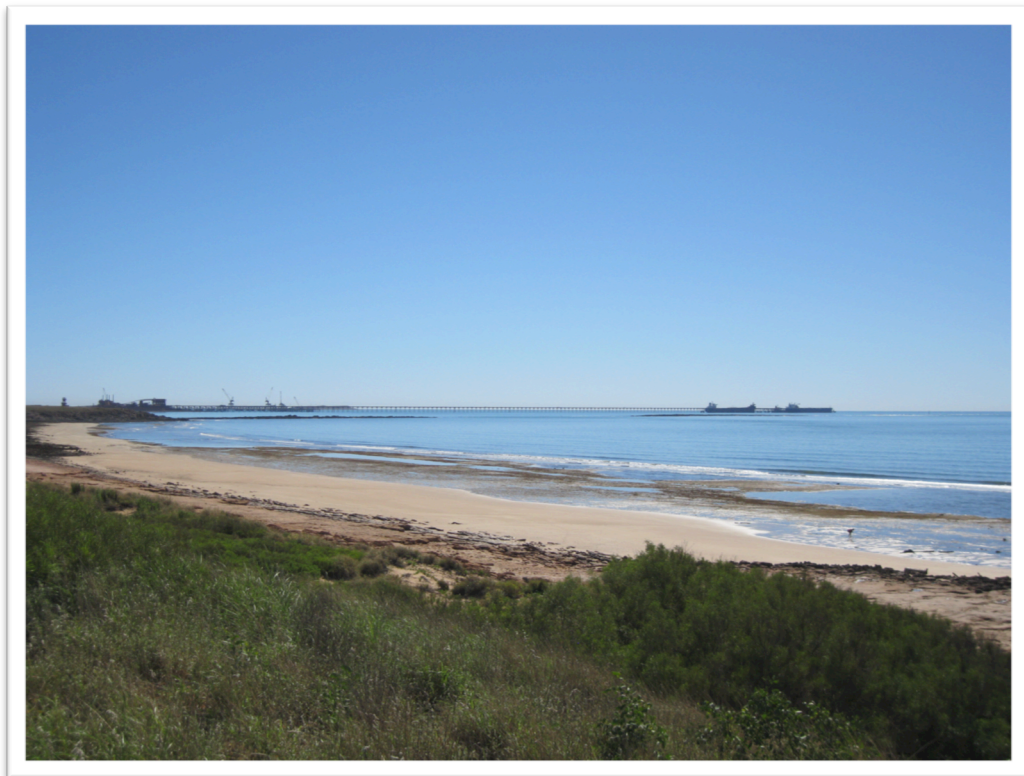
Seabed coverage: The site is spread over an area composed of sandy beach but mainly of rock and reef platform extending from below the low water mark to above the high water mark. Most of the site lies within the inter-tidal zone.

Colonizing flora and fauna: Mainly barnacles, but also small algae and sponges can be observed on surfaces of the ferrous features.

Figure 3. View of the site environment from the top of sand dunes (Photograph: R. Anderson)

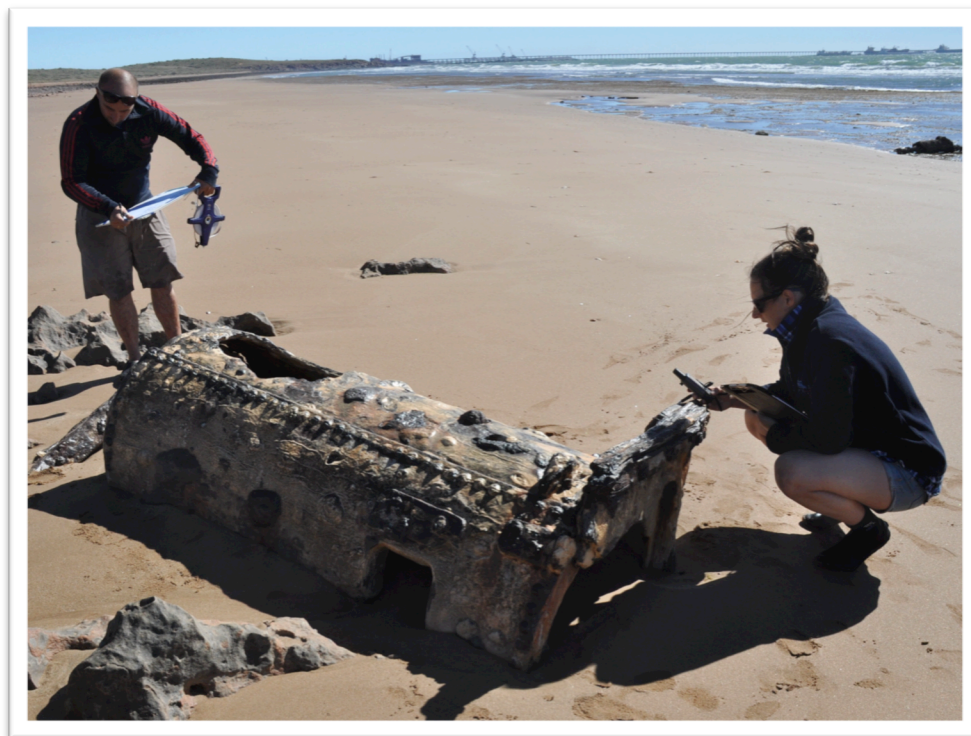
On the 25 June 2012, an attempt was made to conduct the survey using a total station (Leica TCR 305) placed from the top of the sand dune, adjacently to the *Solveig* Bicentennial of Western Australia plaque. However a technical malfunction of the theodolite's laser on the day caused this method to be abandoned. Alternatively, positions of the features were recorded using a handheld GPS unit by M. McAllister. Concomitantly, a mud map of the entire site and a brief sketch of each positioned feature was carried out by N. Bigourdan, along with a photographic record by P. Baker (see Figures 4 and 5, and Appendix).

Figure 4. M. McAllister and N. Bigourdan surveying the donkey boiler (Photograph: P. Baker).

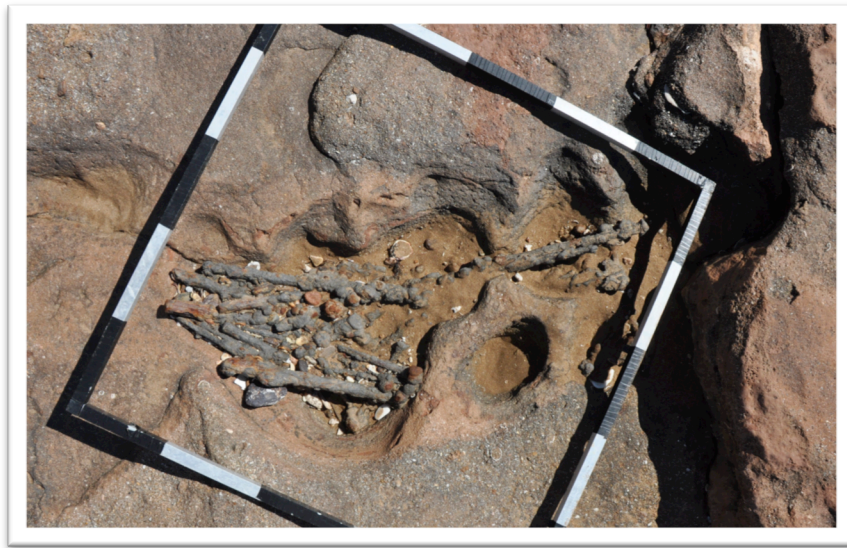
The majority of features are heavy non-portable items that remain concreted to the reef and rock platform. The site is fully exposed to sea-water and air, and the features are actively corroding.

Figure 6. Concreted bolts assemblage visible among gaps between rocks (Photograph: P. Baker).

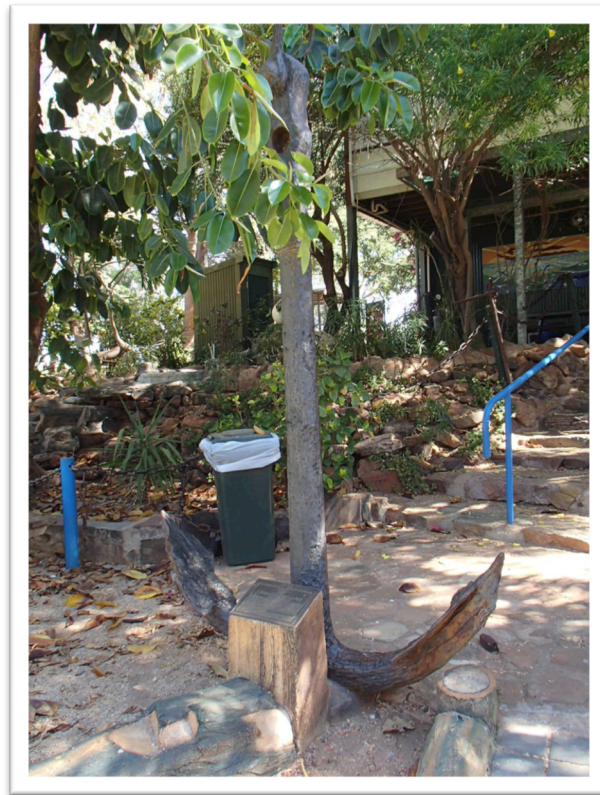
disappeared, only very minimal impacts are to be expected from human visitations to the site. For instance, no anchors have been recorded from the site, however an anchor is observable in the Samson Caravan Park and a plaque (erected as part of the Emma Withnell Heritage Trail funded by the State and Commonwealth as an Australian Bicentennial project (Figure 8). The presence of distinctive features such as the capstan or the donkey-boiler suggests that they were abandoned due to damage sustained and/or the vessel's age (McCarthy 1998). The patent windlass is longer on the site, and may have been salvaged for re-use. Although the site is considered to be stable, monitoring is recommended, as the area can be seasonally affected by strong winds and storms.

Figure 8. Anchor from the *Solveig* (Photograph: Anita Cheeseman)
