# **THE HAMELIN BAY, JERVOISE BAY AND MANDURAH SHIPWRECKS**

A field exercise linking wreck site archaeological research  
With wreck trail promotion

Submitted by Ed Punchard as a course requirement for the  
Graduate Diploma in Maritime Archaeology (MA 592)

Report—Department of Maritime Archaeology, Western Australian Maritime  
Museum, No. 140

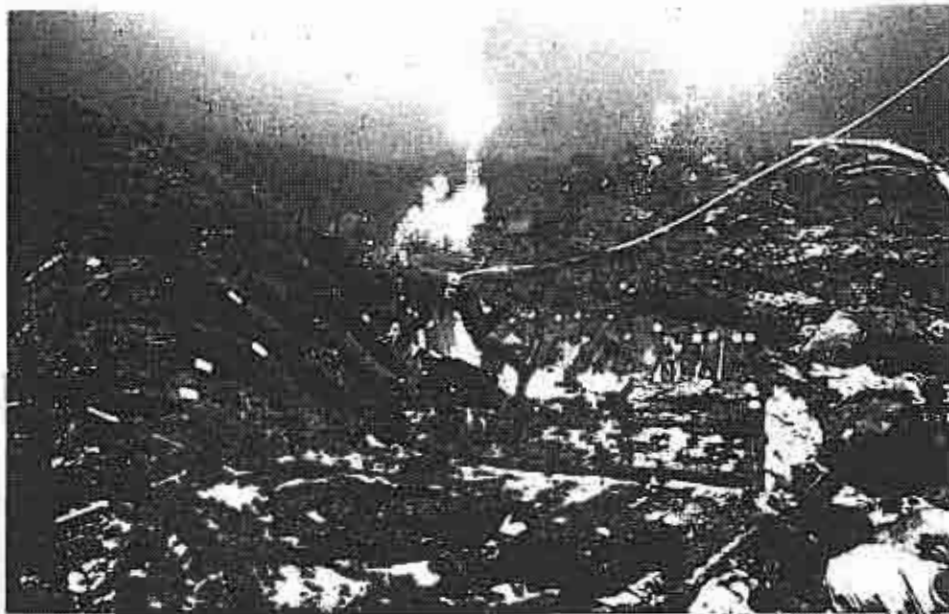
Figure 39: Timbers from the VOC ship *Batavia* lying on an Abrolhos reef. The stern quarter is clearly seen.
