Shipwrecks of the Ningaloo Reef: maritime archaeological projects from 1978–2009

Jeremy Green (Editor)

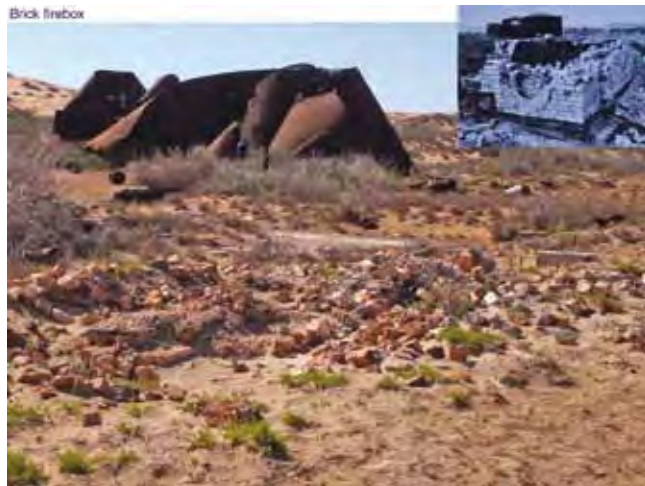
Figure 10. Brick fire-box, 1982 and 2007 (Colin Cockram).

As reported by Cockram in 2007, the brick fire-box shown in Stanbury (1985: 36, figs 16 and 17) is now reduced to a loose scatter of bricks, the latter being eagerly sought by transient campers and/or regular visitors to the area for the construction of barbeques. While undertaking the survey, parties in 4-wheel drive vehicles arrived looking for piping to build clothes lines at their temporary camps, and were somewhat surprised when told the site was protected as a historic site. Evidence of visitation was most noticeable by the graffiti on two of the digesters to the north-west of the central workshops area (Station 1) (Figure 45 and Figure 46), and inside one of the old Norwegian type digesters (see 1982 Site Plan, Figure 47).

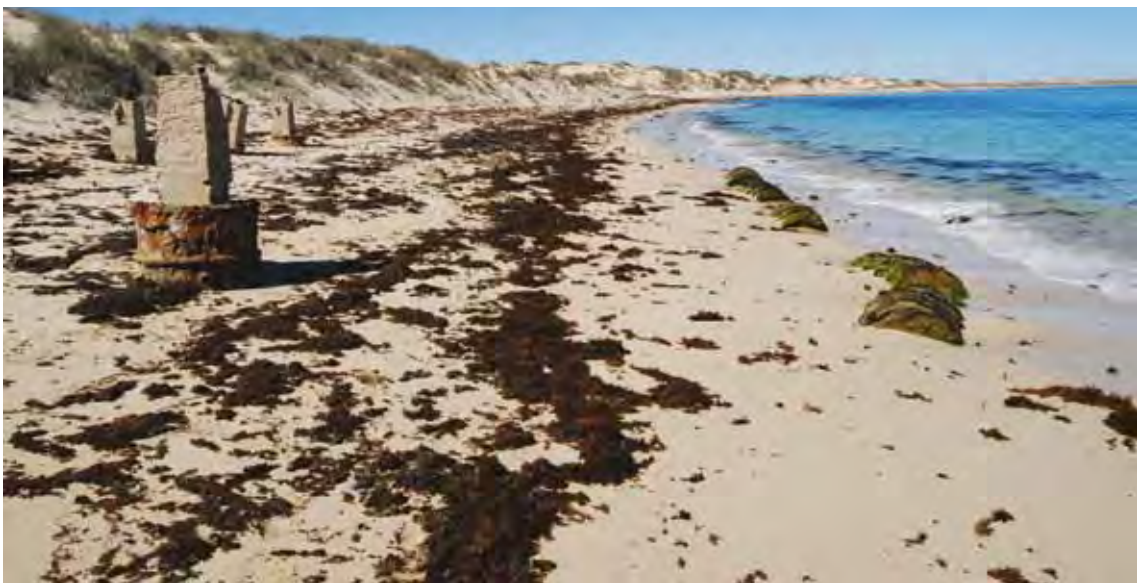
Figure 32. Concrete posts set in 44-gallon drums and other cemented drums halfburied in the sand 2009 (Myra Stanbury).

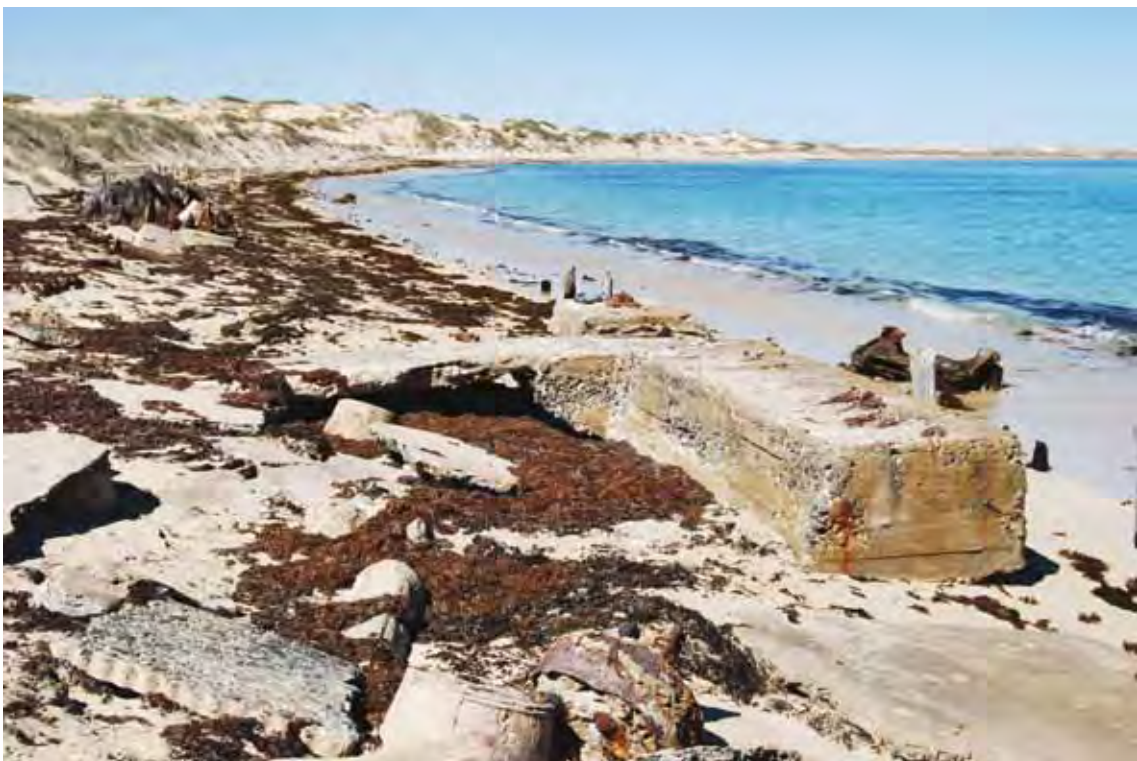
Figure 37. Concrete foundations, cement barrels and iron debris on beach 2009 (Myra Stanbury).

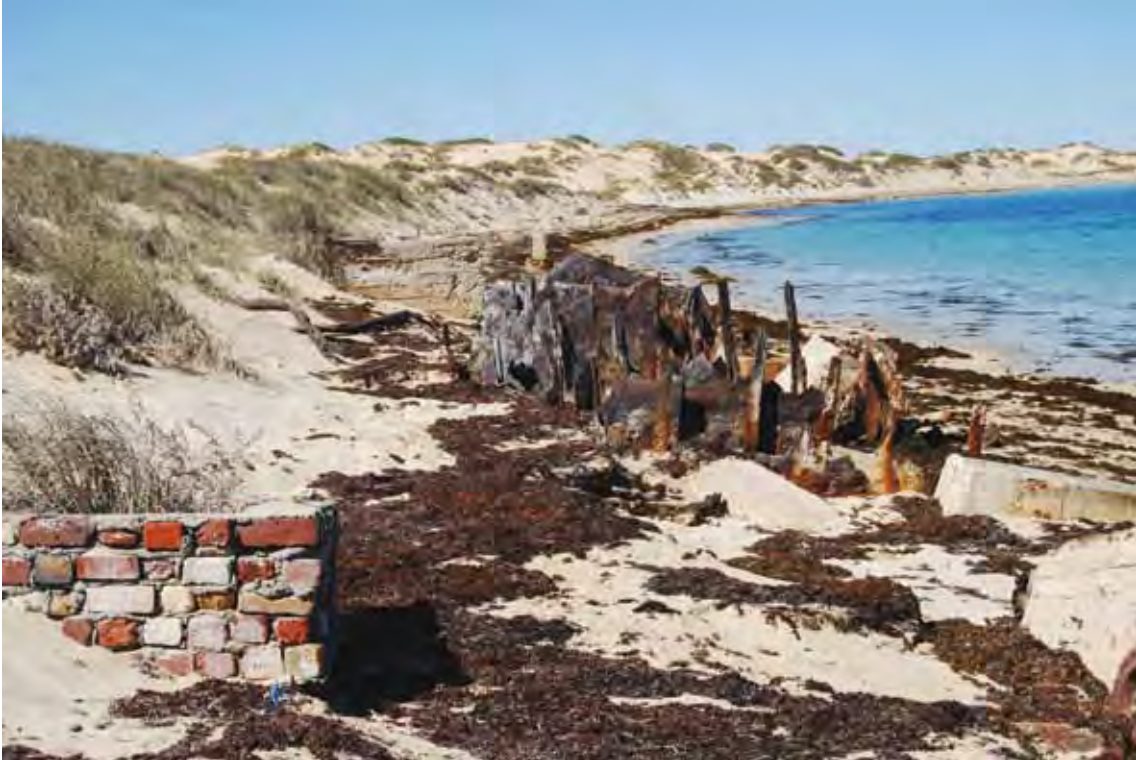
Figure 38. Brick structure, iron debris and fallen concrete pillars on the beach to the south of the former flensing deck, 2009 (Myra Stanbury).

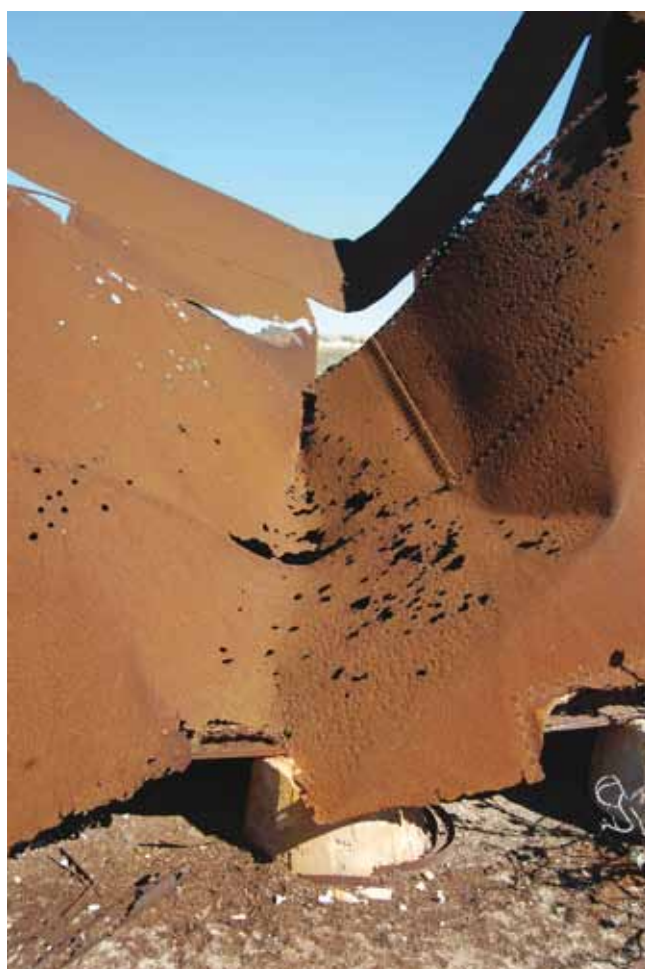
we experienced on the site, the collapsed walls of the tanks were observed to be continually moving. This constant movement would undoubtedly be one cause for the gradual separation of the walls from the base of the tank (Figure 51).

Figure 51. Wall of oil storage tank separated from the base (Myra Stanbury).

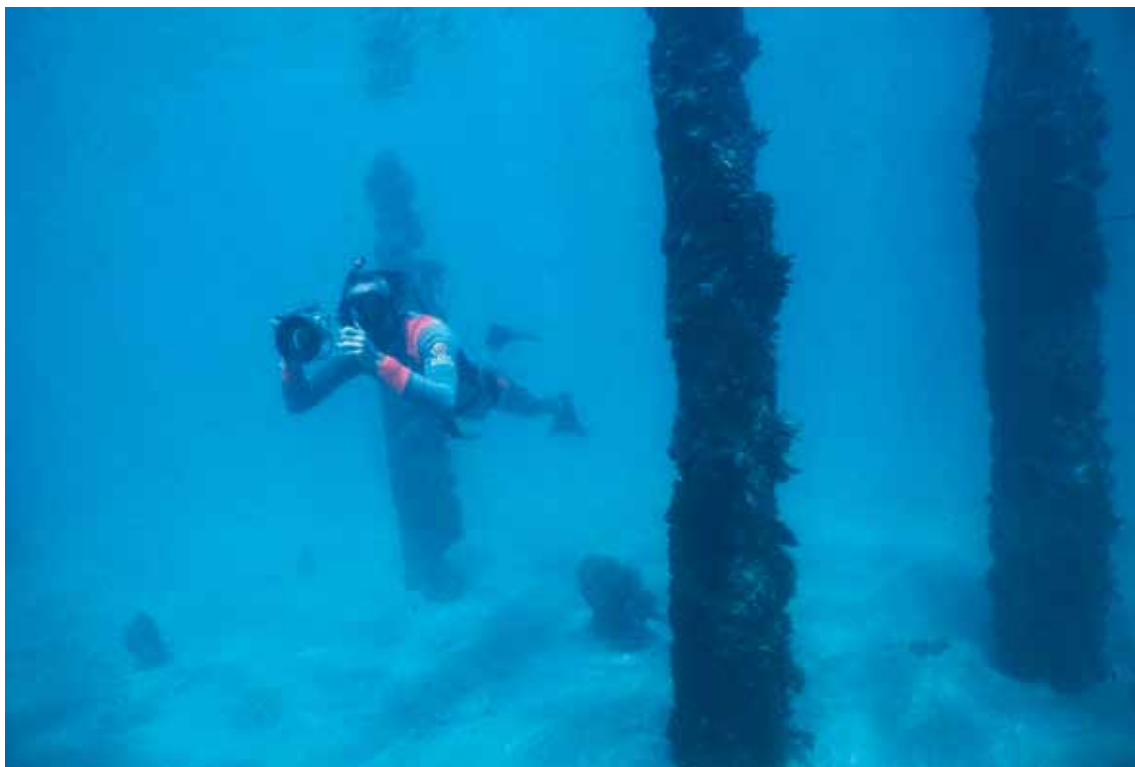
Now demolished, only a few piles remain visible on the seabed and above water. Despite this the remains are an historic structure representing the days of wool lightering in the late 19th and early 20th centuries and the heyday of the sheep station in the North-West.

Figure 62. The jetty piles at Maud Landing (Patrick Baker).

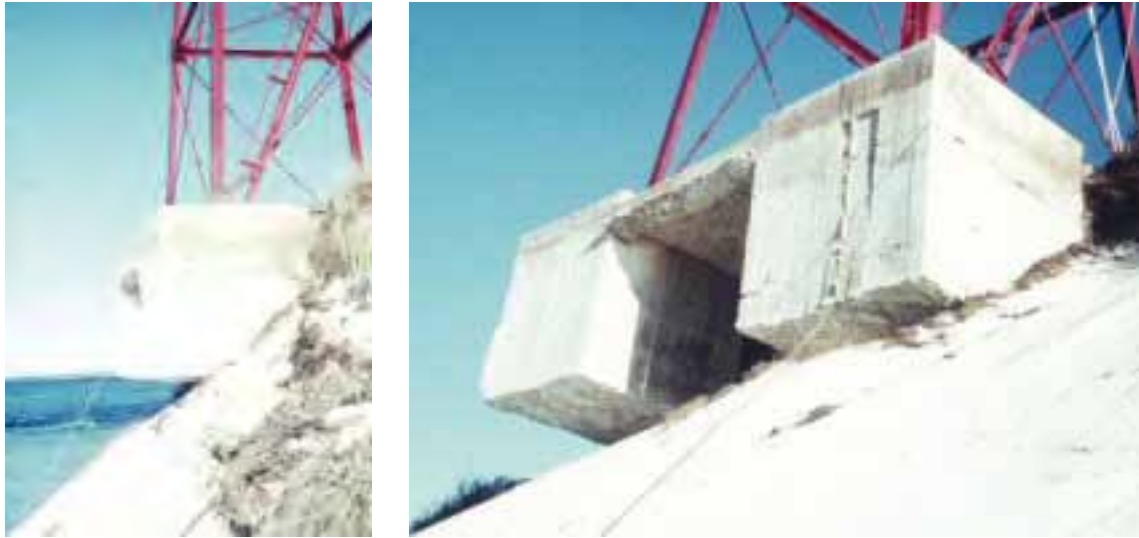
Figure 67. Fraser Island Light in the process of being undermined (Meakins Collection).

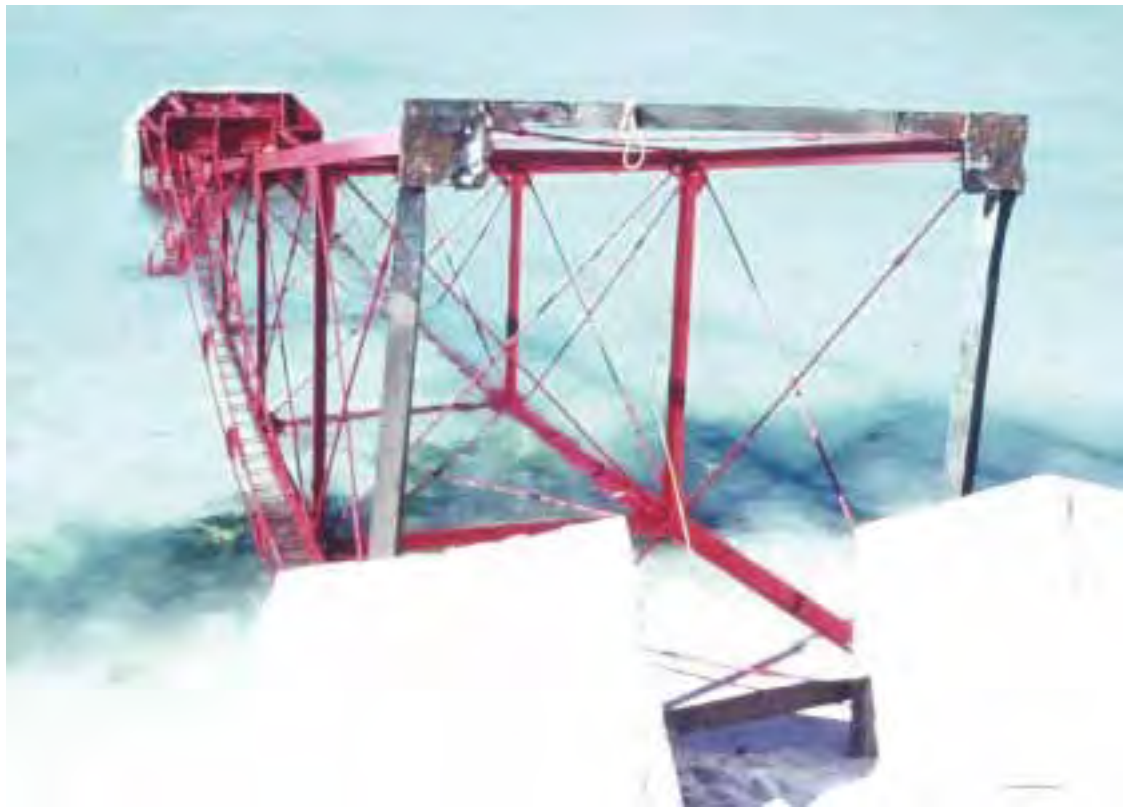
Figure 68. Fraser Island Light collapsed (Meakins Collection).

at an elevation of 97 ft (30 m) from a framework tower 74 ft (22.5 m) high (Cumming, *et al.*, 1995). The tower was repaired in 1949 but was swept away by a storm in 1966, blowing the island away from the base of the lighthouse tower as can be seen in Figure 68 from the Ralph Meakins Collection. The tower has gradually disintegrated over the years. It was visited and photographed in 2009 (Figure 69).

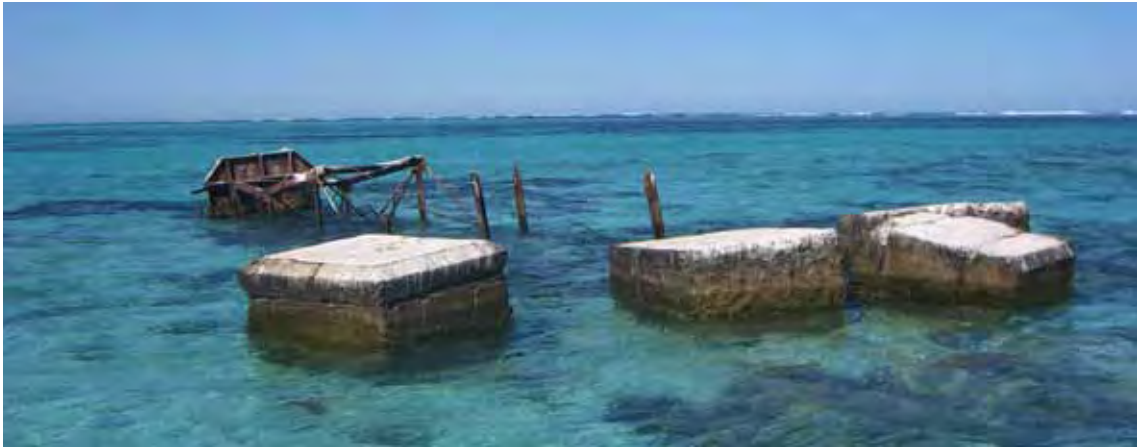
Figure 69. Remains of Fraser Island Light in 2009 (Jeremy Green).

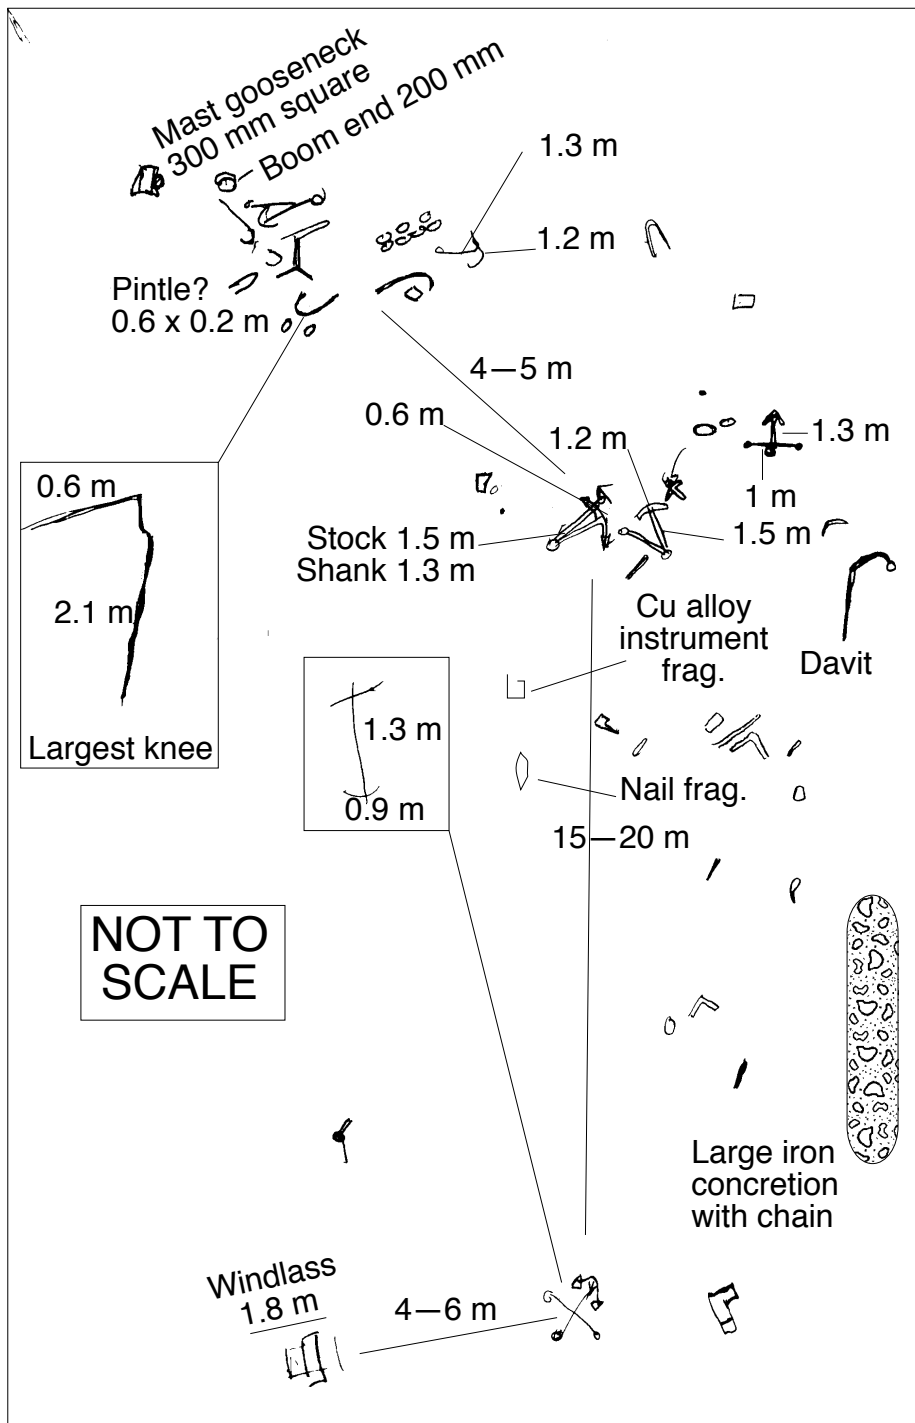
Figure 79. Sketch plan of the *Emma* wreck site in 1988 (Geoff Kimpton).

The site plan (Figure 79) shows the major features and the objects raised for security, conservation and diagnostic purposes. These were the crushed diving helmet (Figure 84), sheathing fragment, a deck light, assorted fastenings and fittings, a ballast sample, bottle, sherds, the small boat gudgeon, the stencil letter, a length of chain with 4 in x 3 in x ¾ in links and a bottle. In examining the evidence, it was concluded that the wreck is that of a mid-to late 19th century vessel, iron fastened in the deadwood, keel and keelson, and part copper and brass fastened elsewhere. Iron knees and in some places knee riders were also used in the construction of the vessel. The two anchors, with stocks set, are more an indication of vessel size than those apparently being carried as cargo. The chain and fastenings sizes point to a substantial vessel of the 100–200 ton range, most likely European built. The presence of the davits, small boat gudgeon, diving helmet, wool bale stencil?, lead ingot and two book presses are significant and make a NW destination or point of origin likely. Of the vessels lost in that trade only the *Emma* (1867) and *Occator* (1856) fit the size and temporal range.

WRECK DESCRIPTION: See the *Emma* sketch plan (Figure 79 on page 69) in this report. The wreck site consists of a dominant mound (approx. 2 m² by 1 m high) of iron objects, corroded and concreted together and a number of isolated iron objects at varying distances around this focal point. Wreck material is concreted to the seabed and/or held there by its own weight. Anchors (Figure 80), a windlass (Figure 81) and two iron presses (Figure 82) are easily recognized. A number of other iron fittings will need to be identified. One of the presses is held by concretion to the main mound; the other sits atop a pedestal of coralline concretion a short distance away. It would appear that this press must have formerly been held in this elevated position (approx. 300 mm off the seabed) by parts of the ship that no longer exist.

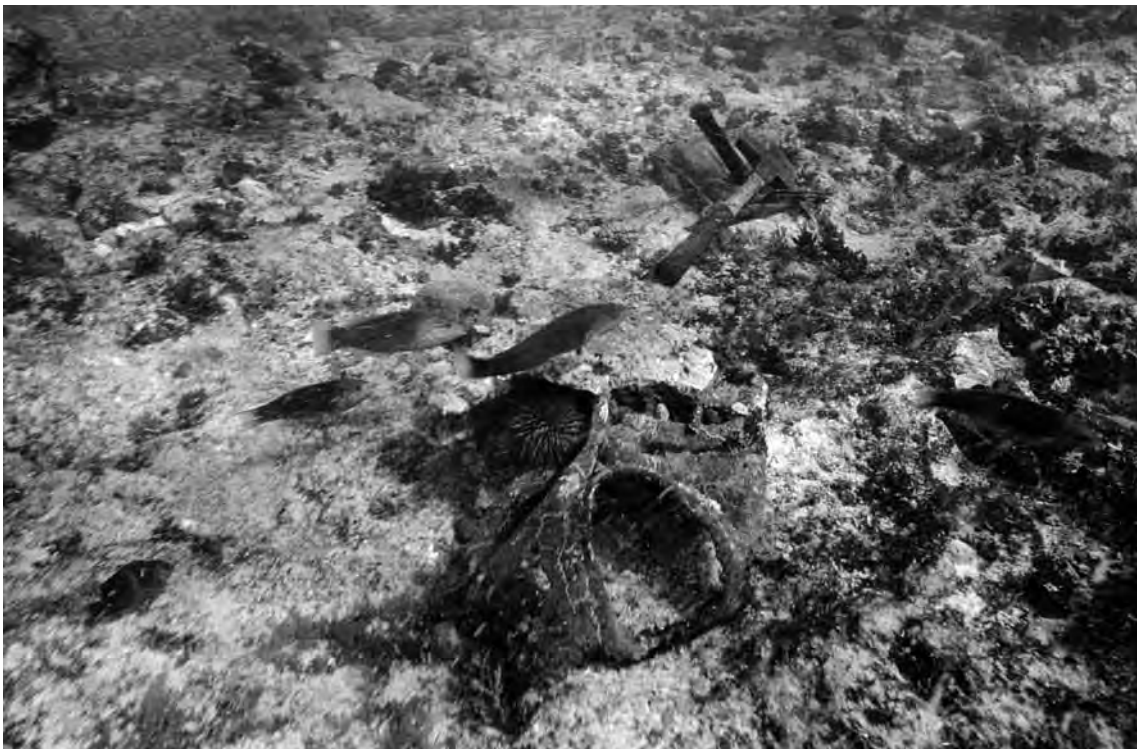
which terminated in the bilge. Two davits...were recorded, as were iron pump sections, piping, 2 hawse-pipes one at each end of the site, and the remains of a crushed diving helmet (Figure 83). This was seen concreted to what appears to be a pump section. Ballast stones are in evidence throughout. The concretions appear very rich with 1 lead ingot 25 x 13 x 7 mm visible, 2 book presses [one a 400 mm x 250 mm press, Figure 82], copper sheathing, one piece being a wool bale stencil with the letter 'P' clearly visible. Iron bolts in much corroded form are also visible (c. 20 x 2.5 mm). A diaphragm pump appears overgrown by coral close to a windlass 1.8 m in length. At a bearing of 210° from the cargo anchors and at a distance of 50 m a small boat gudgeon, fastenings, a diving helmet, wing nut and other assorted brass materials were recovered.

The location of the 'diving helmet', or 'hard hat', on the wreck (Figure 83) poses an, as yet, unanswered question about the chronology of the use of 'diving apparatus' in the pearling industry. The find also reinforces the understanding that *Emma* is an extremely significant wreck.

Figure 83. Diving helmet *in situ* in 1988 (Graeme Henderson).

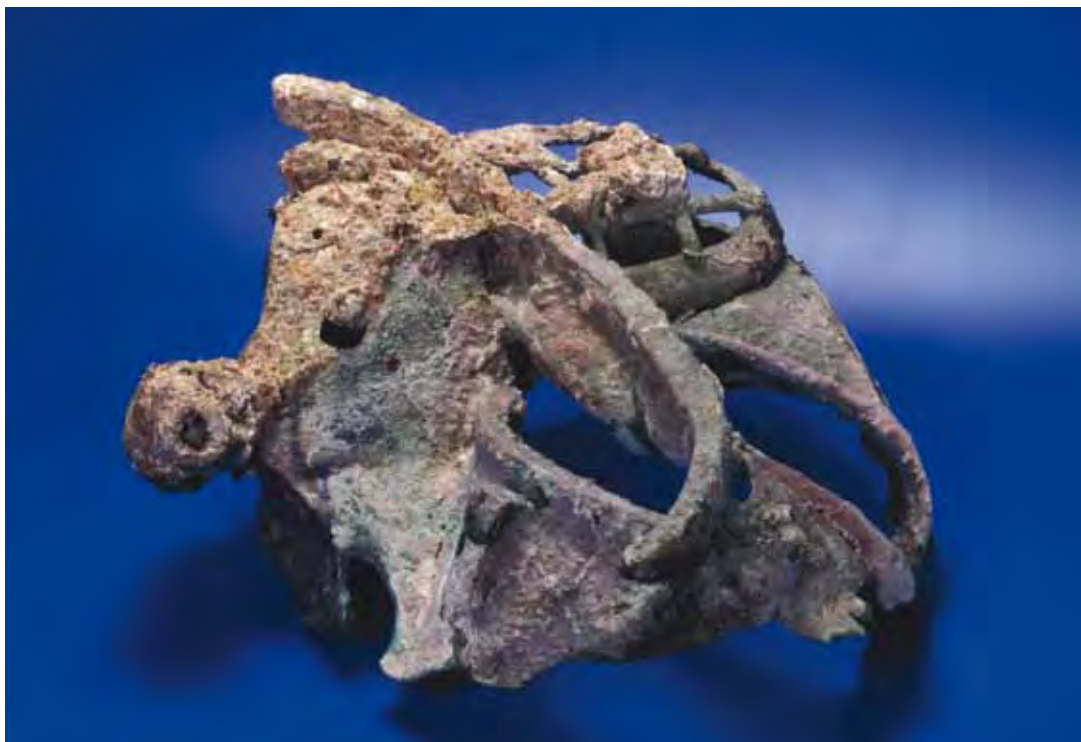
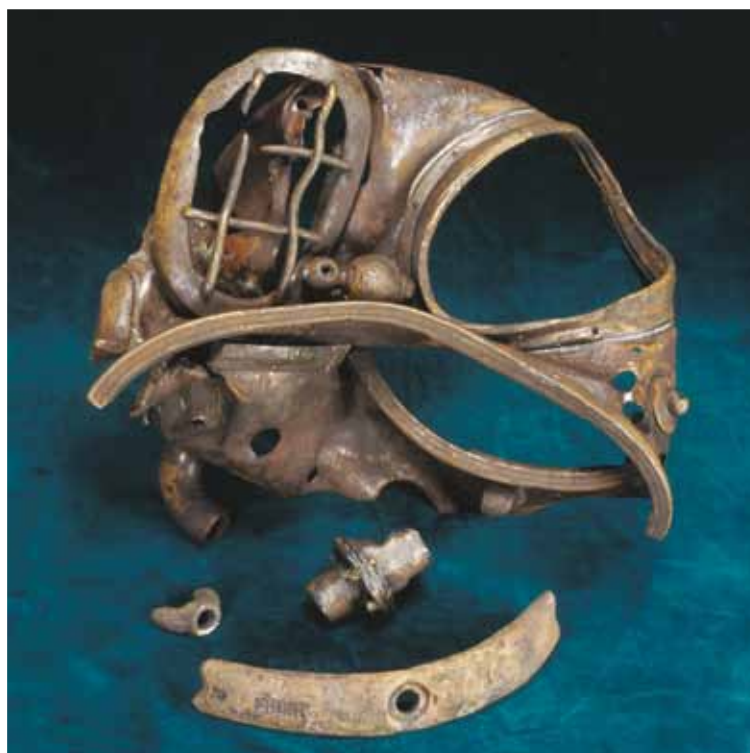
Figure 84. The *Emma* helmet before and after treatment (Patrick Baker).

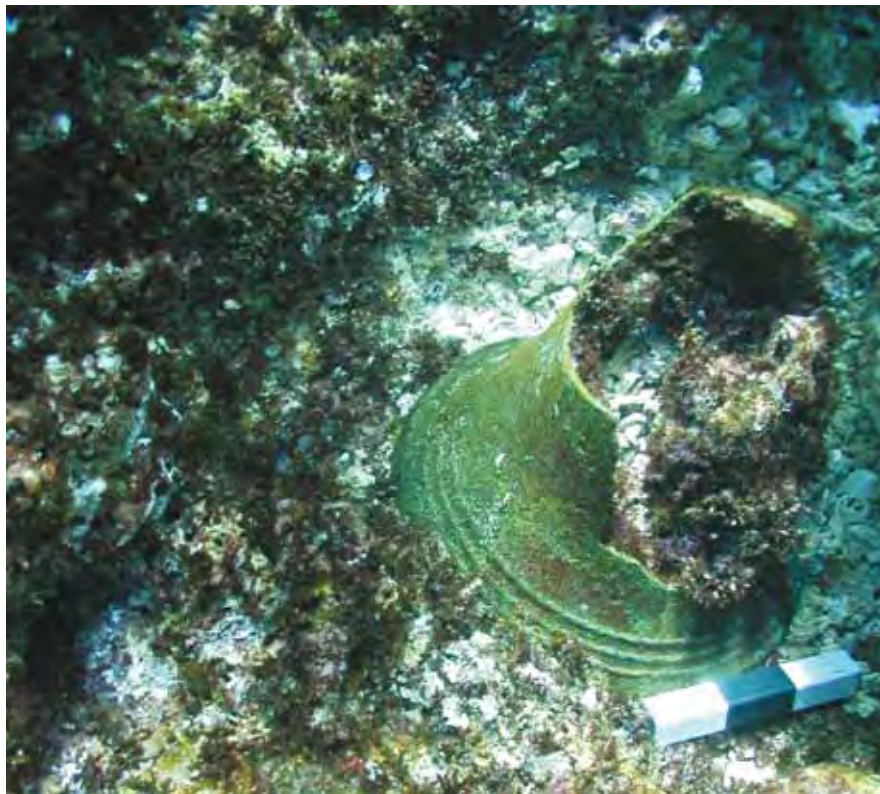
Figure 105. The NRU wreck bell *in situ* on the site (Patrick Baker).

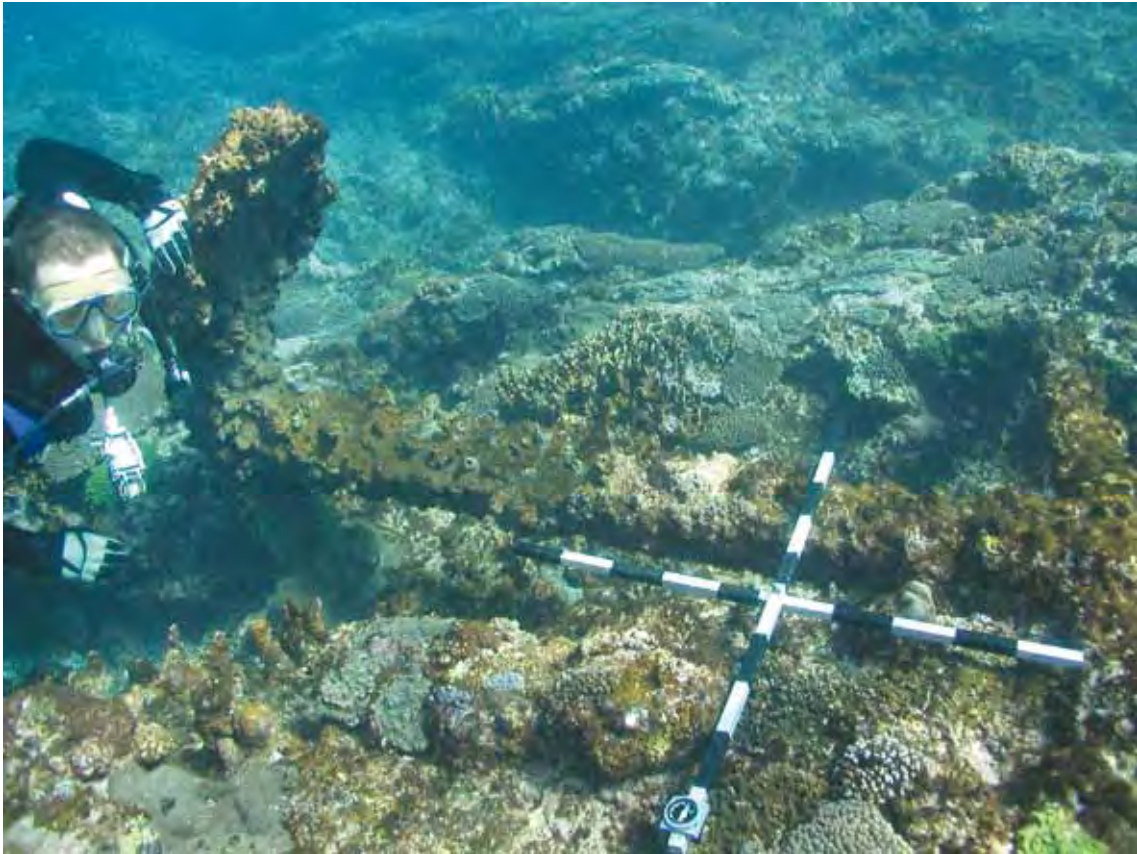
Figure 106. Stocked anchor on wreck site (Corioli Souter).

Corrosion data was recorded from three anchors and a windlass (Figure 106 and Figure 107). A fourth anchor was found during the survey but no data was recorded from it due to time constraints. Corrosion data recordings were carried out using standard methods

EXPOSED ARTEFACTS: Windlass, wrought and cast (?) iron, the more robust components remain. Four anchors (3 iron-stocked), wrought iron with cast iron fixtures, visually intact

as concreted objects but depth of holes drilled to conduct corrosion survey suggests surfaces are quite extensively corroded (the exposure to dynamic sea conditions imply this would be the anticipated outcome for metal objects on this site). Distributed to seaward along the site are ships' fastenings, rudder pintles and gudgeons and miscellaneous objects. Copper alloy fastenings are very worn due to abrasion. The very few ceramic sherds observed are in good condition and not overly worn despite site conditions. Most sherds were observed closer in towards the reef top. Ceramic and glass fragments were also seen in some isolated pockets on the seaward reef of the site. Fragments include a probable decanter stopper. A single piece of crystal glass was also observed but green and 'black' glass fragments are predominant.

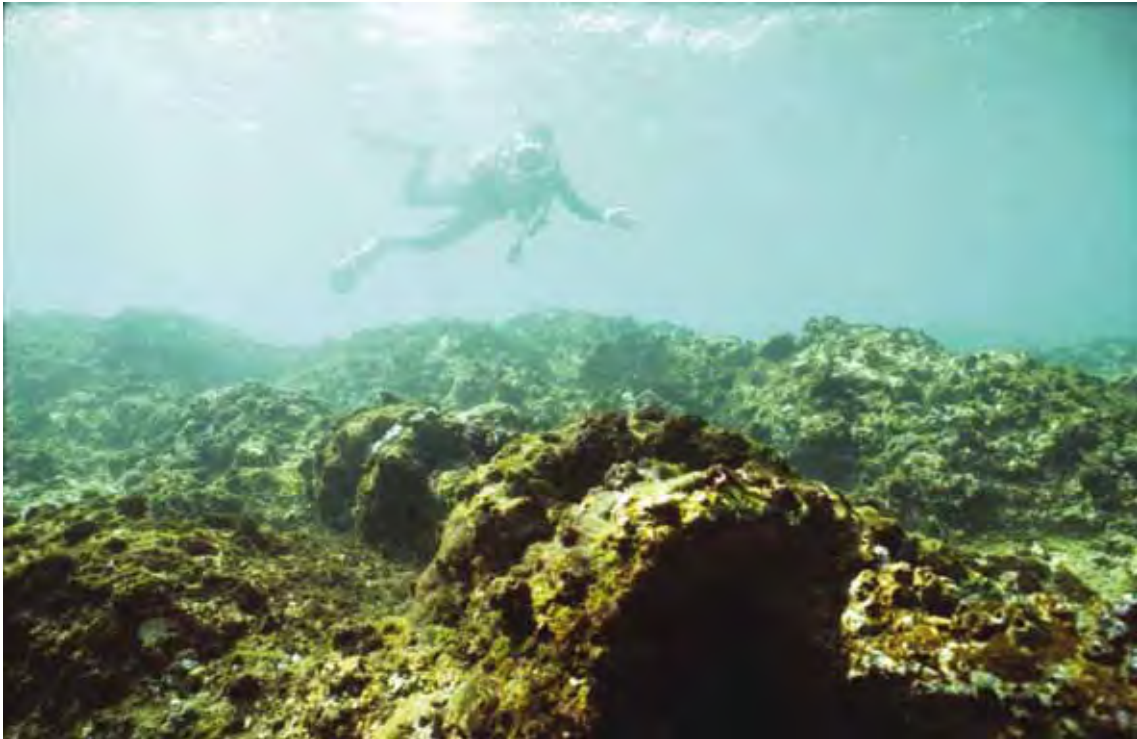
Figure 107. Windlass on the Ningaloo Reef Unidentified site (Patrick Baker).

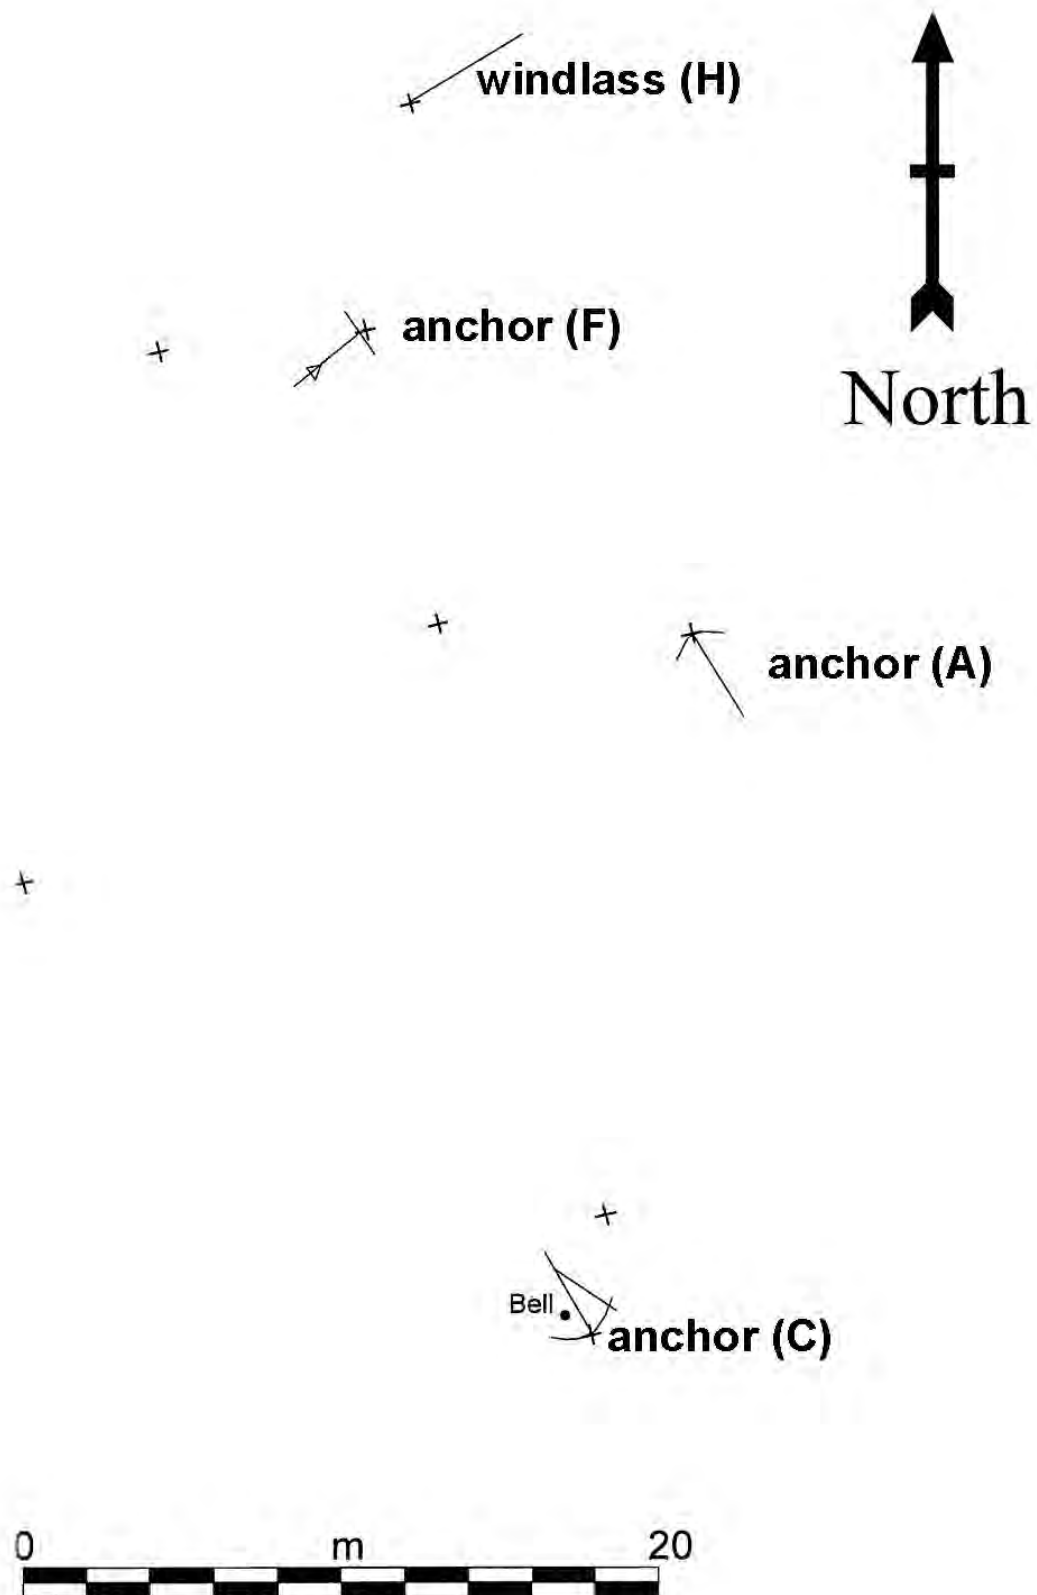
The corrosion parameters of some major ferrous elements on the NRU site were measured and the results are presented in Table 5. The on-site positions of the measured features are shown in Figure 108. The average water temperature on the site during the survey period was $26.8 \pm 0.2^\circ \text{C}$ and significant quantities of gas were released on drilling all iron features.

Description	pH	E_{corr} vs NHE (V)	Depth of concretion + corrosion (mm)	Depth of concretion (mm)	Depth of corrosion (mm)	Water Depth (m)
Windlass (H)	6.39	-0.306	22	nd	nd	2.8
Anchor (A)	6.03	-0.301	42	nd	nd	3.8
Anchor (C)	6.66	-0.311	36	nd	nd	4.0
Anchor (F)	6.02	-0.328	16	nd	nd	3.4
nd – not discernible

The iron structural features exposed to this oxidising marine environment were covered with thick aerobic concretions, heavily encrusted with secondary marine growth. Iron is not biologically toxic and increases the growth rate of encrusting organisms. The concretion acts as a semi-permeable layer on the surface of the iron, effectively separating the anodic and cathodic sites and produces an acidic, iron and chloride rich micro-environment at the residual iron surface. By plotting the measured voltages and the corresponding surface pHs of the residual metal on the Pourbaix diagram for iron at 10^{-6} molar in aerobic sea water at 25°C , the thermodynamic stable state of the iron

Figure 108. Plan of the Ningaloo Reef Unidentified site indicating the positions of the measured ferrous elements (Richards 2011 after Gainsford 2004).

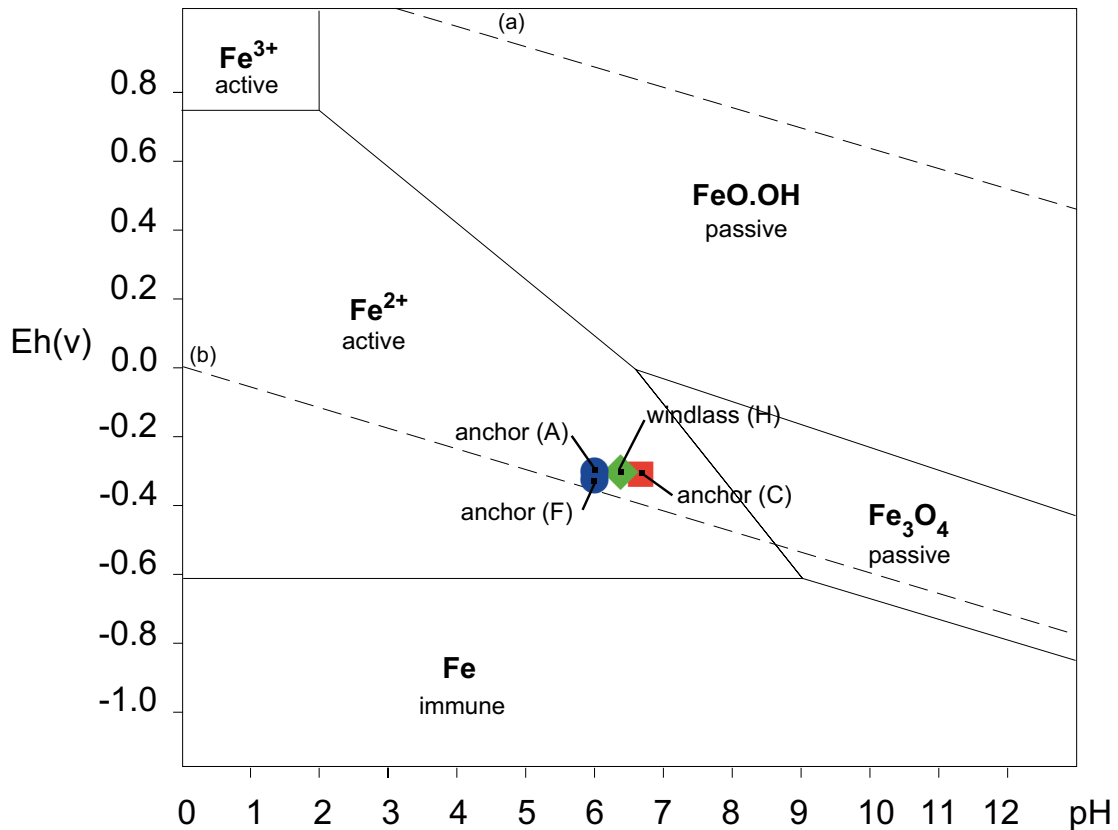
Figure 109. The Pourbaix diagram for iron (10⁻⁶ molar) in aerobic sea water at 25° C indicating the intercepts of the ferrous metal artefacts measured on the NRU site (Vicki Richards).

can be easily ascertained (Figure 109).

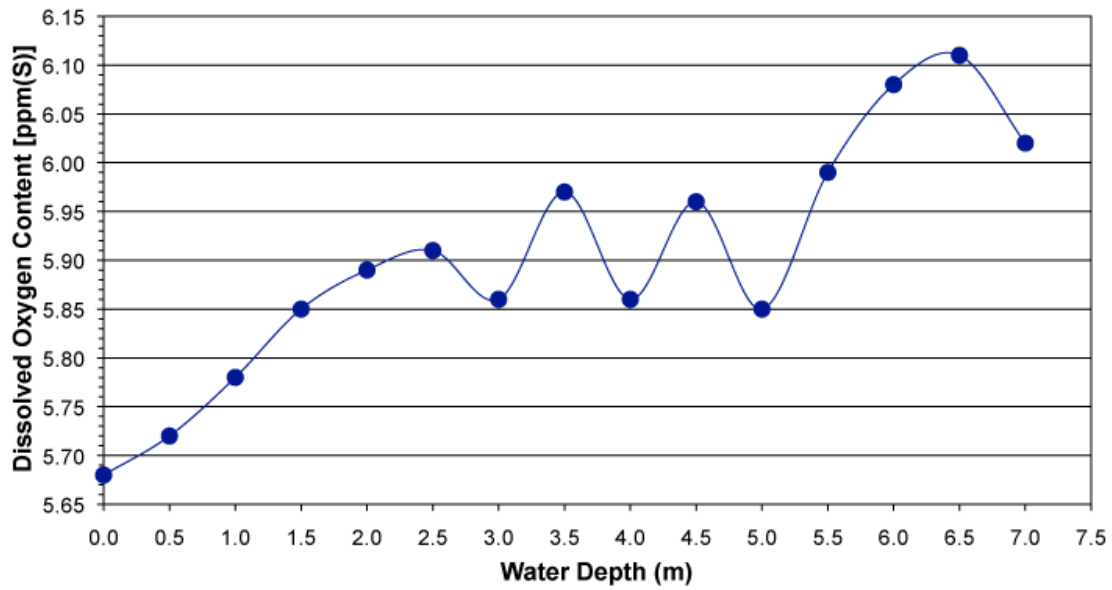
There was no significant change in salinity and temperature with increasing water depth, which is typical of the hydrology of well mixed near coastal waters. The average water temperature was $26.8 \pm 0.2^\circ \text{C}$ and the average salinity of the water column was 36.1 ± 0.2 ppK. The usual salinity range for the open ocean is 32–36 ppK and the sea water near this site falls within this expected range. The average dissolved oxygen concentration of the sea water was 5.90 ± 0.12 ppm (74% saturation at 27°C), however there appeared to be an increase in dissolved oxygen content with increasing water depth (Figure 110).

Figure 110. Change in dissolved oxygen concentration with increasing water depth measured between the *Correio da Azia* and NRU sites (Vicki Richards).

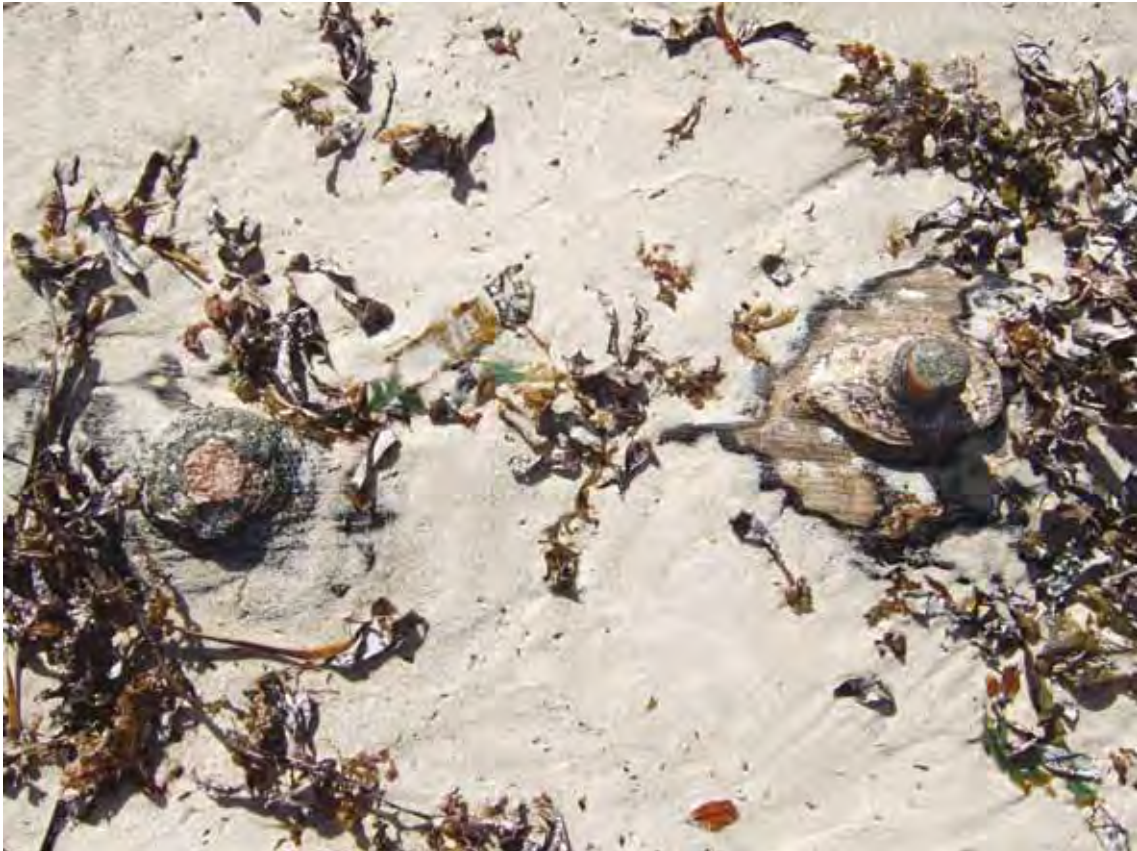
The presence of buried timbers with copper or copper-alloy fastenings on the beach at Jane Bay was brought to the attention of museum personnel at the beginning of the May 2009 fieldwork (Ningaloo Expedition Day-book 8/5/09). The buried timbers had been exposed and lay visible on the beach, following scouring by waves during winter storms (see Figure 119).

Figure 119. Buried timbers with copper or copper-alloy fastenings (Jeanette Gammon).

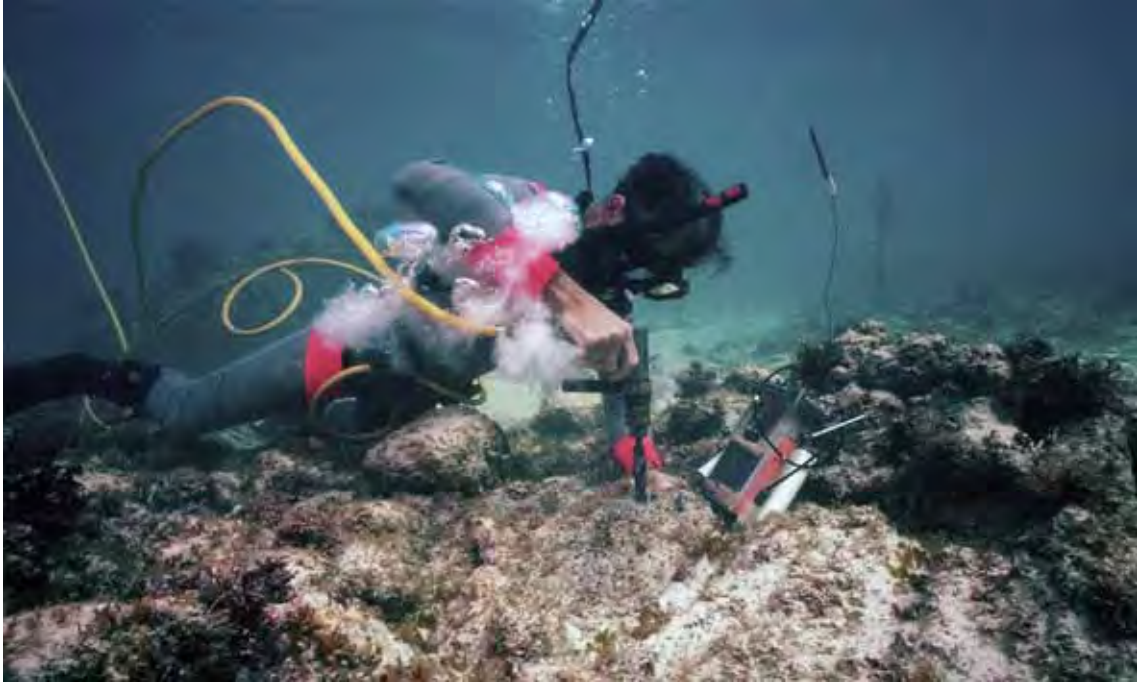
WOOD CONDITION: No attempt was made to uncover buried and/or ballast covered wood. The exposed wood was dark brown in colour with slight surface furrowing. It appeared well preserved an observation supported by investigative drilling to obtain a pH profile (Figure 126). At a depth of 20 mm the wood became a natural oak colour. The results of the pH profile are presented in Table 9 and the on-site position of the measured timber is shown in Figure 129.

Figure 126. Jon Carpenter measuring the pH profile of an exposed timber on the *Rapid* site in 1992 (Patrick Baker).

The site was inspected in 1992. Corrosion measurements were taken on the two anchors (Figure 127) and a pH profile measured on an exposed timber situated near the bow (Figure 126). The results of these surveys will be discussed below.

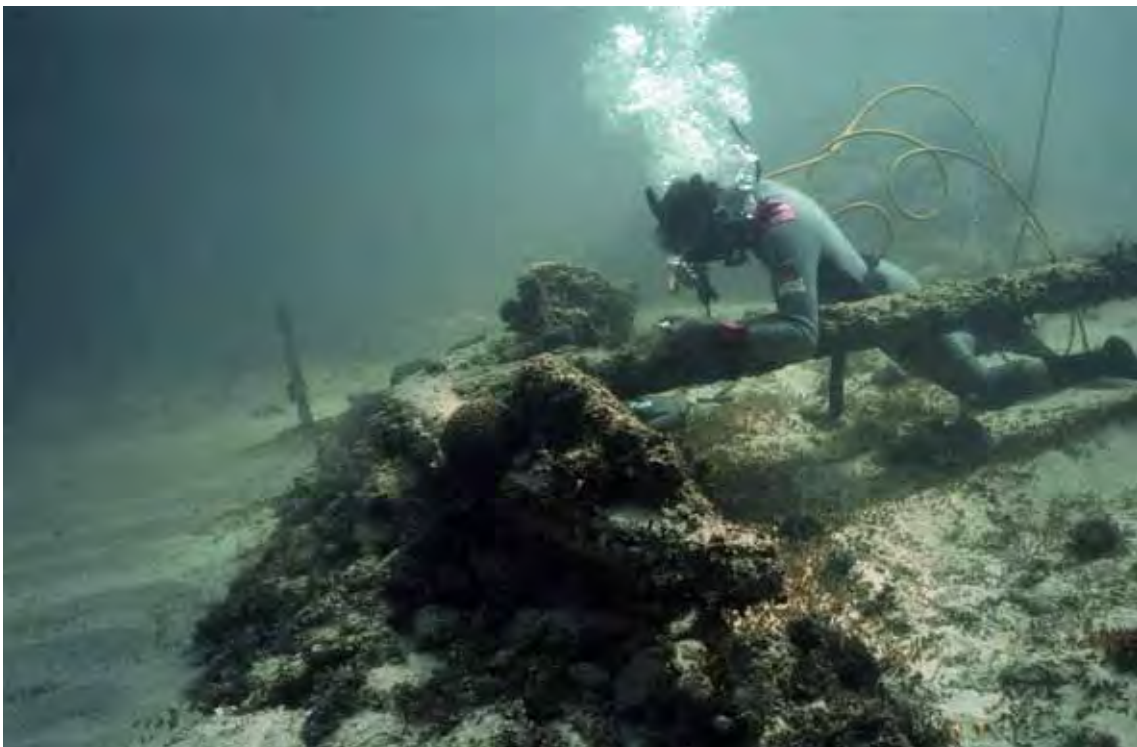
ELECTROCHEMICAL SURVEY: The pH and corrosion potential measurements were recorded on both anchors (Figure 127). The results are outlined in Table 8 and the on-site positions of the anchors shown in Figure 129. The pH of the sea water was 8.2. The water temperature was 20° C and the maximum water depth was 4.5 m.

Figure 127. Jon Carpenter measuring corrosion parameters on the *Rapid* anchor 1 in 1992 (Patrick Baker).

In comparing the E_{corr} and pH measurements of anchor 1 to anchor 2 taken in both 1992 and 2009 it appears that anchor 2 is corroding faster than anchor 1. That is, the corrosion potentials of anchor 2 are more positive than anchor 1 and the average pH values of anchor 2 are more acidic than those measured on anchor 1. One explanation for this corrosion difference between the two anchors is the presence of the large coral head just a few metres to starboard of anchor 1, which may be providing some protection from increased water movement and thus, oxygen impingement to the concreted corroding surface during periods of increased swell and current.

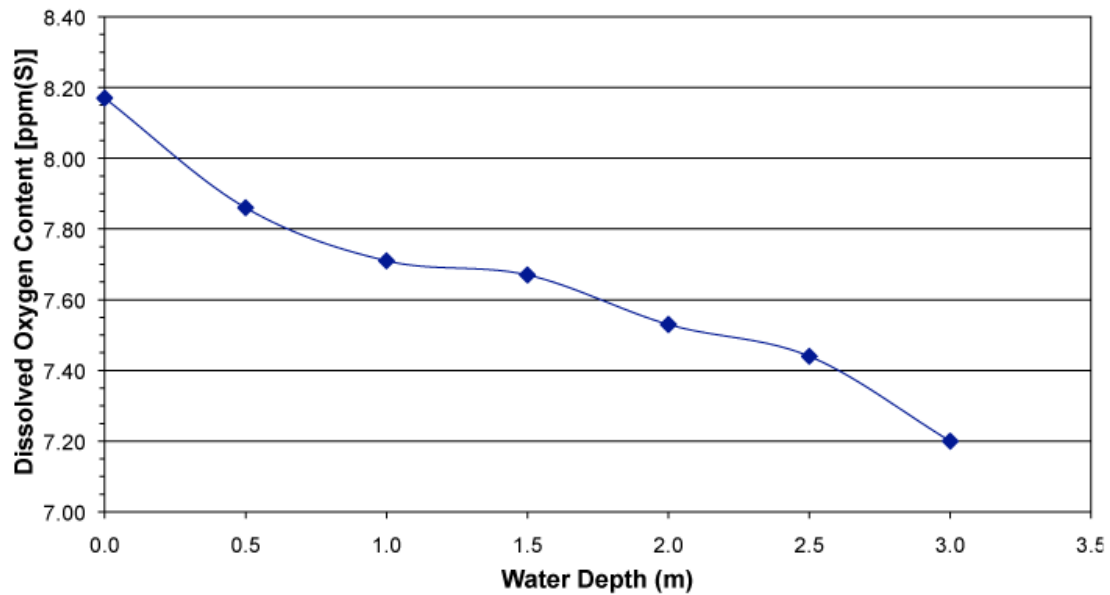
Figure 128. Change in dissolved oxygen with water depth on the *Rapid* site (Vicki Richards).

(4.5 m) than the *Zvir* site (8 m) so an increase in the average dissolved oxygen content on the *Rapid* site would not be unexpected. The decrease in dissolved oxygen content with increasing water depth is shown in Figure 128. This trend is similar to that observed on the *Zvir* site, except the dissolved oxygen measurements are much higher due to the decrease in water depth, average temperature and salinity.
