Shipwrecks of the Ningaloo Reef: maritime archaeological projects from 1978–2009

Jeremy Green (Editor)

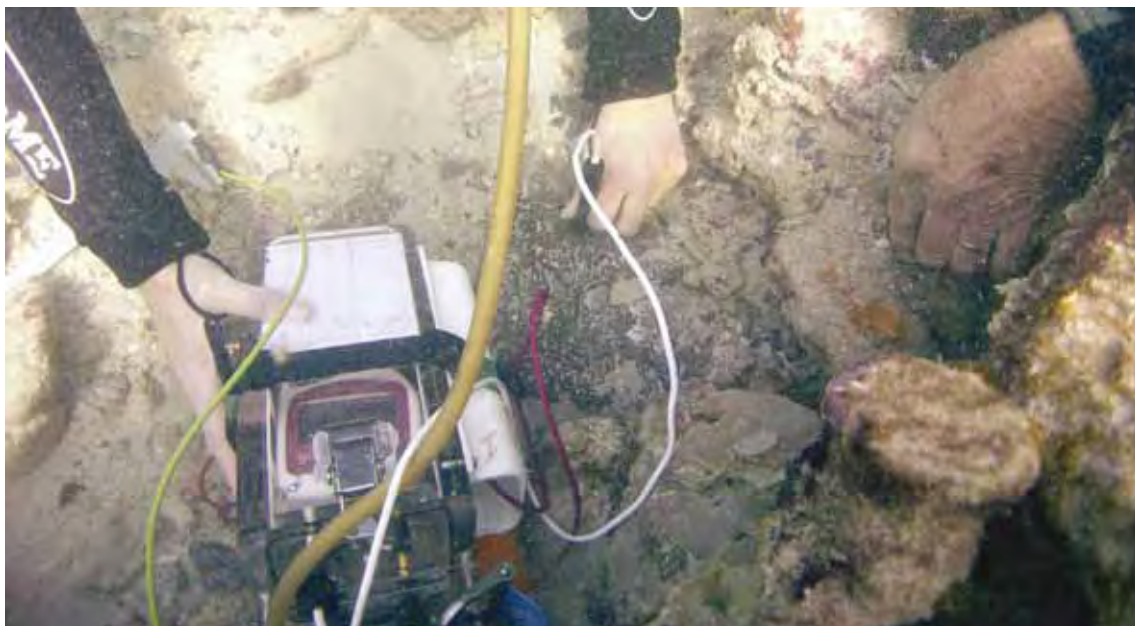
Figure 130. Measuring pH profiles of the timber in Test Trench 1 (TT1) on the *Rapid* site in 2009 (Patrick Baker).

WOOD ANALYSIS: There were no marine organisms present on the freshly exposed timbers in the test trenches that would indicate recent exposure to an aerobic environment, however there was some evidence of past depredation by teredo worm on the timbers in Test Trench 1 (Figure 130). Preliminary wood identification of some timber samples recovered from the hull remains in 1979 indicated that white oak ribs and spruce planking affects had been used in the construction of the vessel (Henderson, 1980). *In-situ* pH profiles and probe depths of the exposed structural timbers in the three test trenches were obtained. In teredo damaged timbers, the presence of excreted calcium carbonate that lines the worm bore holes effects the maximum water contents and therefore, this particular measurement cannot be applied to timbers with extensive marine borer attack. However, pH profiles provide a good indication of the state of degradation irrespective of the extent of wood borer attack. The results of the pH profiles, including the measurements recorded on the exposed timber in 1992 are shown in Figure 134.

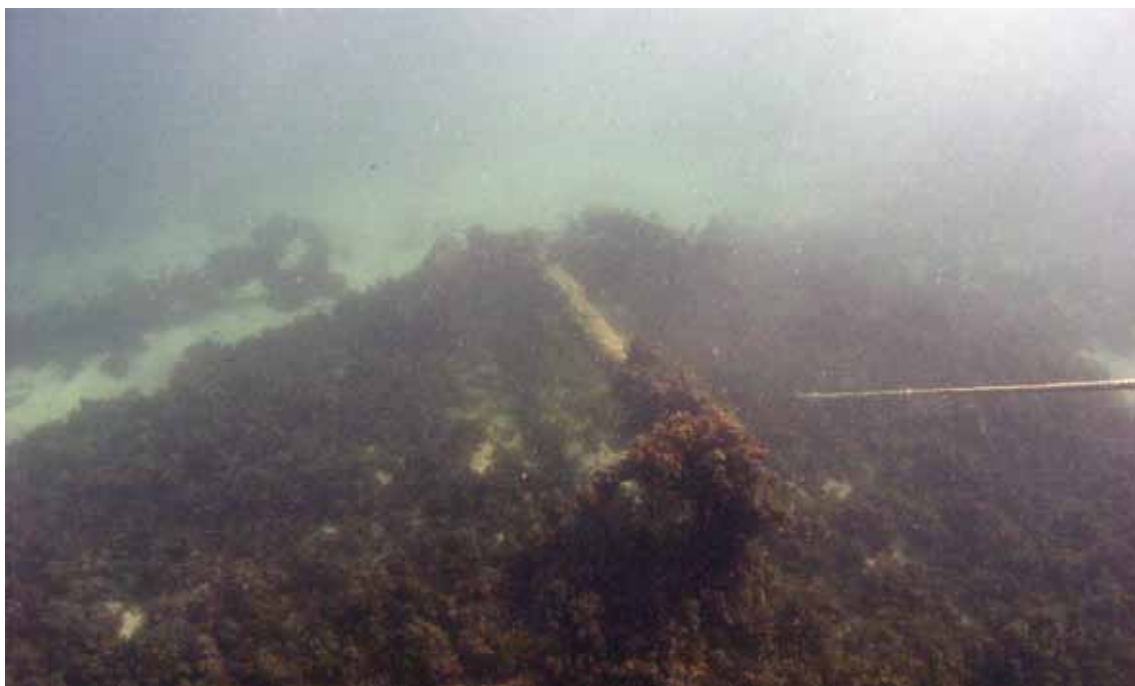
The most exposed areas of the wreck are the iron anchors on the starboard bow and the ballast mound. Anchor 1 lies directly on the ballast mound and rises to about 1.5 m and anchor 2 lies on the seabed slightly to the south of anchor 1 (Figure 129 and Figure 132). The concreted surfaces of the iron anchors are quite densely covered with sessile marine organisms including mussels, sponges, barnacles, ascidians, tunicates and a variety of seaweeds. In less concentrated areas of growth, small algal forms are present. There is seaweed, soft corals and algal growth on upper surfaces of most of the ballast stones (Figure 131). No exposed wooden structural features were noted during this inspection but a complete visual survey of the site was not performed.

Figure 132. Anchors on the *Rapid* site in 2009 (Patrick Baker).

these areas were more alkaline than the pH values measured on the crowns and flukes where the concretion layers were much thicker (Figure 132). This may indicate a slight increase in the corrosion rate of the crown and fluke areas where the wrought iron is under the most mechanical stress and may possess a slightly different microstructure than the shafts and rings. It is important to note that where concretion has been recently removed from underlying iron, more alkaline pH values are often measured but the corrosion rates are still high. This observation is supported by the annualised corrosion rate data (Table 11) for the anchors measured in 2009, where the rate of corrosion for the shafts are slightly higher than for the crown on anchor 1; however, there is not enough data to make any definitive conclusions.

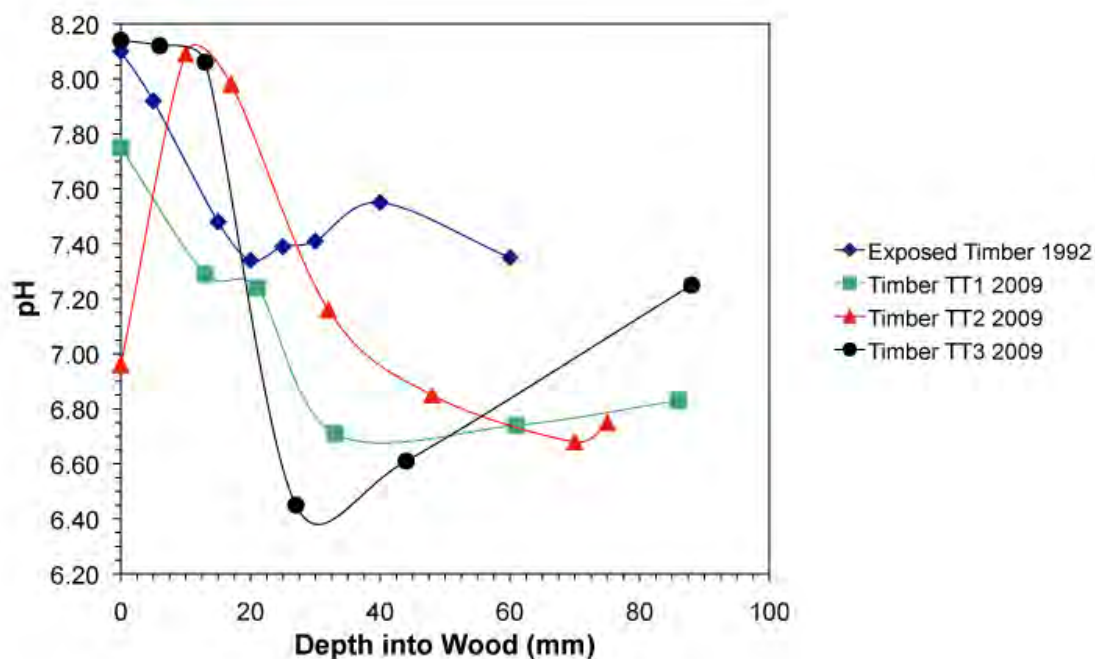
Figure 134. pH profiles of structural timbers measured in 1992 and 2009 on the *Rapid* wreck site (Vicki Richards).

Generally, the pH profiles of the timbers followed a typical sigmoidal relationship (Figure 134). That is, the pH of the wood near the upper, more exposed surfaces was high then as the timbers were vertically traversed there was a decrease in pH that tended to plateau with

increasing depth. The normally acidic nature of undegraded waterlogged wood, albeit more alkaline than undegraded, seasoned wood of the same species, becomes progressively more alkaline with increasing degradation due to the inward diffusion of alkaline sea water into the void spaces of the more degraded wood cells. Therefore, the higher pH values generally observed near the timber surfaces denoted the areas of greater deterioration. The decreasing trend in pH as the core depth increased was indicative of a gradual decrease in the extent of degradation towards the interior of the timbers until the pH reached a minimum that represented the area of least deterioration. For the ‘buried’ timbers measured in 2009 after the minimum pH is reached there is a turning point and the pH begins to increase again. This indicates a gradual increase in the extent of wood deterioration as the interior side of the timber is approached. In addition, the final pH of the timber is considerably more acidic than the pH measured on the upper, more degraded surfaces. Hence, the extent of deterioration of the outer surfaces is significantly greater than the interior surfaces. This is not unexpected as the upper surfaces of the timbers would be more exposed to the degradative effects of the local micro-environment.

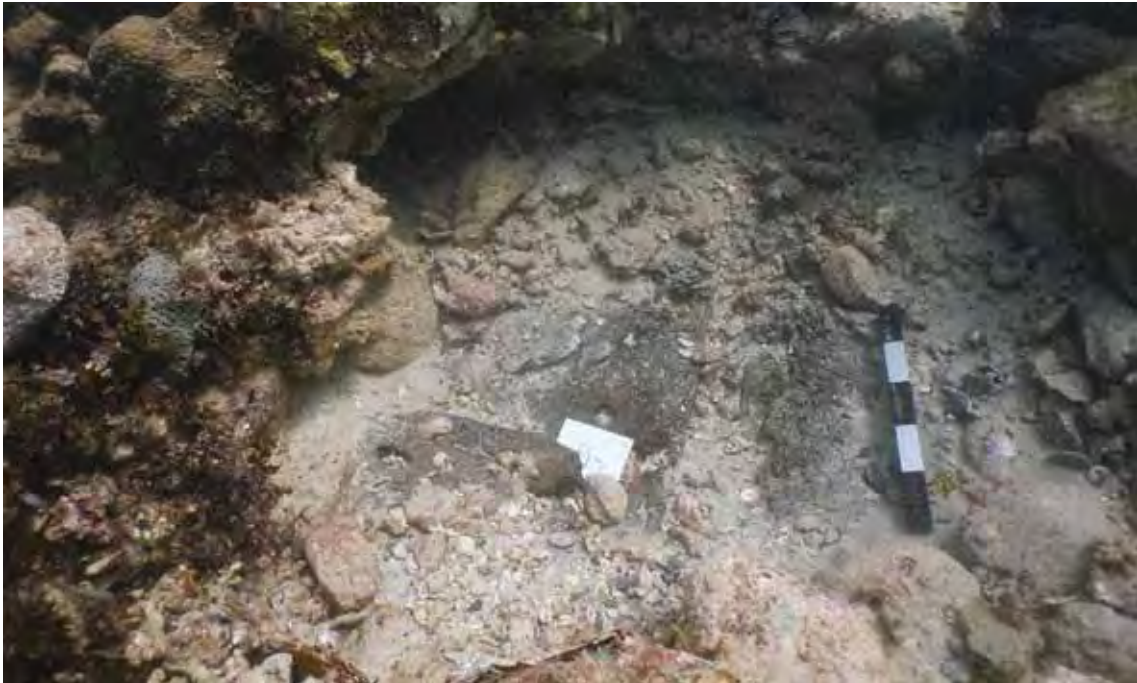
Figure 135. Timber measured in Test Trench 2 on the *Rapid* site in 2009 (Patrick Baker).

Overall it would appear that the timber in TT2 (Figure 135) is more degraded than timber

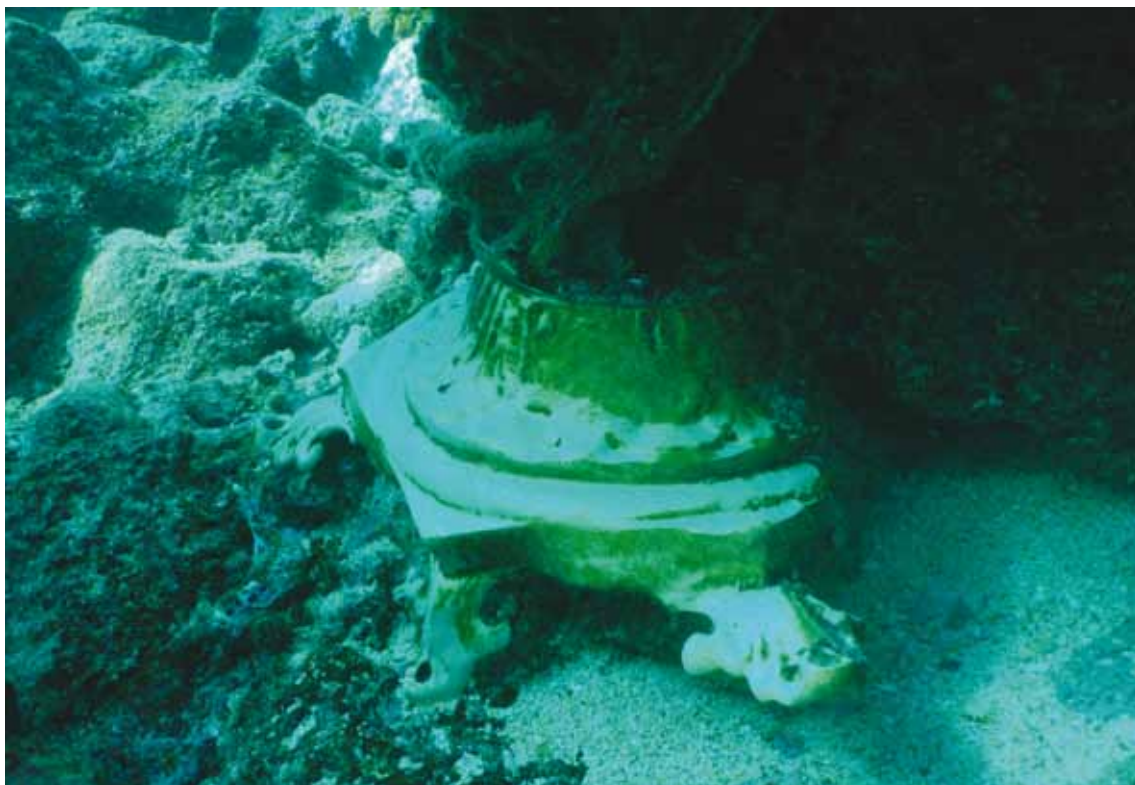
Figure 137. The binnacle stand of the *Benan* (Corioli Souter).

A copper-alloy instrument binnacle stand was recovered from a sand gully near the stern (Figure 137). Other miscellaneous features include, mast steps, brass port-holes, dead-eyes, davits and a capstan near the bow anchor.

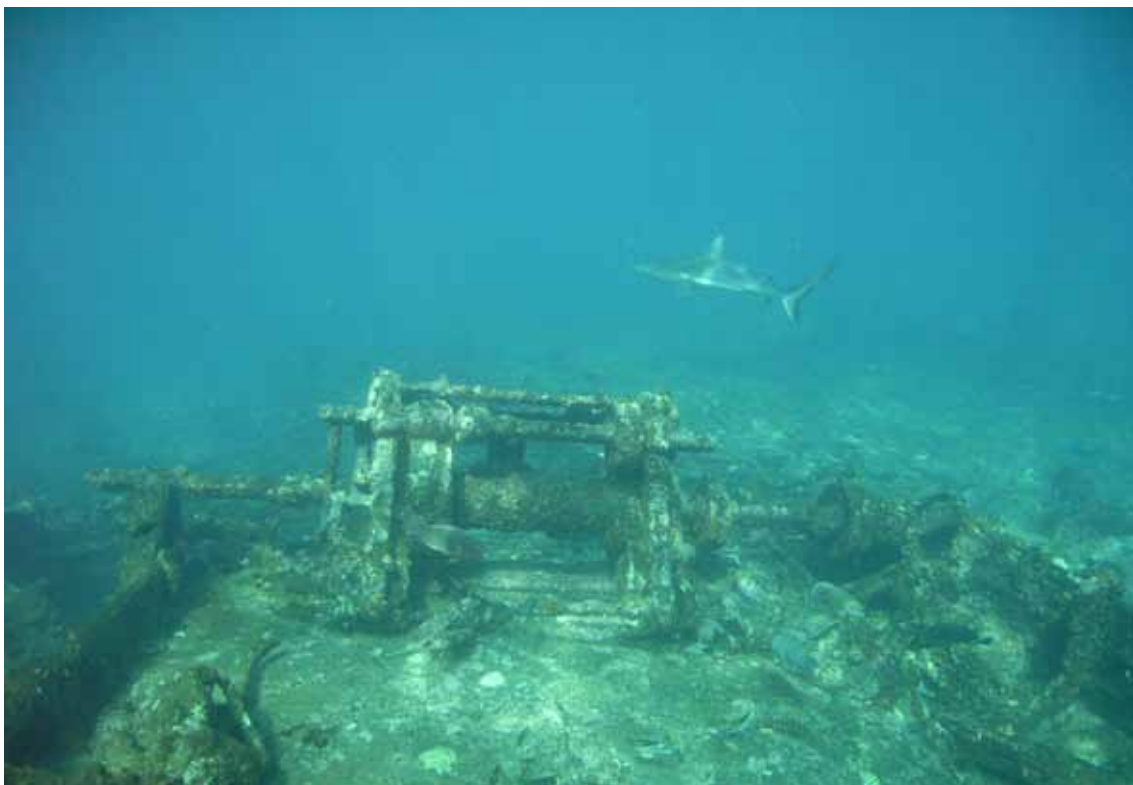
Figure 139. The *Benan* winch (Patrick Baker).

A number of iron mast and spar sections are spread across the wreck, many wedged in the sand gullies located to the west of the site. A number of masts also have spider bands still attached. Three anchors are visible, one in a set position located at the bow and two located approximately midships, one is a large folded anchor and the other a smaller anchor. Three windlasses were recorded on the primary site during this survey: a large derrick winch approximately midships and small anchor winch near the main anchor (Figure 139). Interestingly, no coal has been found on site during this, or previous inspections.

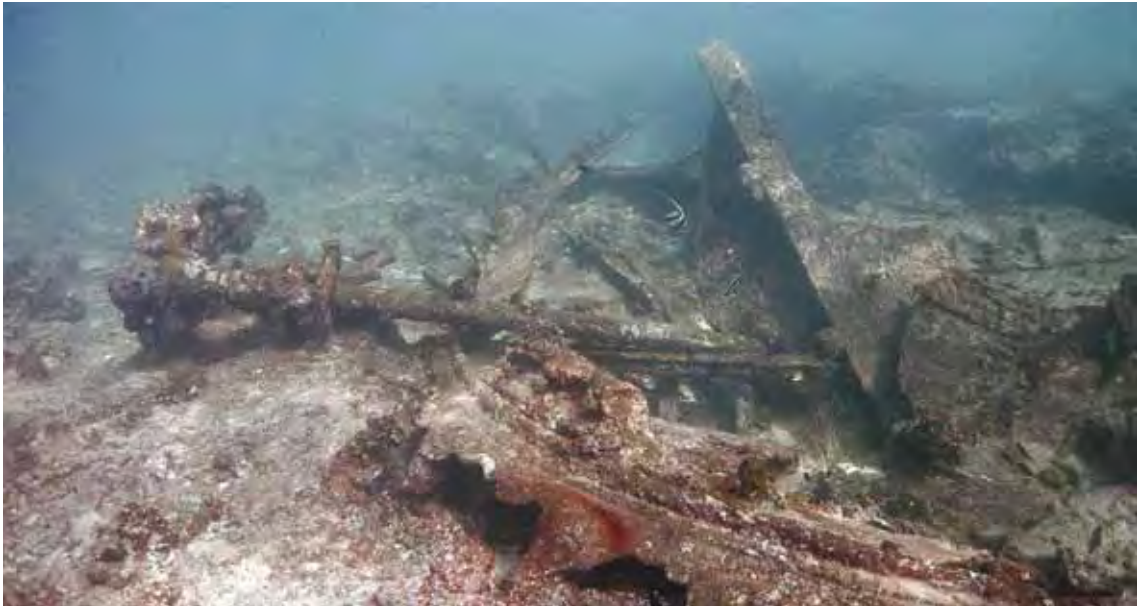
Figure 143. The rudder, steering shaft and steering mechanism on the main *Benan* wreck site (Patrick Baker).

CORROSION SURVEY: The corrosion parameters of two ferrous elements (rudder and steering shaft) (Figure 143) and a copper alloy reinforcing band on the steering mechanism (Figure 138) located on the main section of the *Benan* wreck site (Figure 146), outside of the reef, were measured and the results are presented in Table 14. At the time of the survey, the water

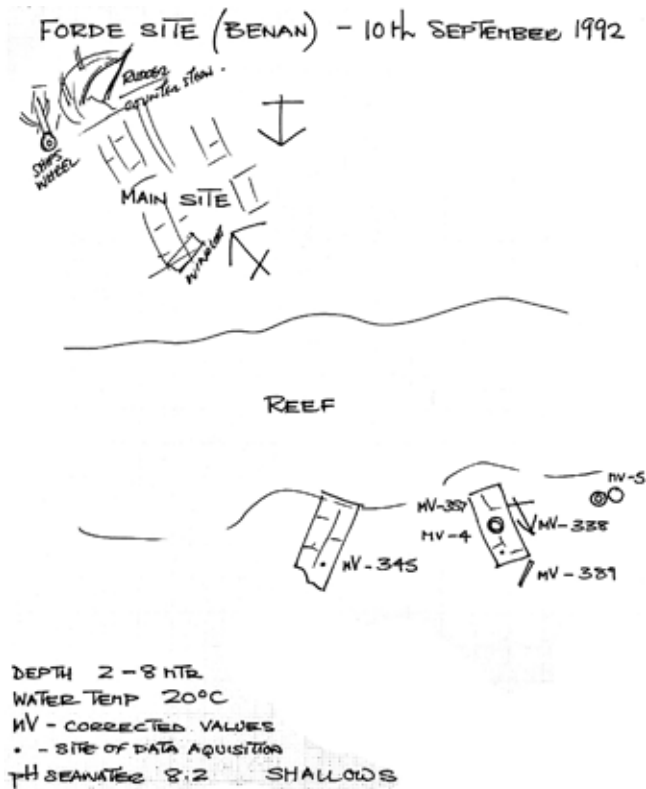
Corrosion potential measurements were successfully acquired from artefact material on the inner reef site (Table 13, Figure 144). No attempt was made to acquire surface pH of artefact materials due to the lack of concretion. The pH of the sea water was 8.2, the water temperature 20° C and the water depth ranged from 2–8 m.

Figure 144. Sketch plan of the *Benan* site inside the reef indicating the positions of the structural features measured in 1992 (Jon Carpenter).

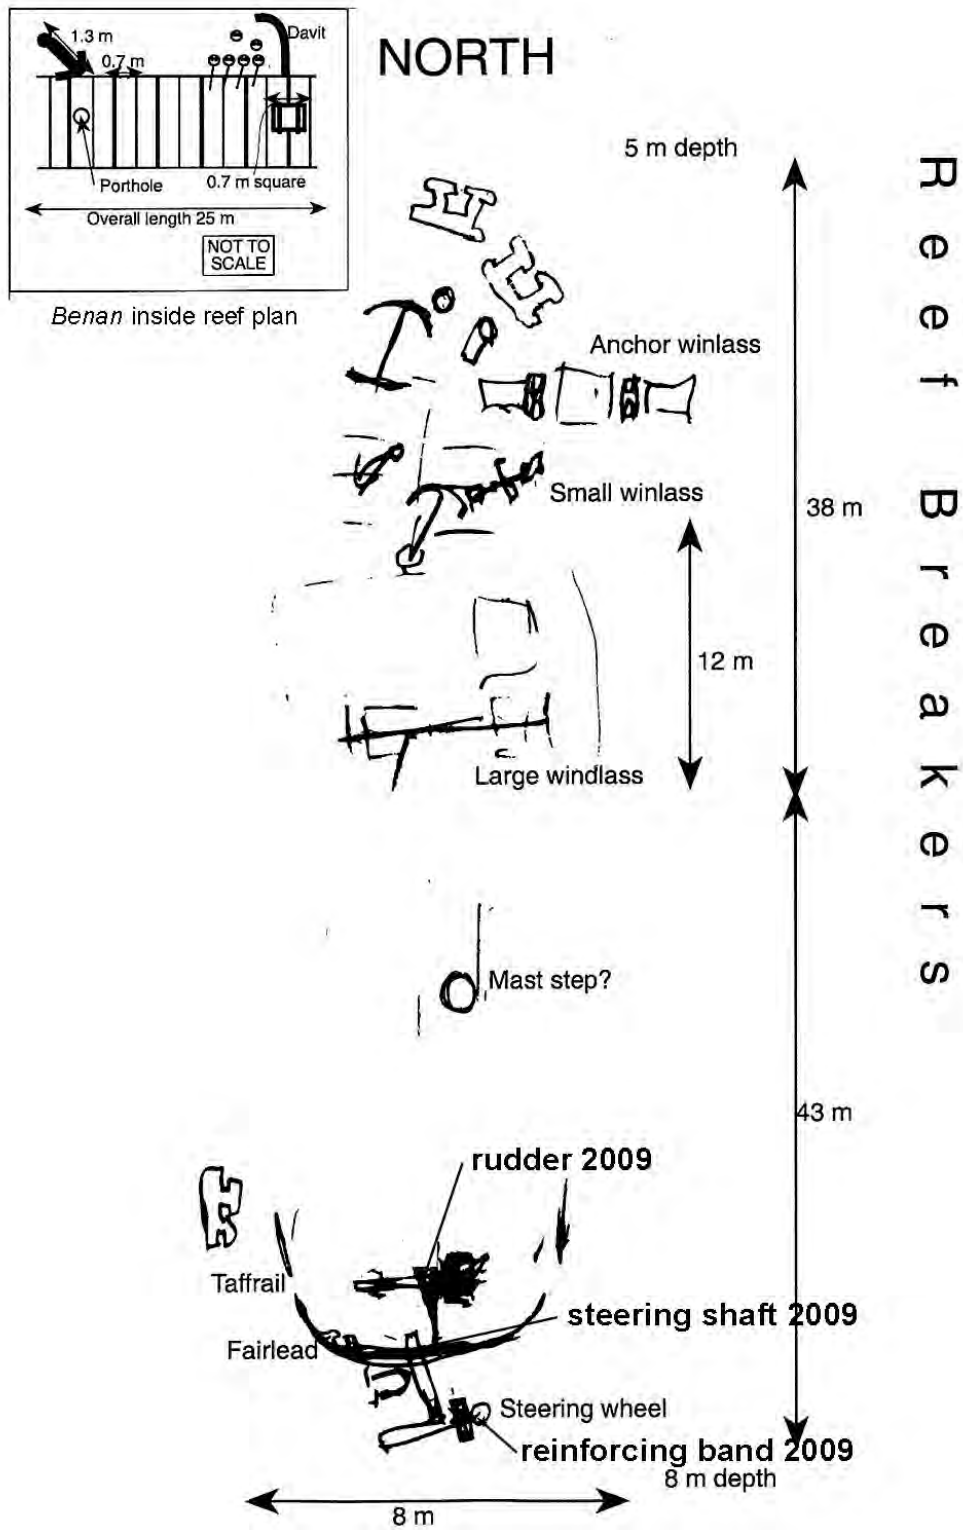
Figure 146. The *Benan* site plan showing measurement positions (Vicki Richards after Green, *et al.*).

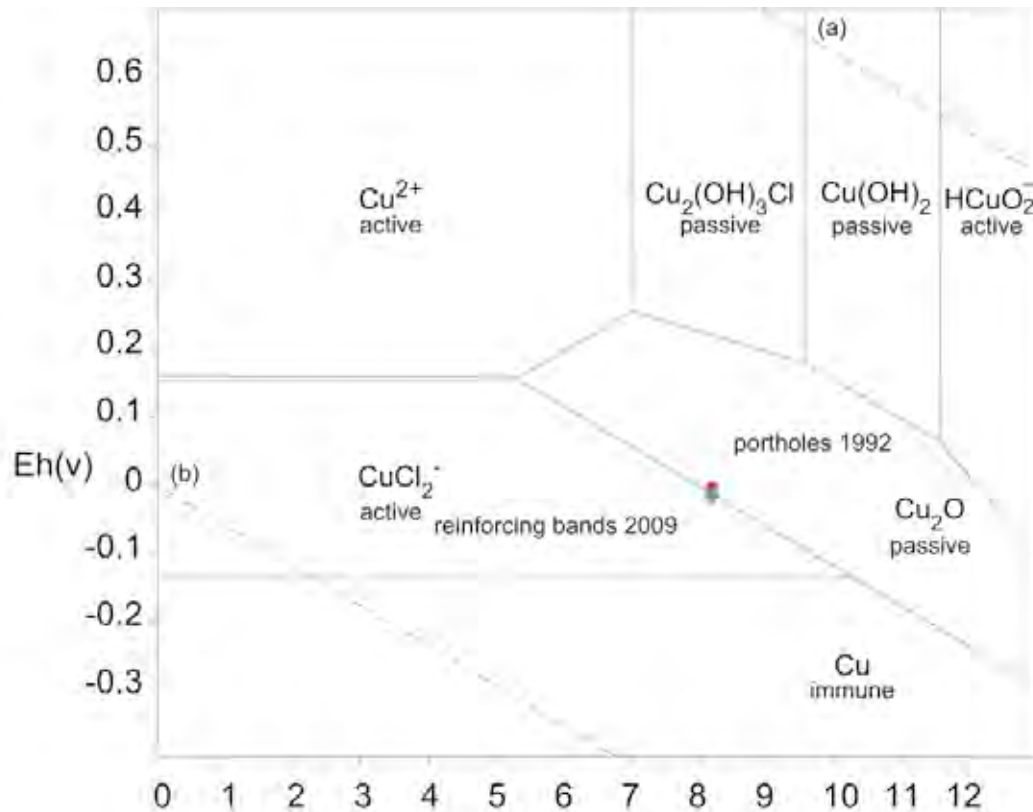
surrounding sea water at the time of the survey was used as the default. Again, the intercepts of the copper alloy structural features lie very close to the equilibrium line between active corrosion and the passive region (Figure 147). In aerobic marine environments, copper alloys readily form protective layers of cuprite (Cu_2O). However, the chloride ions from the sea water can penetrate this protective oxide layer and react with the metal to form cuprous chloride complexes, such as nantokite (CuCl_2^-), the rate being controlled by the diffusion of these complexes from the metal surface to the sea water interface. There the cuprous chloride complexes can then hydrolyse to produce cuprite. This is the basis of the pitting corrosion mechanism for copper alloys and this corrosion process is cyclic in nature.

Figure 147. The Pourbaix diagram for copper (10^{-6} molar) in aerobic sea water at 25° C indicating the intercepts of the copper alloy structural features measured on the *Benan* wreck site in 1992 and 2009 (Vicki Richards).

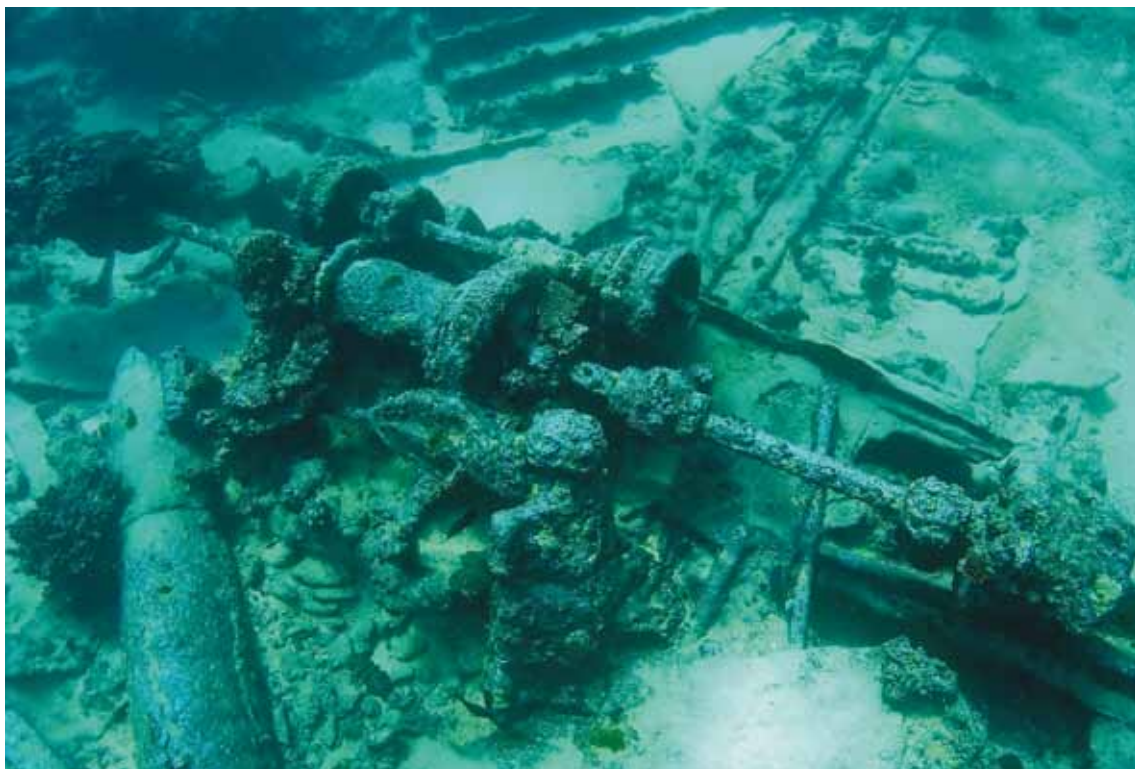
Figure 157. The bow windlass of the *Zvir* (Patrick Baker).

There are four winches or windlasses with both integral and ancillary warping head units, one at the stern and two at the bow (Figure 157). Deck plating is strewn all over the site often obscuring the machinery and other hull components. Hawse-pipes and bollards are found at both ends of the site. At the stern these bitts lie forward of the rudder frame.

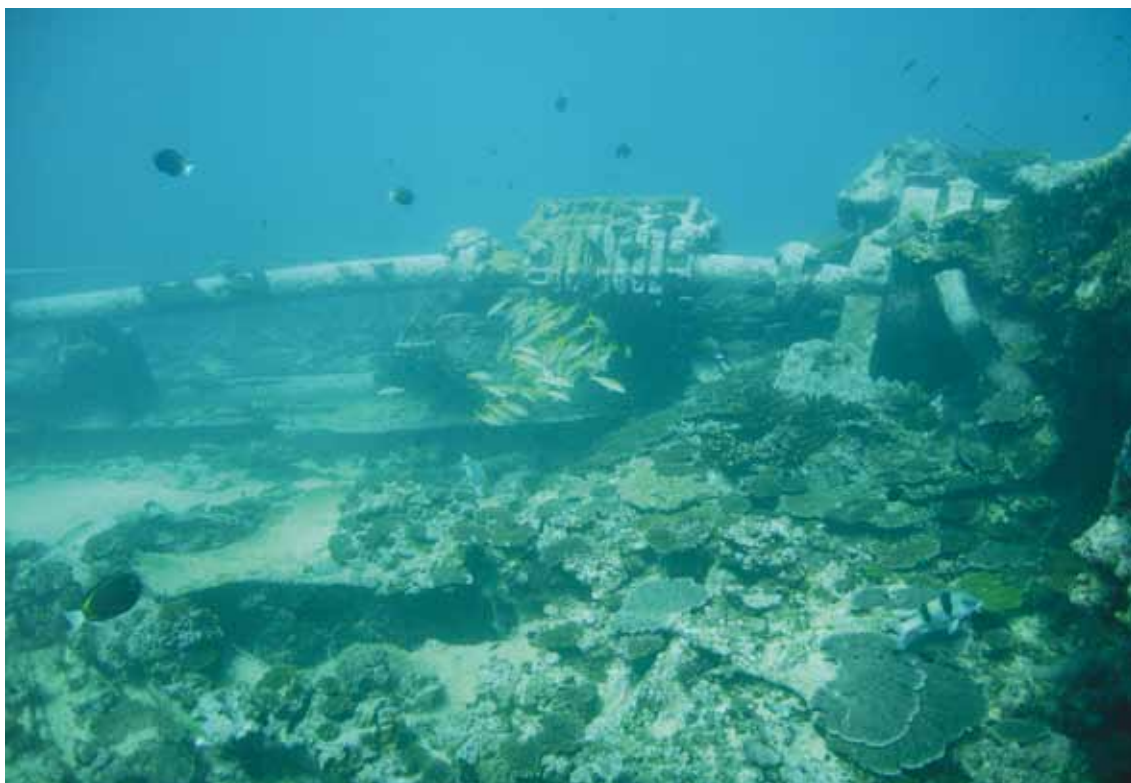
The wreck site was discovered by skin divers Frank Paxman, Barry Paxman and Glynn Dromey in 1978. The site lies on a east/west orientation in 8–10 m of water and located on a coral bottom, shoreward of a sandy patch, approximately 400 m from a breaking reef. The site is generally oriented NNE/SSW. Following the line of the drive shaft from the rudder assembly to the forward end of the thrust block/condenser unit, the orientation is 50°. The keelson is separated forward of the boilers and lies at a 60° angle towards the bow. The vessel sits virtually upright on the keel, canting slightly to starboard. The hull has fallen away on both sides to reveal a complete set of propulsion machinery. A triple expansion engine is lying on its side (Figure 161) along with the crankshaft and condenser system, located in the middle of the wreckage. Directly forward of this machinery, running athwartships, three boilers can be seen (Figure 158). These are no longer in the same position as at the time of wrecking, presumably rolled by dynamic underwater conditions. The drive or propeller shaft which runs approximately 40 m aft to the propeller is twisted to starboard forward of the thrust block (Figure 159). This starboard twist is seen throughout the line of the visible

Figure 159. The *Zvir* propeller shaft (Patrick Baker).

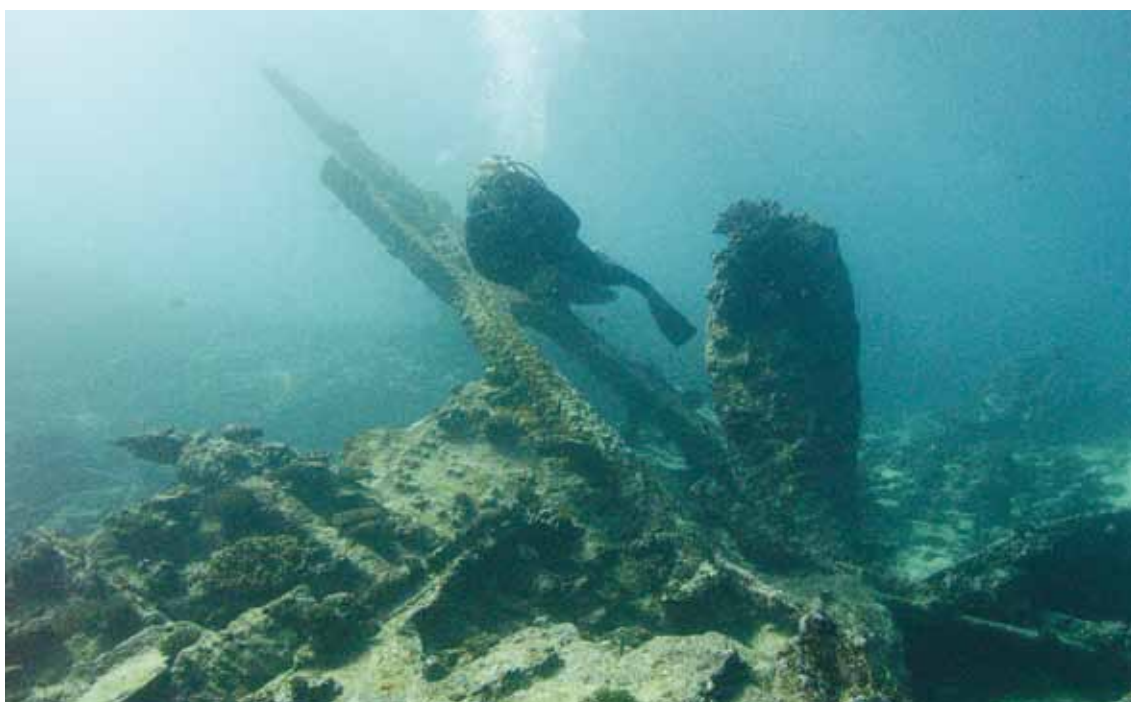
Figure 160. The *Zvir* propeller (Patrick Baker).

The propeller and rudder assembly are also in fairly good condition with the lower part of the rudder still in its original position, standing proud of the seabed and leaning to starboard (Figure 160). The rudder frame is broken 4 m above the keel and the stern-post marks the shallowest point on the wreck site. Part of the steering quadrant is still visible and attached to the rudder assembly.

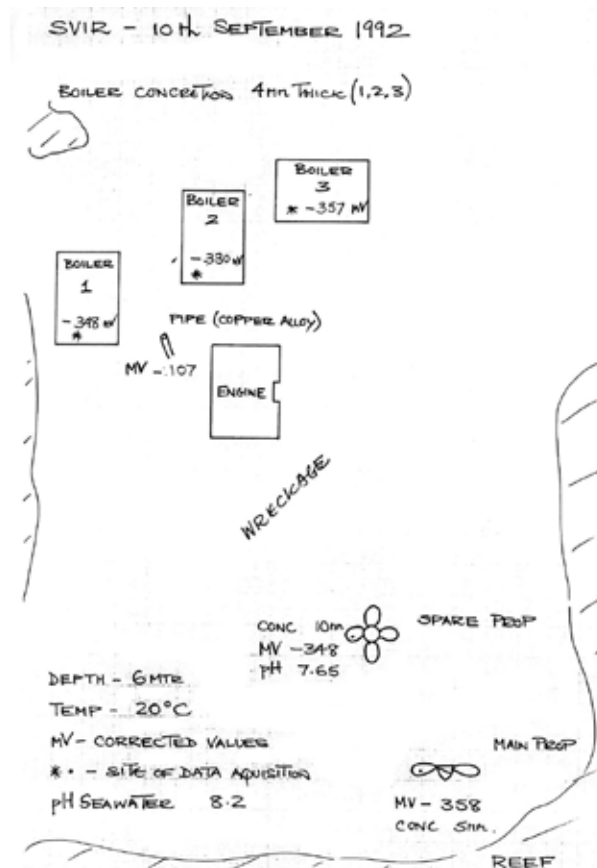
ELECTROCHEMICAL SURVEY: Corrosion potential measurements were successfully acquired from artefact material on site and the results are outlined in Table 16. The positions of the artefacts measured on site are shown in Figure 162. Only one pH measurement was obtained as the corrosion layer on all but the spare propeller was too thin to prevent mixing with ambient sea water. The depth of concretion plus corrosion on the spare propeller was 10 mm and the pH of the residual metal surface was 7.65. The depth of concretion plus corrosion

Figure 162. Sketch plan of the *Zvir* wreck site indicating the positions of the structural features measured in 1992 (Jon Carpenter).

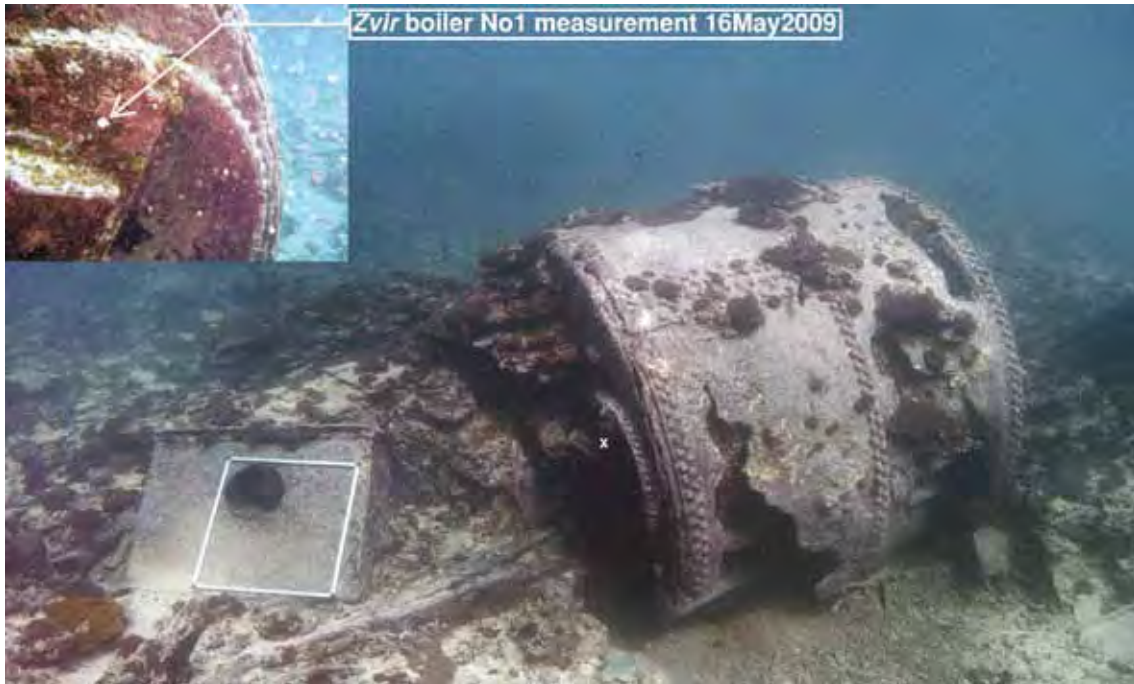
Figure 163. Measurement location (x) on the boiler 1 on the *Zvir* wreck site (Kalle Kasi and Patrick Baker).

CORROSION SURVEY: The corrosion parameters of six ferrous alloy features (boiler 1, Figure 163; boiler 2 and 3, Figure 165; main propeller, Figure 166; spare propellers, Figure 167; upright pipe, Figure 168) were measured on the *Zvir* wreck site. The on-site positions are shown in Figure 169 and the results are presented in Table 18. At the time of the survey, the average water temperature was $27.6 \pm 0.1^\circ \text{C}$ and the pH of the sea water was 8.01 at 7.4 m. Five of the same features (boiler 1, 2, 3, main and spare propellers) were measured in 1992 (Figure 162), allowing direct comparative analysis of the corrosion data possible.

It appears that boiler 3 is corroding faster than boiler 2 based on the more acidic pH and greater corrosion depth. The corrosion parameters on boiler 1 were measured at a completely different location (flange located on the end of the boiler) compared to boilers 2 and 3, where the measurements were taken on the actual fabric of the boilers. There was no encapsulating concretion on this flange associated with boiler 1 so it is not surprising that the pH was more alkaline despite the depth of corrosion being similar to that of boiler 3. Comparison of the pH measurements and corrosion rates of the propellers indicate that the main propeller is corroding at a slightly faster rate than the spare propeller. This is probably caused by the more upright and shallower position of the main propeller on the site (Figure 166) where it would be subjected to greater water movement and oxygen impingement increasing the overall corrosion rate as compared to the spare propeller that lies flush with the bottom of the hull remains (Figure 167). The upright pipe possesses a relatively acidic pH and is corroding at more than twice the rate of the other iron features (0.159 mmy^{-1}). This may be explained by the fact that this pipe lies in a shallower, very exposed location in the middle of the site where it would be subjected to greater water movement and oxygen impingement increasing the localised corrosion rate. Also, the surface area of the pipe is much less than the other iron

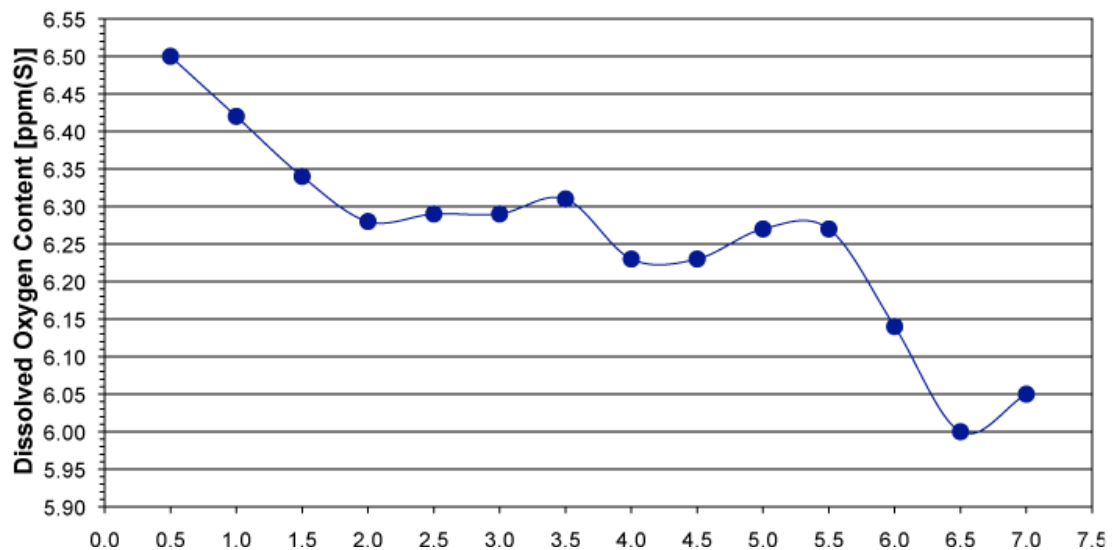
ENVIRONMENTAL CONDITIONS: The temperature, salinity and dissolved oxygen concentration of the water column are shown in Table 17. There was no significant change in salinity and temperature with increasing water depth, which is typical of the hydrology of well mixed near coastal waters. The average water temperature was $27.6 \pm 0.1^\circ \text{C}$ and the average salinity of the water column was 37.3 ± 0.1 ppK. The usual salinity range for the open ocean is 32–36 ppK, however salinity will increase with increasing water temperature so 37 ppK is within range for warmer, shallow coastal waters. The average dissolved oxygen concentration of the sea water was 6.26 ± 0.13 ppm (77% saturation at 28°C), however there was a decrease in dissolved oxygen content with increasing water depth (Figure 164).

Figure 164. Change in dissolved oxygen concentration with increasing water depth measured on the *Zvir* wreck site (Vicki Richards).

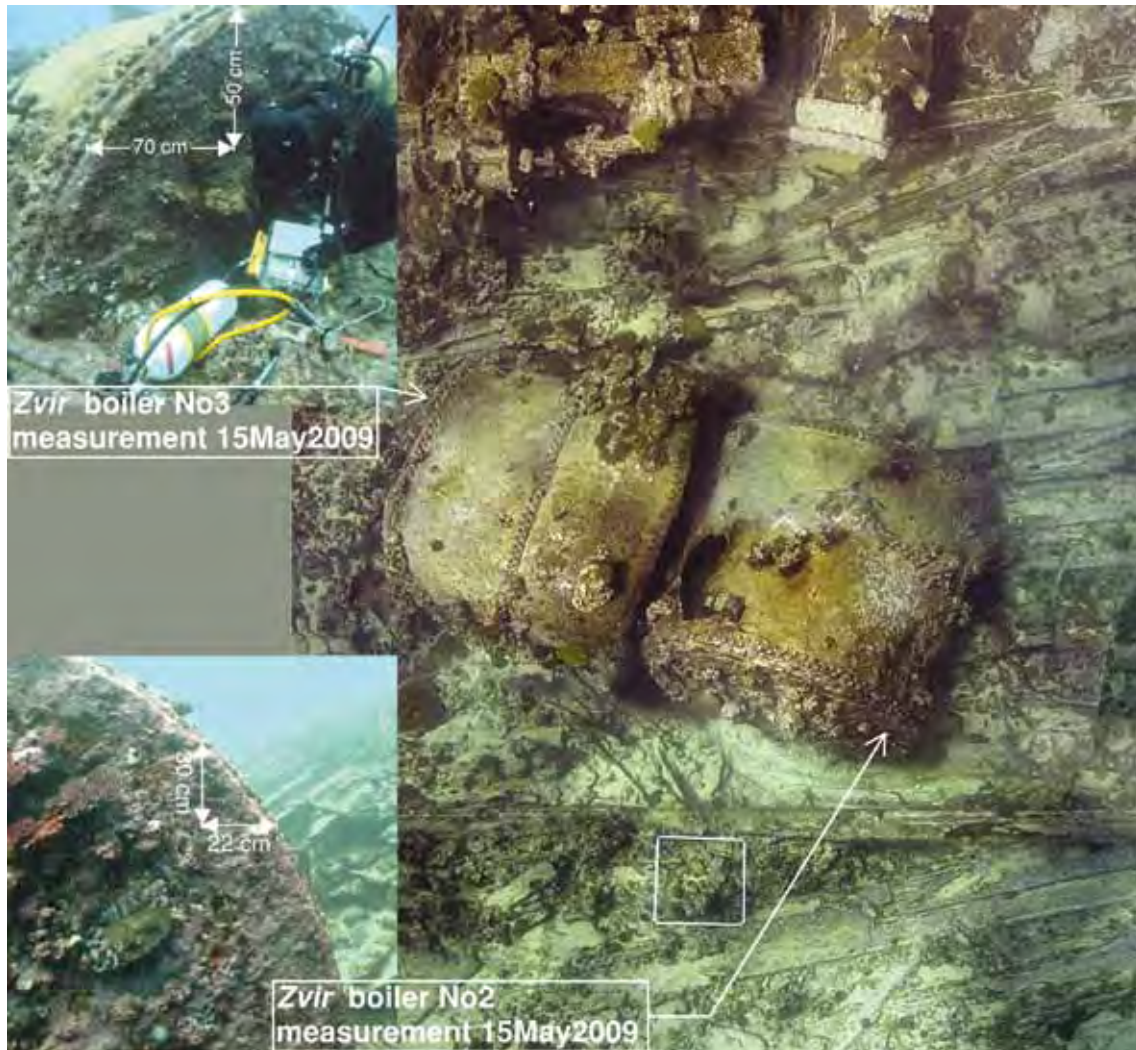
Figure 165. Boiler 2 and 3 on the *Zvir* wreck site (Kalle Kasi and Geoff Kimpton).

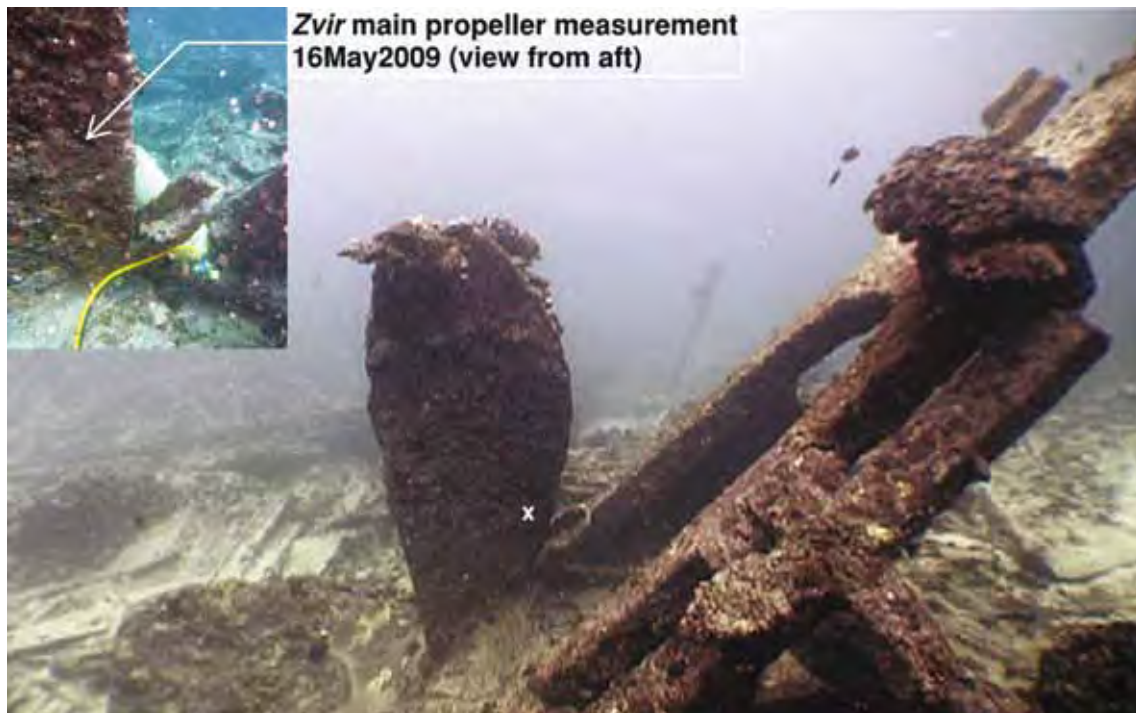
Figure 166. Stern section with the main propeller on the *Zvir* wreck site (Kalle Kasi and Patrick Baker).

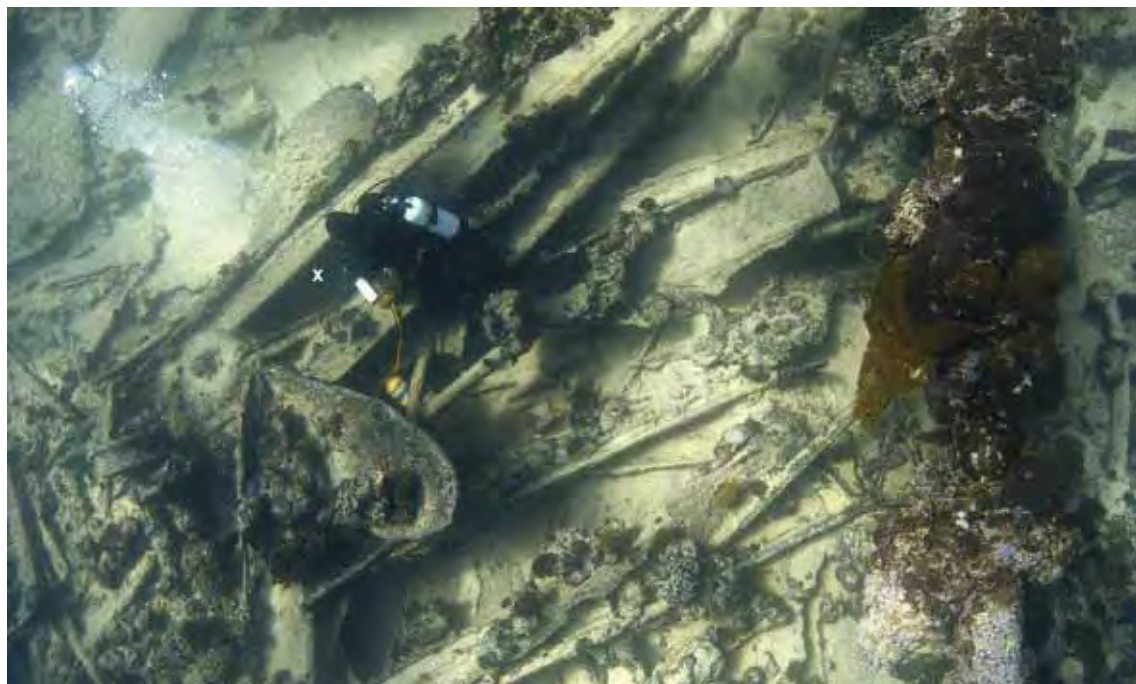
Figure 167. Measurement location (x) on spare propeller on the *Zvir* wreck site (Patrick Baker).

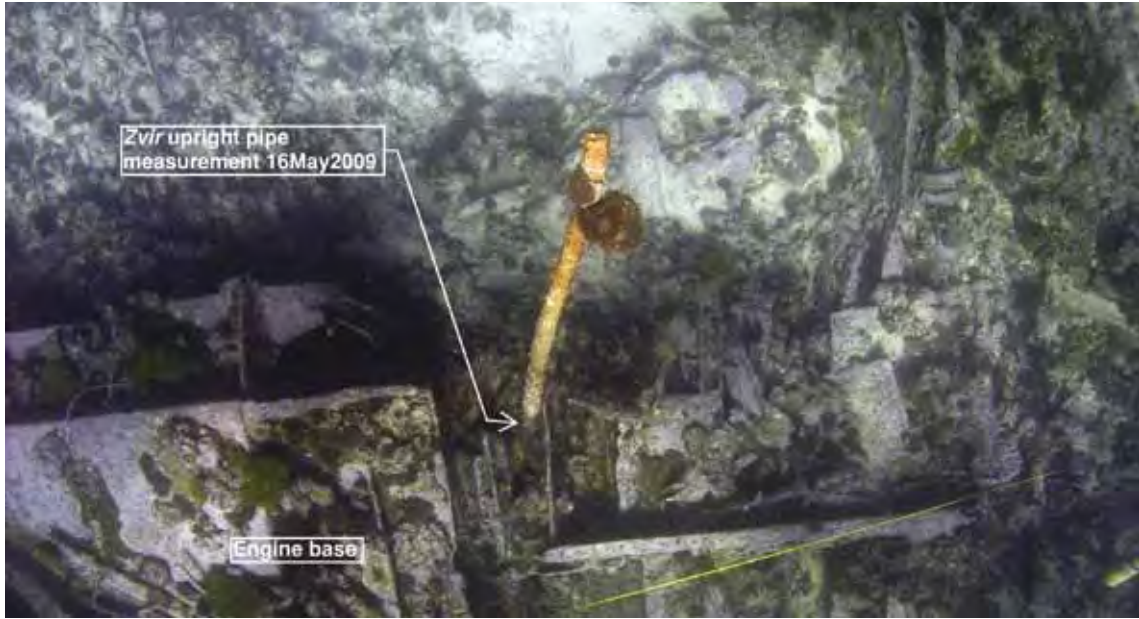
Figure 168. Upright pipe, adjacent to the engine on the *Zvir* wreck site (Kalle Kasi and Patrick Baker).

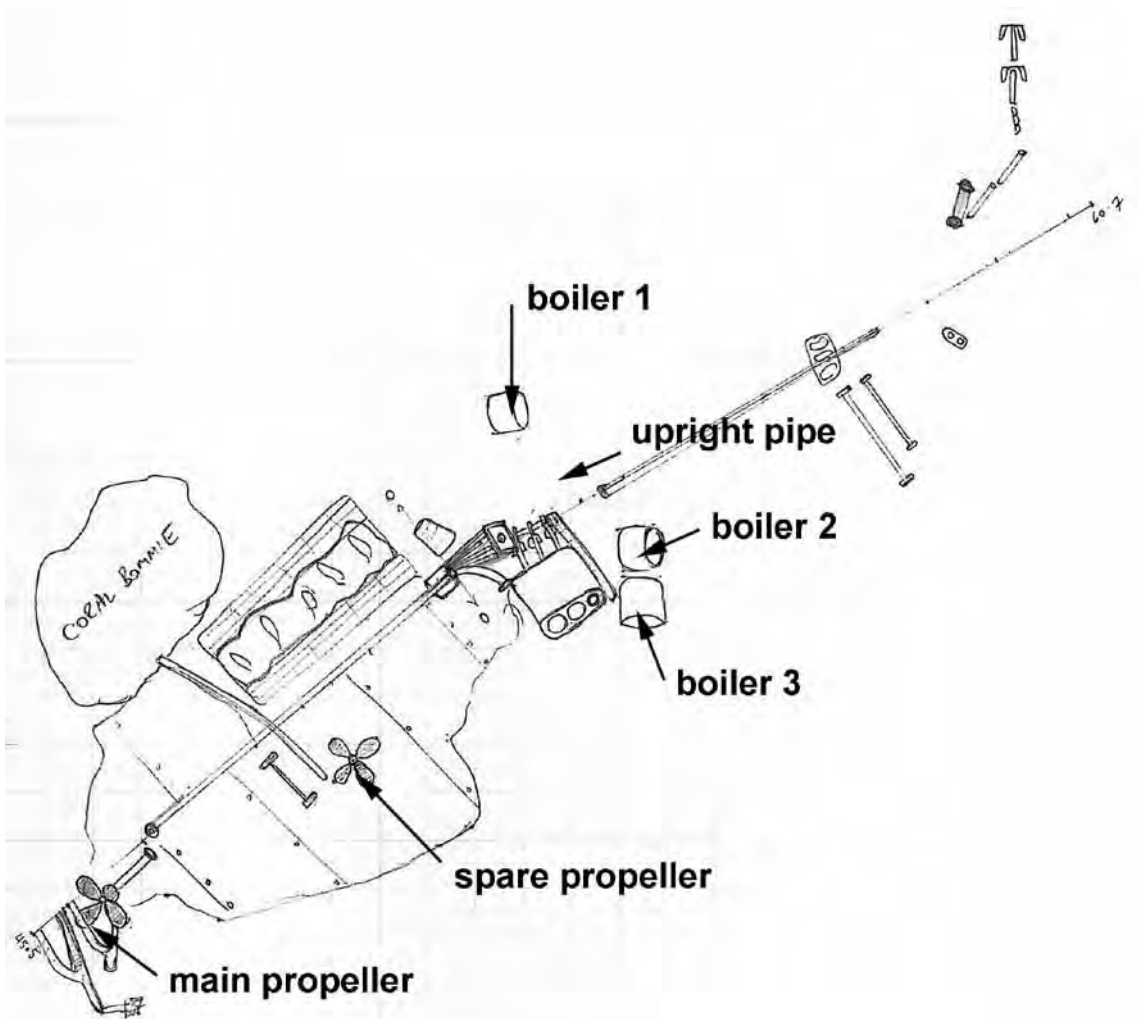
Figure 169. Sketch plan of the *Zvir* wreck site indicating the positions of the structural features measured in 2009 (Kalle Kasi and Corioli Souter).

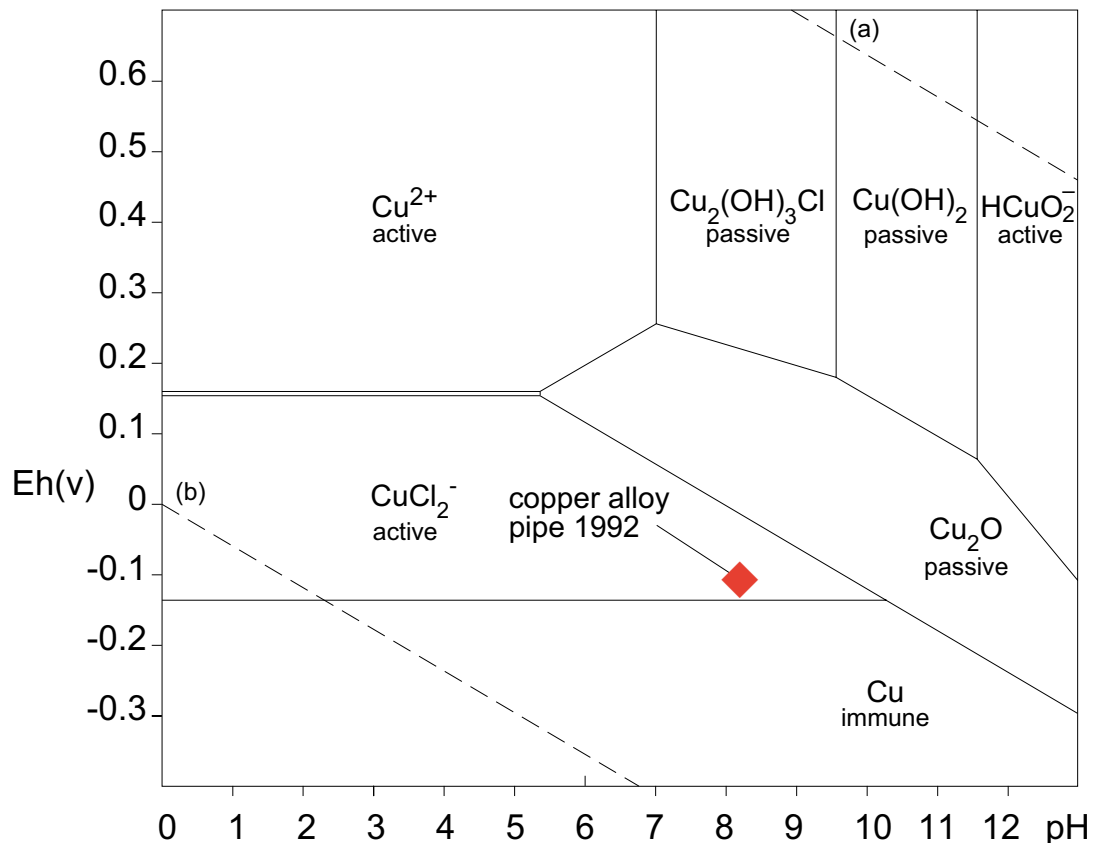
Figure 171. The Pourbaix diagram for copper (10^{-6} molar) in aerobic sea water at 25°C indicating the intercept of the copper alloy pipe measured on the *Zvir* wreck site in 1992 (Vicki Richards).

By plotting the measured voltage and the corresponding surface pH of the copper alloy measured in 1992 on the Pourbaix diagram for copper at 10^{-6} molar in aerobic sea water at 25°C , the thermodynamic stable state of the copper can be ascertained (Figure 171).
