Shipwrecks of the Ningaloo Reef: maritime archaeological projects from 1978–2009

Jeremy Green (Editor)

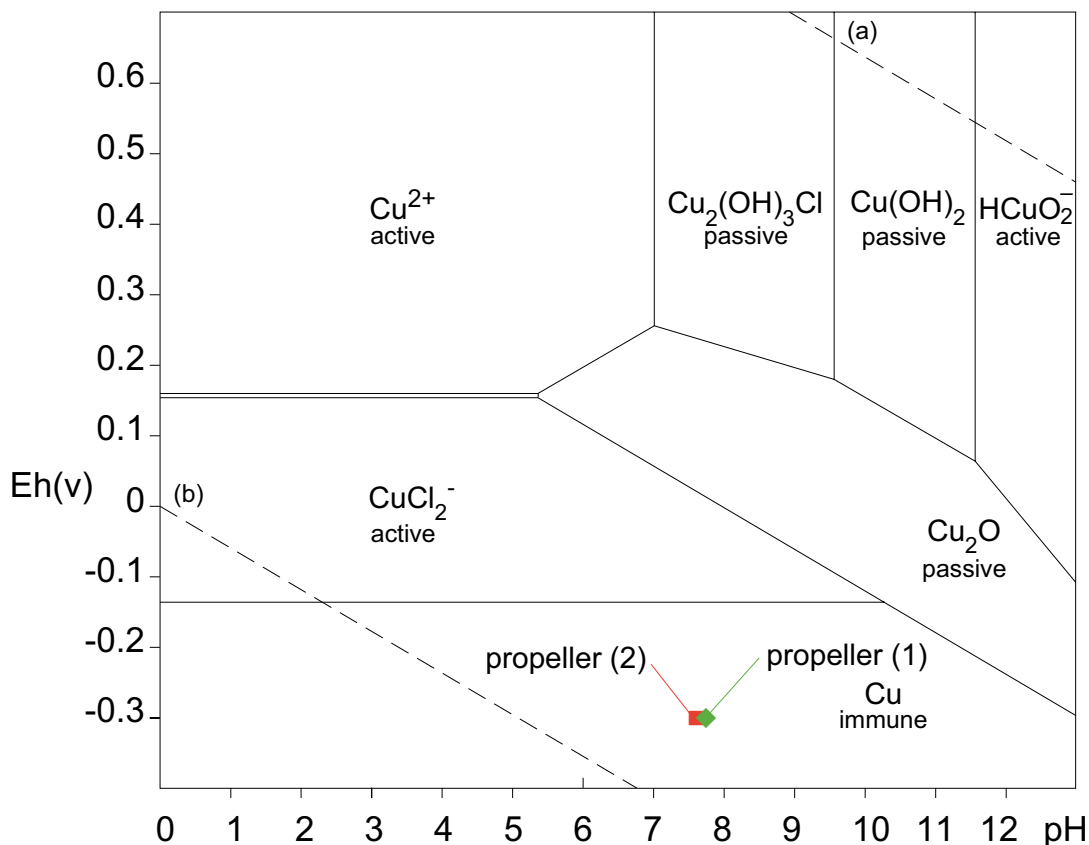
Figure 179. The Pourbaix diagram for copper (10^{-6} molar) in aerobic sea water at 25°C indicating the intercept of the copper alloy propeller measured on the *Chofuku Maru* wreck site in 2009 (Vicki Richards).

The copper alloy propeller on the *Chofuku Maru* site was measured twice in 2009 and the results plotted on the Pourbaix diagram for copper in aerobic sea water (Figure 179).

There was absolutely no variation in the corrosion potential of the propeller measured on two separate locations, which was steady at -0.306 V . However, there was some variation in the pH and the depth of concretion (d_{conc}), where the average pH of the two measurements was 7.68 ± 0.10 and the d_{conc} was $18 \pm 4\text{ mm}$. This is not surprising as these corrosion parameters are more sensitive to small changes in micro-environment and corrosion processes.

Inspection of the copper Pourbaix diagram showed the propeller on the *Chofuku Maru* wreck site lay in the immune region, where copper metal is the most stable species and corrosion does not occur (Figure 179). Corrosion rates for isolated copper samples in oxygenated temperate sea water (approx. 15°C) is about 0.02 mmy^{-1} and this rate appears to increase by a factor of two with every 10°C increase in water temperature. However, copper is usually found only in this immune

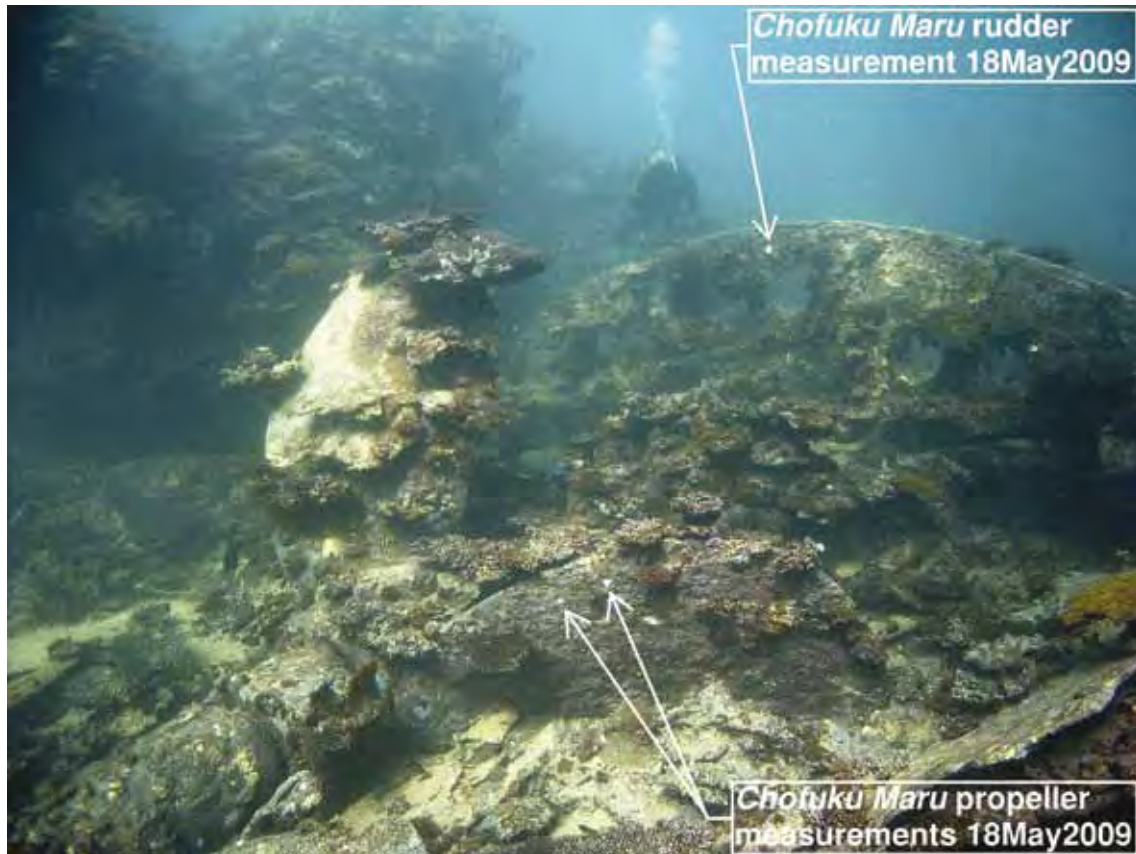
The corrosion parameters of seven structural features (propeller and rudder, Figure 180; propeller shaft, Figure 181; boiler, Figure 182; engine block, Figure 183; deck plate, Figure 184; mast spider band, Figure 185) were measured on the *Chofuku Maru* wreck site. The on-site positions are shown in Figure 186 and the results are presented in Table 19. At the time of the survey, the average water temperature was 26° C and the pH of the sea water was 8.09 at 8.0 m. In order to compare the iron corrosion data collected in 2009 on the *Chofuku Maru*

Figure 180. Propeller and rudder measured on the *Chofuku Maru* wreck site in 2009 (Kalle Kasi and Patrick Baker).

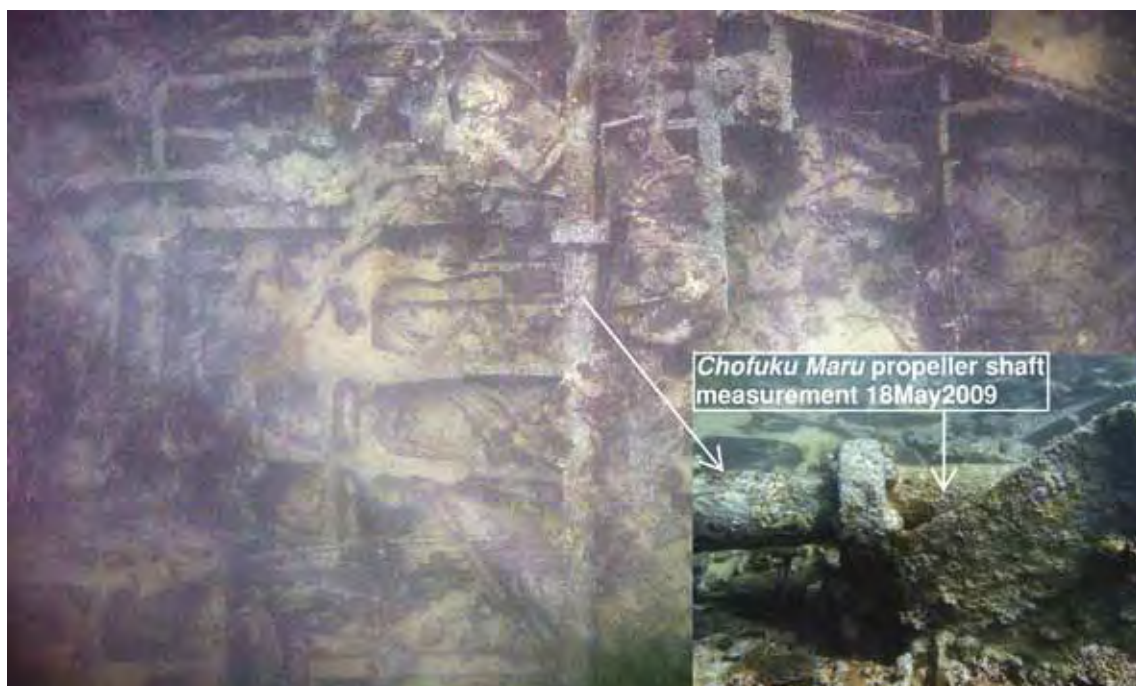
Figure 181. Propeller shaft measured on the *Chofuku Maru* wreck site in 2009 (Kalle Kasi and Patrick Baker).

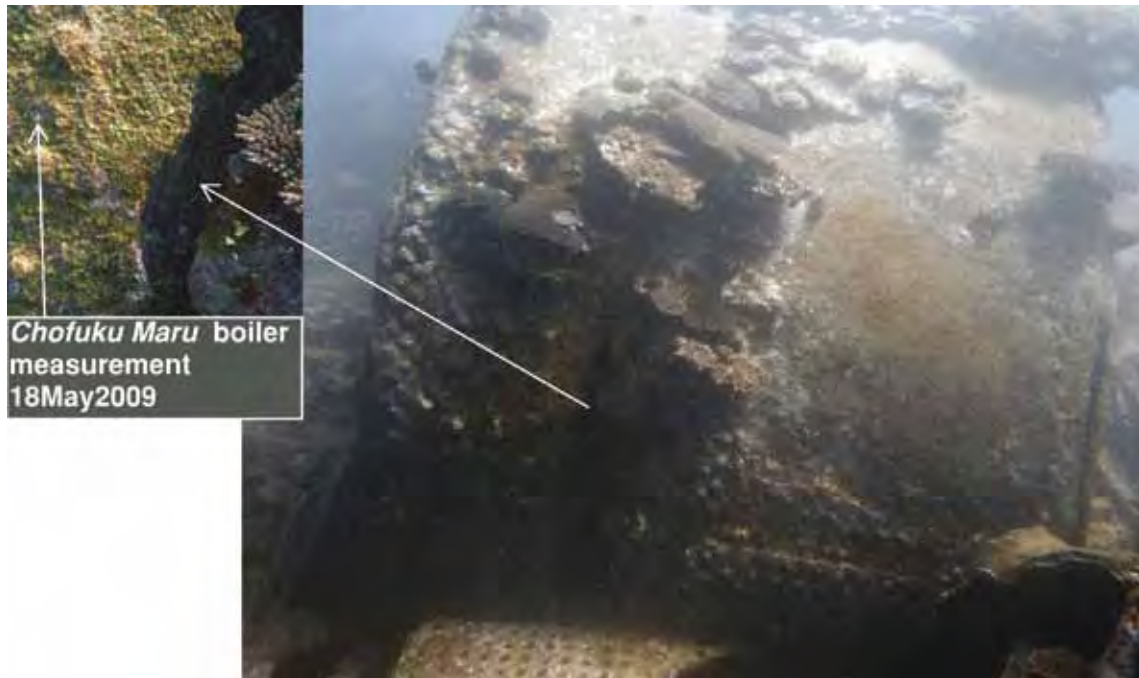
Figure 182. Boiler measured on the *Chofuku Maru* wreck site in 2009 (Kalle Kasi and Patrick Baker).

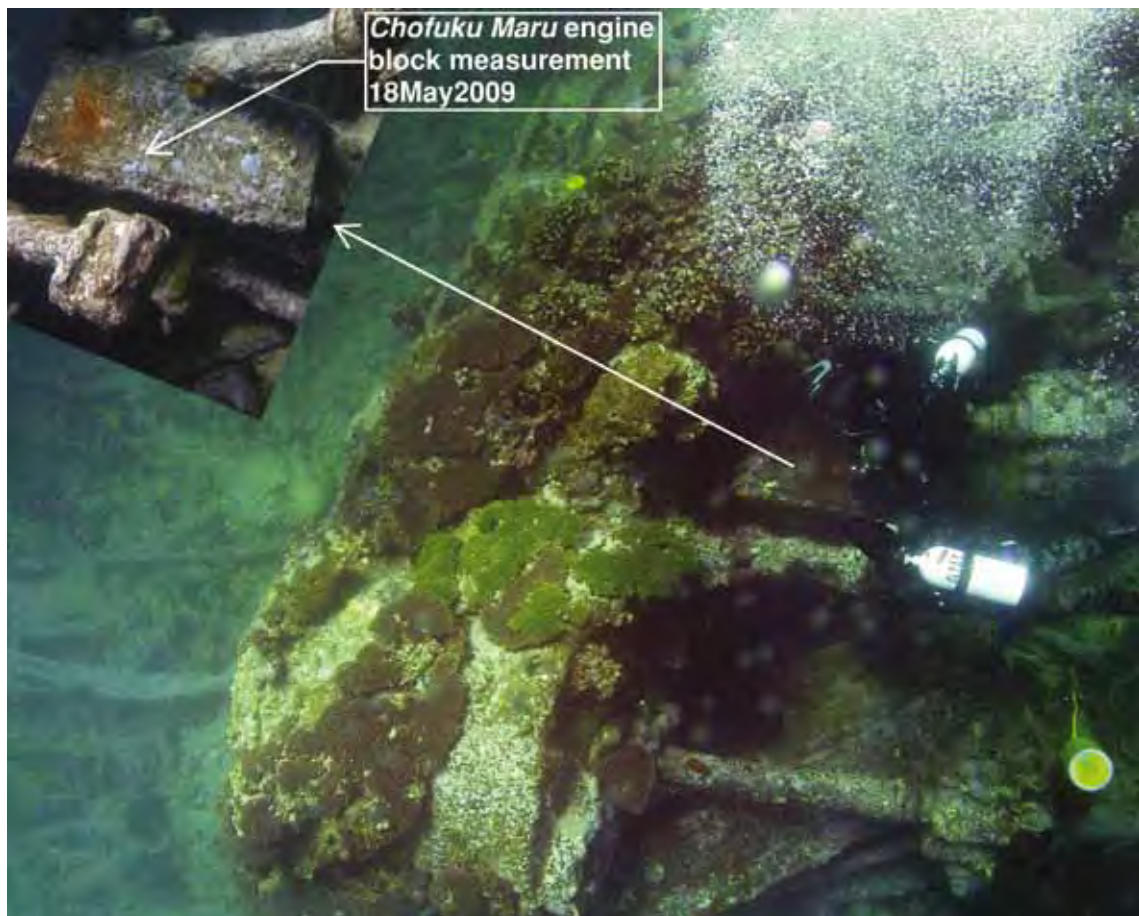
It has been shown that pH data is a useful guide to estimating corrosion rates of concreted iron, since the pH generally decreases with increasing corrosion rate. However, the average depth of concretion on these iron features was very thin at 2 ± 2 mm and three of the iron features possessed no concretion at all again making it difficult to predict corrosion rates using these pH measurements. It should be noted, however that the iron features covered with thin layers of concretion (propeller shaft, boiler and mast spider band) had much lower pHs (average pH = 5.49 ± 0.12) than the rudder, engine block and deck plate that were devoid of concretion (average pH = 6.67 ± 0.36) suggesting that the latter iron structural features possessed lower corrosion rates. On the other hand, the annualised corrosion rates (d_g) (Table 19) calculated from the measured depths of corrosion and the years of submersion (78 years) indicated that the rudder, propeller shaft and boiler possessed the lowest corrosion rates, with the average being 0.098 ± 0.007 $\text{mm} \cdot \text{y}^{-1}$, which is similar to the standard corrosion rate for isolated mild steel in sea water (0.11 $\text{mm} \cdot \text{y}^{-1}$). The deck plate and the mast spider band were corroding at 0.173 ± 0.009 $\text{mm} \cdot \text{y}^{-1}$, which was almost twice the rate of the rudder, propeller shaft and boiler. Finally the highest corrosion rate was 0.308 $\text{mm} \cdot \text{y}^{-1}$ for the engine block.

mechanism occurring on the engine due to the different metal compositions of the engine parts in direct electrical connection causing increased corrosion through galvanic coupling.

Figure 183. Engine block measured on the *Chofuku Maru* wreck site in 2009 (Kalle Kasi and Patrick Baker).

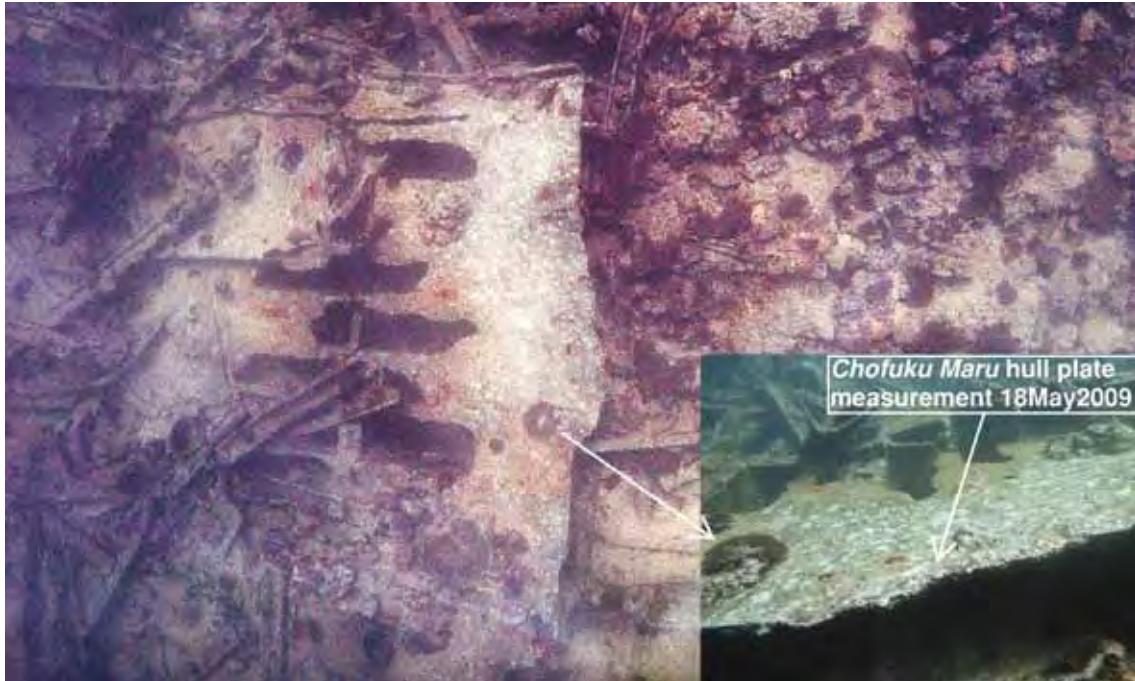
Figure 184. Deck plate measured on the *Chofuku Maru* wreck site in 2009 (Kalle Kasi and Patrick Baker).

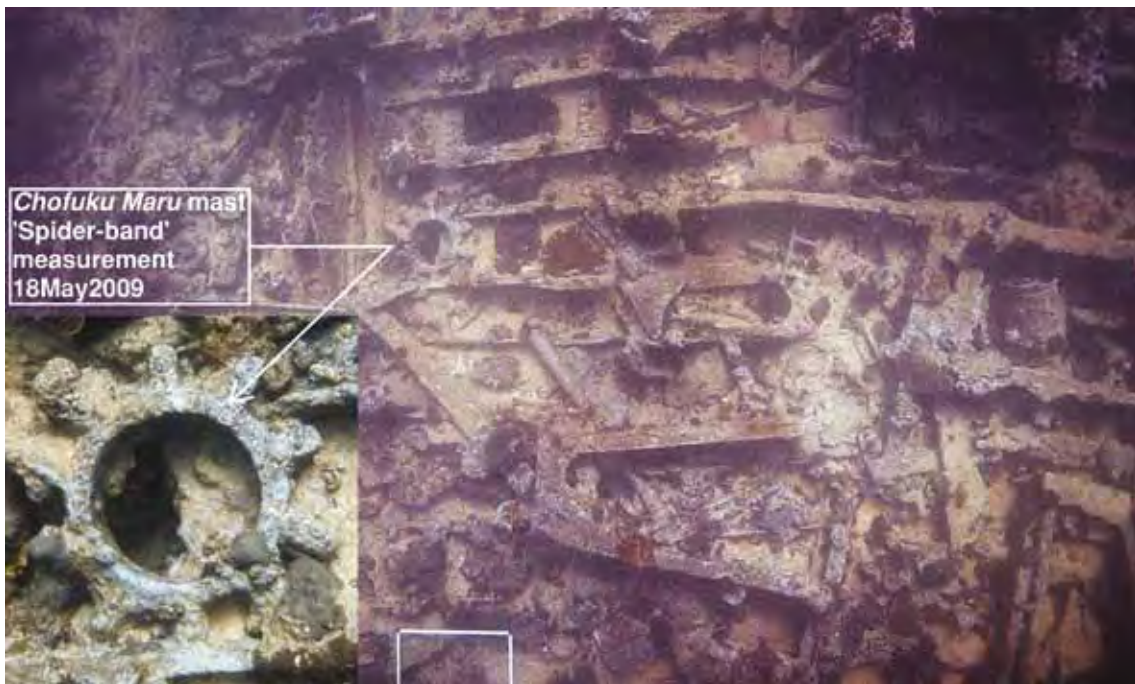
The lower corrosion rates observed for the rudder, propeller shaft and boiler could be due to their increased size and possible direct electrical contact with other large structural features on the wreck site, where the current density of the corrosion process would be spread over a much larger surface area, effectively lowering the corrosion rate as compared to isolated iron artefacts, such as the mast spider band, which will corrode at a much faster rate.

Figure 185. Mast spider band measured on the *Chofuku Maru* wreck site in 2009 (Kalle Kasi and Patrick Baker).

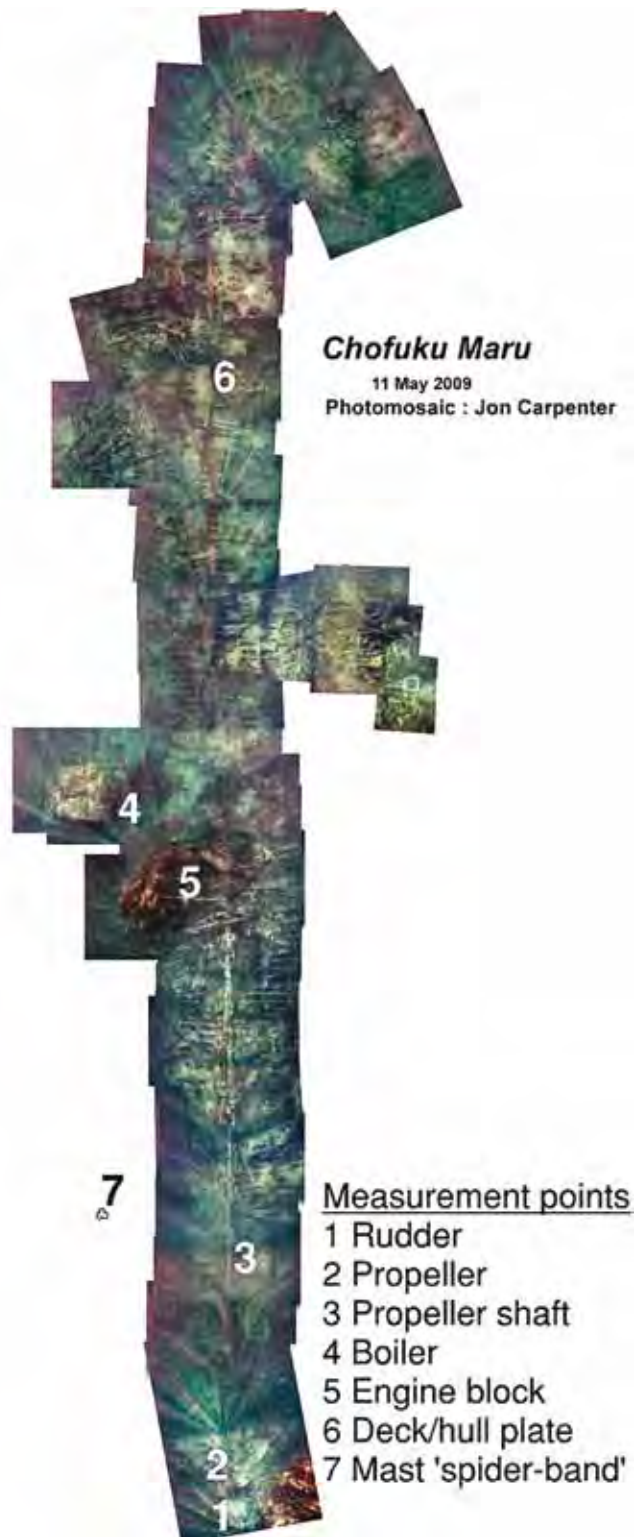
Figure 186. Photomosaic of the *Chofuku Maru* wreck site indicating the positions of the structural features measured in 2009 (Kalle Kasi, after photomosaic by Jon Carpenter and Patrick Baker).

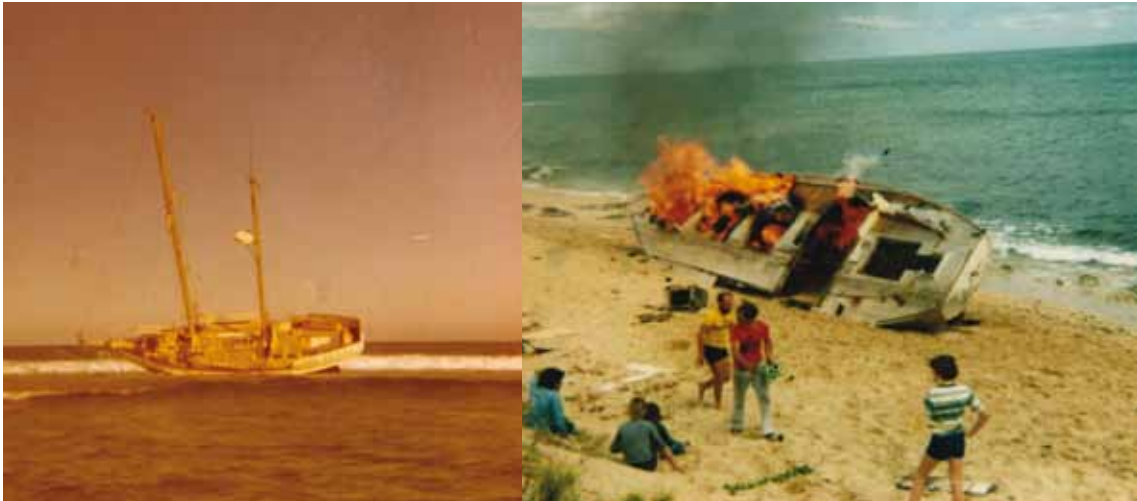
Figure 197. The *Three Sisters* wrecked and then burnt (Brian Stagg).
