The *REDEMPTORA*

Report-Department of Maritime Archaeology
Western Australian Maritime Museum No. 166

**REDEMPTORA
WRECK INSPECTION REPORT**

Inspected 6th September 2002

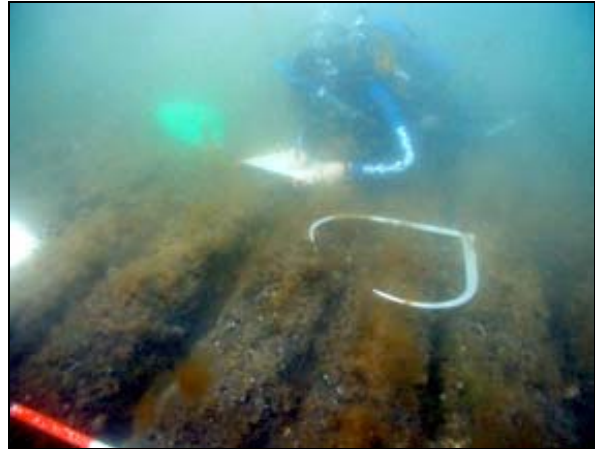
Figure 11. Grant Luckman measuring frames.

Wooden construction sheathed with copper. Through bolts made from Brass. No evidence of Iron. It appears that the wreck has broken off at the turn of the bilge and therefore all that survives is the hull and the turn on one side. The hull remains are; frames (running NW/SE), outer planking (running NE/SW) and stringers that run in the same direction as the outer planking.
