The 2012 Bunbury Jetty Survey

Report prepared for City of Bunbury

Jeremy Green

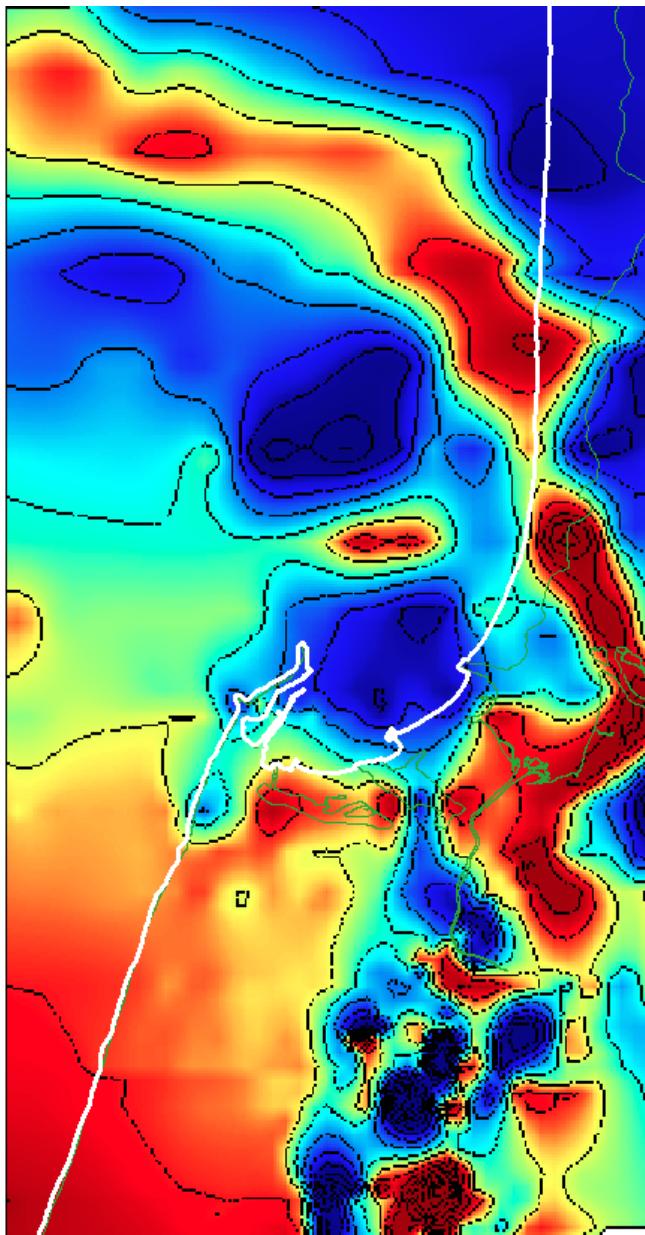
The magnetometer, as it turned out, was not practical to use on the Bunbury Jetty Survey. Within the first few minutes of operation it was found that there were large geomagnetic anomalies in and around the jetty. In addition a large bulk carrier, *BBC Zarate*, which was anchored on the modern Berth 1 to the north-west of the jetty that created an additional magnetic signal (Figure 1). Subsequently, the Geoscience Australia website <www.geoscience.gov.au> was consulted and it was found that the region has a considerable amount of geomagnetic variation (Figure 2).

Figure 2. Magnetic field intensity map centred in the Bunbury region (data source Geoscience Australia).

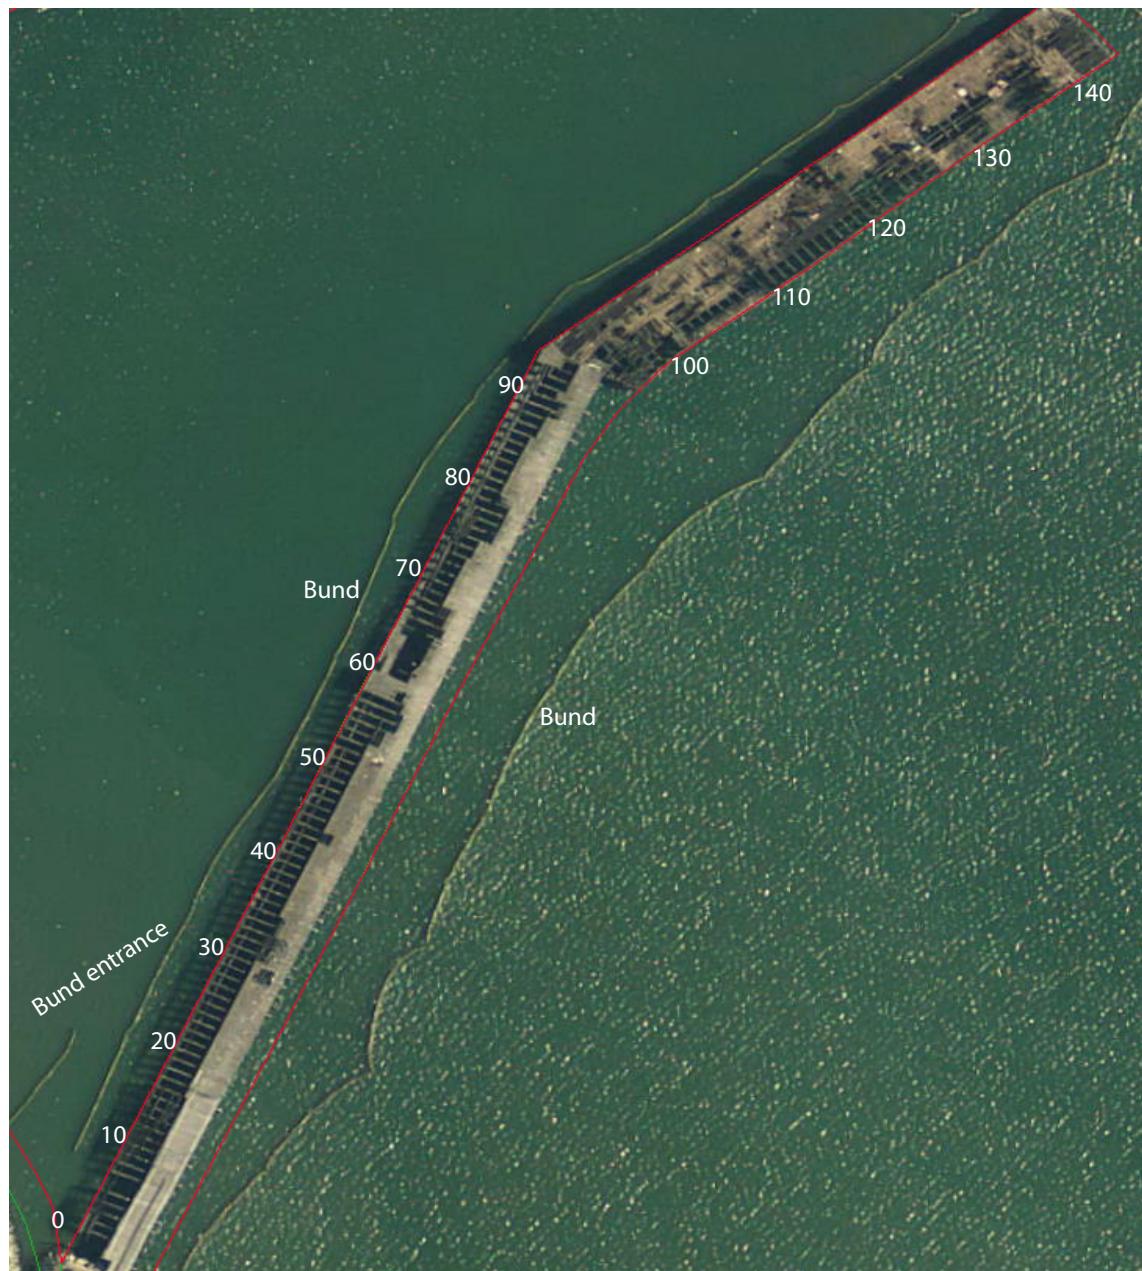
It was immediately obvious that the survey was going to be limited by a floating bund (Figure 3), designed to contain any material that became unattached from the jetty, that otherwise would become a navigation hazard. There was a small entrance that allowed access to the area between the bund and the jetty, so it was decided to first carry out a broad survey around the jetty on the outside of the bund and then enter the inside area and carry out a survey closer to the jetty.

Figure 3. Jetty showing bund and bent numbers used in reference to targets on survey.

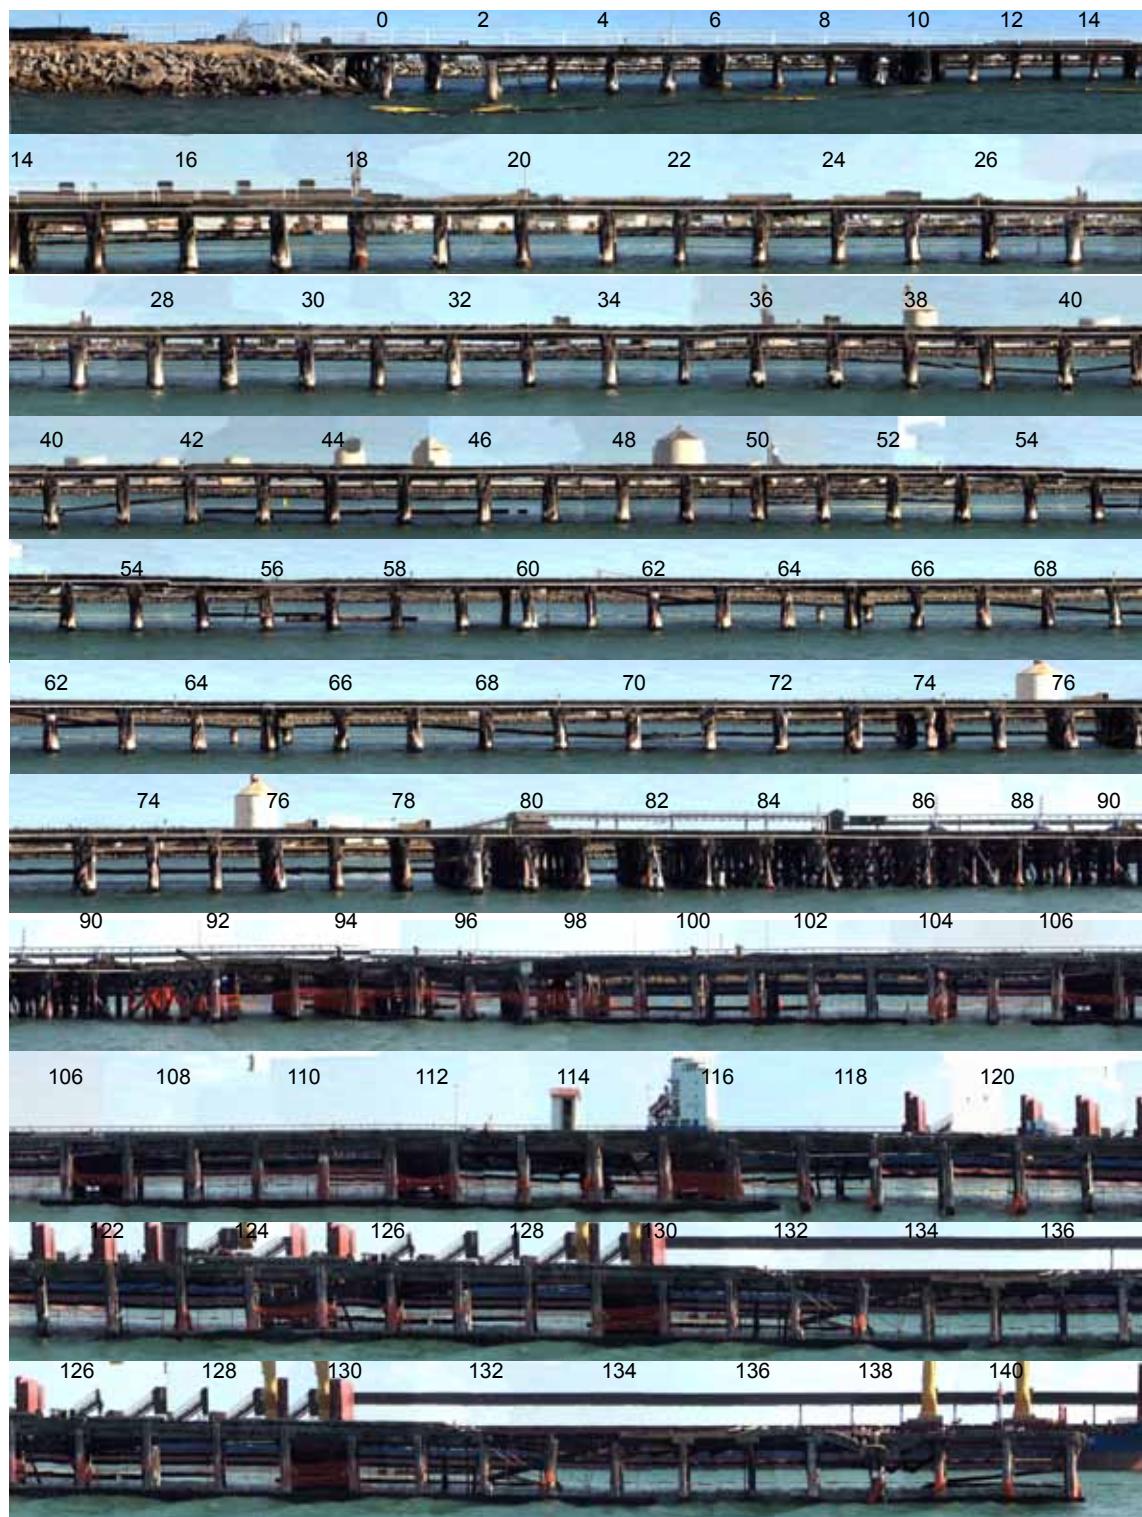
Figure 4. Ortho photograph of the east side of jetty with bent numbers.

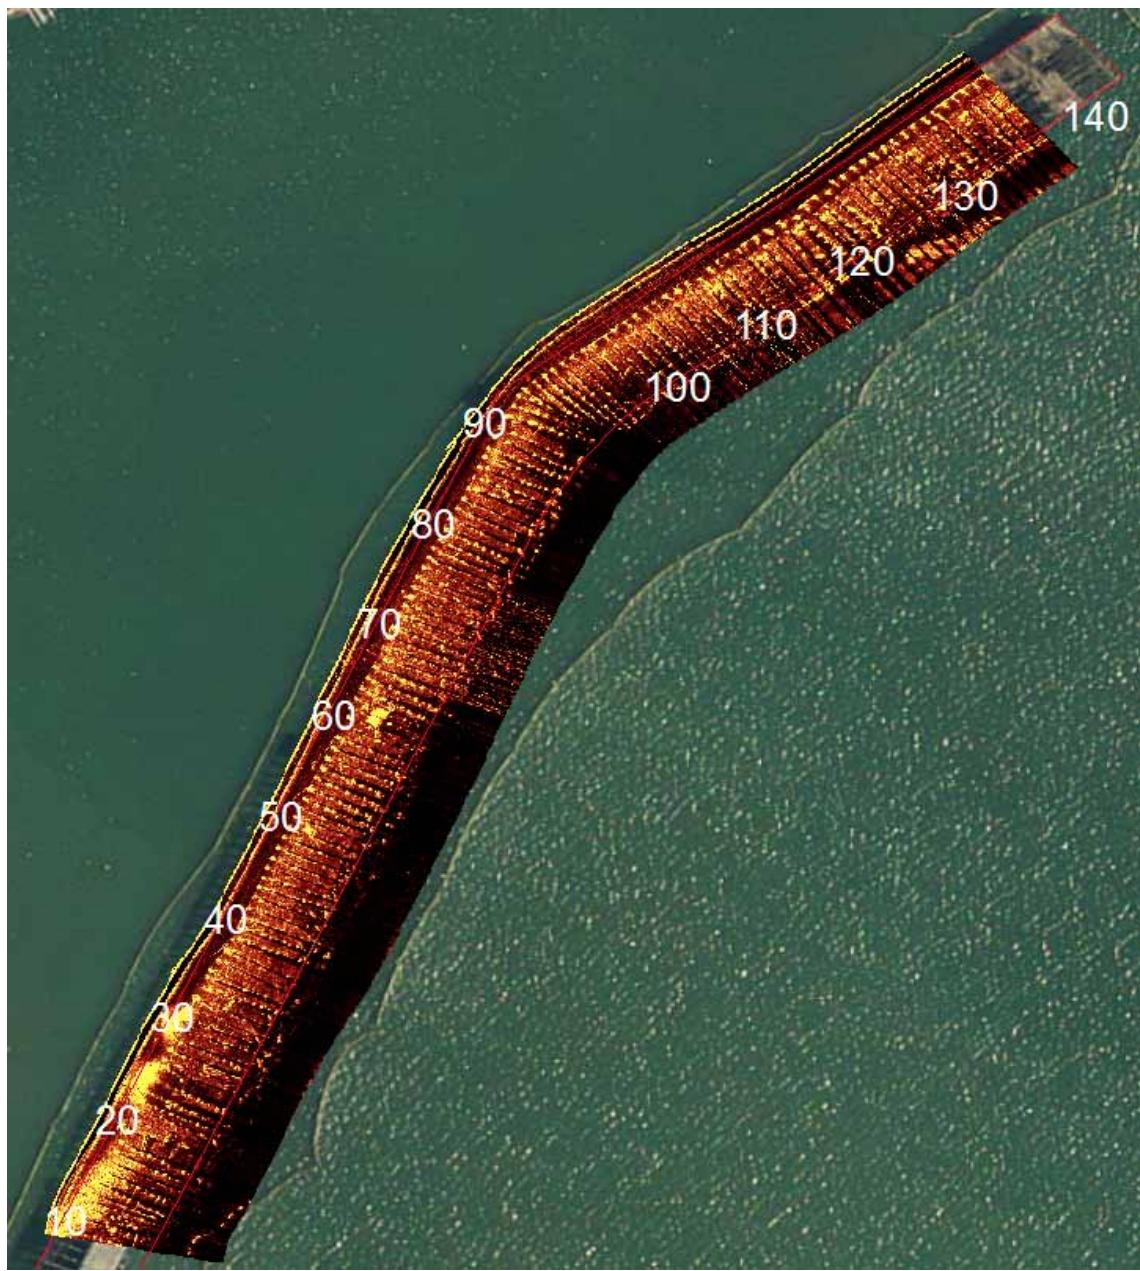
Figure 10. Fifth sonar run (MST 031–035).

This was a single channel run in a southerly direction on the west side of the jetty (Figure 10). This showed a number of unusual features including one at Bent 22 (Figure 12), possibly dolphins seen in Run 1, MST 003–005 (Figure 5). In addition, submerged bents, about 5 m long were noted at Bents 39, 54, 57, 99, 110, 125 and 134 (Figure 14 and Figure 15).

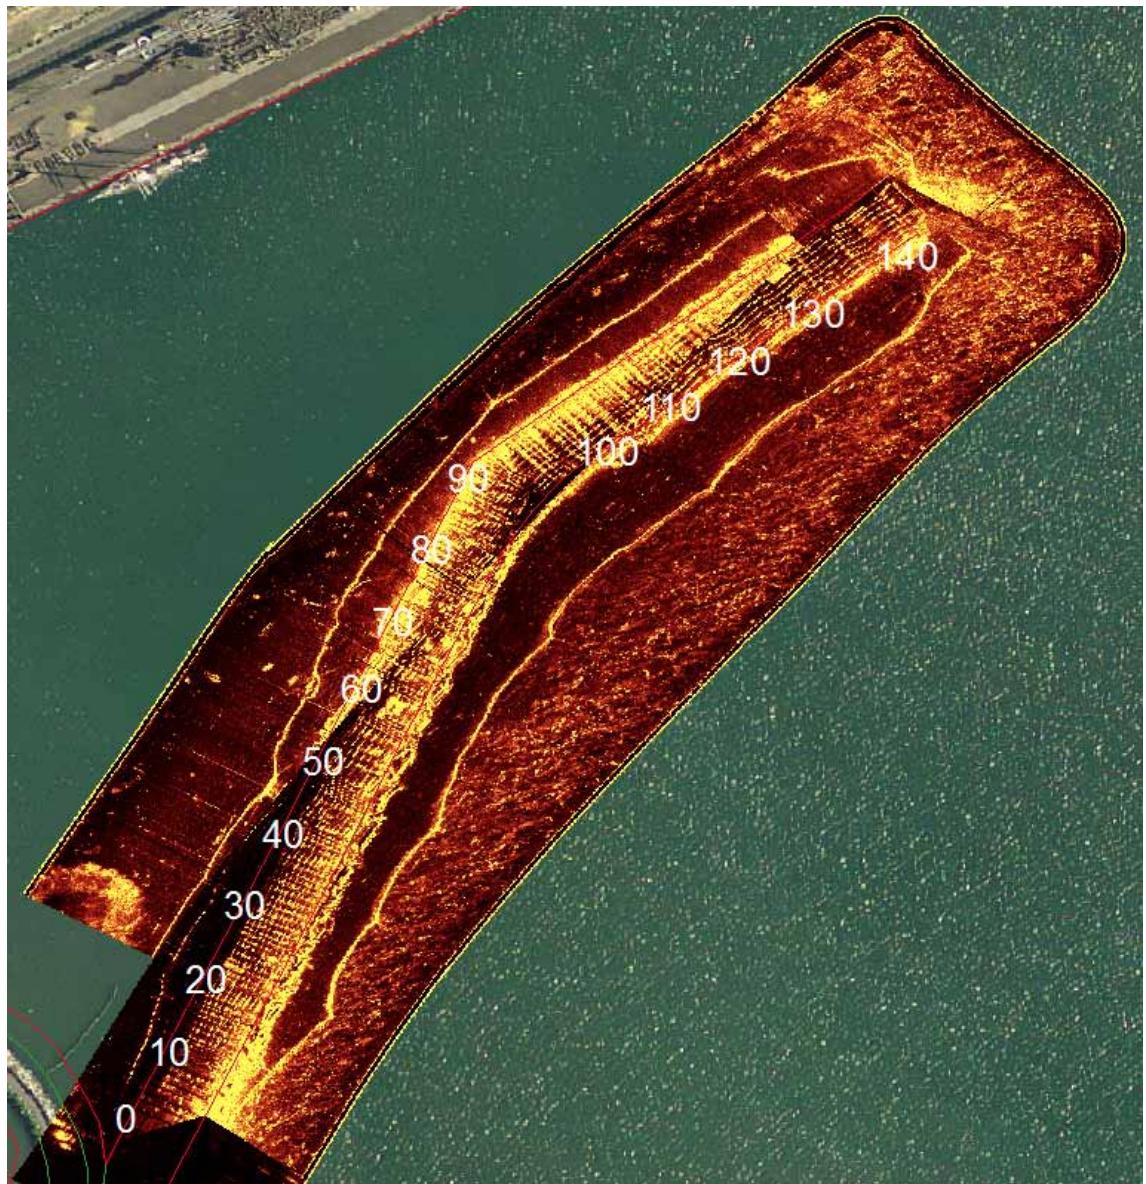
Figure 11. Sixth sonar run (MST 037–043).

This was a single channel run in a clockwise direction around the jetty (Figure 11), the three objects could possibly be dolphins that were observed earlier on the east side of the jetty near the junction with the solid rock groyne (MST 003–005).
