Glenfields Beach timber inspection and identification

Ross Anderson

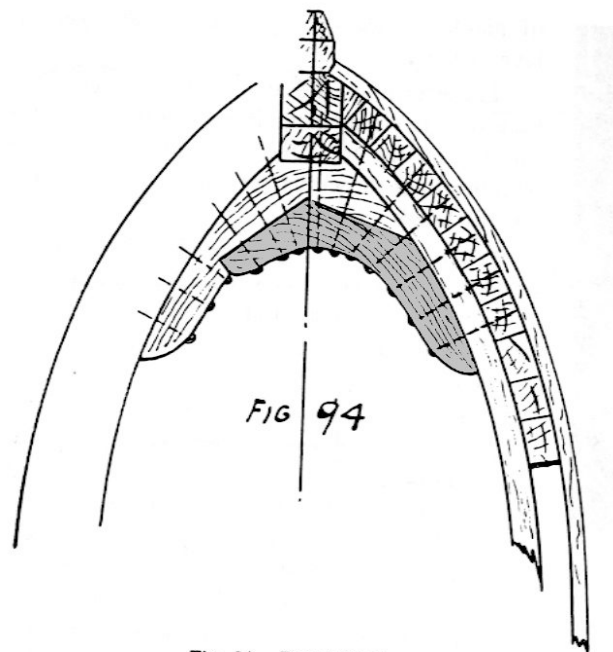
The breasthook is a major structural timber placed horizontally in the bow to give strength to the bow frames, shelf, apron and clamps. 'Breasthook ecking' is a term used to describe breasthook timbers used to lengthen and increase the size of the breasthook, where a grown timber of a suitable size and shape could not be sourced (Bill Leonard, pers. comm. 14/6/10).

Figure 7. Plan view of bow timbers showing a breasthook made up of two large timbers (Desmond 1919: 104). Note angled surfaces and oblique line of fastenings on the shaded timber, and directions of grain to impart maximum strength. This timber is described as 'breasthook ecking' (Leonard, B. pers. comm. 14/6/10).

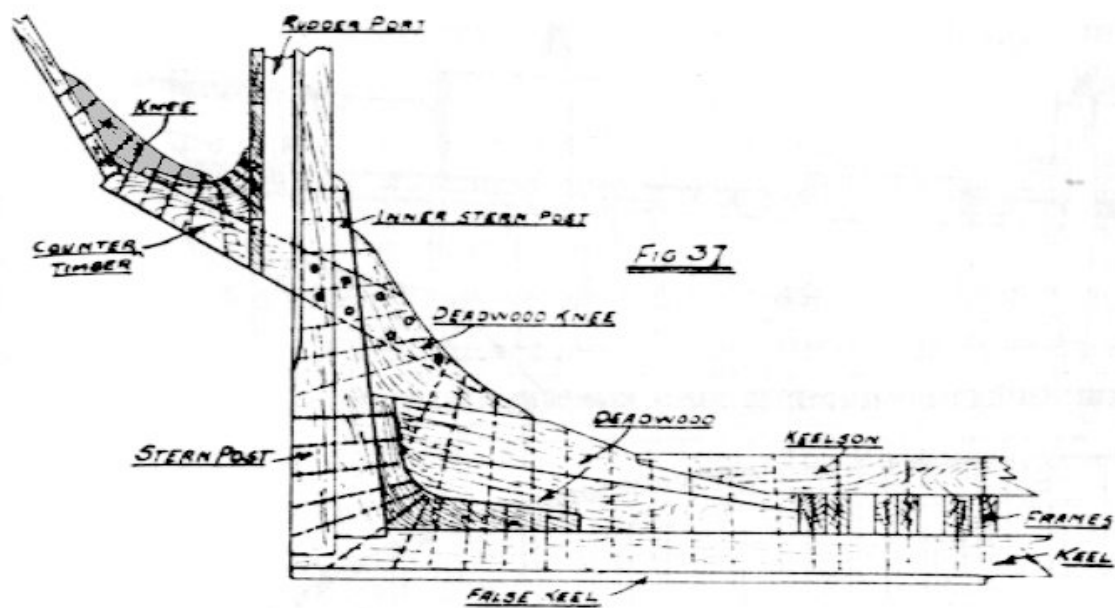
Figure 8. Transom or counter knee at stern of vessel (shaded), note angular shape to fit counter timber and transom, though this knee is scarph-joined with another knee (Desmond 1919: 51).

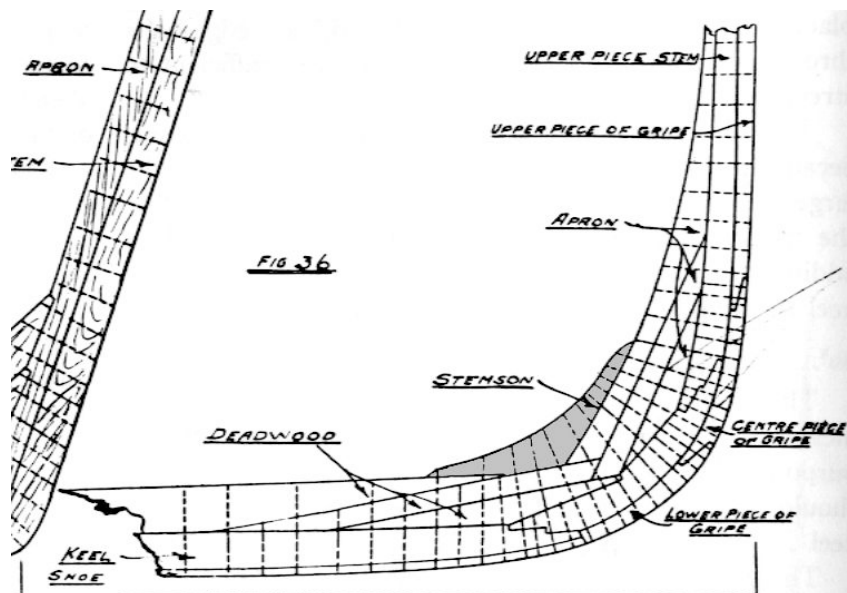
Figure 9. Stemson knee in bow of vessel (shaded) - note straight sides (Desmond 1919: 50).

If the timber is a stemson knee or breasthook, the size of the fastening holes and fastenings is in the range of 32-34 mm allowing for fastenings of $1 \frac{1}{4}$ - $1 \frac{5}{16}$ " diameter, consistent with Lloyds specifications for heel-knee, stemson and deadwood copper alloy/ yellow metal bolts for a vessel between 450 tons ($1 \frac{1}{4}$ ") and up to 899 tons ($1 \frac{5}{16}$ ") (Desmond 1919: 21).
