# 'Butterfly Bay' Site Inspection Report South of Yardie Creek, North West Cape

Report – Department of Maritime Archaeology, Western Australian  
Museum, No. 291

**Site Name:** Butterfly Bay Unidentified

**Date Inspected:** 17 June 2012

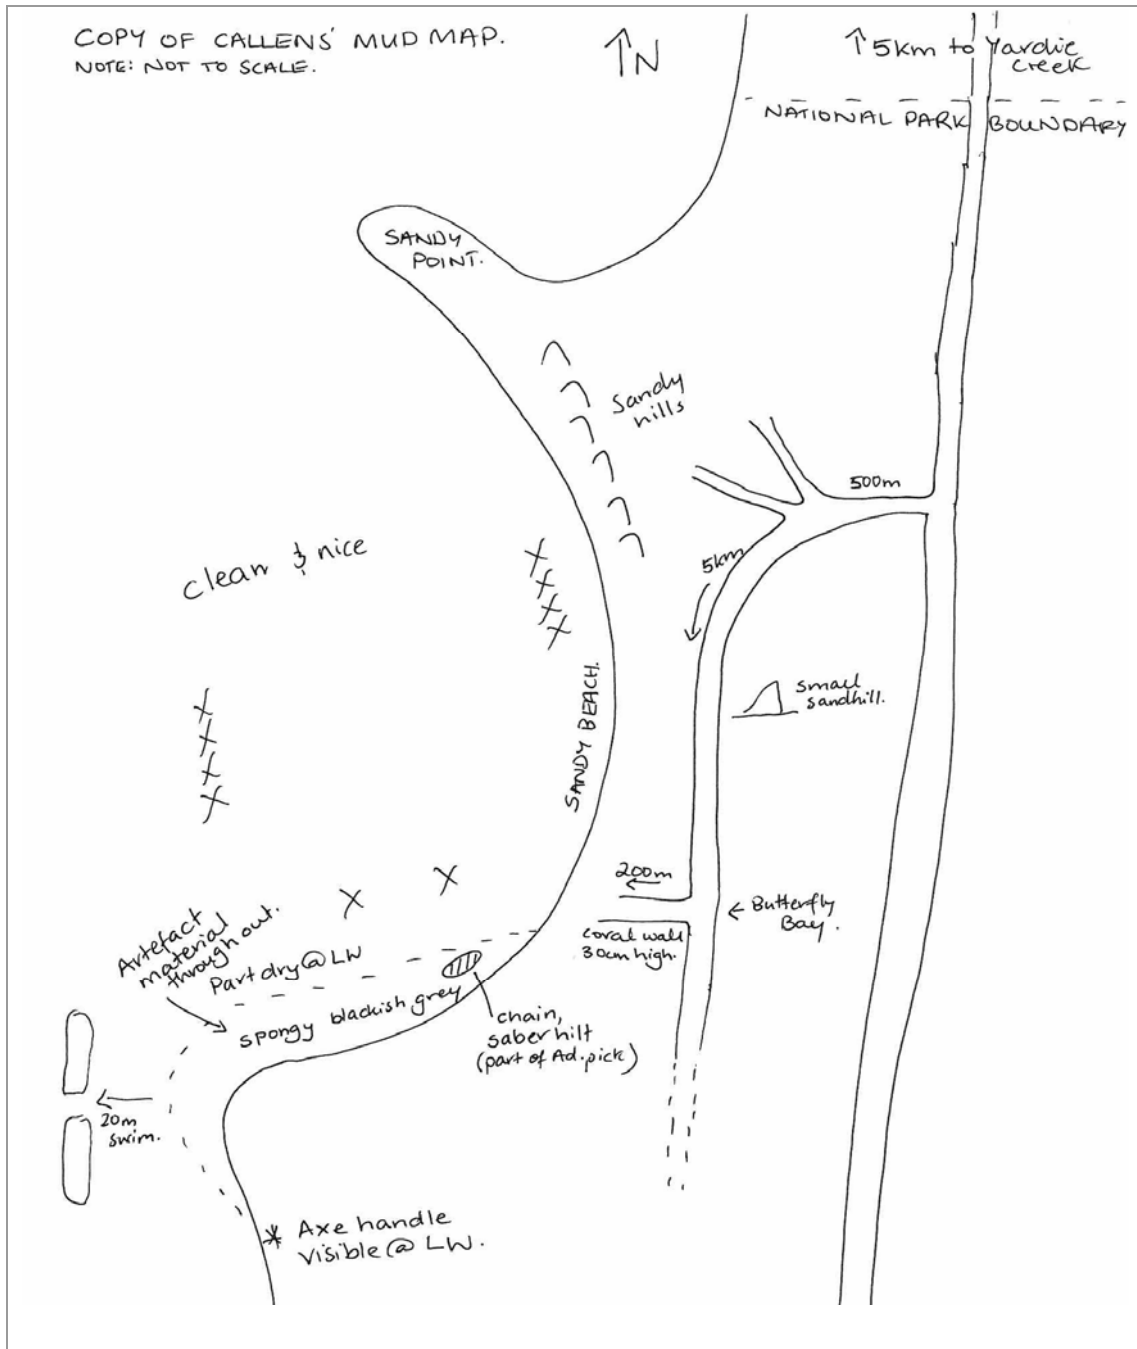
Figure 2. Copy of Callen Family's mud map of 'Butterfly Bay'.

The mud-map and directions were accurate enough to allow the site to be located with ease. Furthermore, the mud-map locating the wreckage was clear and allowed for a thorough and methodical search of the area.
