# **THE HAMELIN BAY, JERVOISE BAY AND MANDURAH SHIPWRECKS**

A field exercise linking wreck site archaeological research  
With wreck trail promotion

Submitted by Ed Punchard as a course requirement for the  
Graduate Diploma in Maritime Archaeology (MA 592)

Report—Department of Maritime Archaeology, Western Australian Maritime  
Museum, No. 140

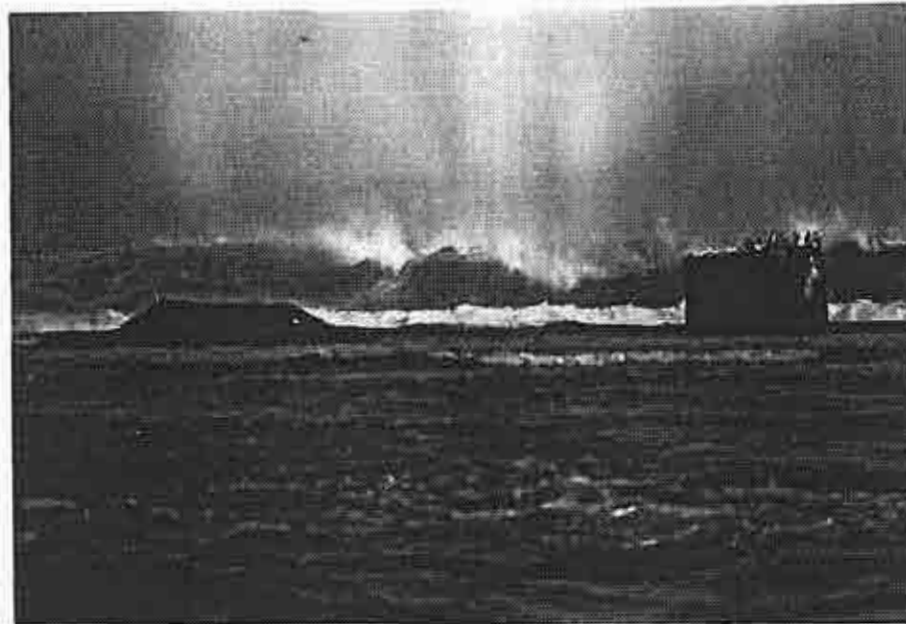
Figure 2a. The boiler of the S.S. *Windsor*, tipped up an Abrolhos shallow and showing the effect well.

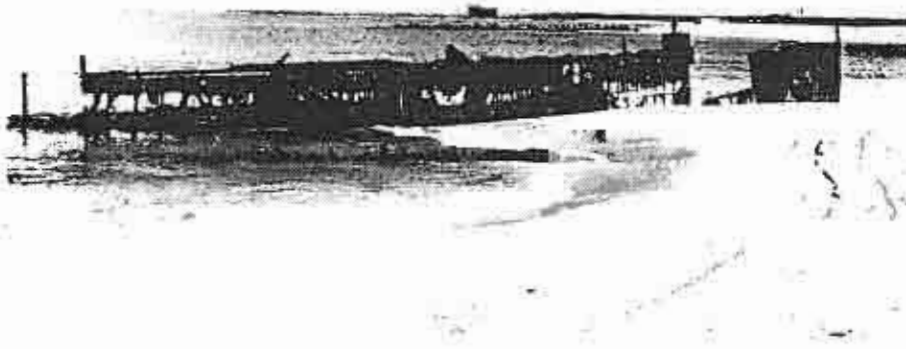
Figure 5. The *Alacrity*, further degraded with *Abemama* in foreground.

It is therefore reasonable to state, that despite the long period when it deteriorated in a beach environment, the *Alacrity* is finally degrading in the ways that Riley has suggested. Whilst beached the *Alacrity* appeared to an extent to have sunk to the approximate water-line as shown in figure 5. Early salvage of heavy machinery will effect the final degradation it undergoes underwater.

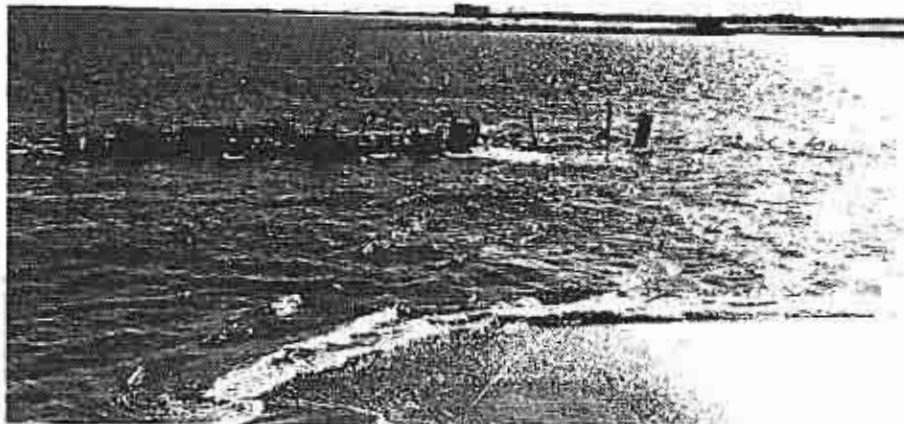
Figure 6. The *Alacrity*, as the coastal changes take effect.

Having lasted remarkably well in its beached position the past years have resulted in considerable further deterioration. However, whilst many of its plates have now collapsed around the turn of the bilge, and the wreck is a beached wreck, there are a number of features where the wreck coincides with the Riley model. The bow and stern remain upright and distinguishable. Also and most noticeably, several major bulkheads are in place forming support for the adjacent ribs and plate work.

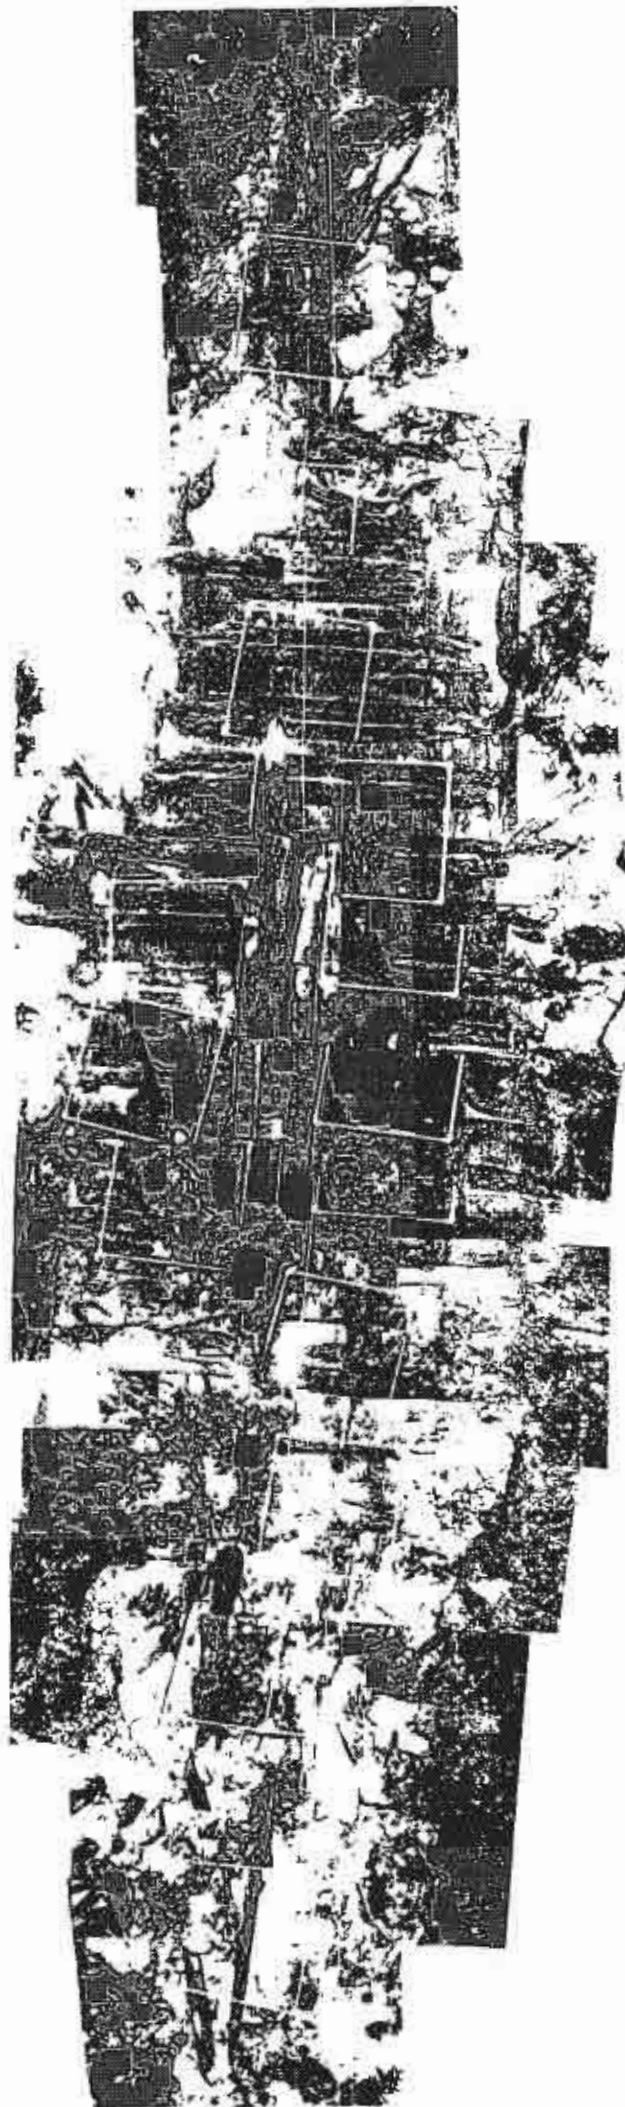
Figure 29. Photomosaic of the Star wreck site 19

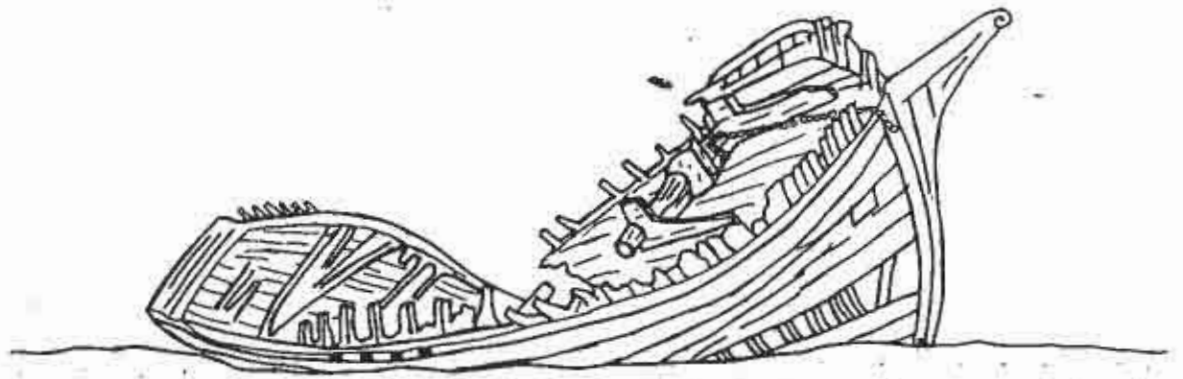
Figure 30. A wooden ship having beached quickly loses its structural strength<sup>22</sup>.
